**ASSESSMENT OF STEELHEAD PASSAGE BARRIERS IN  
PORTIONS OF FOUR TRIBUTARIES TO THE CARMEL RIVER**

**Monterey Peninsula Water Management District  
IRWM - PROJECT 3**

**Final Project Report - July 2014**

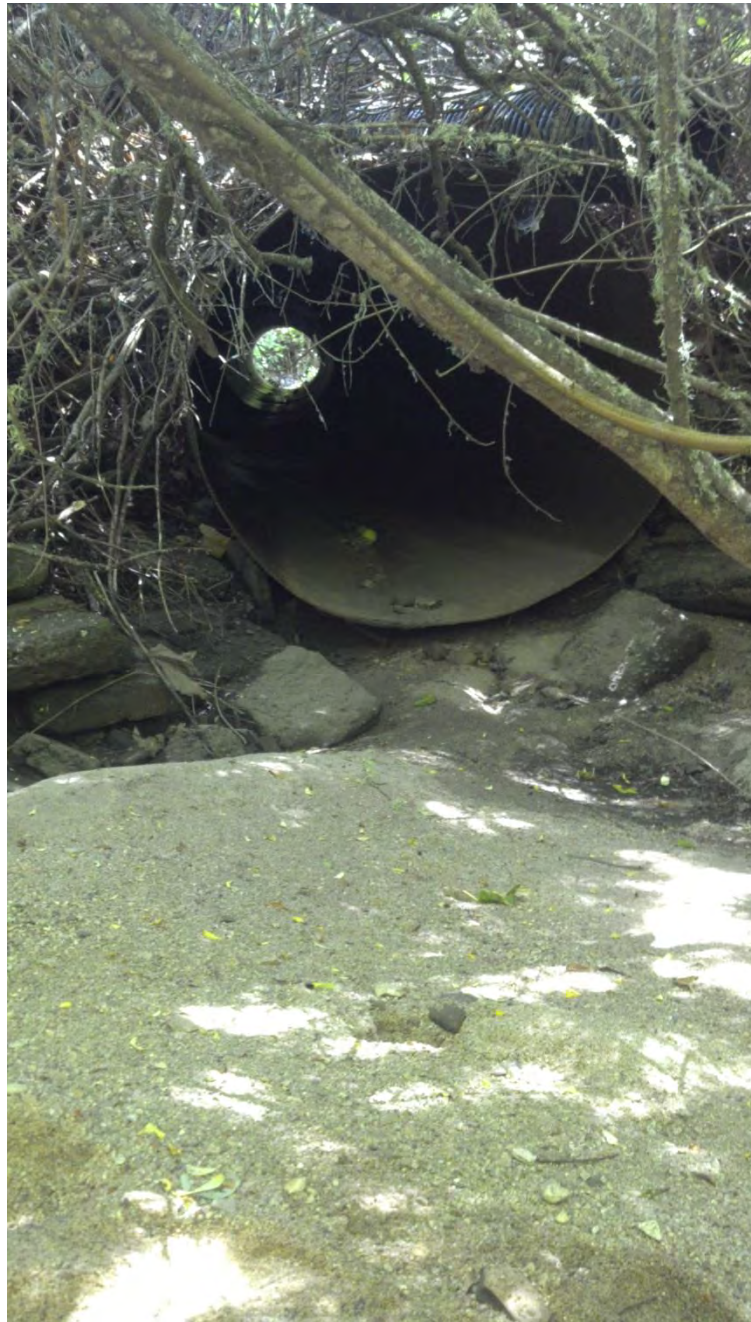
**Site PCB-5. CVAC culvert outlet and plunge pool.**

Pipe is smooth metal and is in two sections. There is a break in slope and angle at 75' where two pipes are riveted together. Upper end pipe is slightly smaller diameter. There is a 6-12" rust hole in bottom and pipe is being undercut. Smooth metal pipe, 100' long, 5' diameter. Outlet free-falls ~6" into a sand pool. Likely a velocity and depth barrier.

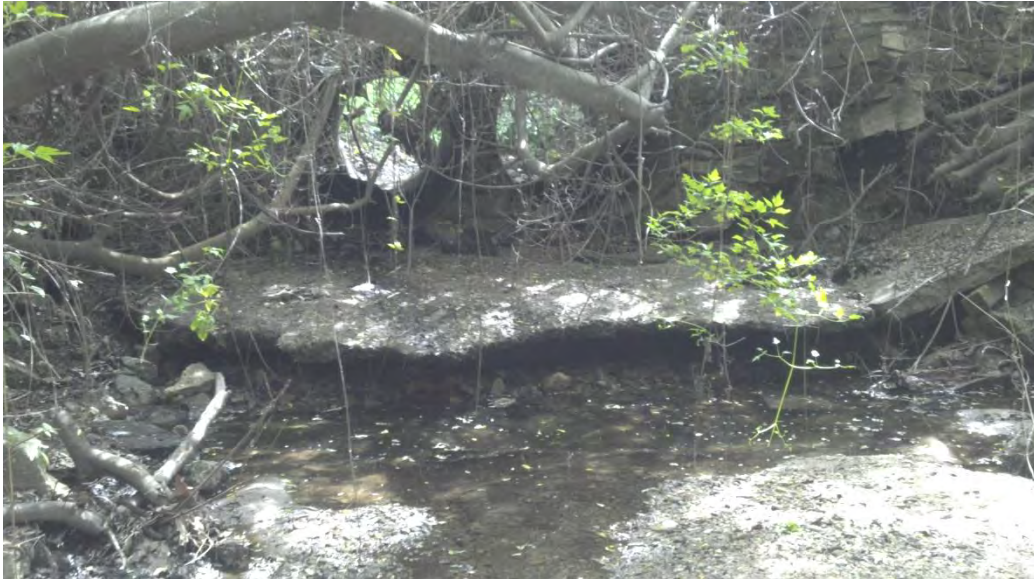
Double culverts under small access road to upper parking lot. Both are in poor condition with large rusted out holes in bottom and bent/warped metal. Water is flowing into the holes and under the pipes. There is a large concrete apron at outlet with a 2' drop onto creek bed.

PCB-6. Outlet apron and drop off.

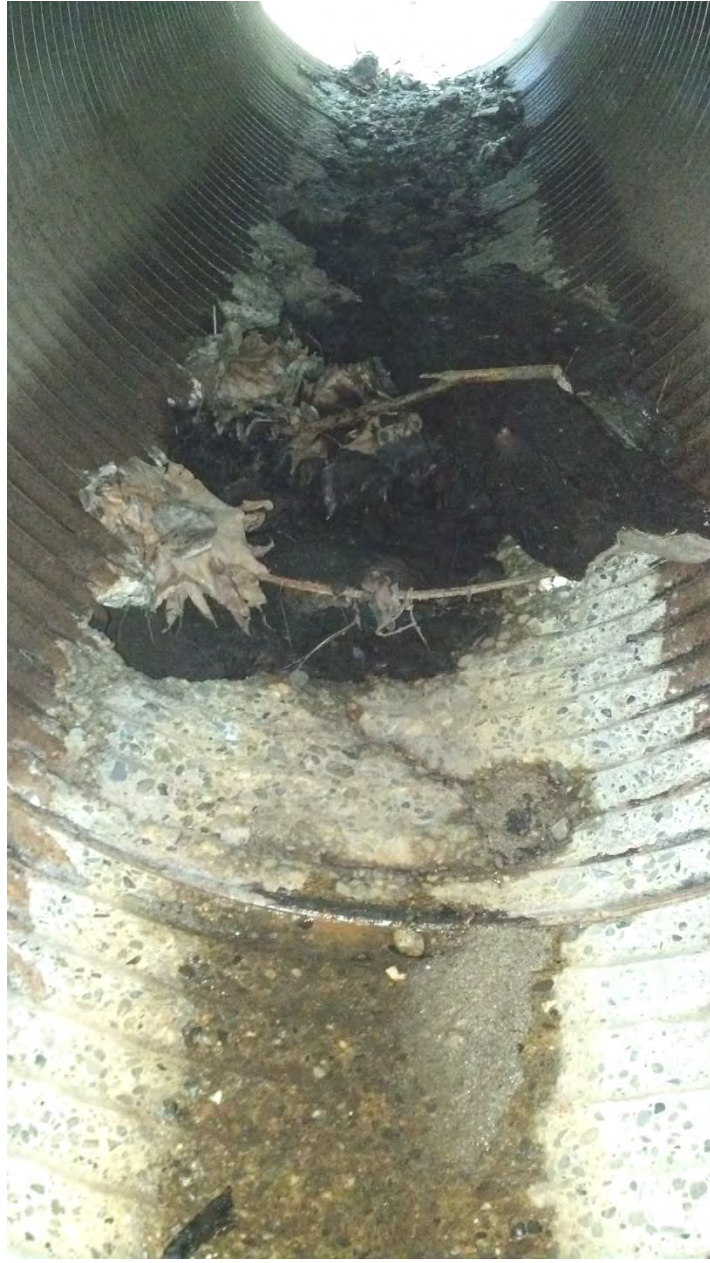
**PCB-6.** Interior of R/B culvert showing large section of rusted out pipe.

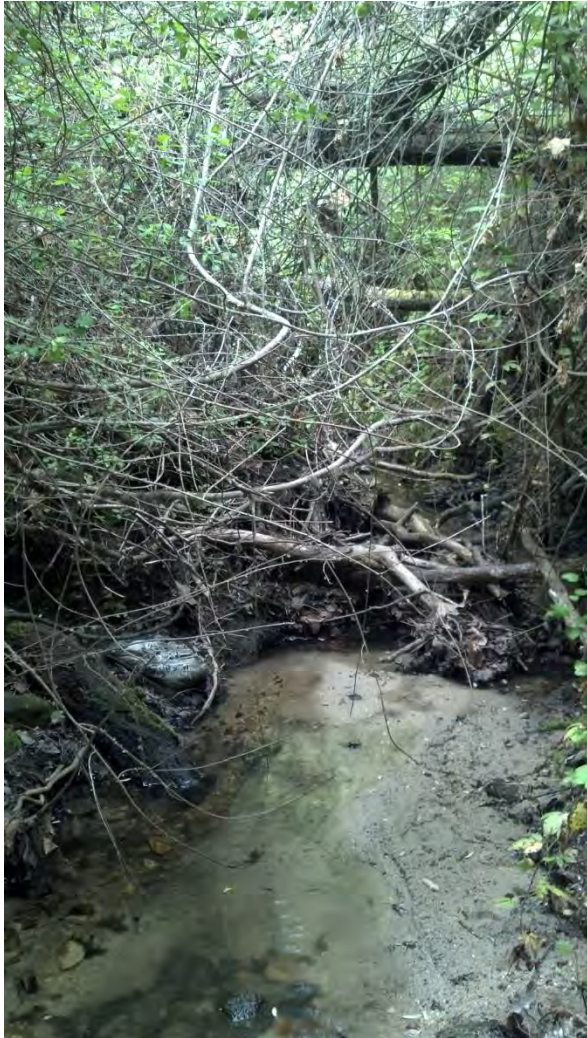
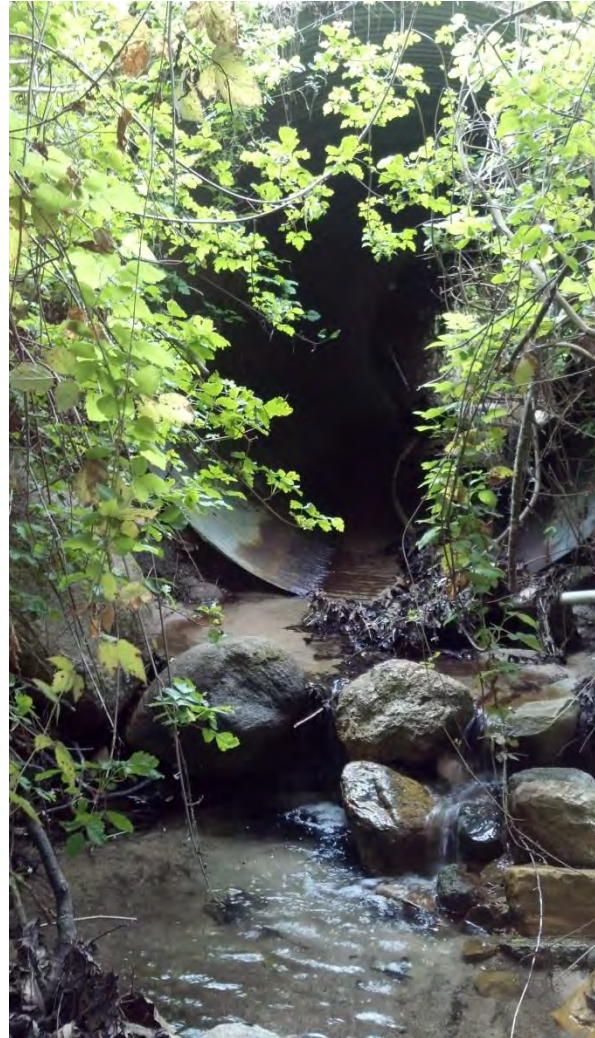
Very large, 7.8' diameter, stream-grade culvert with a sand apron and 1'+ boulder rock-weir drop-off at outlet. Inlet is narrowed by a concrete bag wall and T-posts protruding into entrance. Substrate is sand and small gravel, riparian is thick vines and broken tree branches. Channel is incised.

**Site PCB-7.** Photo #1. Looking d/s at brush and sandy substrate below the culvert.  
Photo #2. Culvert outlet showing the boulder weir and sand apron.

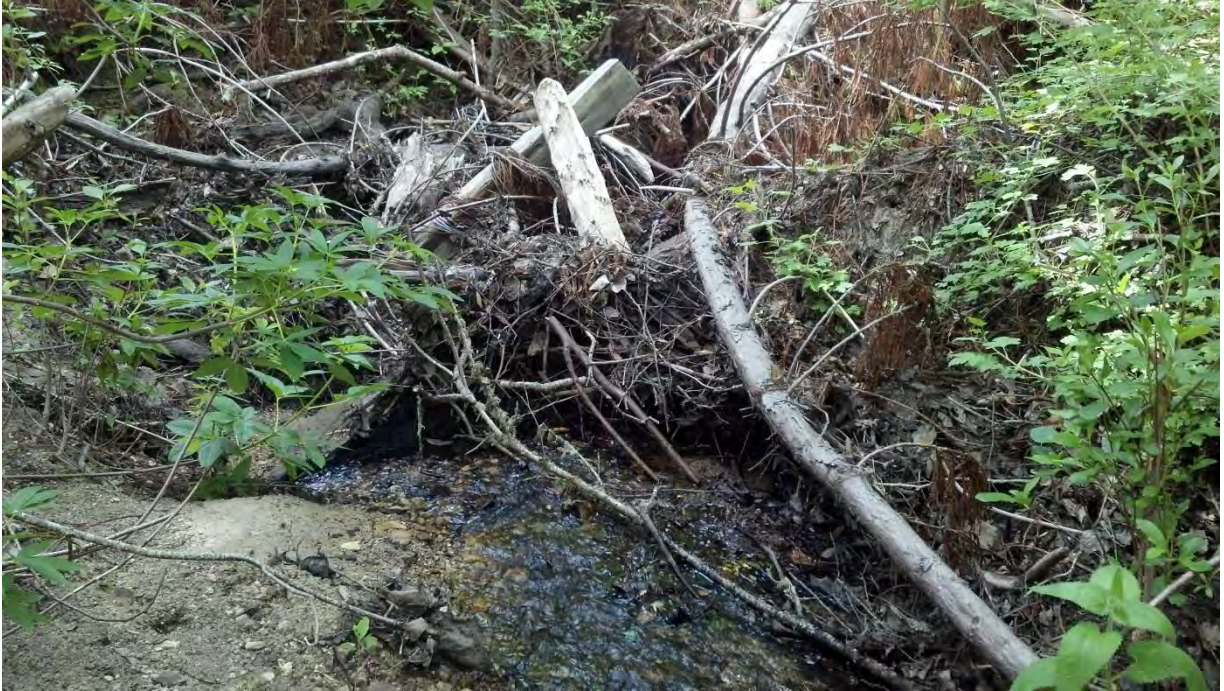
**Site PCB-9.** Log jam located ~100' d/s of PCB-9 bridge. Complete barrier at low flow. Jam consists of a fallen alder tree with lumber and small woody debris stacked up against the tree. The water sieves through the branches, dropping 3 feet into a 2.5 foot deep pool where we observed 10 juvenile steelhead.

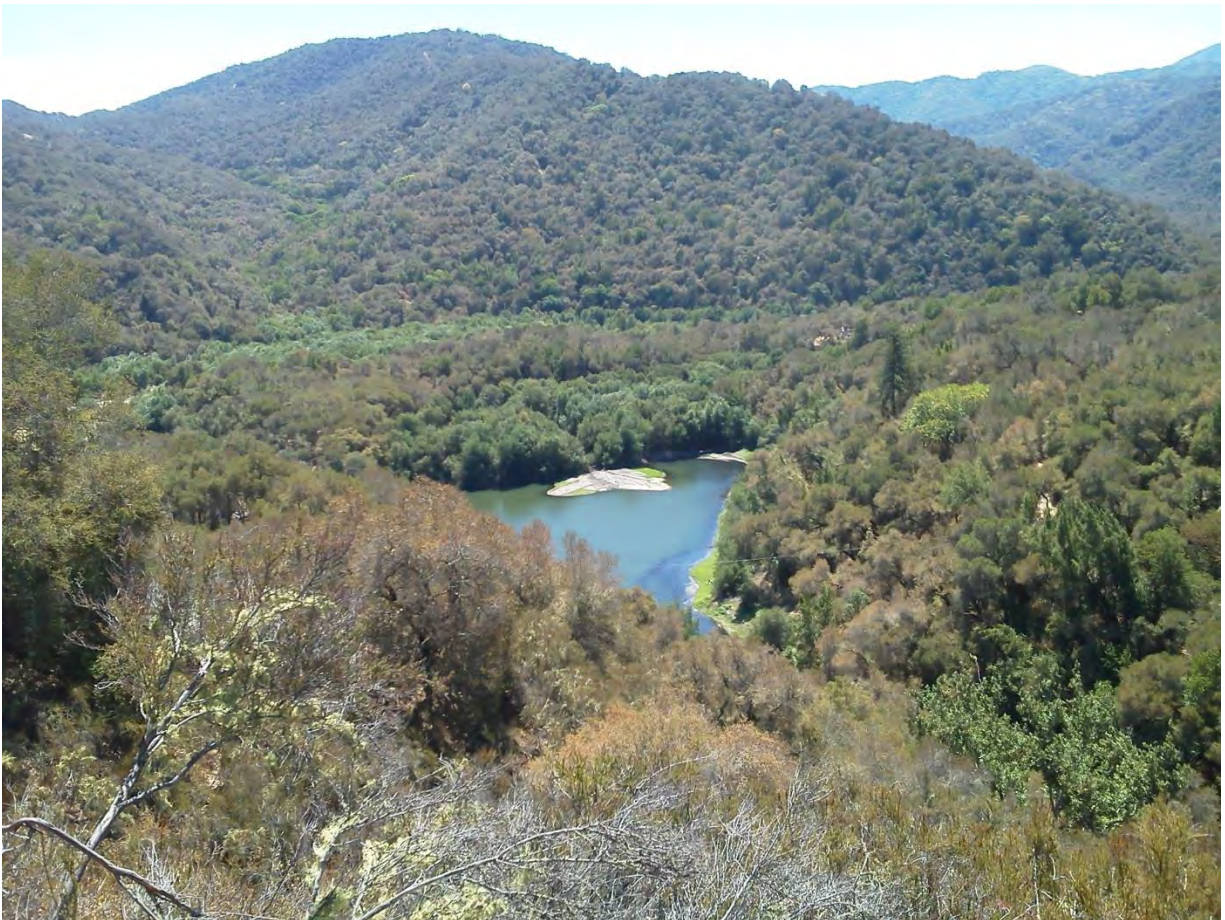
**Site SCC-1.** In 2012 the confluence was very overgrown with thick vegetation (see photos below) and was difficult to examine. In 2013, this entire reach was stripped of vegetation and is being reconfigured as part of the San Clemente Dam Removal Project.

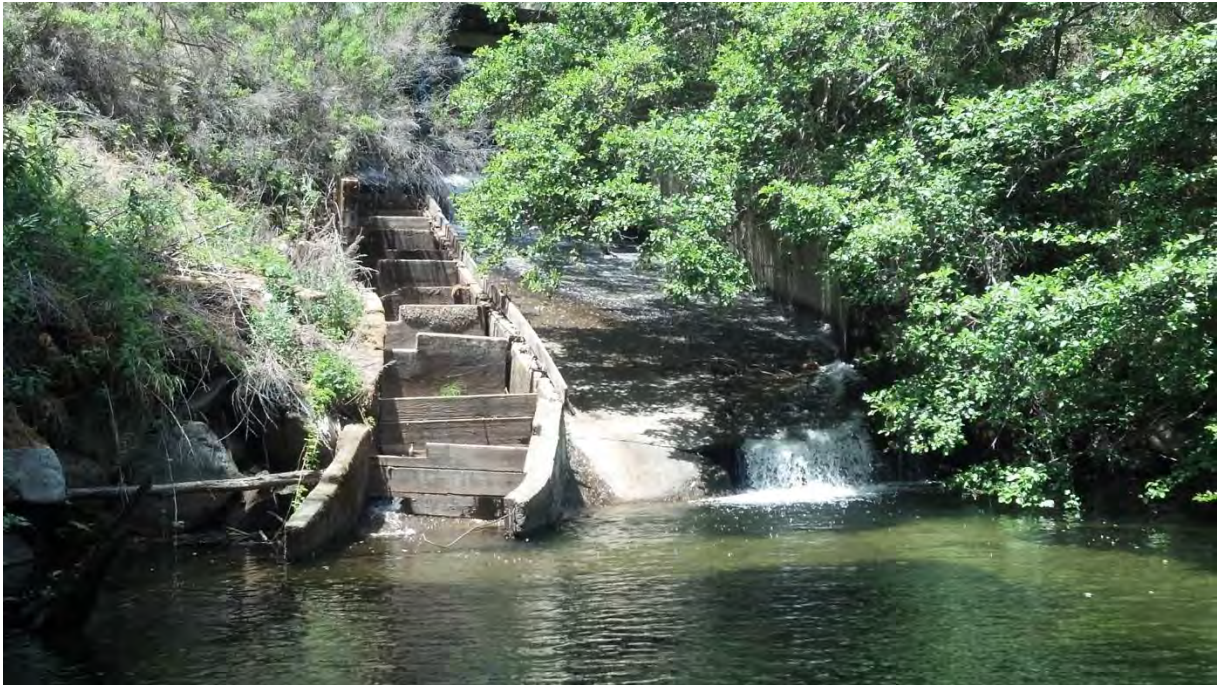
**Site SCC-2. San Clemente Rancho Dam fish ladder and spillway.**  
**RED** 36° 25' 30.3" / 121° 43' 35.7"  
5/21/2012 – ~3 cfs.

This long concrete spillway is completely impassable to upstream summer migrants and would likely cause significant harm to downstream migrants. The fish ladder looks to be of poor design and is in disrepair likely affecting upstream winter adult migration. Neither meets modern standards for fish passage and should be completely redesigned or removed.

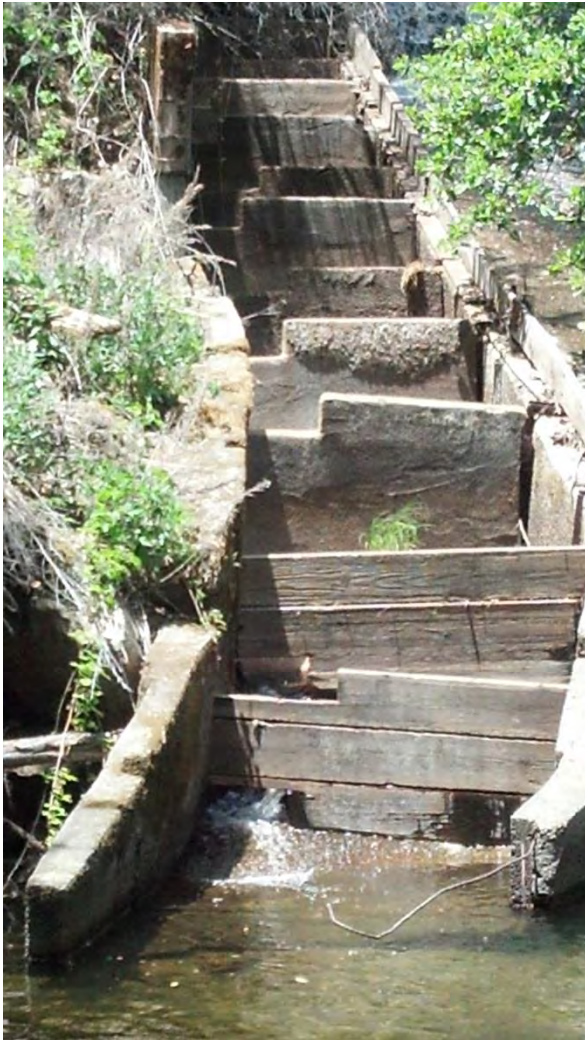
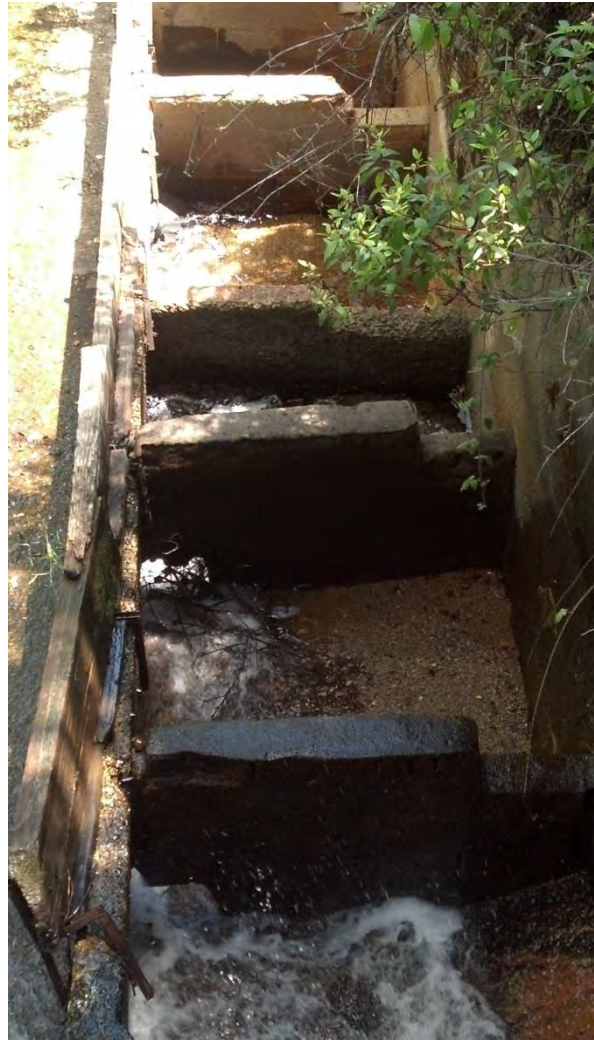
SCC-2. Ladder close-up from downstream (left photo) and from upstream (right photo).

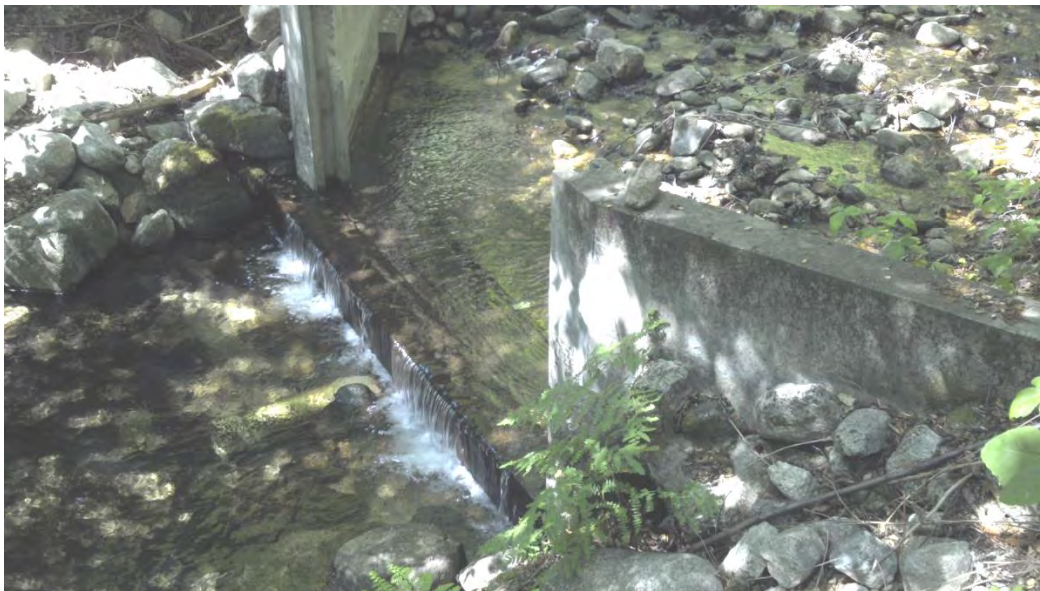
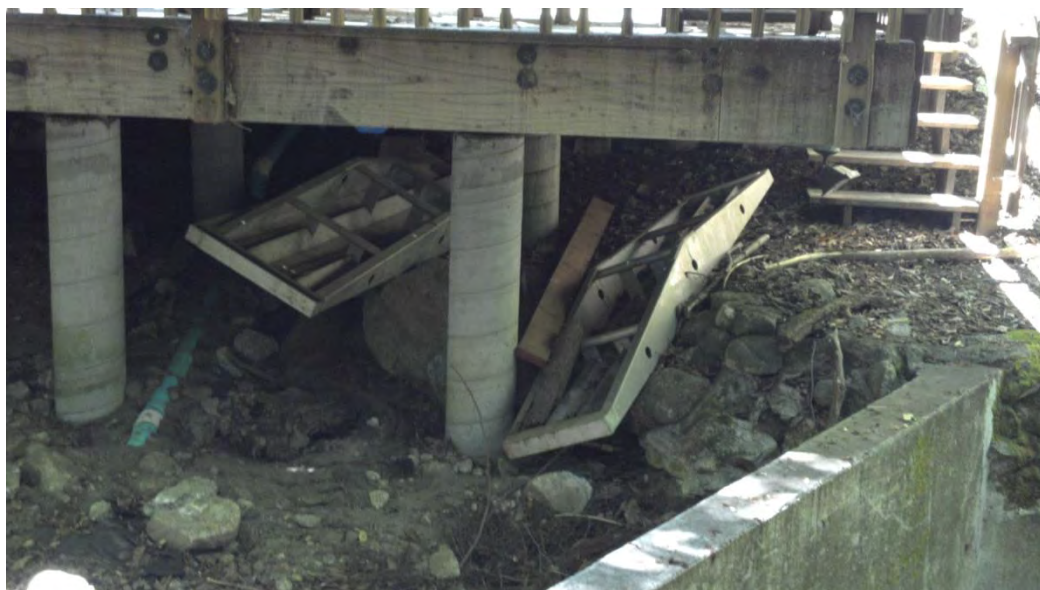
We found three of these concrete summer dams (one with the boards in), and several loose stacked rock dams located behind and around the RSC cabins on both creeks. These need to be addressed.

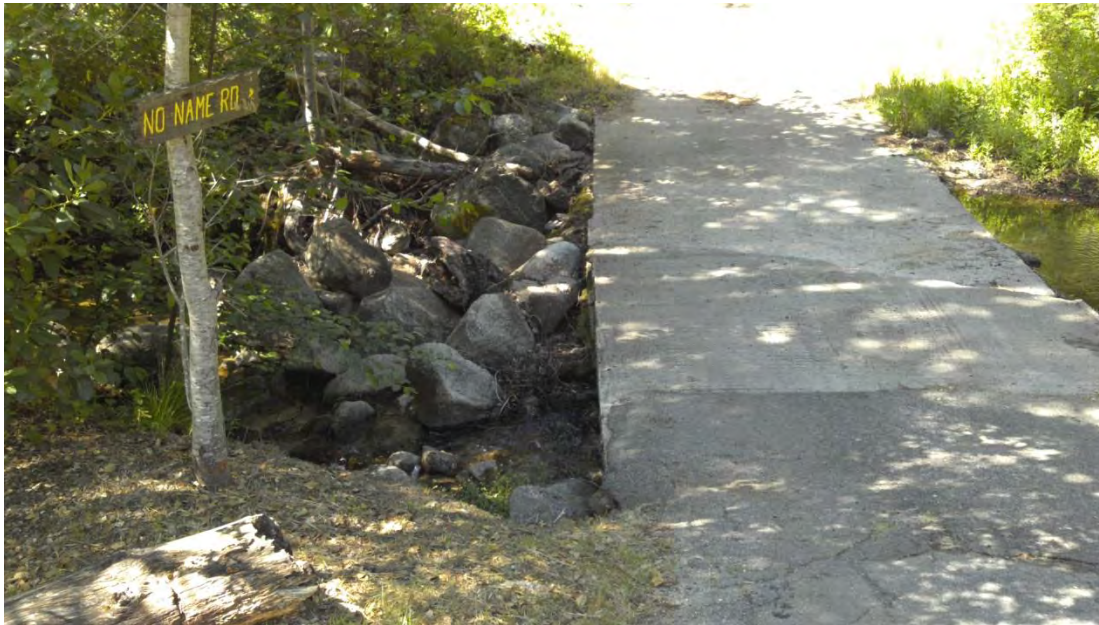
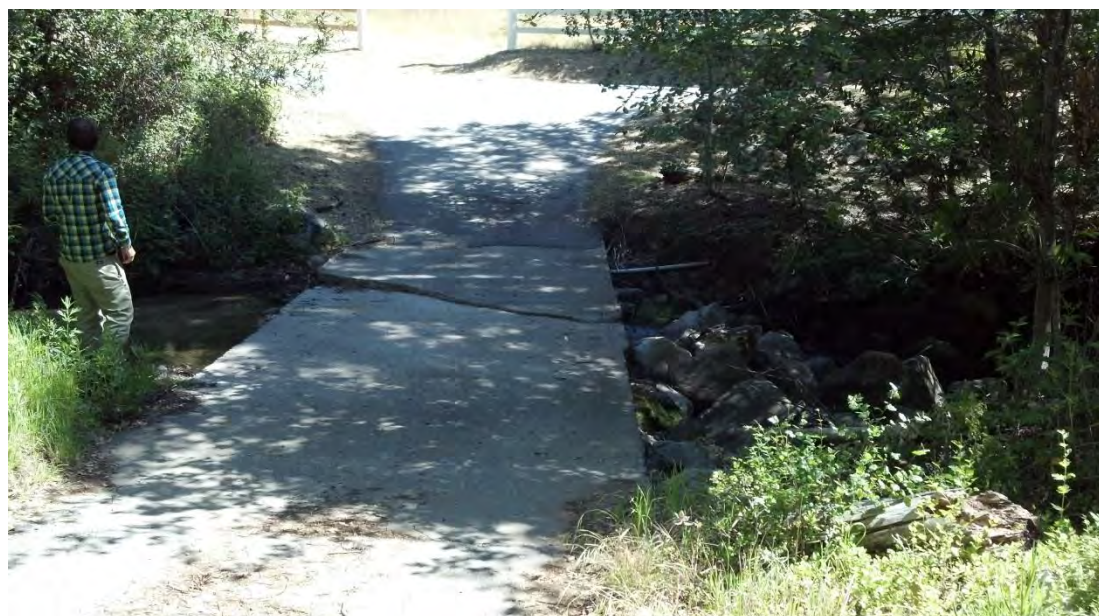
**SCC-8.**  
**Red**

Located on San Clemente Creek, ~0.25 mile downstream from the entrance gate, this concrete ford is a major migration barrier that needs to be replaced with a small bridge. The old culvert is completely smashed and filled with debris. At this flow, 100% of the stream passes underneath the left bank side of the ford but no fish can pass due to failing concrete and a large amount of woody debris. At higher flows, water would go over the top of the ford but the downstream boulders are likely a barrier as well. Above the ford, the substrate is shallow sand.

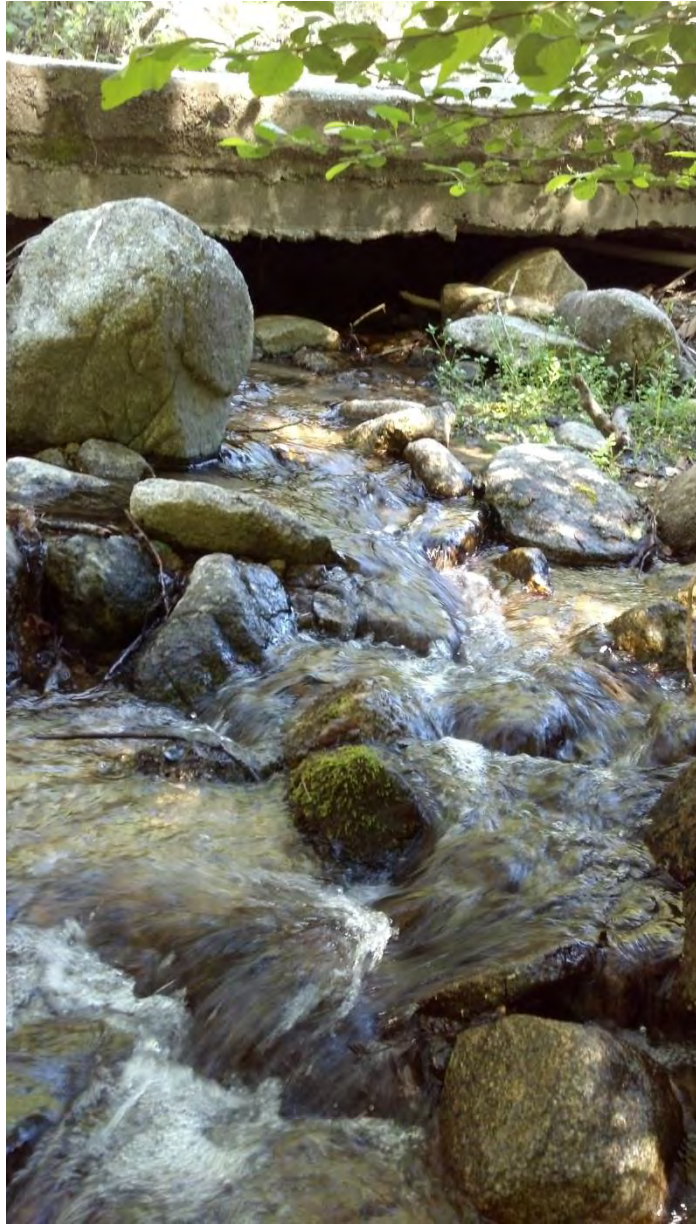
At low flow, the entire creek passes underneath the ford where passage is blocked by woody debris and rocks.

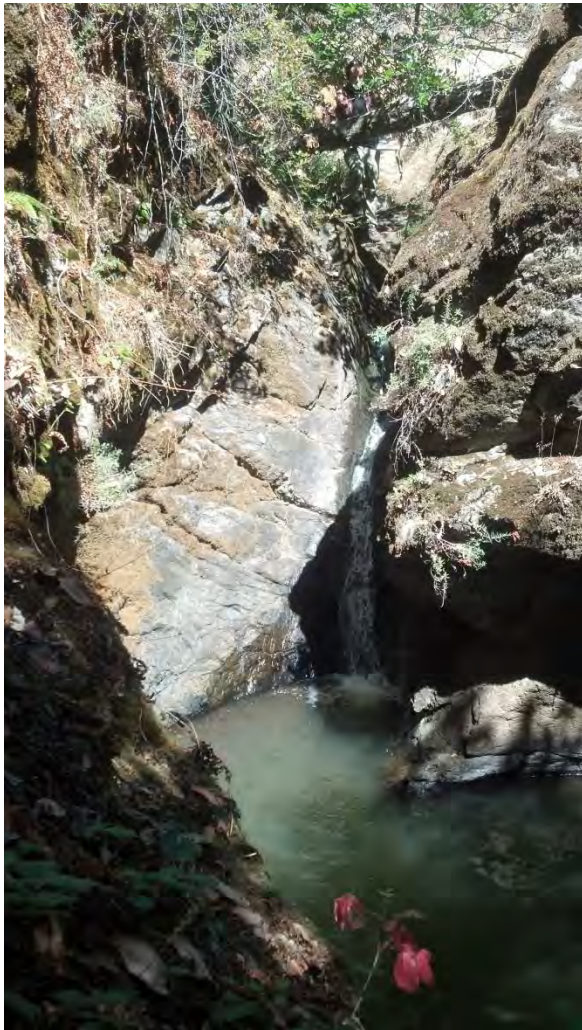
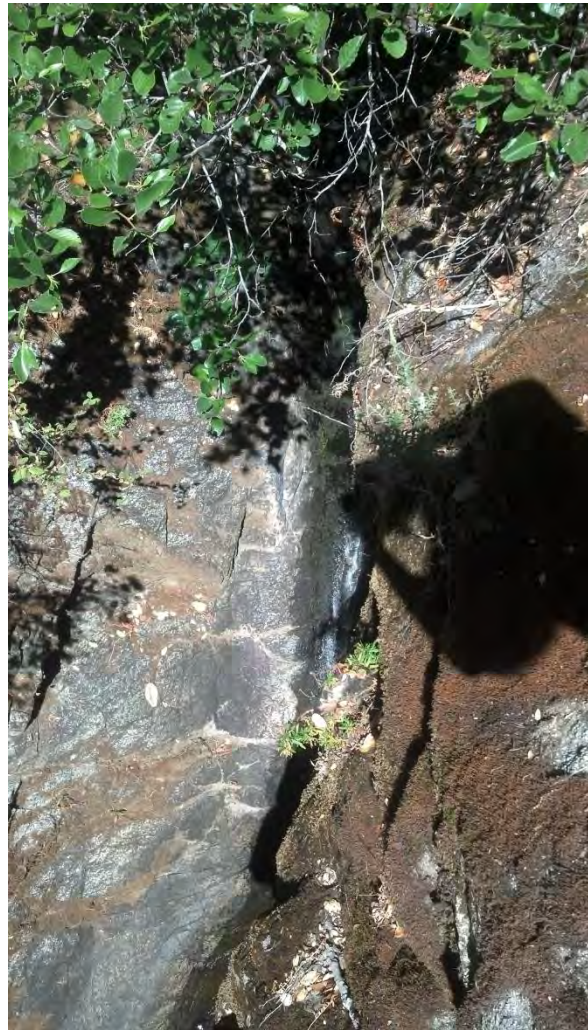
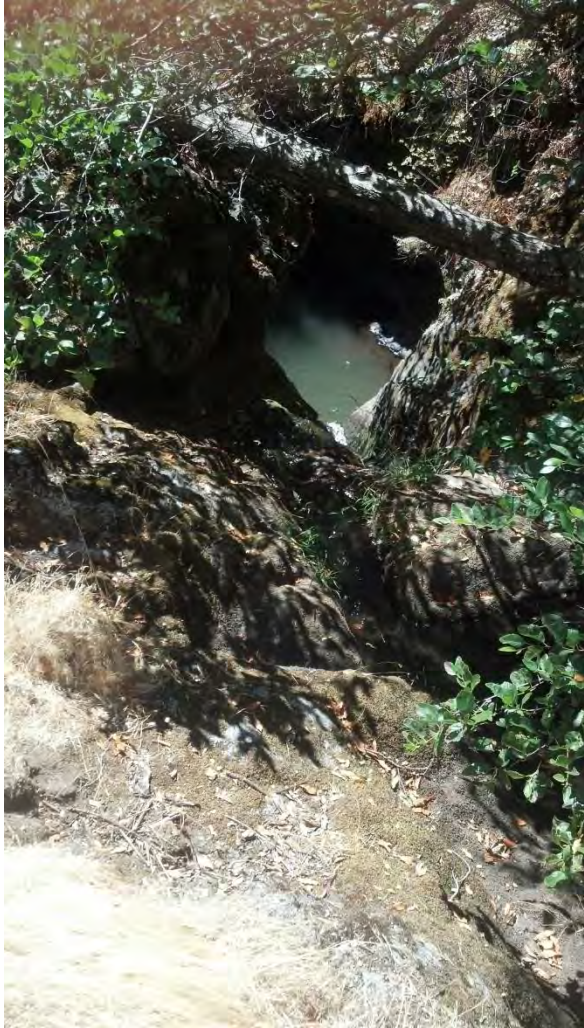
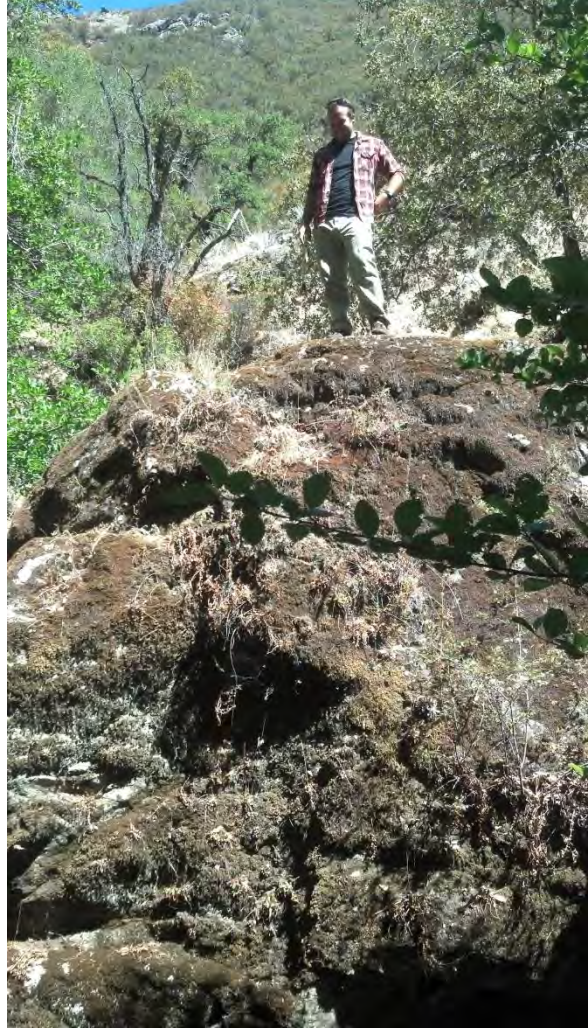
Located approximately 2.8 miles upstream of the confluence, this ~18-foot high, slick bedrock chute is a total/complete barrier for upstream fish migration. Small fish could pass downstream over the falls, but would likely be injured. We observed ~10 fish (3-8") in the chute's plunge pool and no fish upstream.

**SCC-12.**      **Black Rock Creek. Complete, Natural Falls Barrier.**  
**RED**            36° 24' 51.3" / 121° 46' 11.9"  
8/6/2012, ~0.25 cfs

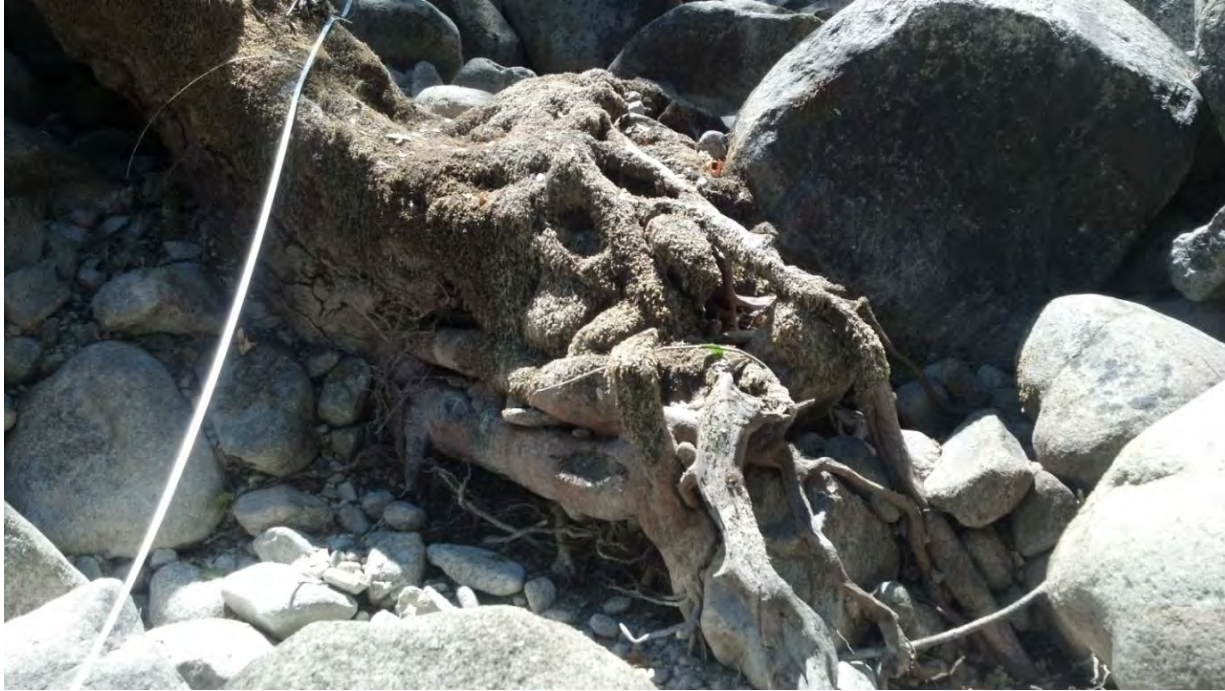
Photo 3) Large tree root mass growing across channel ~50' upstream of the confluence. Fish must jump this in most flow conditions.

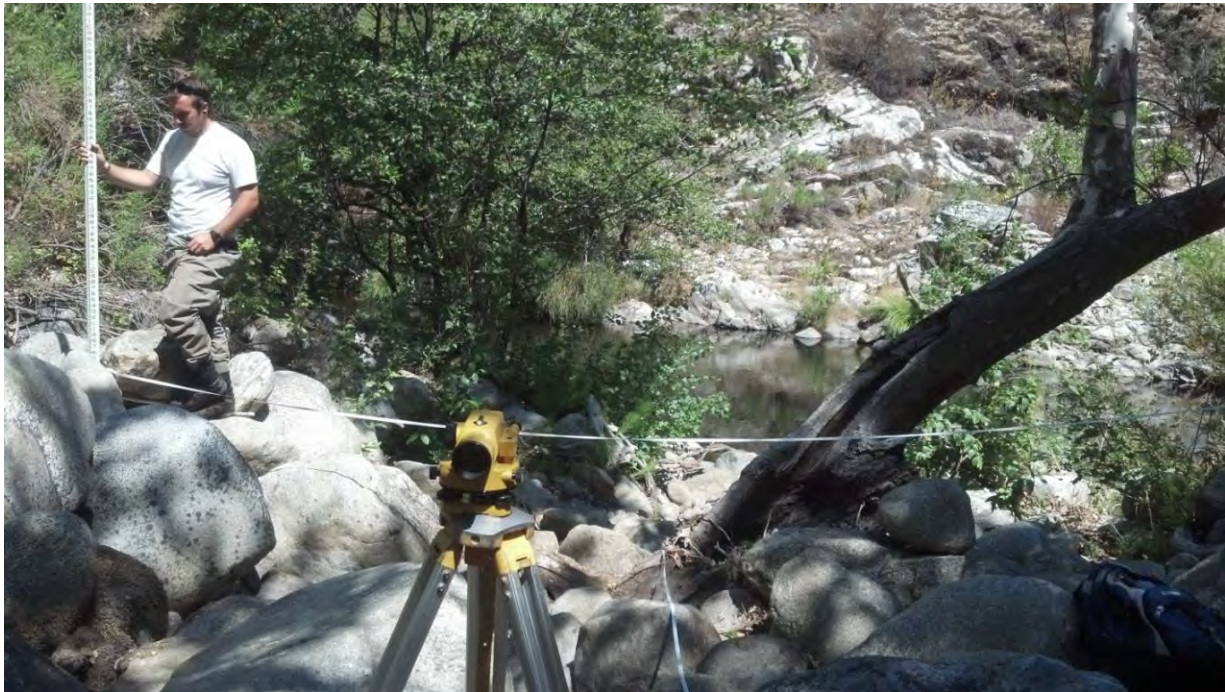
Photo 4) Lower cross section site. Note the large boulders in the low flow channel.

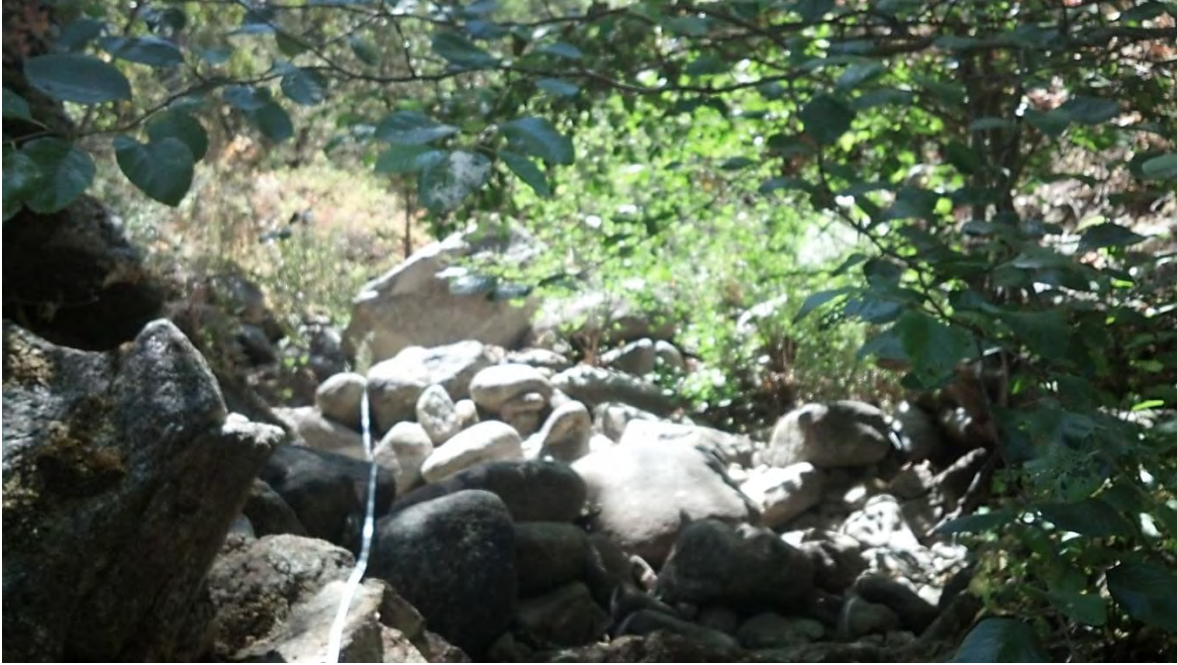
Photo 7) Large boulders stacked near the top of the cascade reach.

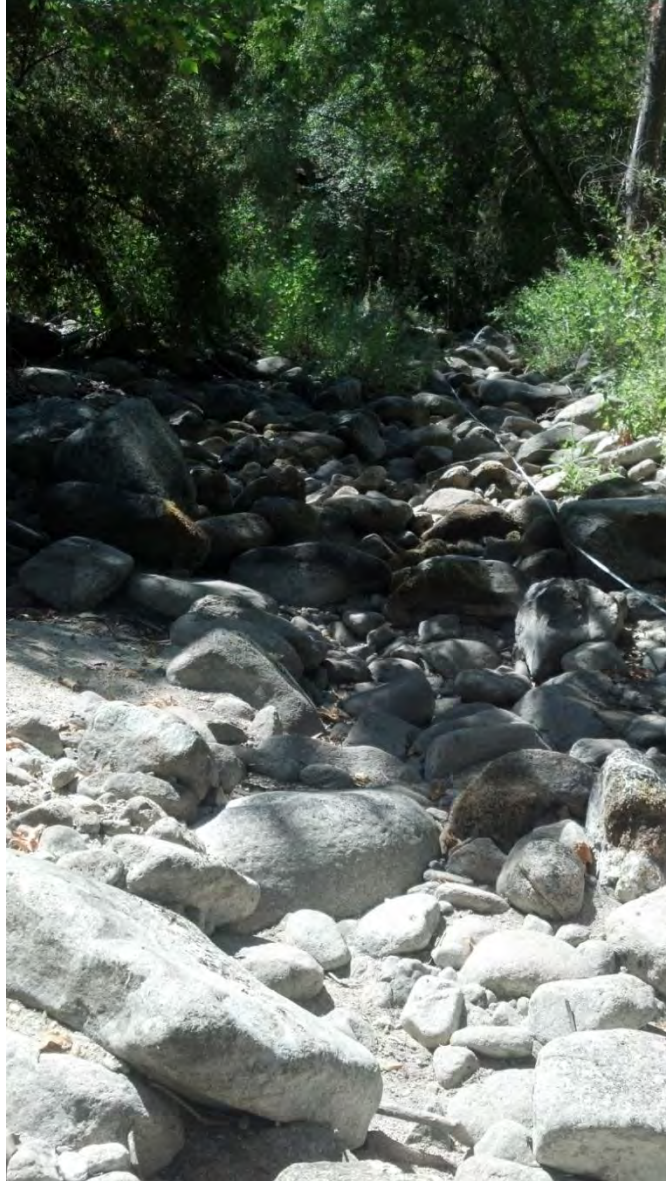
Photo 8) Looking upstream, above the cascade reach (150 feet upstream of confluence). Substrate is still primarily boulders but there are also cobbles and some gravel. Slope is more gradual and there are several small resting pools.

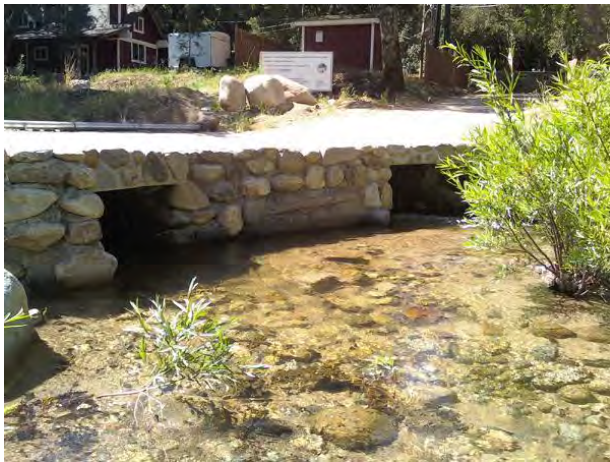
**Site LCC-3.** Outlets.

Culverts could be easily clogged with debris or be a velocity barrier at high flows and a depth barrier at low flows.

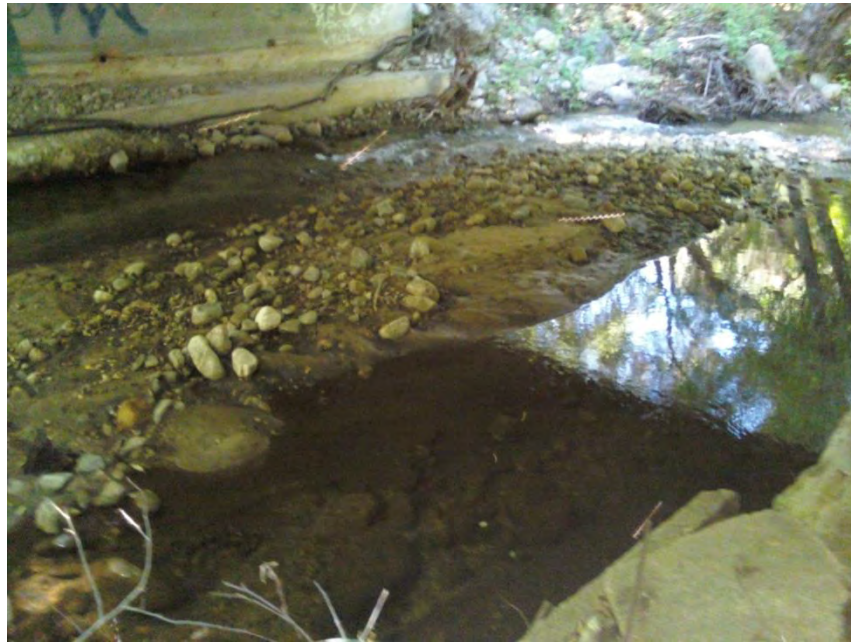
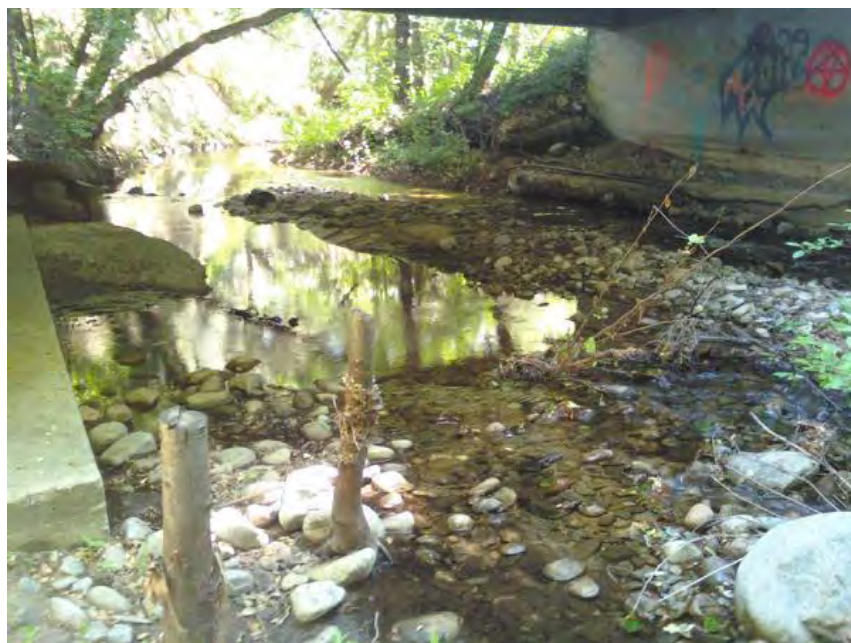
Bridge clear spans creek but concrete abutments have altered the flow structure. Slow water with sand bottom u/s of bridge, sandbar deposit, bank erosion and riffle/chute underneath, and thick willows d/s. This bridge likely is not a passage barrier, but should be monitored on a regular basis.

**Site LCC-4.** Shown at ~7 cfs. Split channel and sandbar under bridge. Looking upstream at abutments.

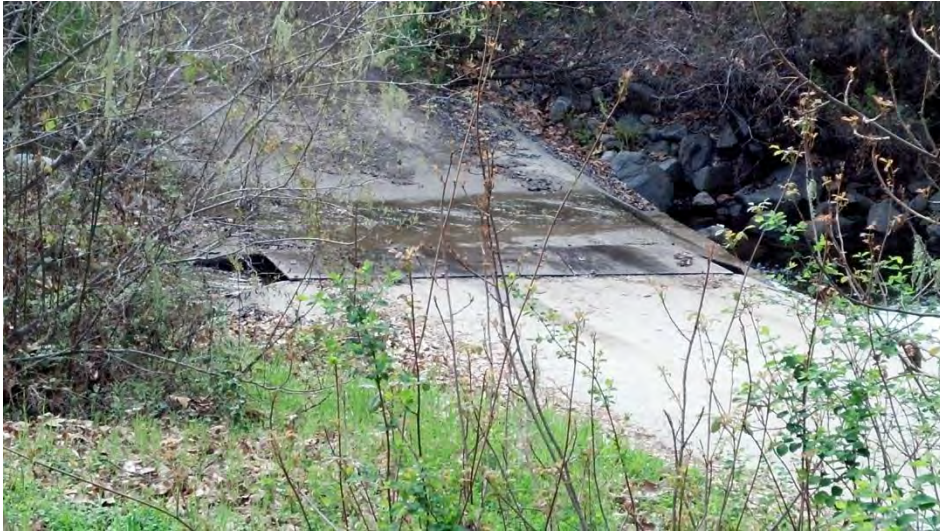
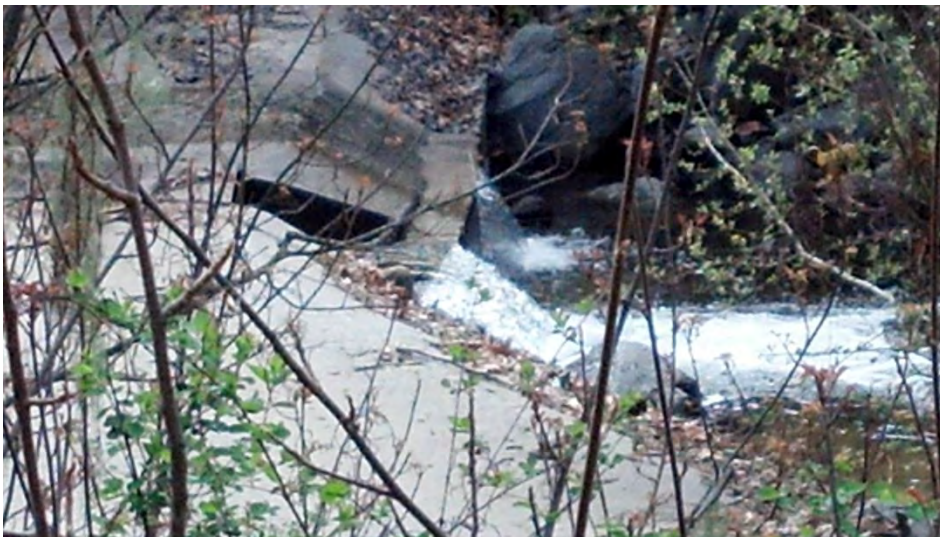
**Site LCC-10.**

This ford has a high probability of being an upstream adult migration barrier and moderate/high probability of causing damage to d/s migrants at both high and low flows. Addition surveys should be completed and the ford should be removed or modified.

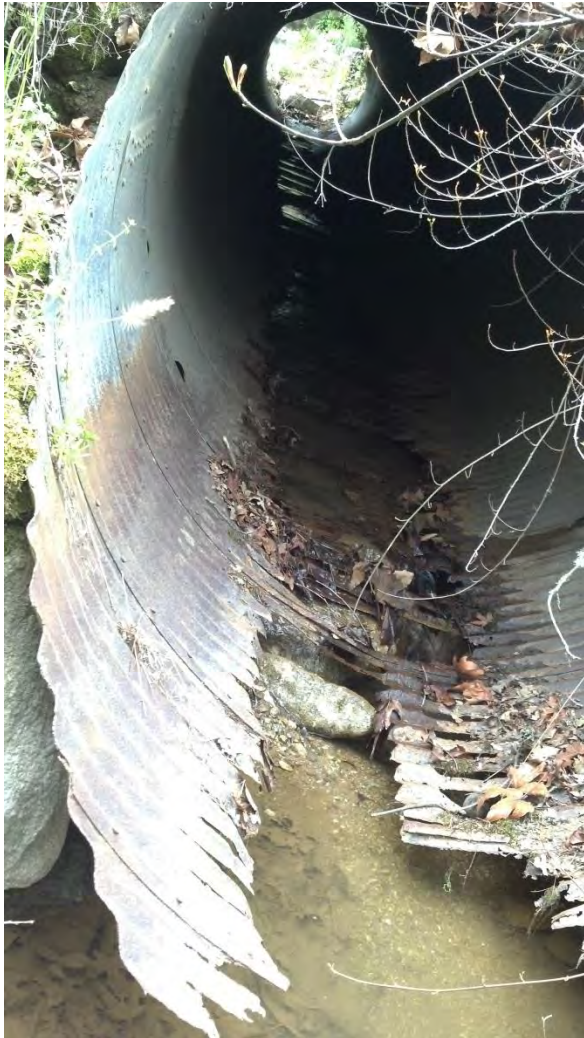
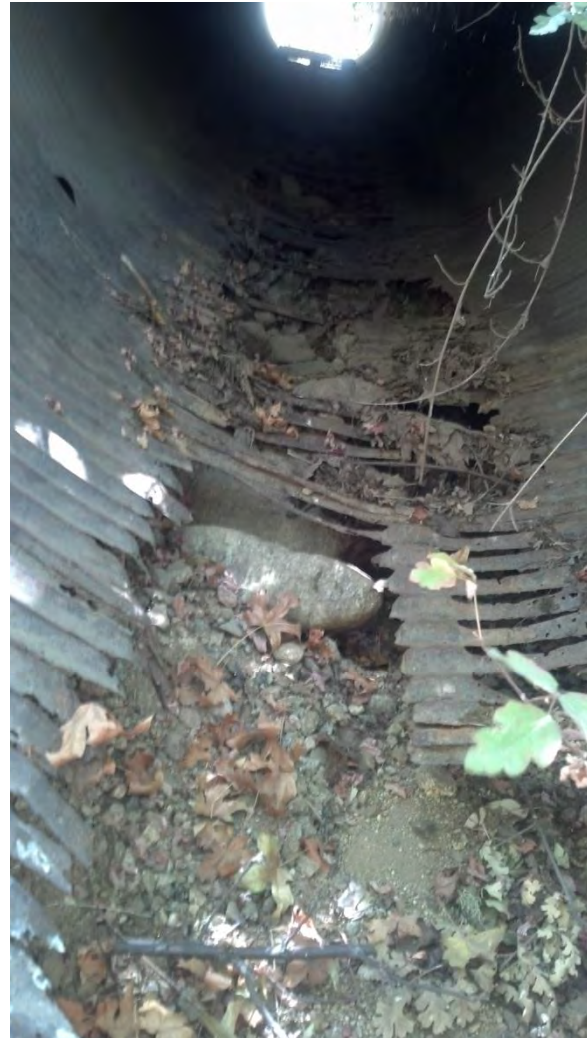
**Jamesburg Culvert.**

A long culvert located on James Creek at Jamesburg is in very poor condition and may need replacing. The lack of suitable steelhead spawning and rearing habitat upstream make this a low priority site for repair.

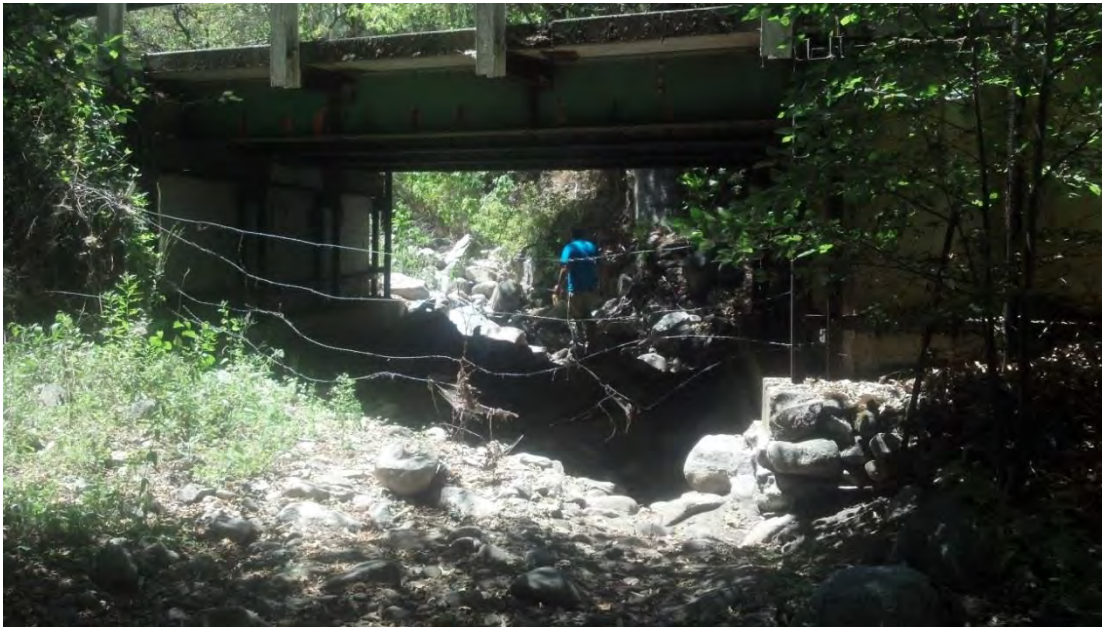
Clear-span bridge. The channel is constricted above the bridge by a large tree growing next the channel and a pile of large boulders, and below the bridge from a loose barbwire fence across the channel and the left bank bridge support. Boulder/cobble substrate. Vegetation is a mix of mature trees and shrubby plants. This site should be monitored regularly.

**Site UCC-7.** Looking upstream. Note the barbwire fence and the boulder wall on the right side of the photo.
