**ASSESSMENT OF STEELHEAD PASSAGE BARRIERS IN  
PORTIONS OF FOUR TRIBUTARIES TO THE CARMEL RIVER**

**Monterey Peninsula Water Management District  
IRWM - PROJECT 3**

**Final Project Report - July 2014**

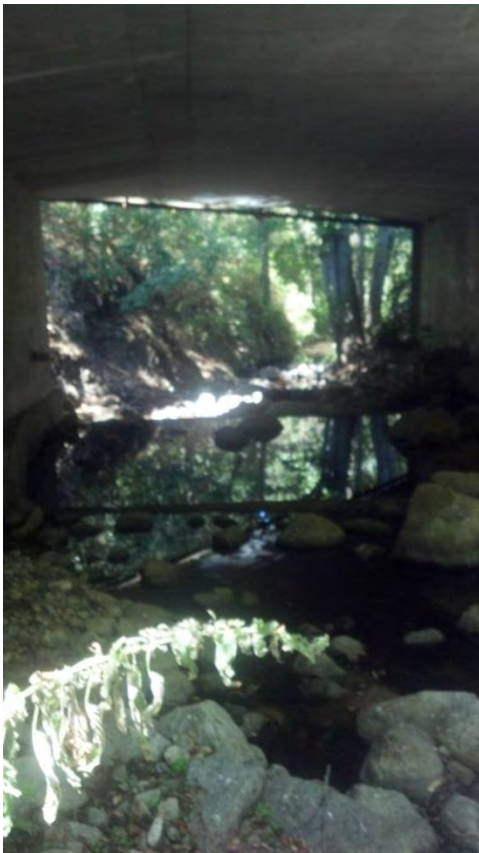
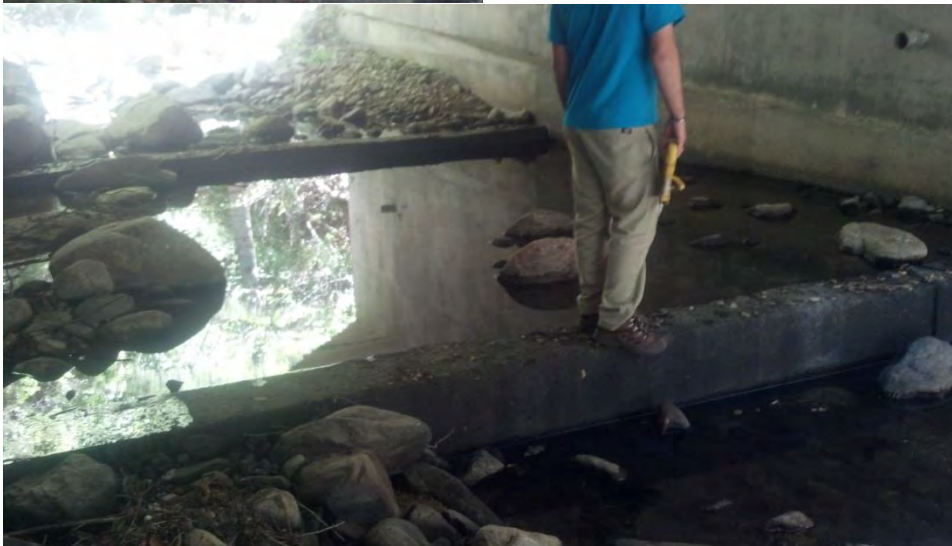
This is a newer concrete, clear-span bridge, but there are two ~1' high concrete weirs across the center under the bridge. Bridge is not likely a barrier, but in low flow the water would be wide and shallow as it passes over the weirs.

Site UCC-9. Looking upstream, and close-up of the concrete weirs.

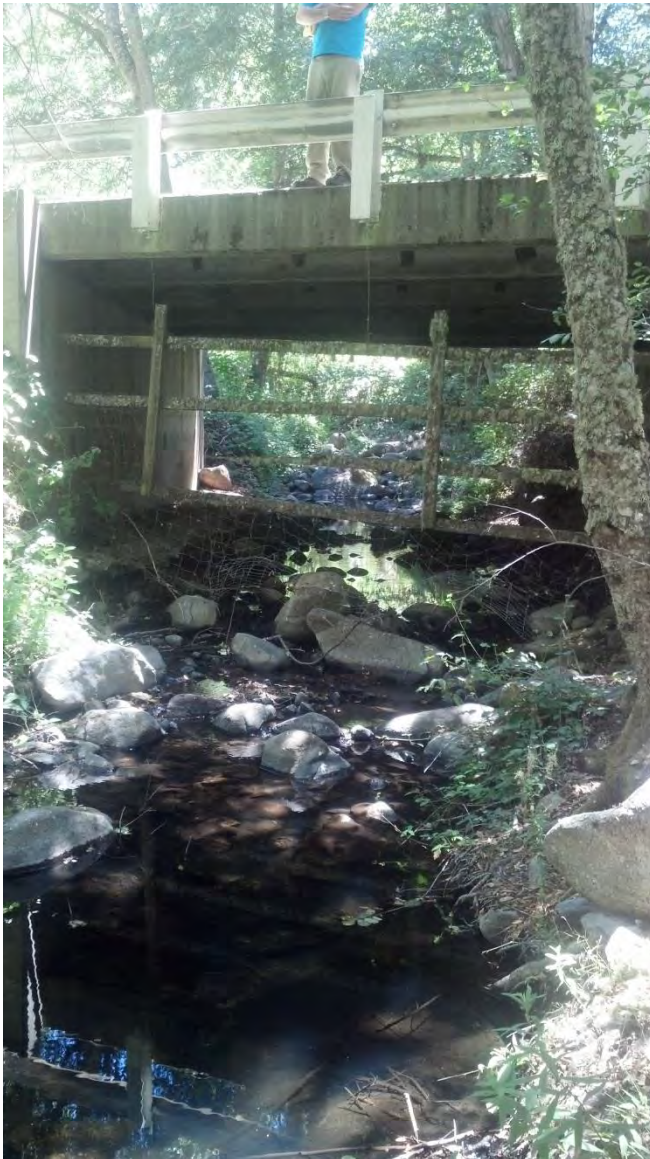
Clear-span bridge is not a barrier but there is a cattle fence (?) hanging loosely from the d/s side of the bridge. Substrate is boulder and sand/mud. Vegetation is a mix of mature trees and shrubby plants.

**Site UCC-10.** Looking upstream. Note the wood slat fence.

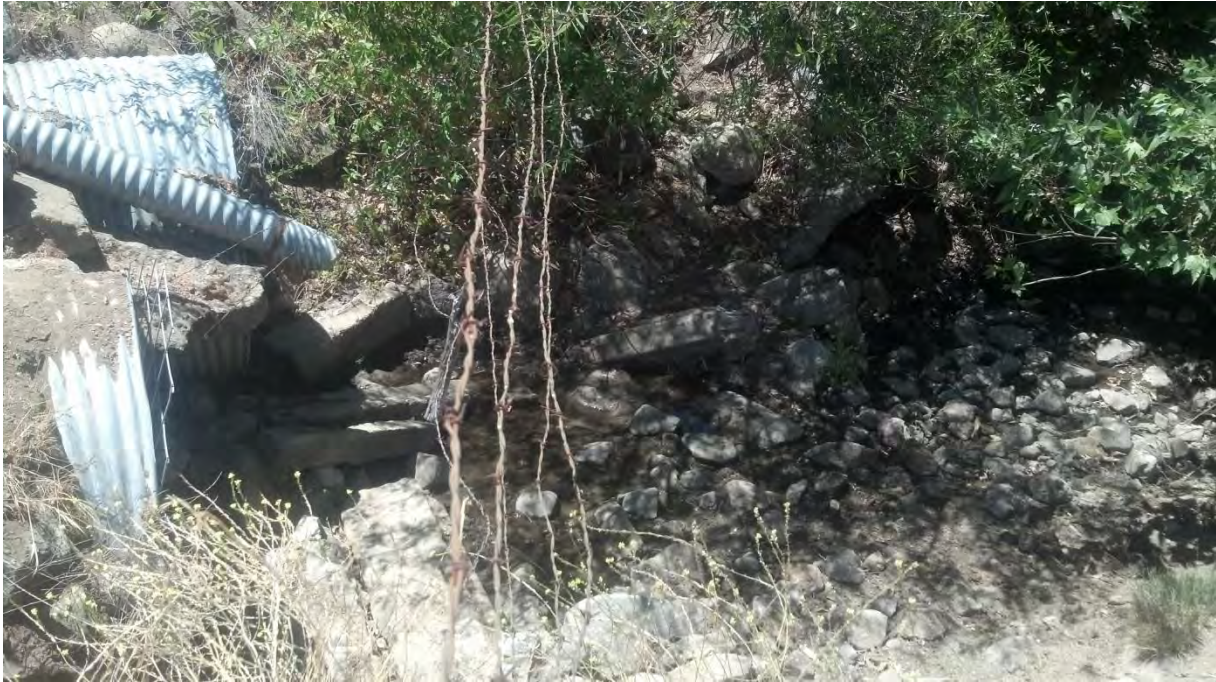
**Site UCC-12.** Looking downstream. Note concrete rubble at outlets.

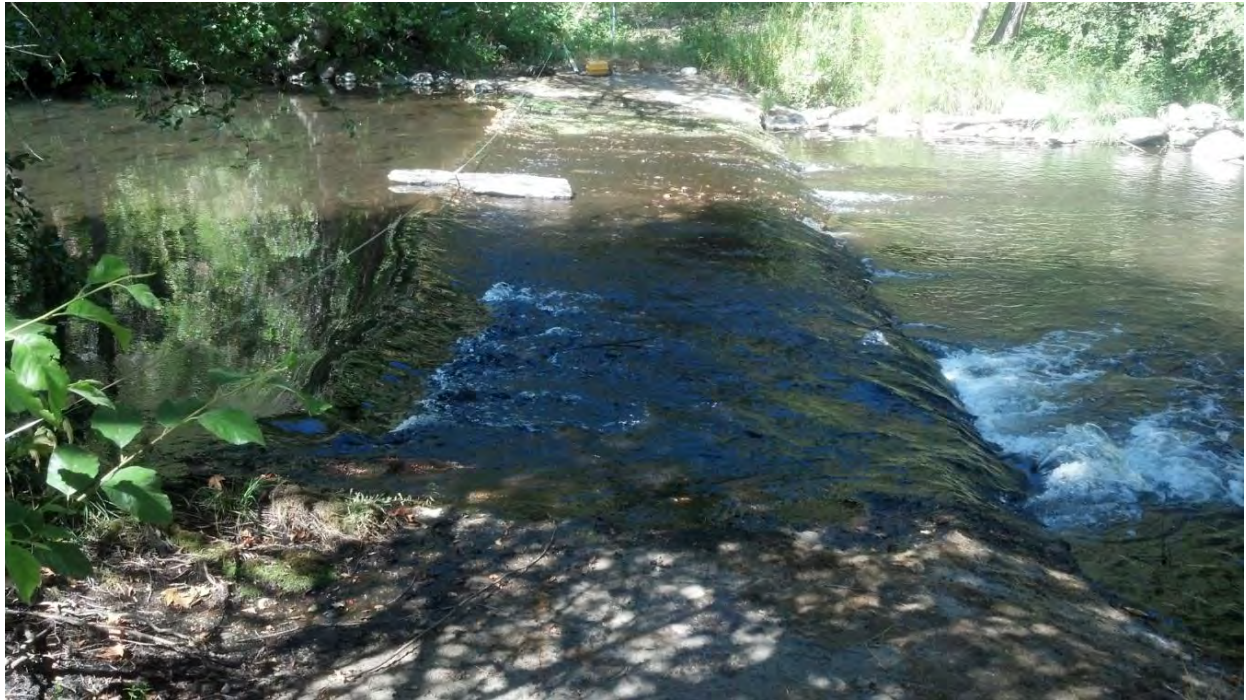
Flavin's Crossing on the main stem is the final ranked barrier (#11) (**Table 3**). This large concrete ford serves little beneficial purpose but is likely a fish passage barrier at lower flows as well as being a large sediment transport barrier. It should be removed to allow this reach to return to a more natural condition.

Photo 1) Looking across the ford from right bank. Note the exposed rebar along upper/rightbank side of ford (white water area in foreground).

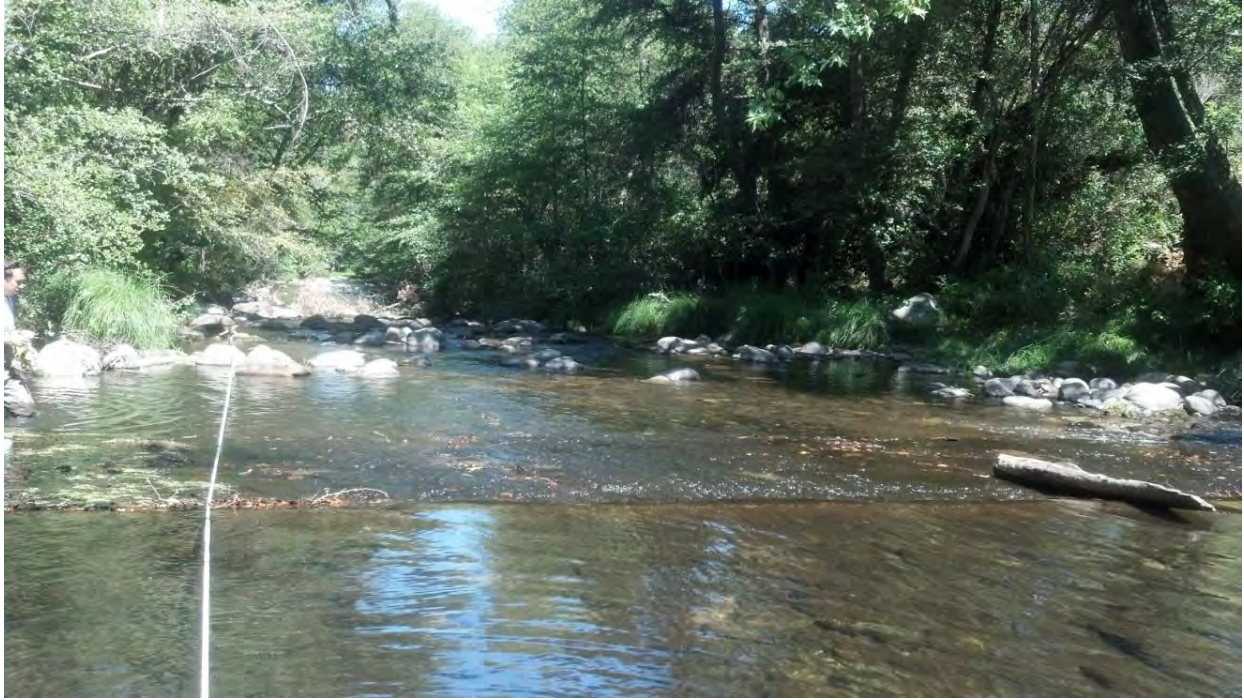
Photo 7) Substrate downstream of ford is a boulders/cobble mix with a steep channel.
