EXHIBIT 9-C

To:
cc: Dave Stoldt, MPWMD General Manager; Chris Cook, Cal-Am Director of Operations, Monterey Division
From: Jonathan Lear, Water Resources Division Manager
Date: May 15, 2023
Subject: Damage to Seaside Middle School Deep Well (MPWMD ID:260) during routine maintenance

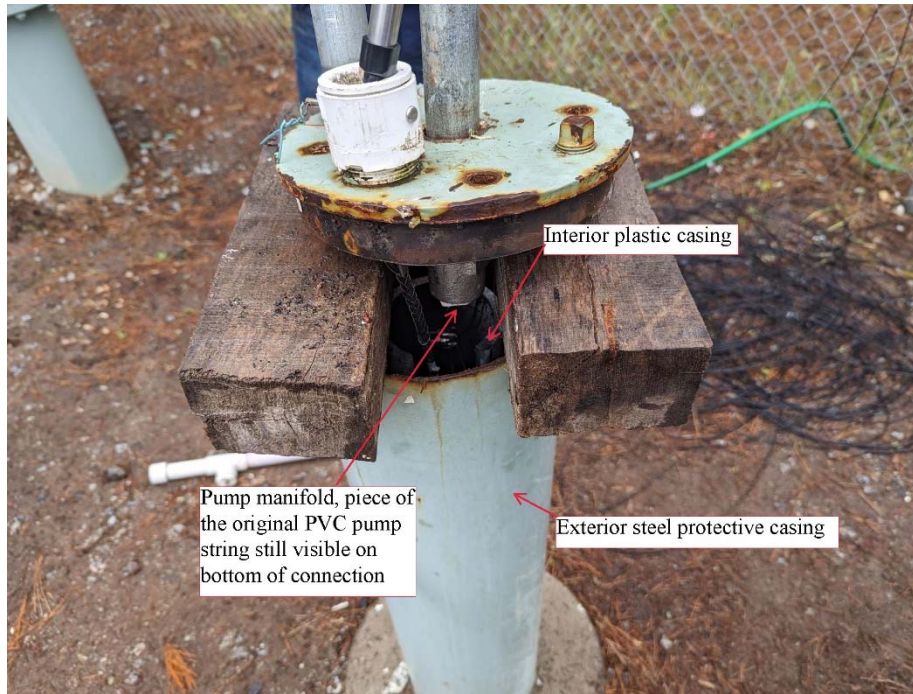
The SMS Deep well is completed at the surface with an exterior steel casing for protection of the

well head and an interior plastic casing, which is the actual well casing (Figure 1).

Figure 1) Showing the layout of the SMS Deep well after the pump had broken

The pump manifold connects to the top of the steel casing through a flange, visible in Figure 1 at the top of the photo. The pump manifold is what connects the top of the well to the pump string and sounding tubes, each one-inch PVC pipe within the interior 4-inch PVC casing. It also suspended the electrical wiring to operate the well.

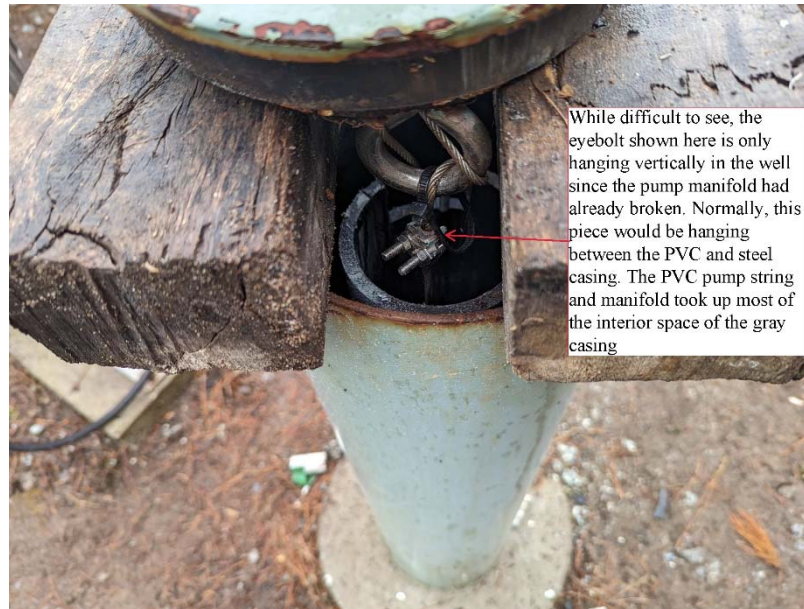
Also suspending the pump is a braided steel cable strung through an eyebolt, visible in Figure 2. The braided steel cable is connected directly to the pump and stops it from dropping in case of breaks to the pump string or pump manifold. The eyebolt is bolted directly into the top flange, between the interior plastic casing and exterior steel casing. Due to clearance issues between the interior PVC casing and exterior steel casing, the eyebolt cannot be suspended directly over the pump, which would be ideal.

As MPWMD Staff lowered the pump for the second time, the eyebolt struck the interior plastic casing, increasing tension on the braided cable as the pump was lowered. Since the eyebolt had to be hung between the interior and exterior casing and not vertically over the pump, this caused a flex in the pump string and sounding tube. The combined weight and flexing of the pump, PVC pump string, and sounding tube snapped the manifold connection nearly instantly, despite a spotter.

Due the weight and complexity of removing the PVC and pump, a driller with more specialized tools will need to be mobilized to the site for removal and resetting the pump. During the mobilization of the drillers, MPWMD will ask for suggestions about how to prevent this from happening again, including cutting down the internal PVC casing or changing how the eyebolt hangs inside of the casing.
