Figure 2 – Los Padres Dam and Reservoir

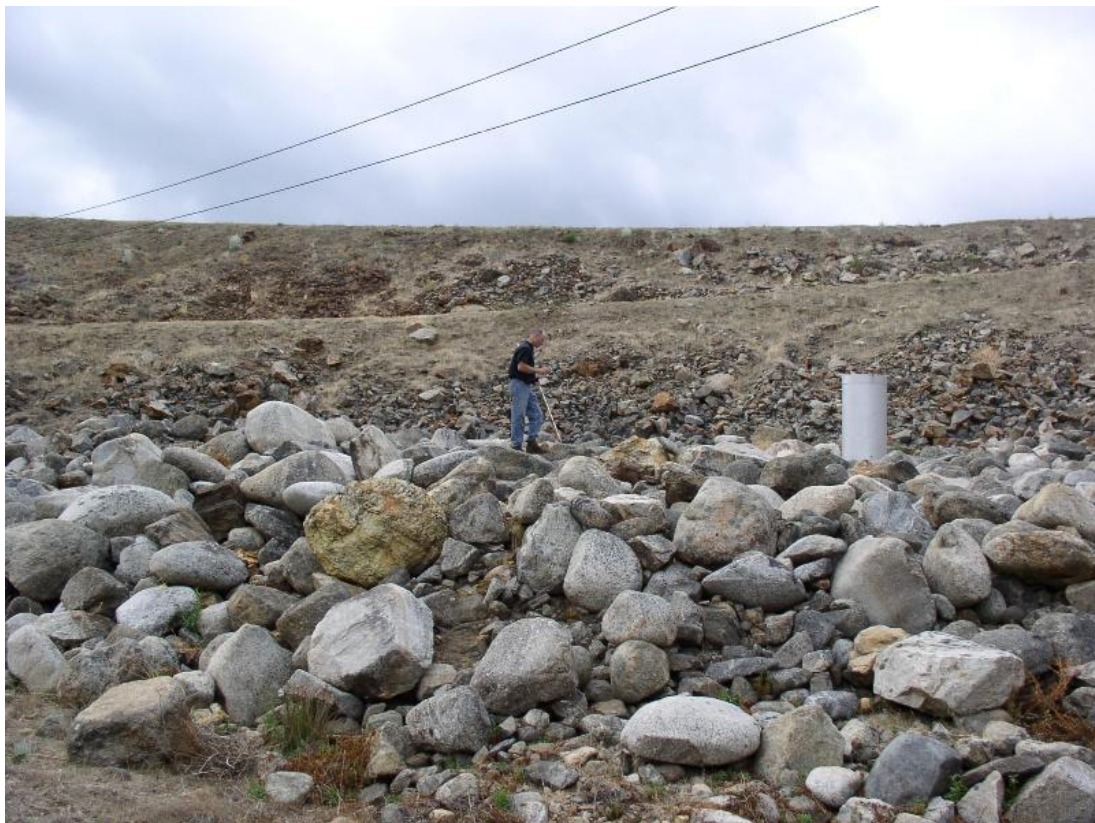
Figure 13 – boulders placed to stabilize downstream face

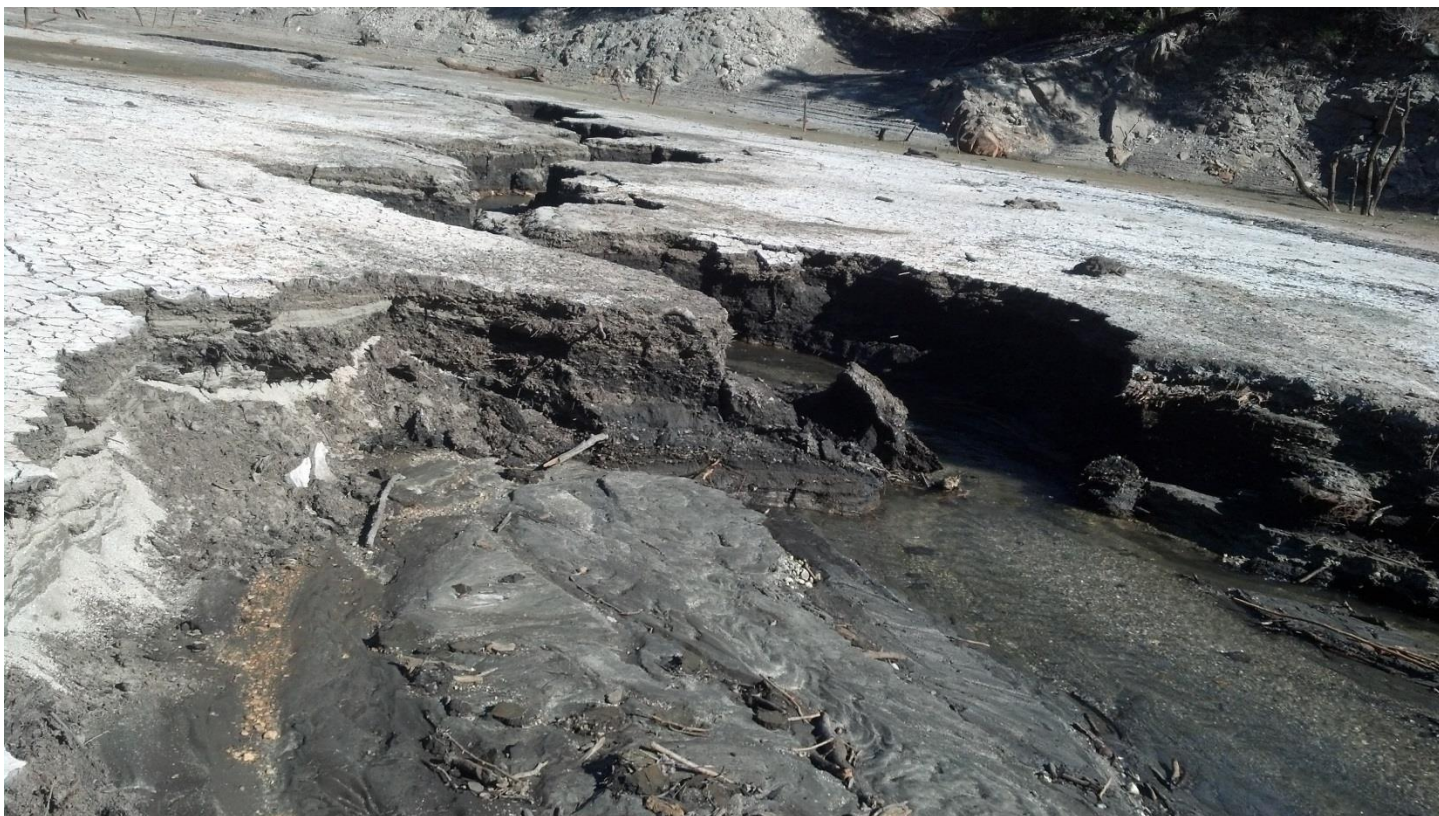
Figure 17 – upper reservoir silt and organic deposits

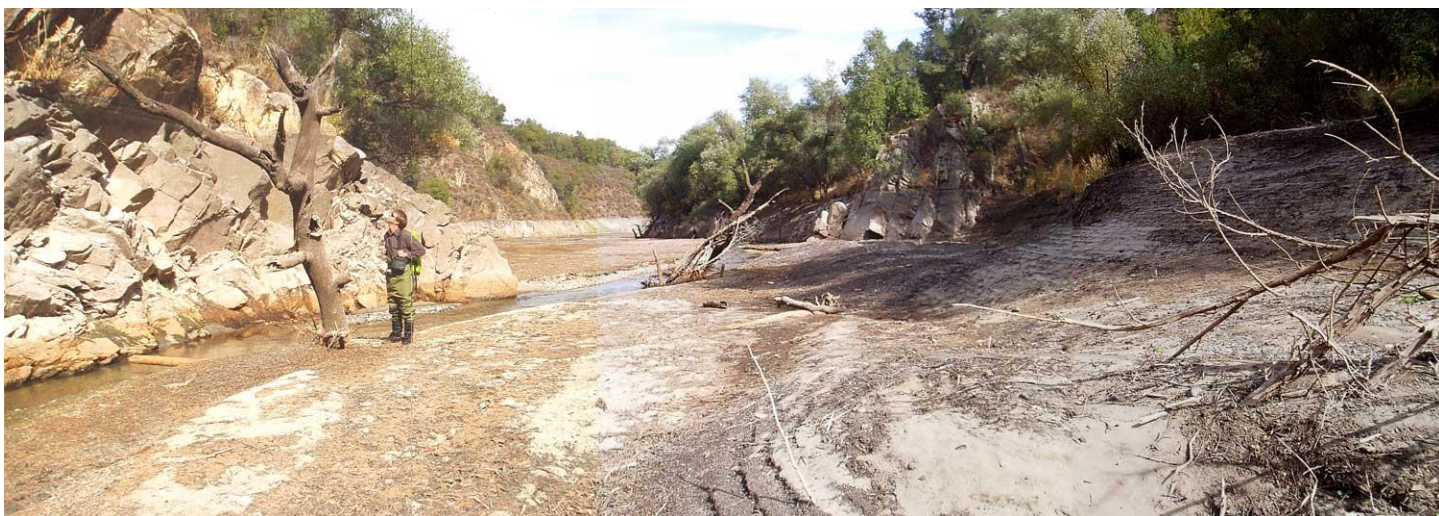
Figure 18 – siltation at upper end of reservoir

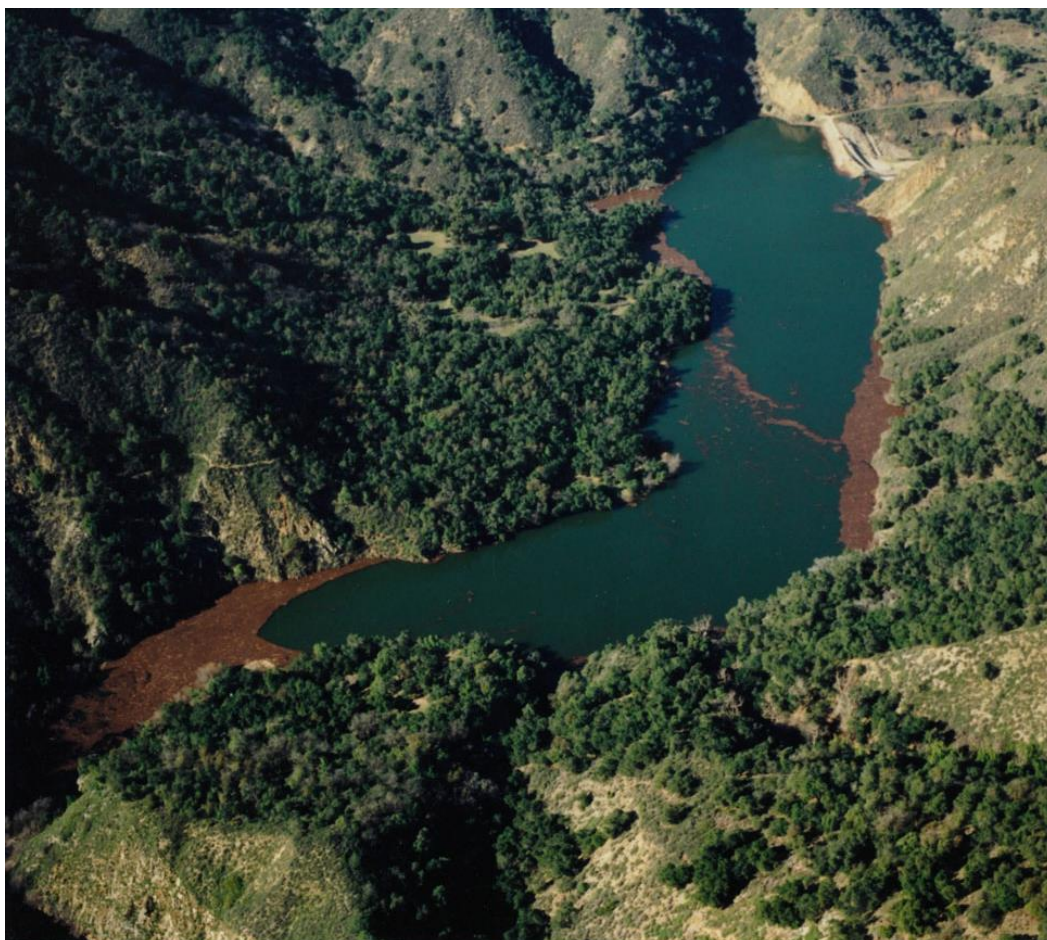
Figure 20 – debris in reservoir, January 1995
