Figure 2 – Los Padres Dam and Reservoir

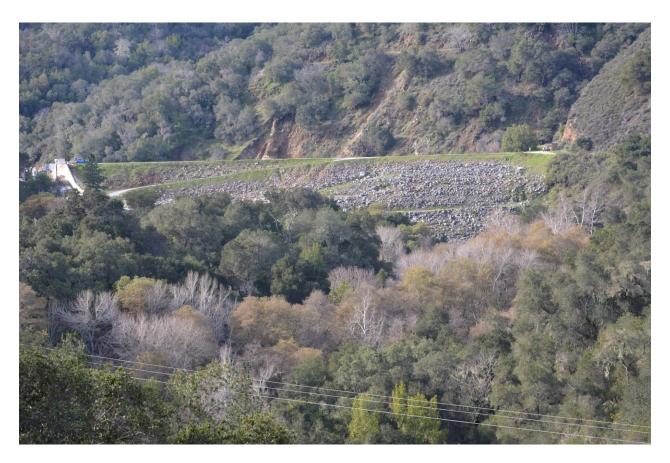
Figure 3 - Looking south to dam face

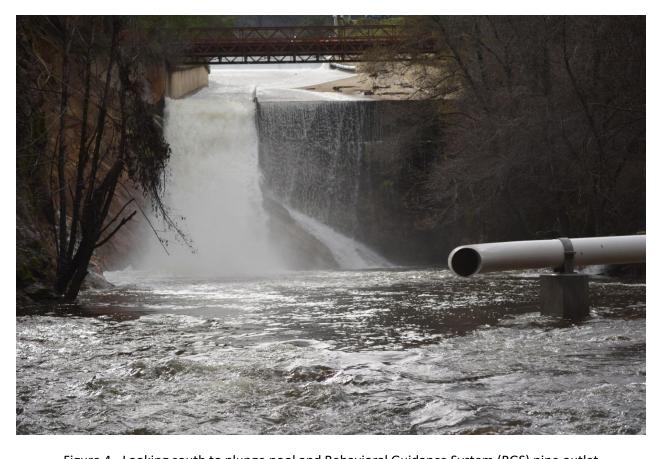
Figure 4 - Looking south to plunge pool and Behavioral Guidance System (BGS) pipe outlet

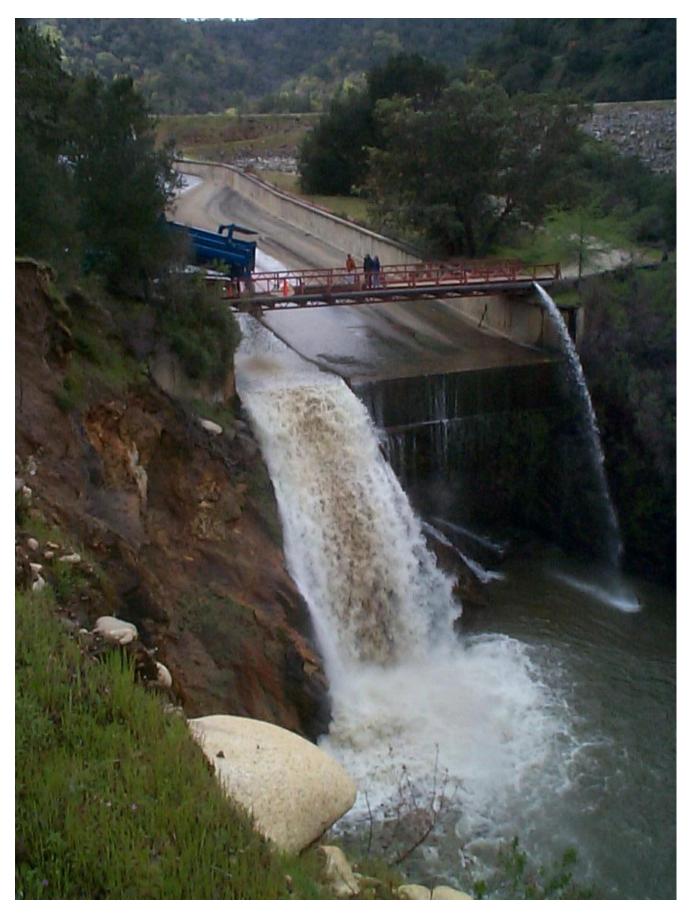
Figure 5 – Bailey Bridge and plunge pool at end of spillway

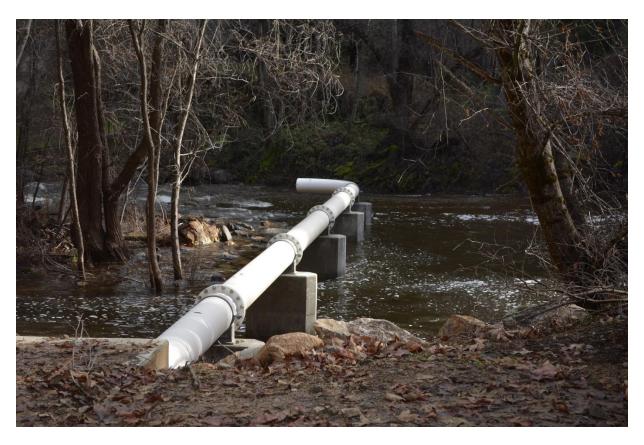
Figure 6 – looking east at Behavioral Guidance System exit

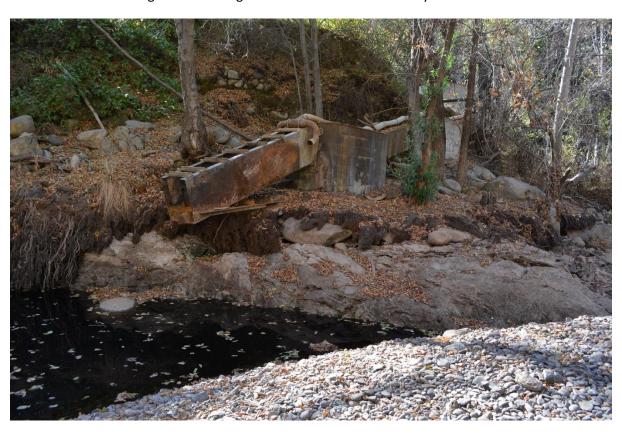
Figure 7 – Existing weir fishway (Denil ladder) entrance in plunge pool

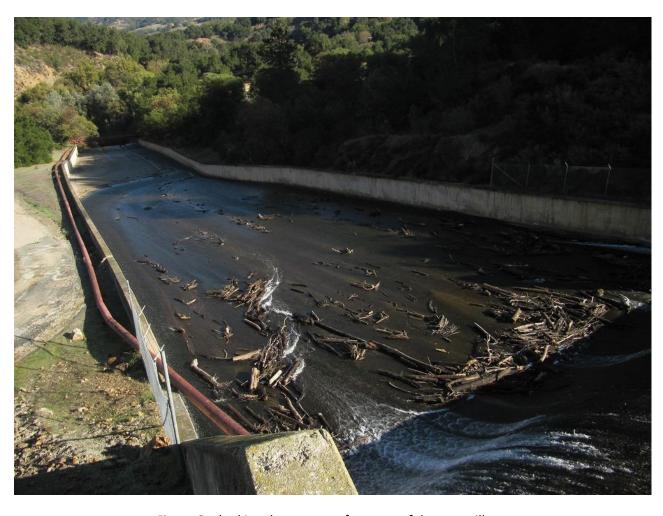
Figure 8 – looking downstream from top of dam to spillway

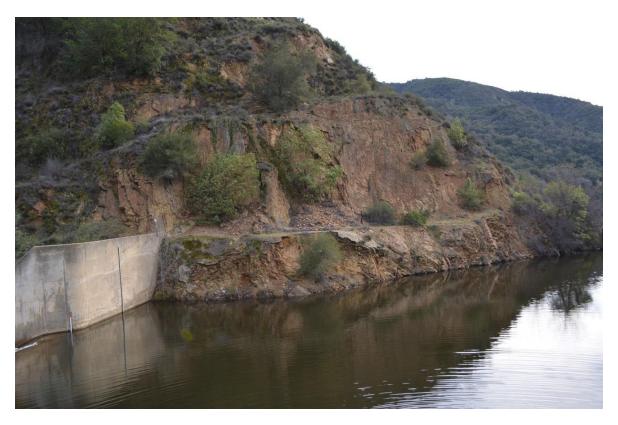
Figure 9 – east abutment

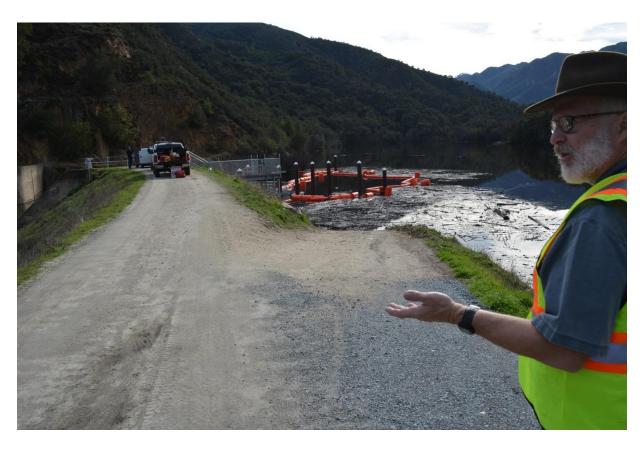
Figure 10 – looking east along top of dam toward spillway

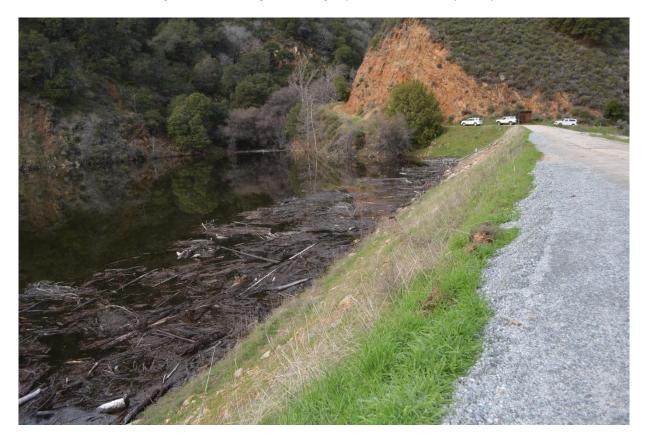
Figure 11 – looking west along top of dam from mid-point of dam to west abutment

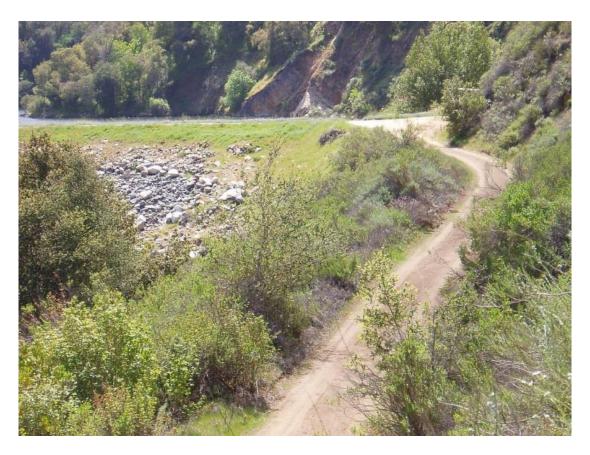
Figure 12 – Looking upstream (south) to west abutment

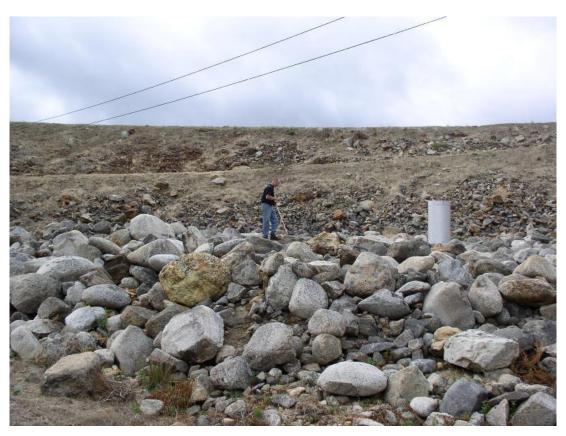
Figure 13 – boulders placed to stabilize downstream face

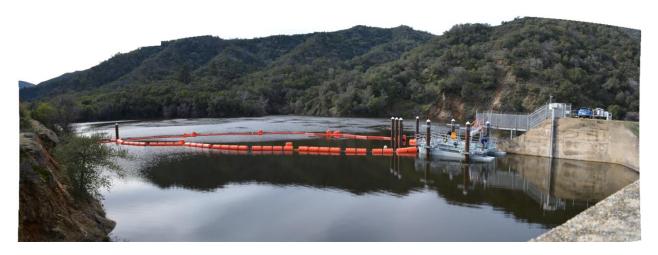
Figure 14 – Behavior Guidance System at dam spillway

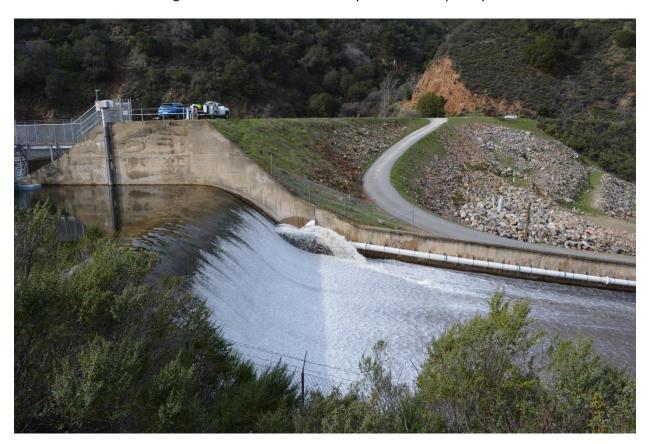
Figure 15 – Looking west at spillway w/BGS anchored to left wall and dam access road in background.

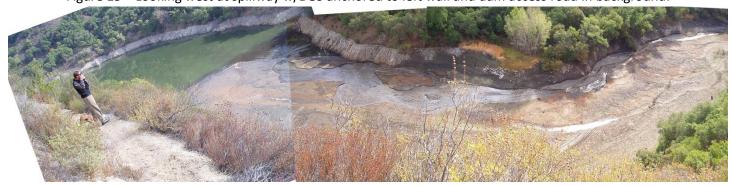
Figure 16 – top of foreset slope

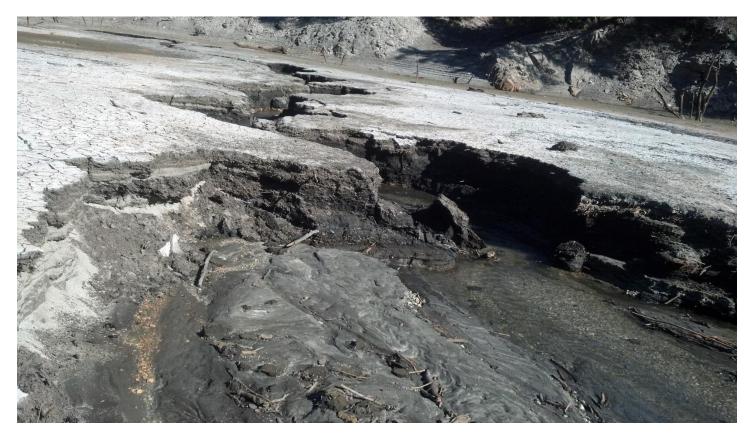
Figure 17 – upper reservoir silt and organic deposits

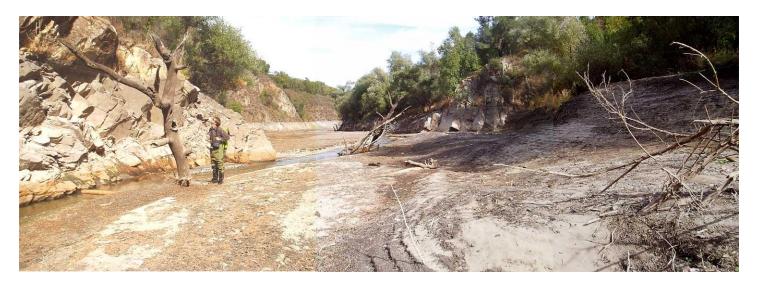
Figure 18 – siltation at upper end of reservoir

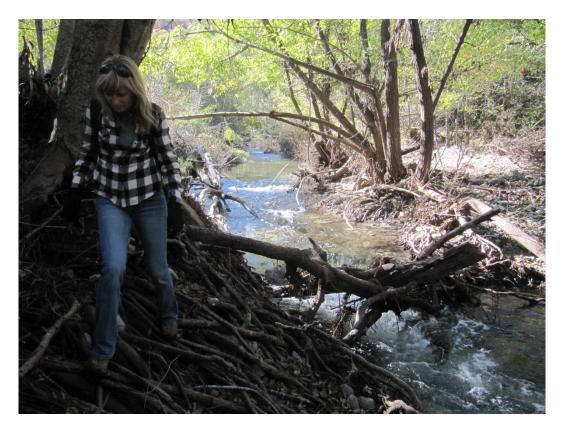
Figure 19 – upstream end of inundation zone

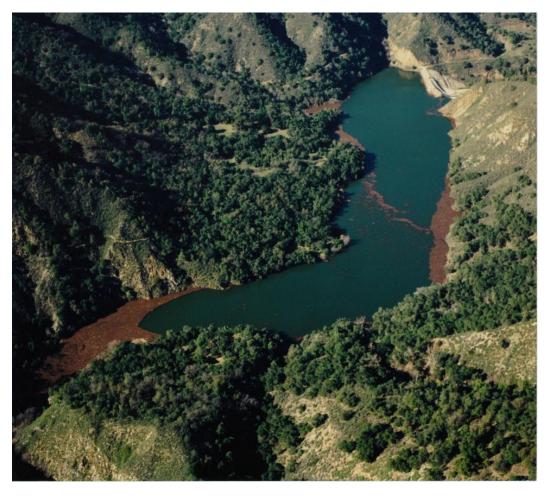
Figure 20 – debris in reservoir, January 1995

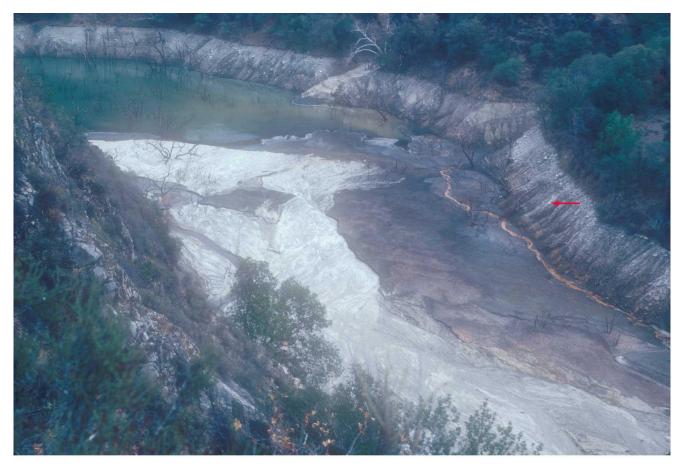
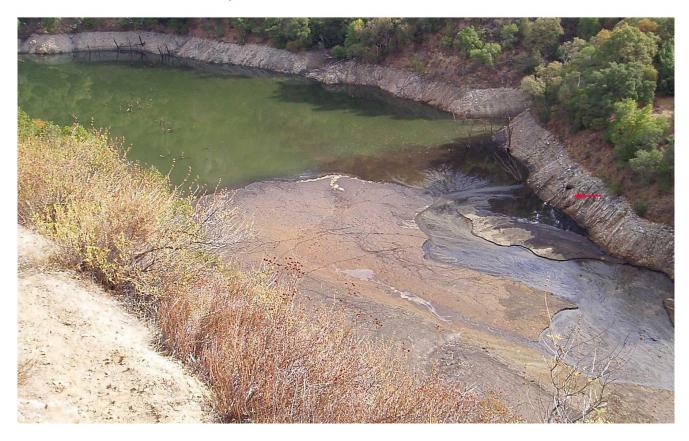
Above: December 12, 1988 Below: October 15, 2007

Figure 21 – reservoir comparison

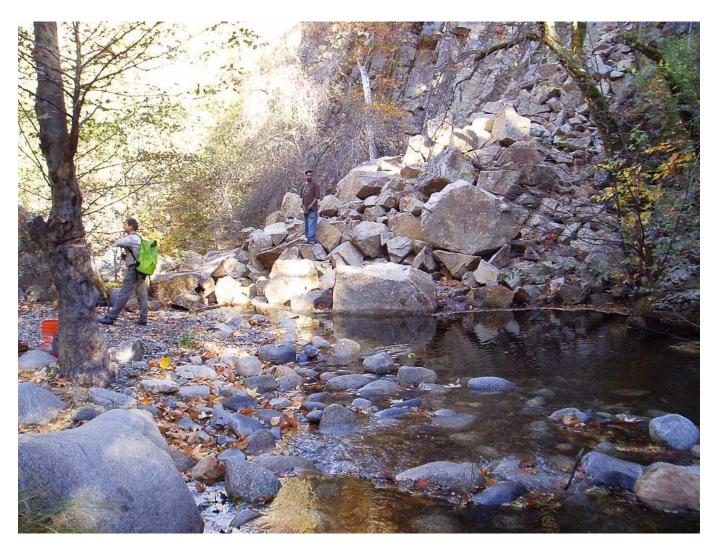
Figure 22 – slide in upper Carmel River above Los Padres Dam
