**THOMPSON**  
**WILDLAND MANAGEMENT**

February 15, 2018

Subject: Construction impact assessment for trees located at the Sleepy Hollow Fish  
Rearing Facility

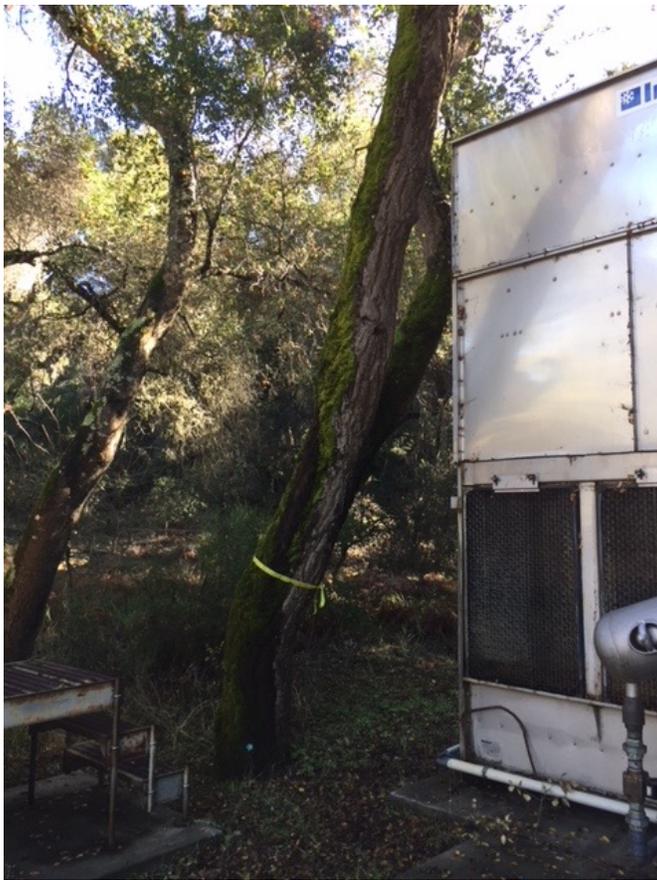
Figure 1. Coast live oak identified as Tree #1 is proposed for removal to make way for planned facility improvement operations.

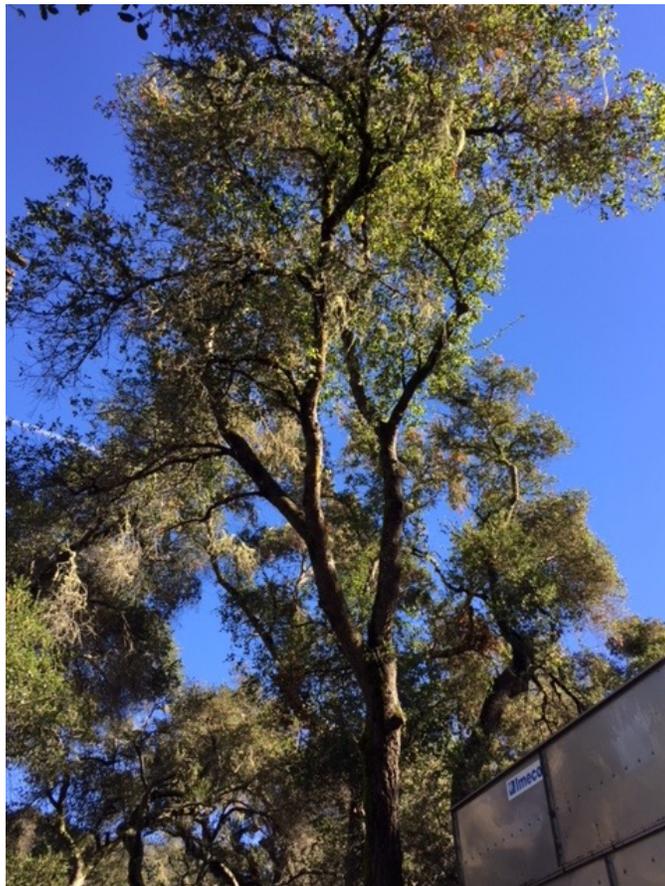
Figure 2. Mid to upper-canopy of oak identified as Tree #1. Tree is in fair overall health and condition.

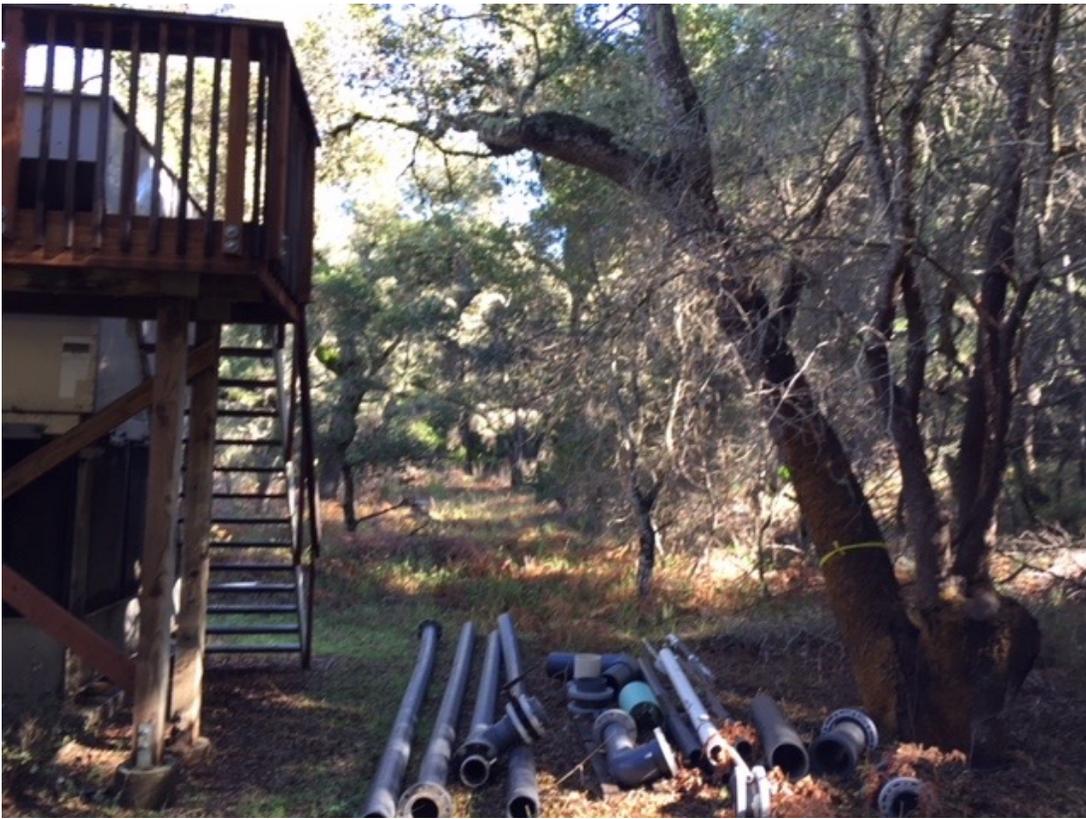
Figure 3. Multi-trunk coast live oak identified as Tree #2 (right side of photo) is proposed for removal to make way for planned facility improvement operations.

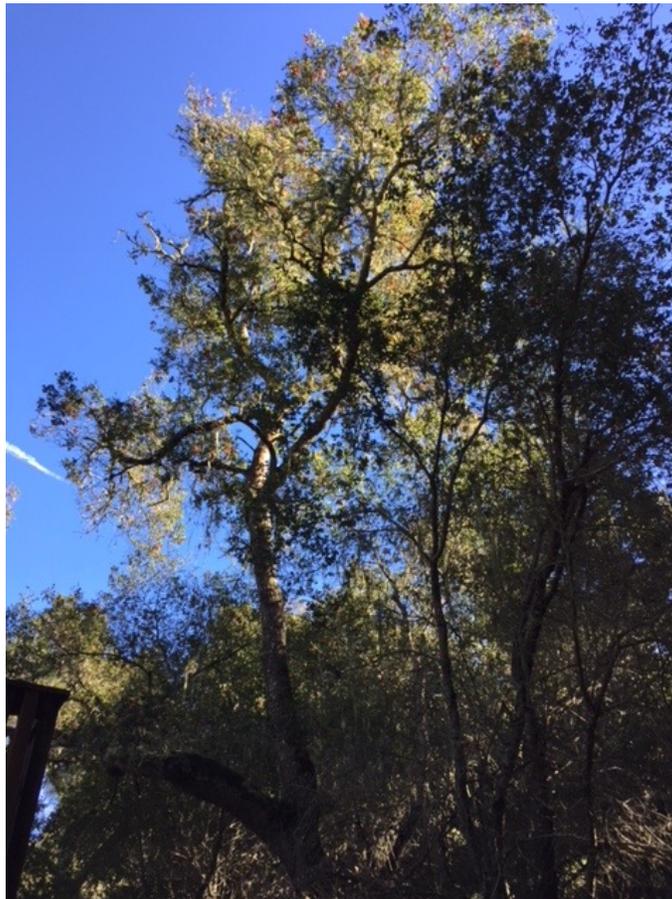
Figure 4. Mid to upper-canopy of oak identified as Tree #2. Tree is also in fair overall health and condition.
