SCHULTE RESTORATION PROJECT

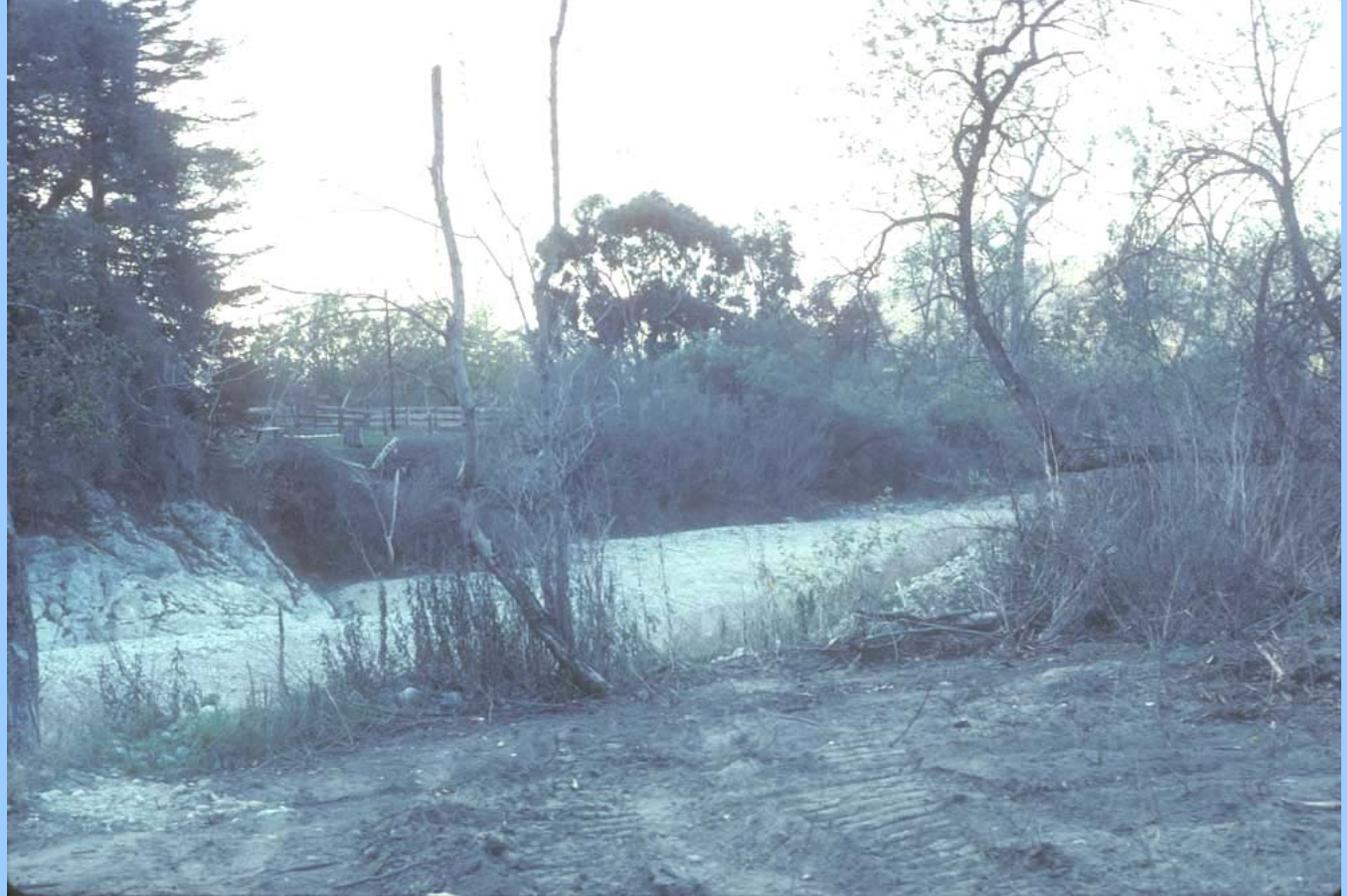
In November 1976, when this photo was taken, Carmel Valley was in the grip of an intense drought. Pumping dropped groundwater levels to as much as 55 feet below the riverbed, which caused a massive die-off of streamside vegetation.

Look closely in the foreground and you can see bulldozer tracks. Streambanks were mechanically cleared of dead vegetation during the summer and fall months. This activity probably took away the last vestige of protection along the loosely consolidated streambanks and contributed to the episode of erosion that followed the drought.

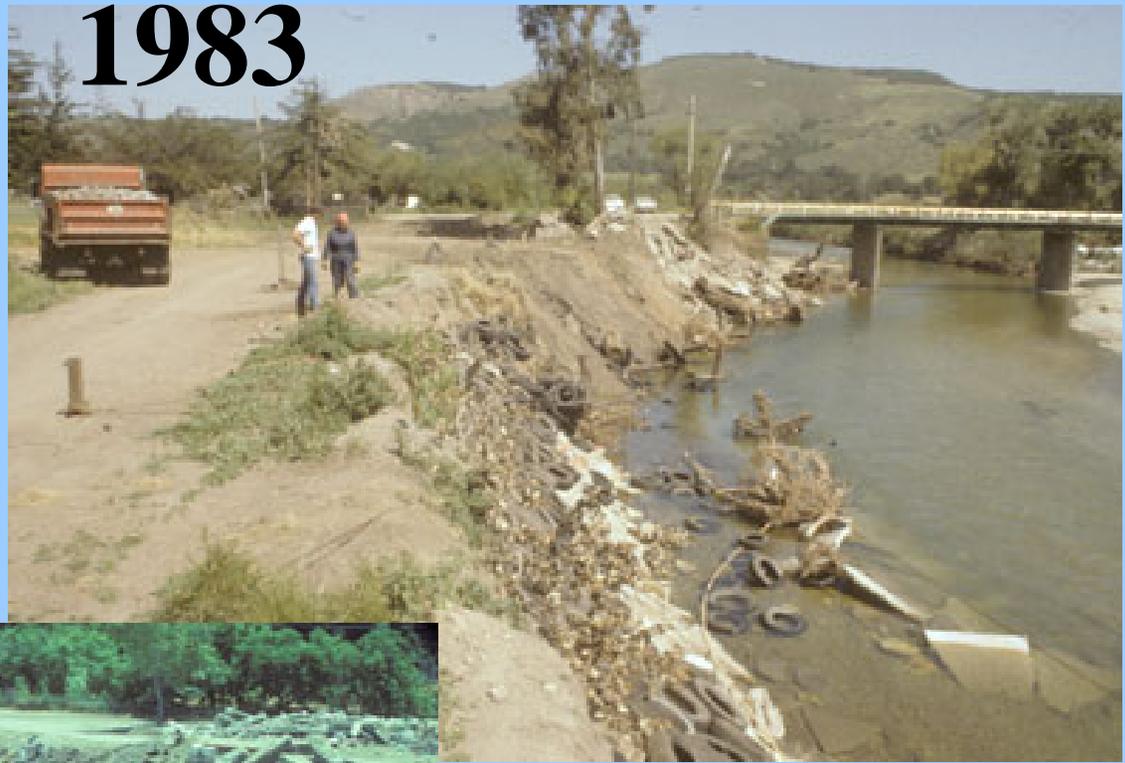
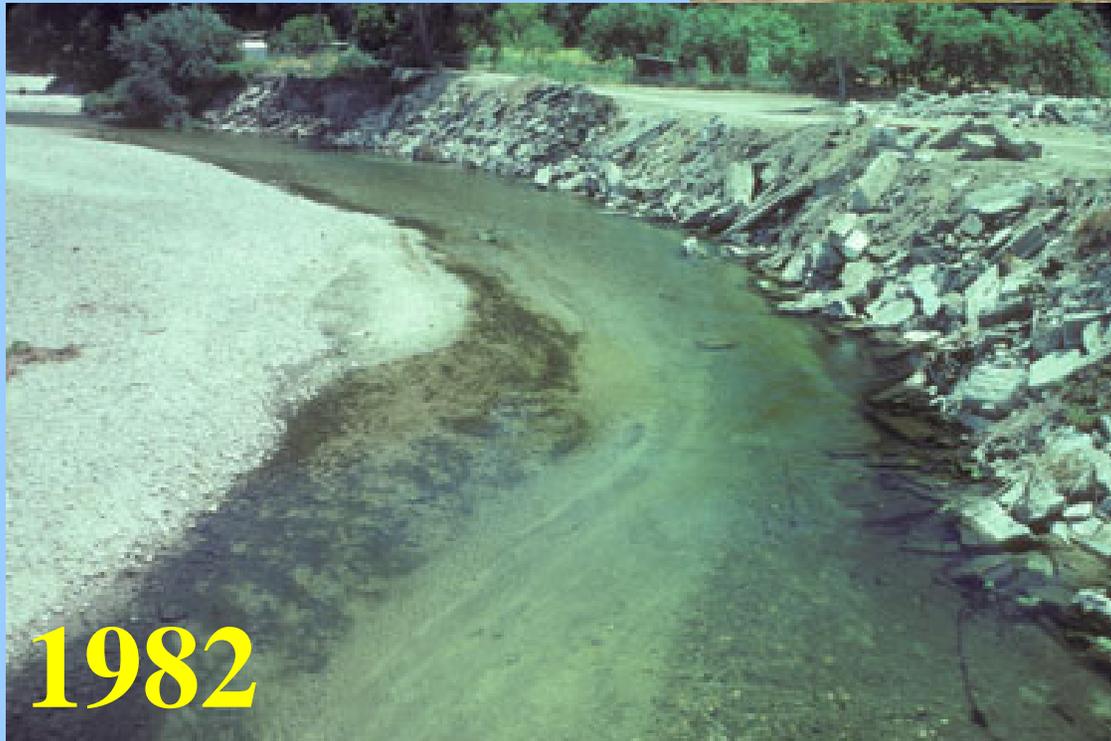
Rains and swift flows returned in 1978 and continued through 1983. Property owners, desperate to halt bank erosion, dumped many types of materials over the streambank during high flows. Left - concrete rubble dumped in 1982 on the streambank washed out in 1983 and was replaced by tires banded together (above), which also failed. Schulte Bridge can be seen in the background.

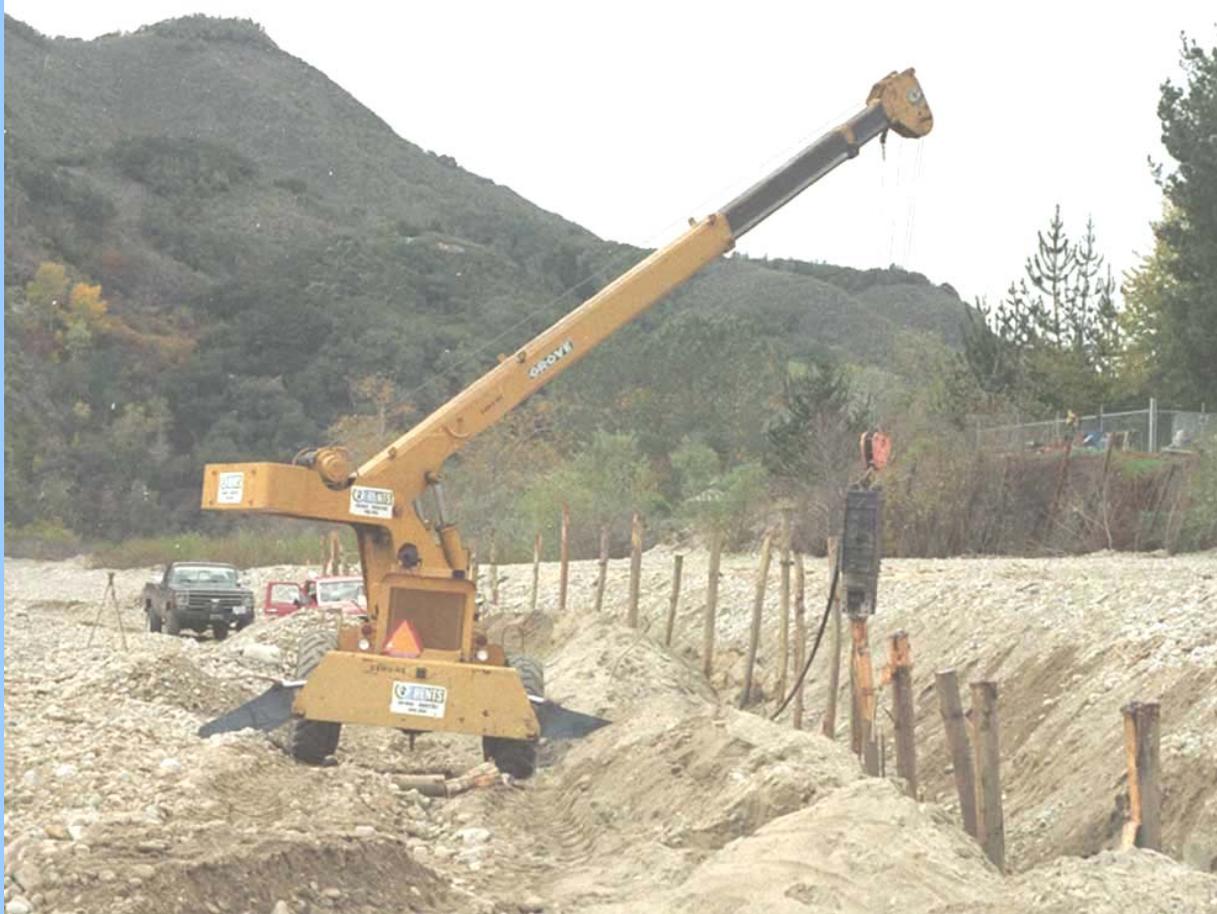
Above - 12-foot long eucalyptus posts were sunk at 10-foot centers at the toe of the streambank along the outside of bends. This provided the framework to place six-foot wire mesh that resembled chain link fence. About three feet of the mesh was buried below the streambed to resist toe scour. This method worked fairly well at the Schulte Project, as a drought between 1987 and 1991 allowed vegetation to become established enough to resist high flows.

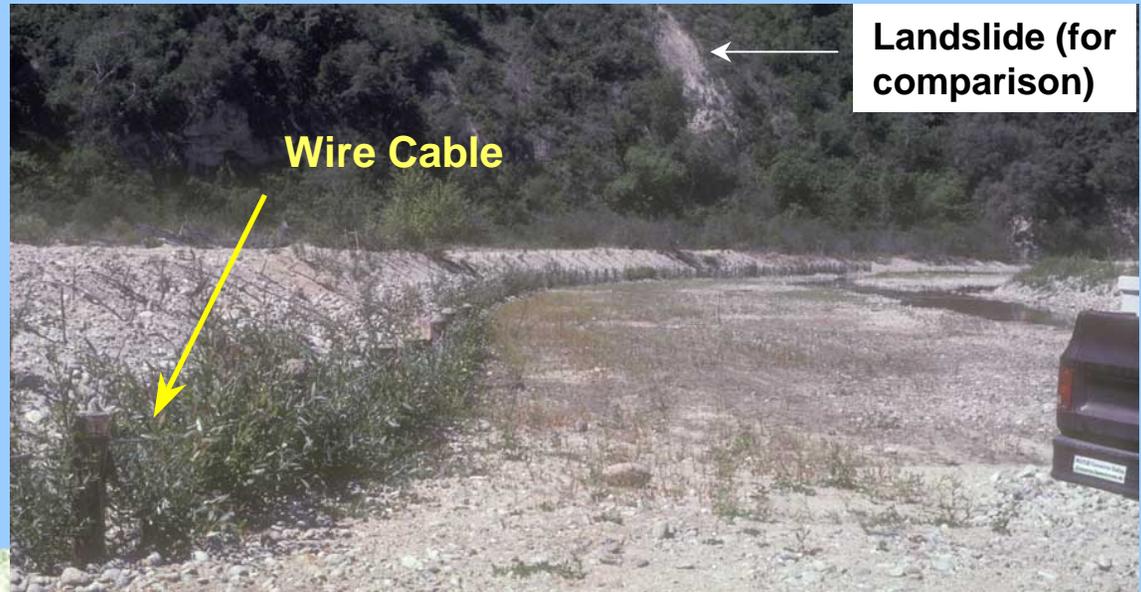
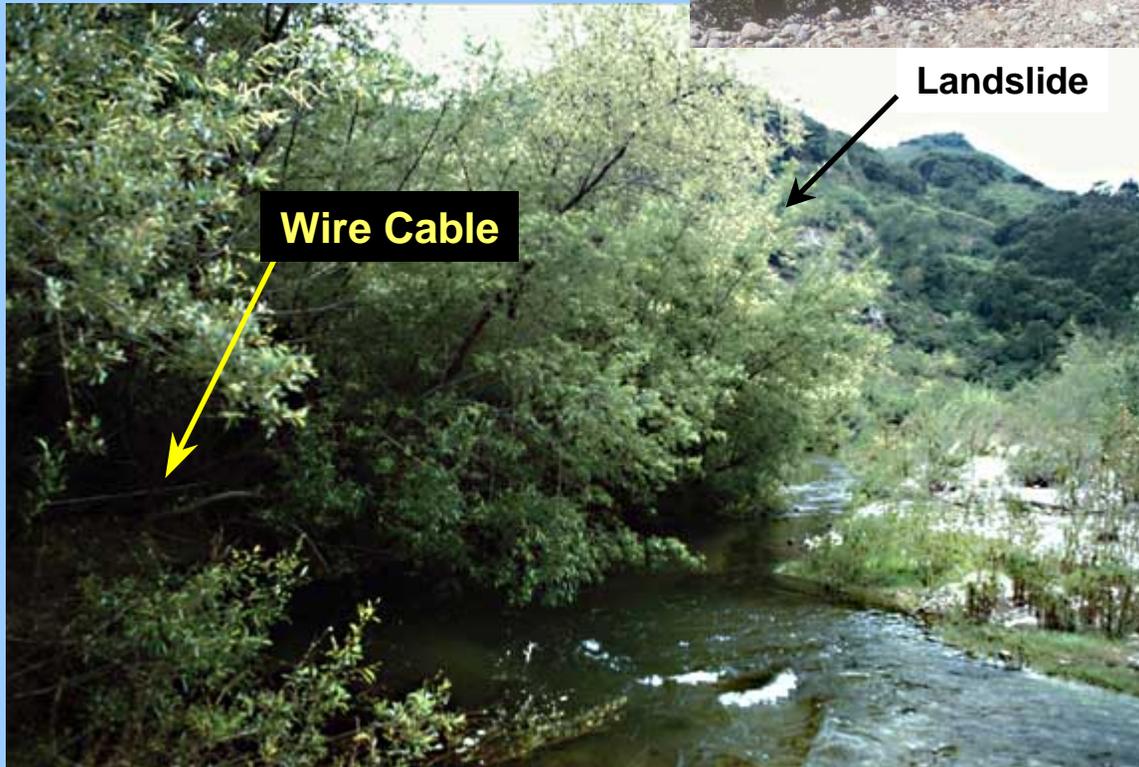
Right – view downstream in May 1988, shortly after construction.
Below – same view in May 2002.

As streamside plants mature, the post and wire is incorporated into the trees and can provide significant protection; however, after several years, the posts rot at the toe of the slope. This reduces the effectiveness against erosion and can be a liability if the wire mesh and posts move downstream and clog the channel. In addition, fisheries biologists object to wire mesh placed near the path of migrating adult steelhead.

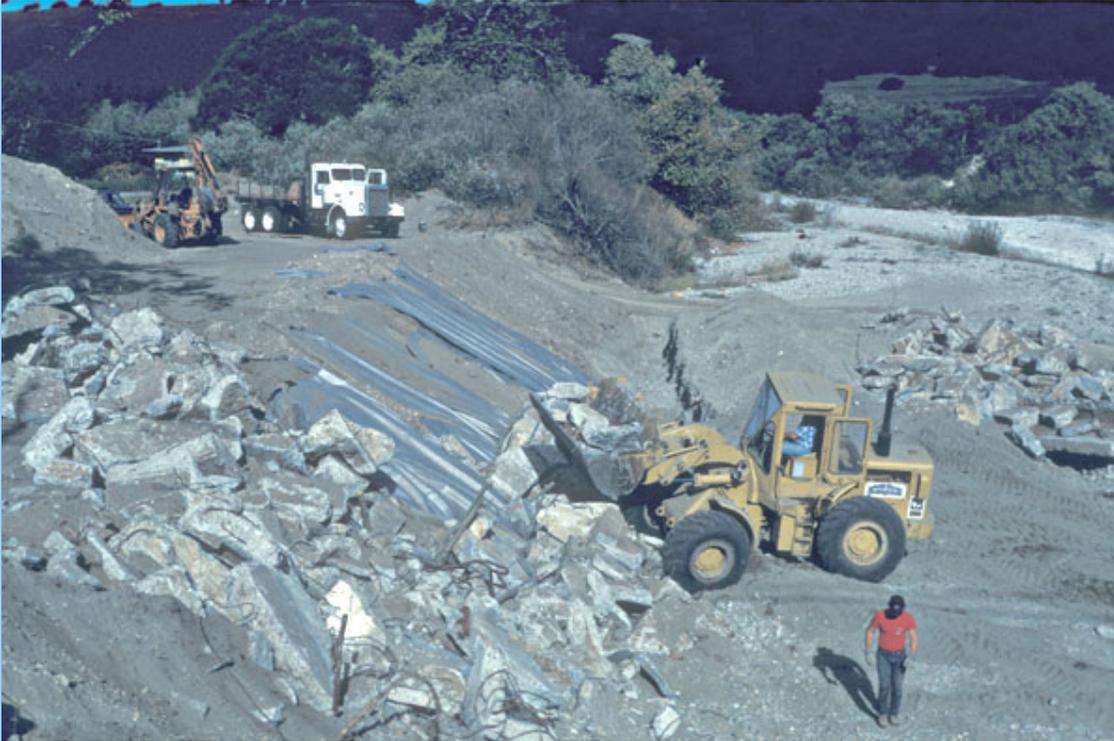
Restoration work was carried out in three phases, with work at the bridge scheduled first. Here, concrete rubble is placed on a streambank rebuilt with native river material. The shiny black cloth under the rubble is used to stop fine streambank material from washing out during high flows.

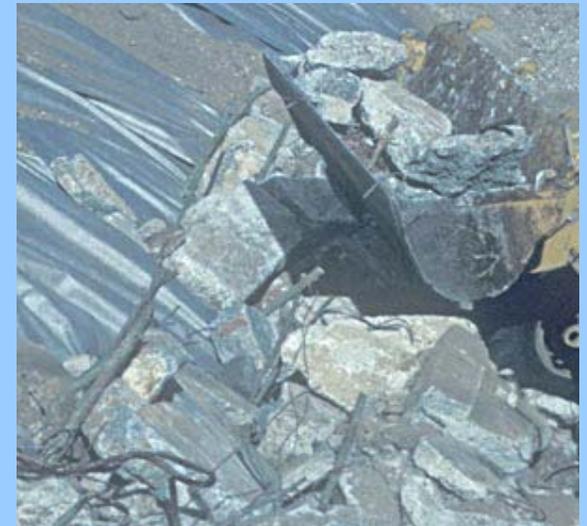
Right – a close up near the loader bucket, showing what appears to be green sticks amongst the rubble. Willow cuttings were integrated into the slope protection from the beginning.

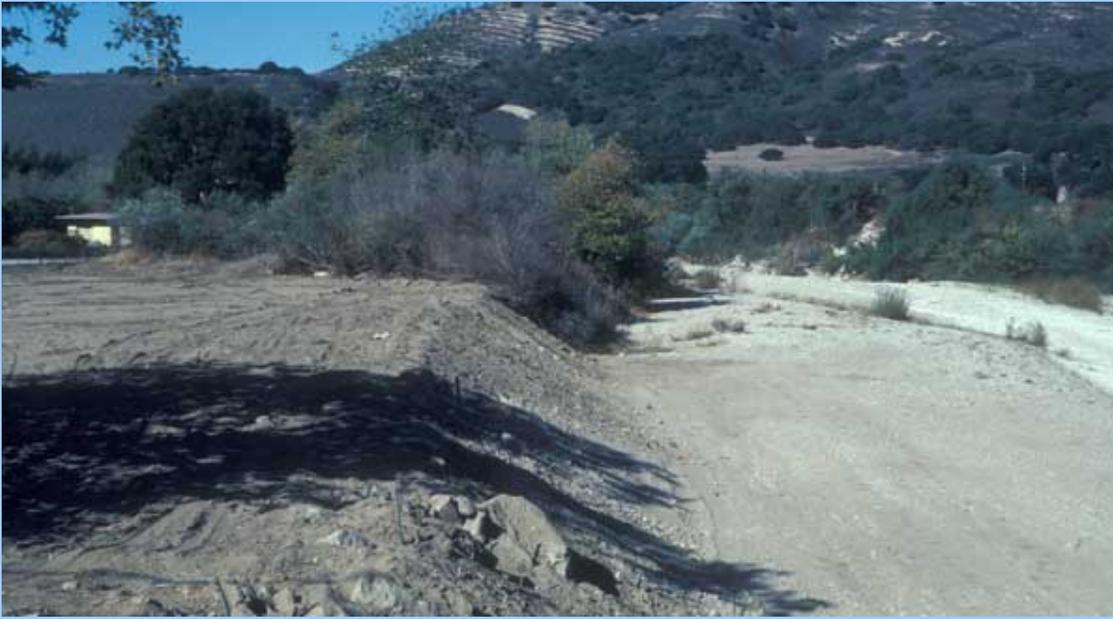
Above - finished bank in 1986.

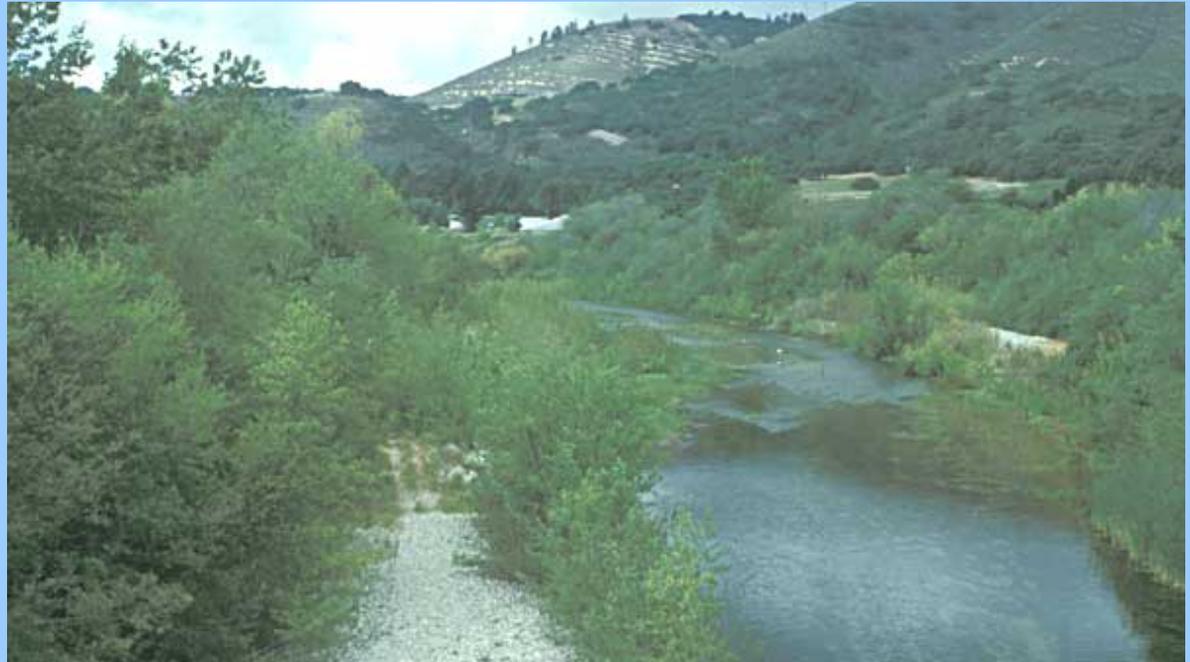
Right – same view 16 years later in May 2002. There are few visible signs of the concrete rubble and filter cloth installed during construction, but the erosion protection placed to protect the bridge withstood two of the highest flows on record in 1995 and 1998. MPWMD continues to irrigate and maintain this area.

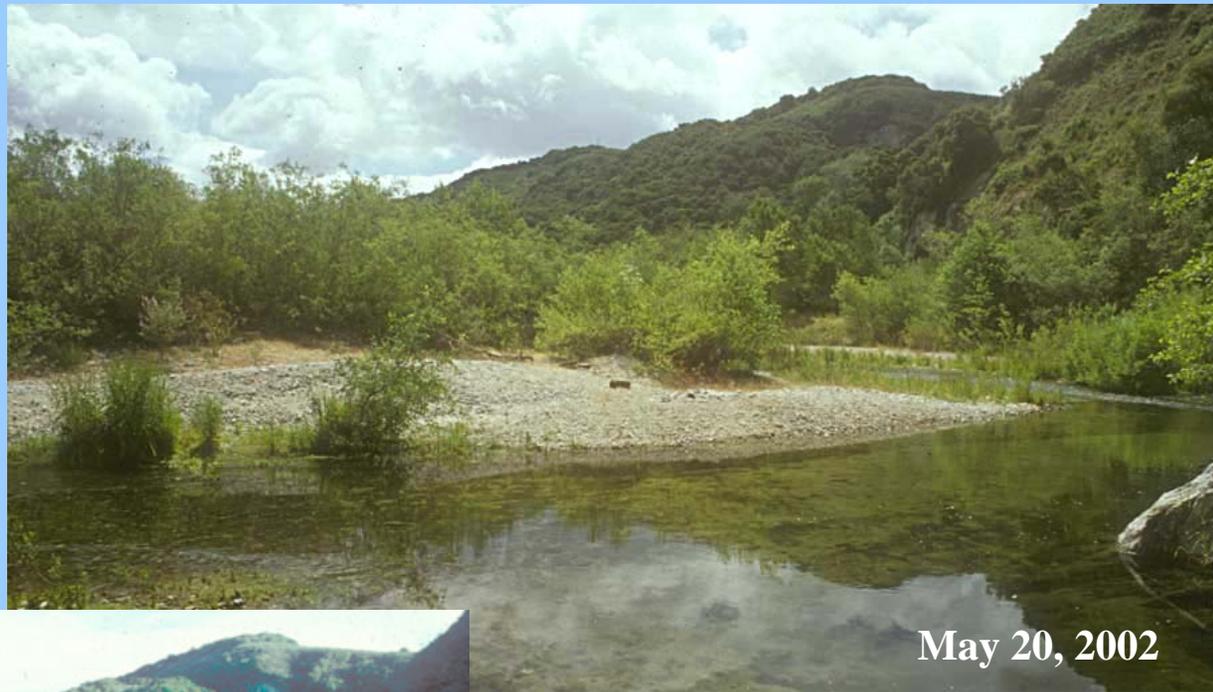
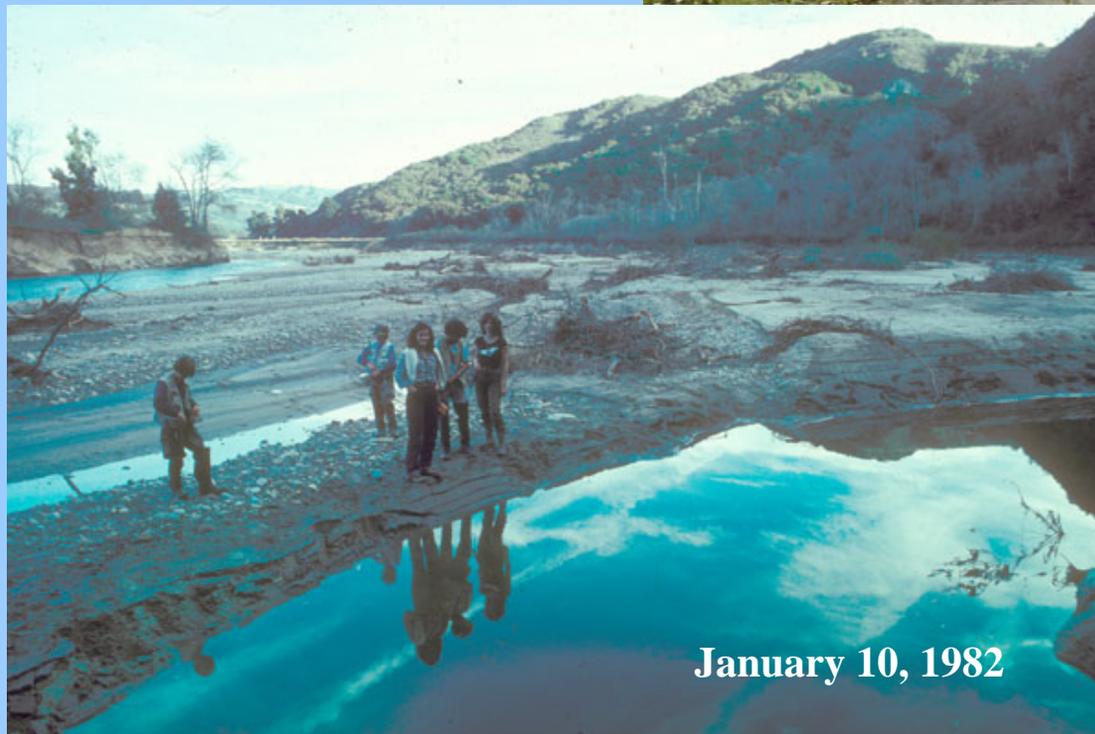
Left - degradation of the riparian corridor culminated in an episode of erosion that scoured the channel and streambanks between 1978 and 1983 and transformed the reach into a braided, meandering channel with virtually no streamside cover. After many years of effort, a dense riparian corridor is now forming in this area as shown in the above photo.

These views were taken upstream of Schulte Bridge from the rock outcrop above the "Steinbeck" pool.

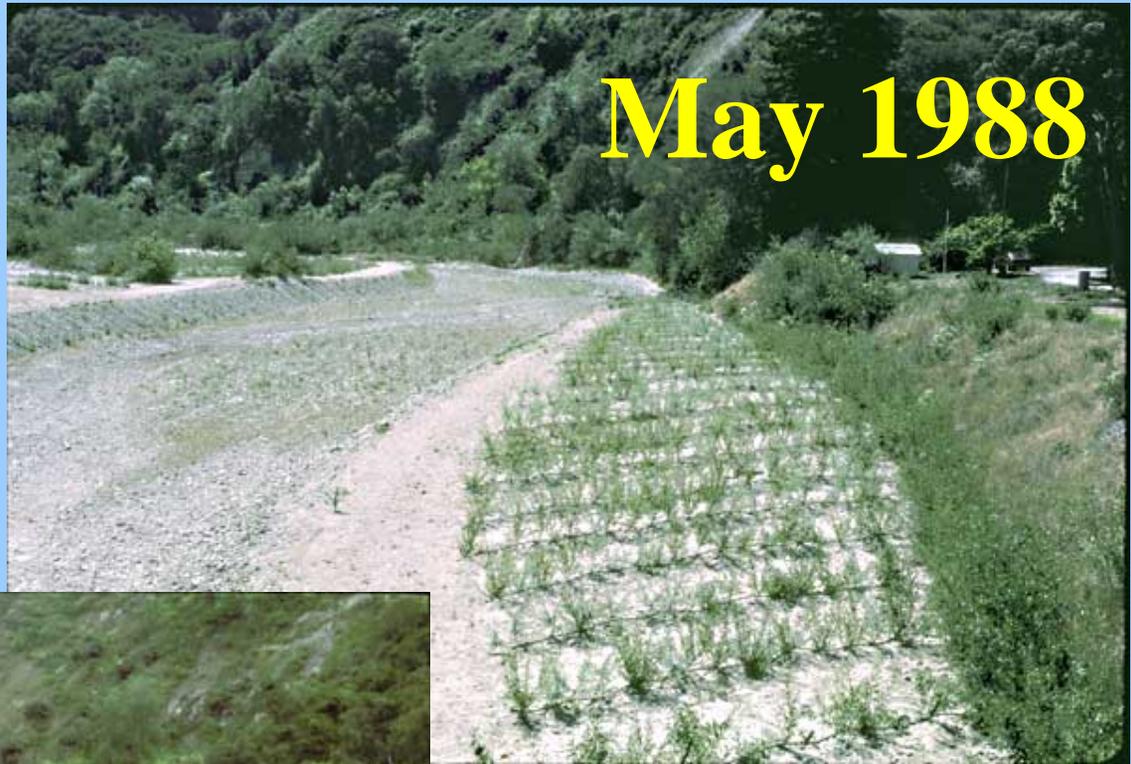
Right – willow cuttings installed in 1988 benefited from very low winter flows initially, which allowed these to mature. Today, these willows are more than 30 feet tall and have resisted extreme flow events with relatively small losses.

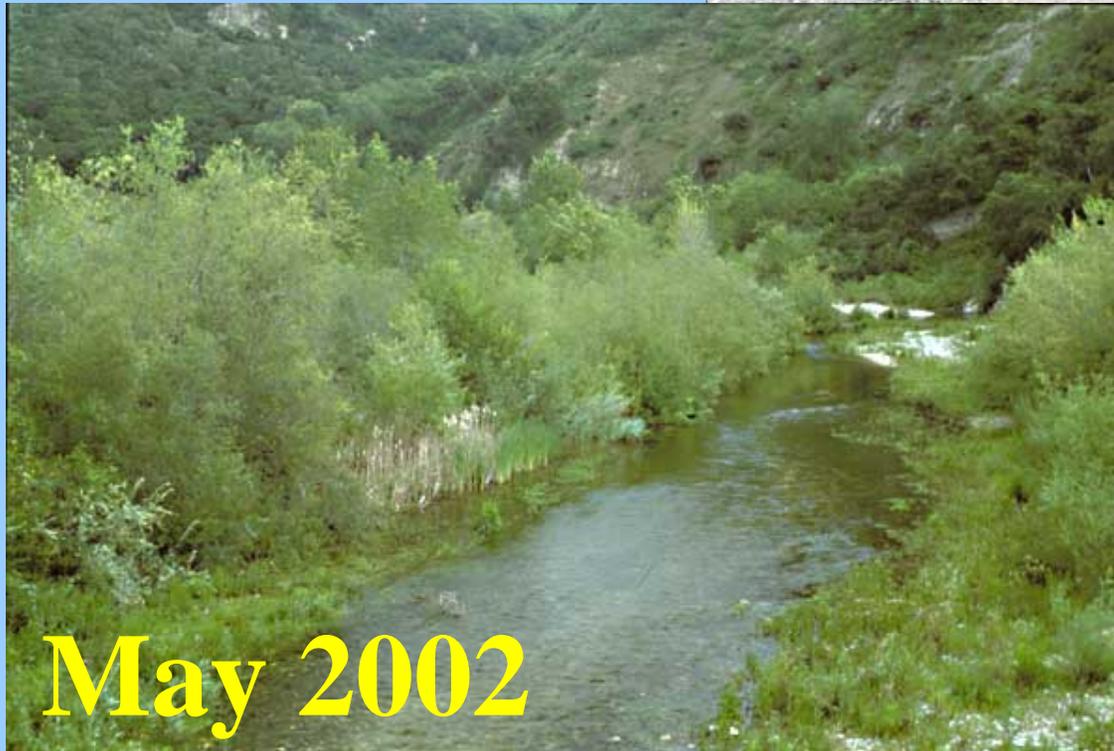
Left – nearly perennial flow between 1995 and 2002 encouraged more wetland species, such as the cattails just left of center. In late summer 2002, this reach dried up, which resulted in the loss of several streamside alders and cattails. Irrigation continues in the floodplain. Increased avian diversity and a strong increase in the number of spawning steelhead indicate good improvement of habitat. But intensive management is likely to continue in the foreseeable future.
