Carmel River Bank Stabilization at Rancho San Carlos Road Project Description and Work Plan – March 2018

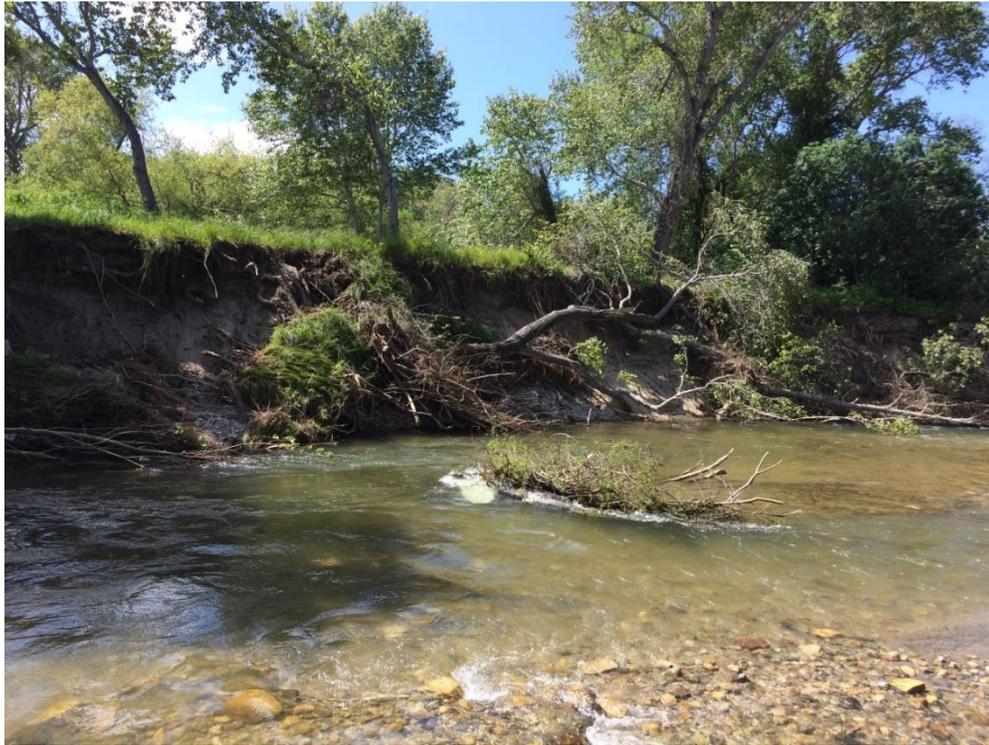
The proposed Carmel River Bank Stabilization at Rancho San Carlos Road Project (RSC Project) is located at River Mile 3.8 (measured from the Pacific Ocean) just downstream of the Rancho San Carlos Road Bridge (**Figure 1**). The project area contains two eroding stream banks almost opposite from each other. Concern for the stability of the right bank (looking downstream) on APN 015-251-027, Moratz Property started in 2011 and interim measures such as jute netting, willow planting, and irrigation were carried out in an effort to stabilize the bank. In February of 2017, during a high flow event of 9,570 cubic feet per second at the U.S.G.S Near Carmel gage, the left bank along APN 157-121-027, Quail Lodge Property experienced significant erosion and up to about 55 feet of streambank was eroded along 300 lineal feet (**Figure 2**).

During the high flows, numerous large cottonwood trees toppled out of the river bank and culturally significant Santa Barbara Sedge beds were lost. Currently, the left bank is vulnerable to erosion from high flows because it has lost its protective vegetative cover and is on the outside of a meander bend in an area that can erode during high flows. Because these vulnerable streambanks are so close together, work on one bank can impact the other. Therefore, a comprehensive project addressing both banks is being proposed (**Figure 3**).

Figure 2. Left streambank after winter of 2017 erosion event (note lack of protective vegetation)

A log crib wall will protect the most severely damaged portion of the left bank. Other options for treating the left bank were considered—for instance, boulder barbs and log/boulder toe protection—but the crib wall was chosen for a number of reasons. The 2D hydraulic model indicated that shear stress is relatively low at the 10-year design event (at most 1.0 lb./ft.² on the left bank) and velocity is at most 8.1 ft/sec. According to stability thresholds for stream restoration materials summarized by Fischenich (2001), a number of treatments would be capable of withstanding these conditions. A purely vegetation based treatment was not selected because the long-term stability of the treatment depends on the successful establishment of vegetation. Moreover, there is high risk for failure of vegetative treatments during the establishment period, which could be as much as four to five years. For example, the probability of a 10-year event—which would be expected to cause a vegetative treatment to fail—during a 5-year establishment period is approximately 41 percent. On the opposite end of the spectrum from a purely vegetative treatment are hard surfacing options such as rip rap. A hard-surfacing option was not selected because large clasts are not geomorphically appropriate for the project reach. Furthermore, hard surfacing options are predisposed to offsetting a bank erosion problem to downstream reaches. Riprap and similar hard surfacing schemes are not favored by regulatory agencies for similar reasons. Lastly, these types of treatments tend to detract from the aesthetic quality of a system.

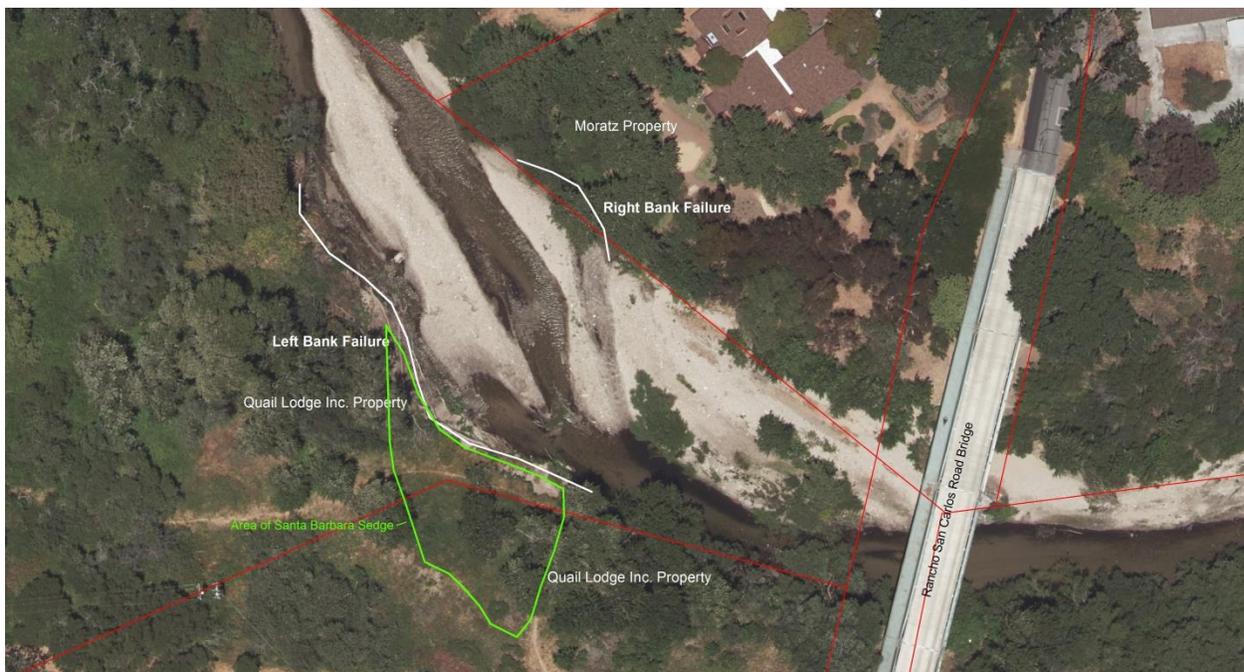
Figure 3. Aerial image showing locations of erosion just downstream of Rancho San Carlos Road Bridge

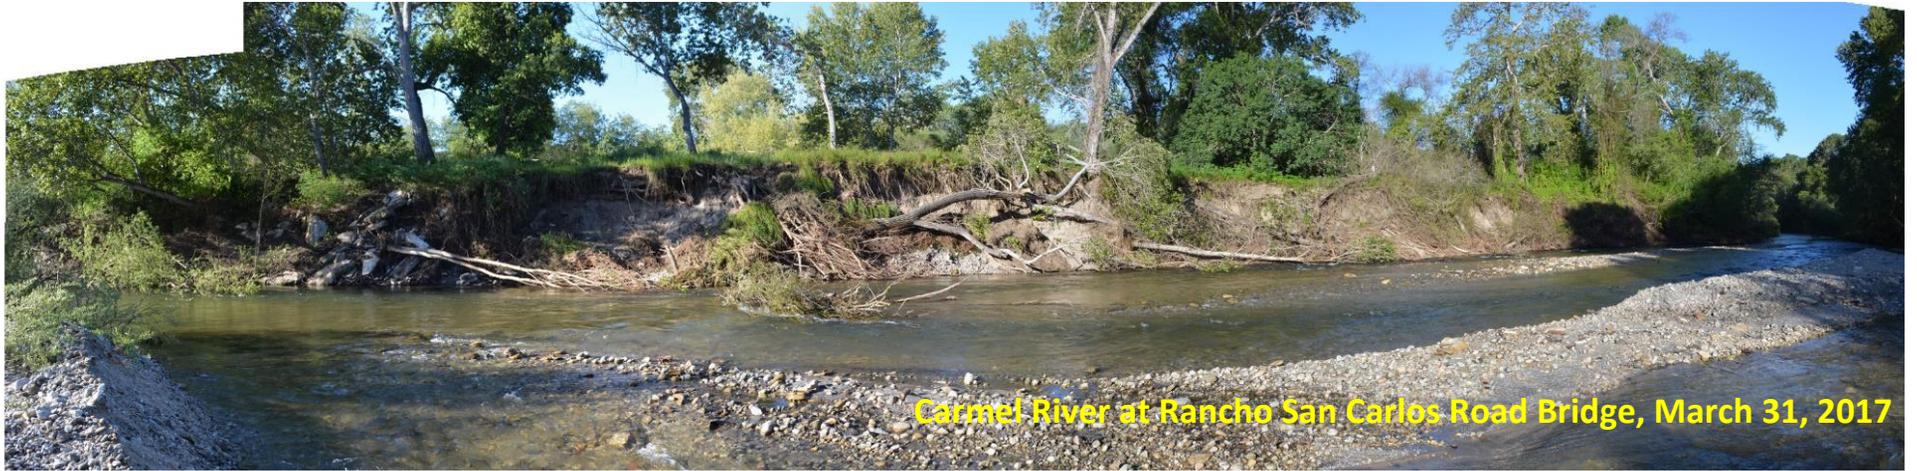
Carmel River at Rancho San Carlos Road Bridge, March 31, 2017

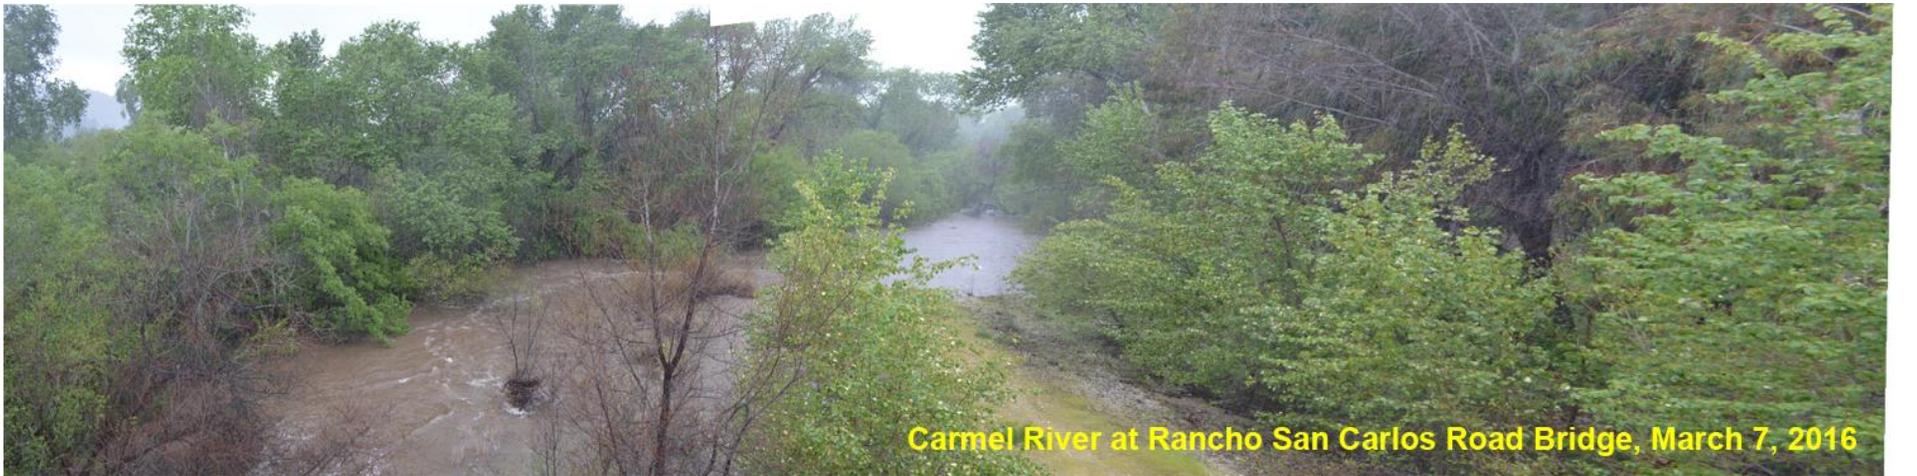
Carmel River at Rancho San Carlos Road Bridge, March 7, 2016
