**MONTEREY PENINSULA WATER MANAGEMENT DISTRICT
PROJECT DESCRIPTION FOR SELECTIVE VEGETATION MANAGEMENT
IN THE CARMEL RIVER CHANNEL, BANK RESTORATION, AND CONCRETE
PIER AND DECK REMOVAL, SUMMER AND FALL 2017**

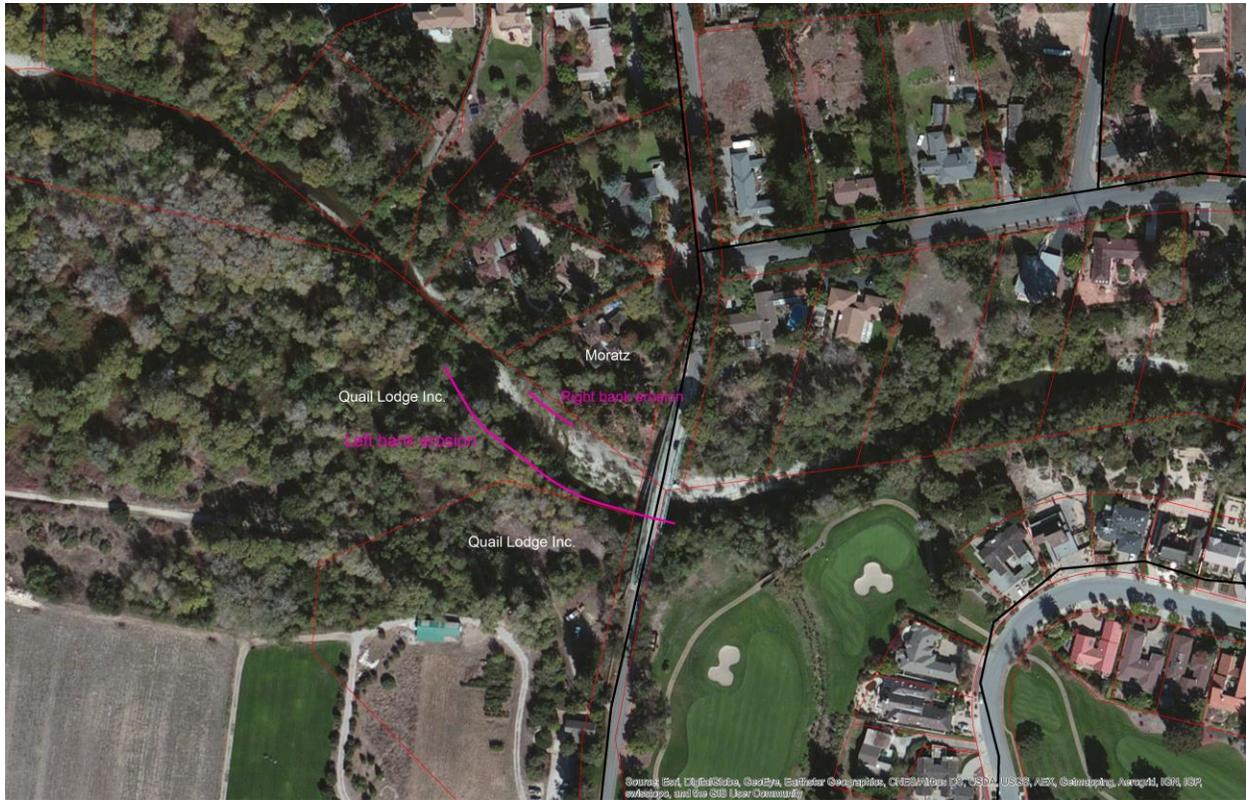
Streambank erosion occurred along approximately 75 feet of the right streambank and up to 400 feet of the left bank just downstream of the Rancho San Carlos Road Bridge at RM 3.8 in the winter of 2017. The right streambank initially started showing signs of instability in 2011 when moderate flows were directed by a large gravel bar directly into the streambank. However, the right bank continued to show only minor adjustments during drought years 2012-15. Then in the winter of 2017 during a high flow events in January and February the left bank on the outside of the meander bend had a significant failure where approximately 10 to 15 feet of property over approximately 300 plus feet eroded into the river as several large cottonwoods fell out of the streambank. Temporary measures to stabilize the right bank including installation of jute net, sand bags, large wood, and willow cuttings do not appear to be adequate to protect the bank from large flow events. Now with the new erosion of the left bank on the outside of the meander bend and the foreseeable loss of additional land, including a portion of the only remaining mature riparian forest along the lower 15 miles of the river, the District would like to restore these two streambanks to prevent a large scale erosion event in future winters. The intent of the project is to stabilize the streambanks, encourage deposition between the vanes, and focus the energy of the river into the center of the active channel.

Aerial Image showing locations of erosion just downstream of Rancho San Carlos Rd. Bridge

A series of rock vanes/barbs (without the J-hook extending into the middle of the channel) consisting of ¼ to two ton rip rap is proposed to be installed along with some rock placed on the slope. Filtering to prevent piping would be accomplished with an appropriately sized gravel filter. For the right bank, approximately 30-40 cubic yards of rock (about 60 to 80 tons) would be imported to the site and placed along the streambank to form a vane/barb. For the left bank, approximately 125 cubic yards of rock (about 250 tons) would be imported to the site and placed along the streambank to form a series of vanes/barbs. Work would be carried out when the river dries up or during very low flows when the river could be contained in a small low flow channel through the reach. Access into the river bottom would be through an existing ramp into the river located about 200 feet downstream of the bank erosion (the San Carlos well ramp) or through Quail Lodge Inc. property. Limited vegetation removal would be required for construction equipment access. Willow cuttings would be placed into the streambank and channel bottom along the rock vane/ barbs as part of the installation.

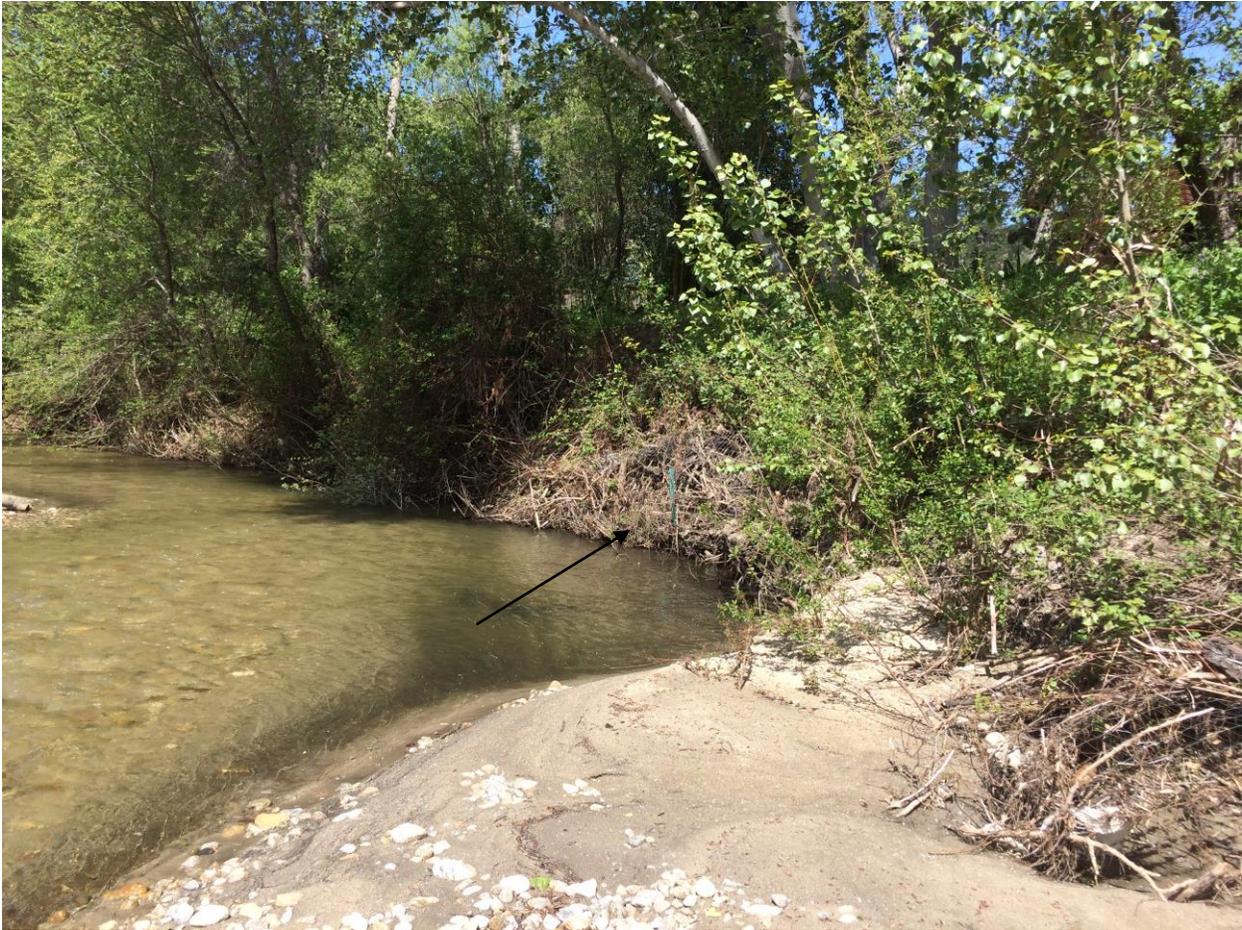
Right bank area susceptible to erosion along Moratz property, Carmel River, Monterey County, California, March 27, 2017.

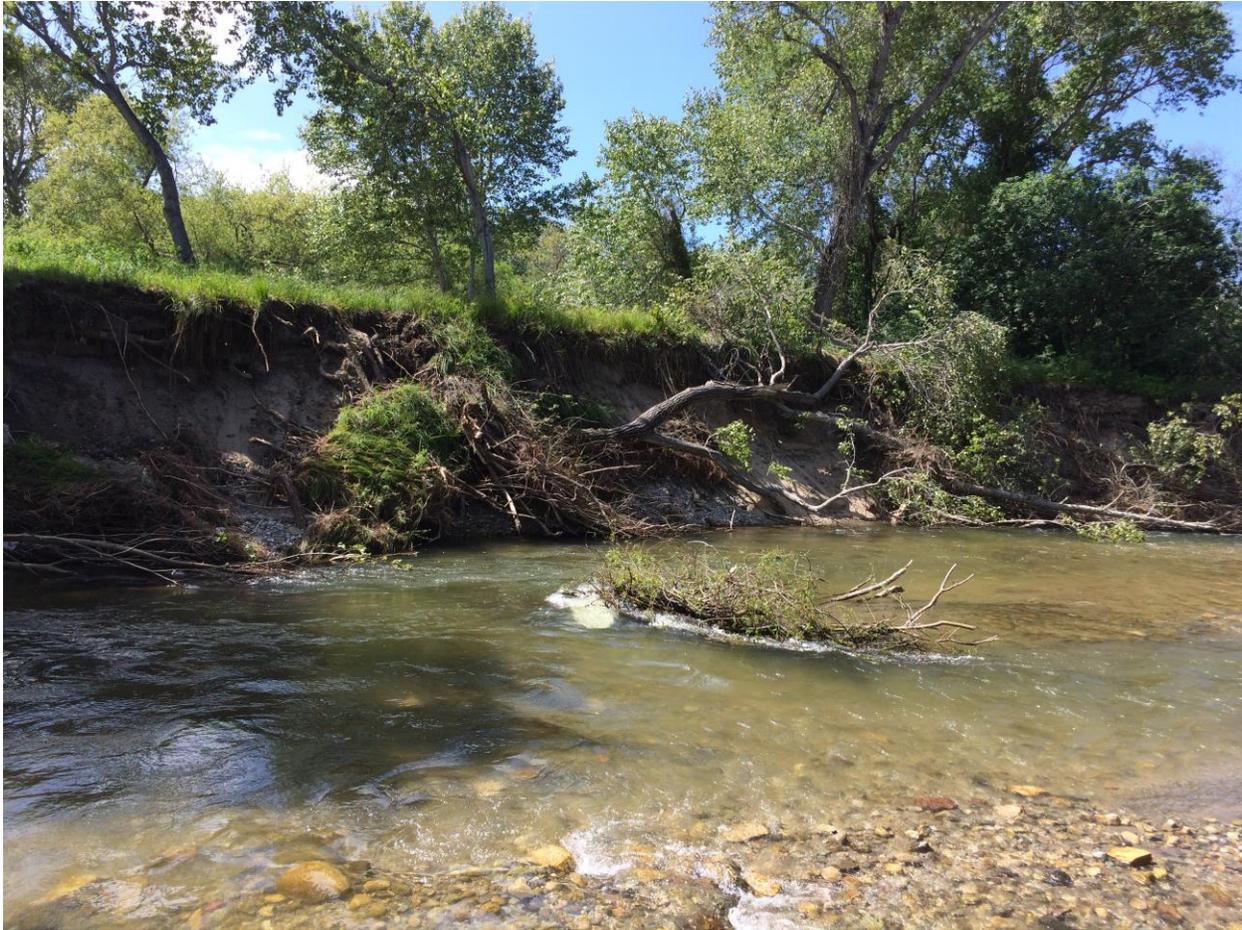
Left bank erosion on outside of meander bend with mature cottonwood forest trees dropping into river during high flows along the Quail Lodge Inc. property, Carmel River, Monterey County, California, March 27, 2017.

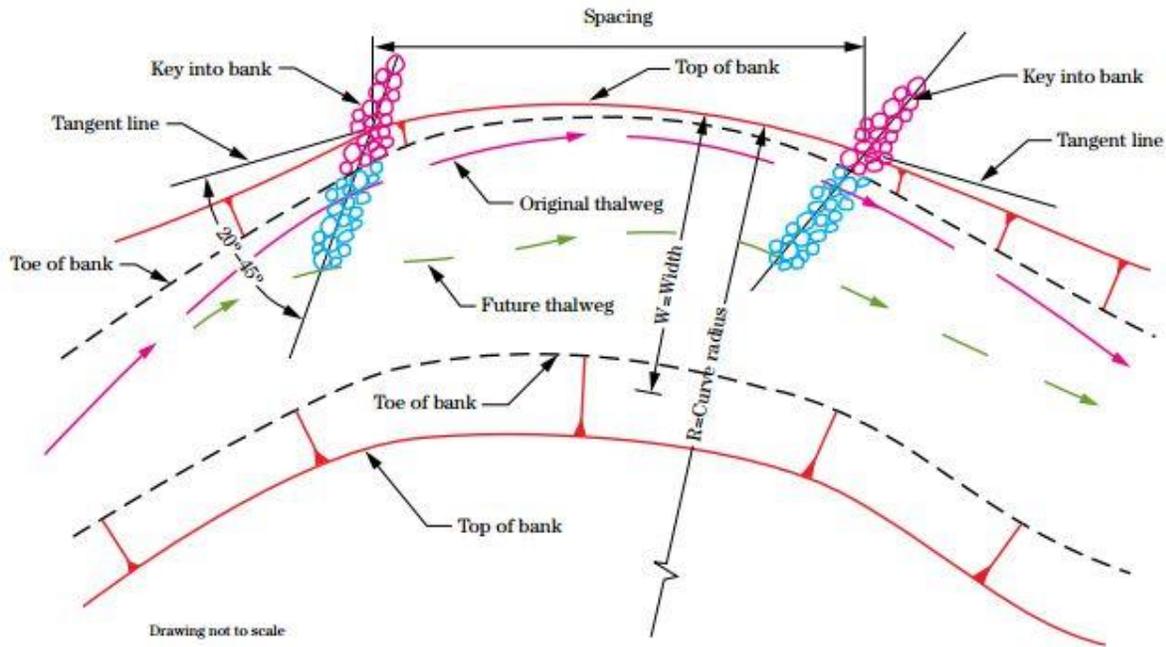
Conceptual design for outside meander bend (Left Bank) protection and restoration with rock barbs. Additional protection would be placed on the inside of the meander bend because a gravel bar sometimes directs flow straight into the bank. Part 654 Stream Restoration Design, National Engineering Handbook, United States Department of Agriculture Natural Resources Conservation Service

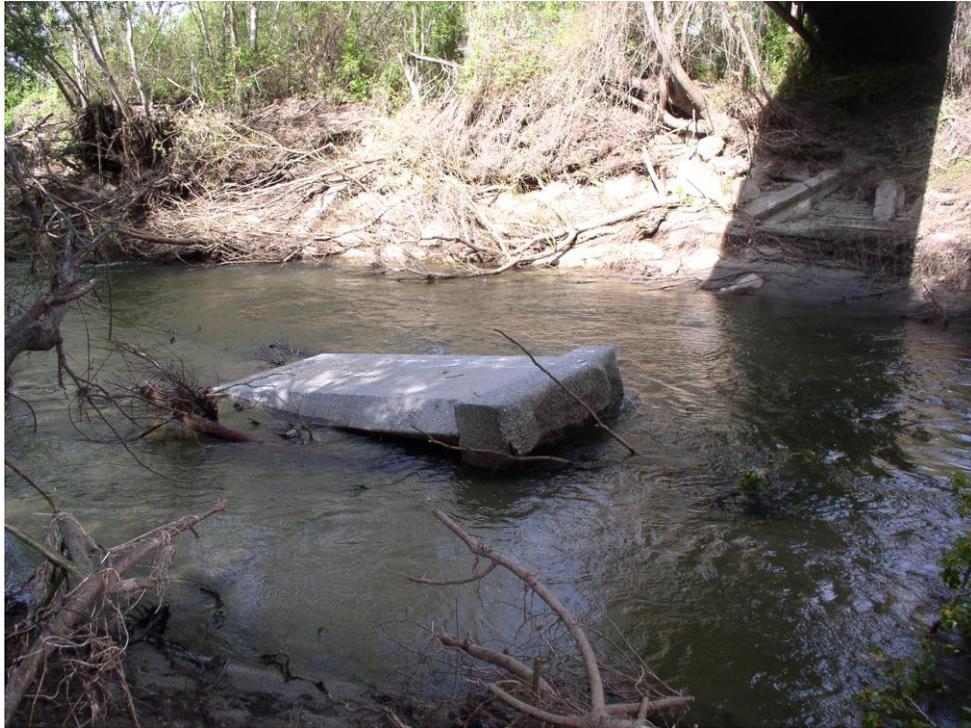
During the March 10, 1995 flood, the furthest downstream bridge on the Rancho Cañada Golf Course collapsed. A concrete center pier and a portion of the bridge deck are still located in the streambed. Now that the Rancho Cañada Golf Course has closed and land along the Carmel River corridor will be donated to the Monterey Peninsula Regional Park District, the MPWMD believes there is an opportunity to remove the concrete pier and deck with hand held jack hammers, or with a crane that could lift the bridge deck out. The pieces of concrete would be carried out by hand to a truck to be disposed at a recycling center. It is important to note, that this reach typically goes dry in a normal rainfall year. However, this year has been extremely wet so a low flow may still pass this reach. MPWMD hopes that both of these structures will be out of the flowing stream when work is carried out. MPWMD has carried work like this in the past with low flows by isolating the work area with straw bales (see final picture).

The concrete structures prevent spawning where they cover the channel and affect the substrate up and downstream of the structures by causing a backwater condition and unusual turbulence near the structures. Removal of the structures would permanently re-establish natural hydraulic conditions that would quickly result in additional spawning and rearing habitat for steelhead.

Concrete Bridge Pier during higher flows in March 2017

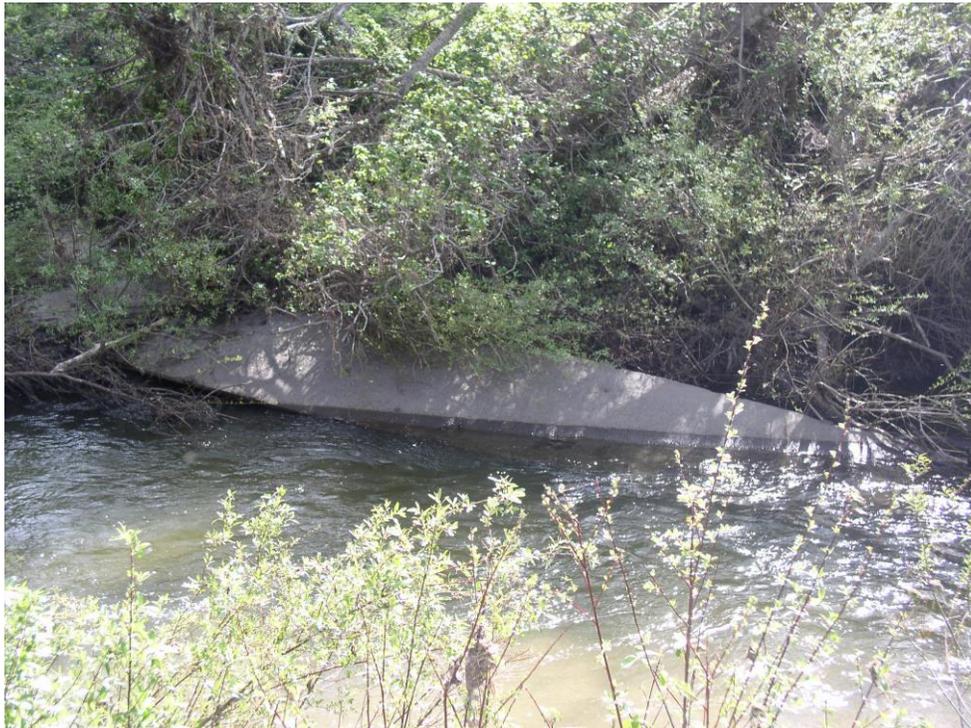
Concrete Bridge Deck during higher flows in March 2017

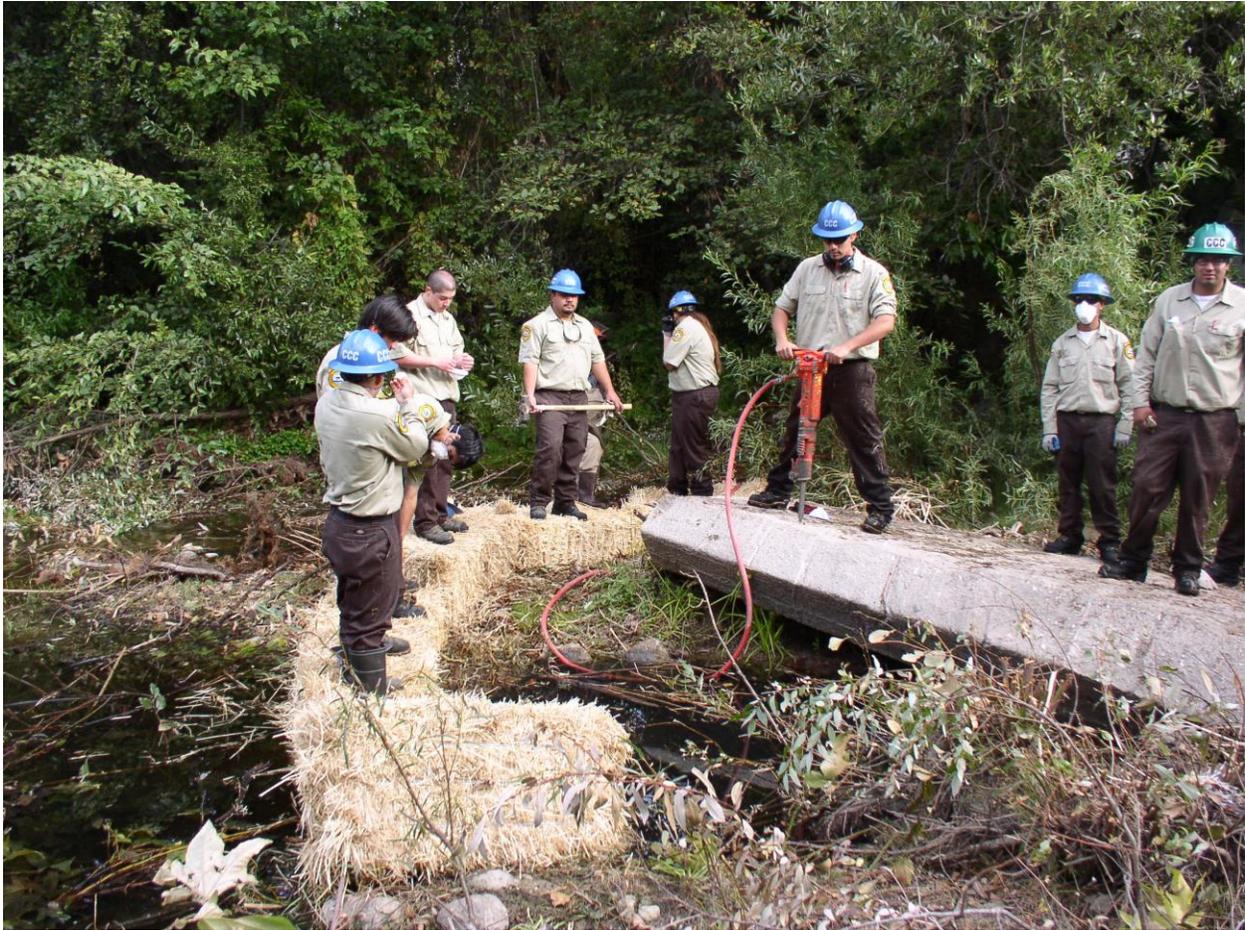
Example of concrete pier removal that was carried out in 2008.
