Littoral Processes and River Breachings at Carmel River Beach
Edward B. Thornton
Naval Postgraduate School
Monterey, CA 93943

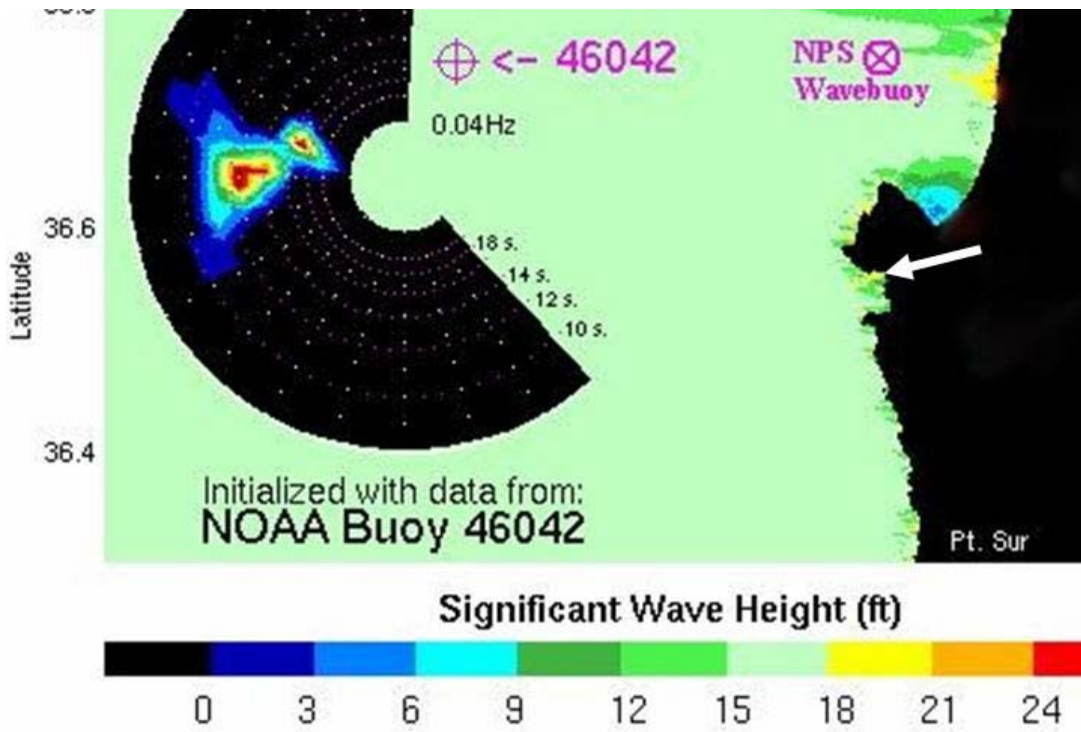
Figure 2. Large winter storm waves from the west focusing energy at Carmel River Beach (arrow).

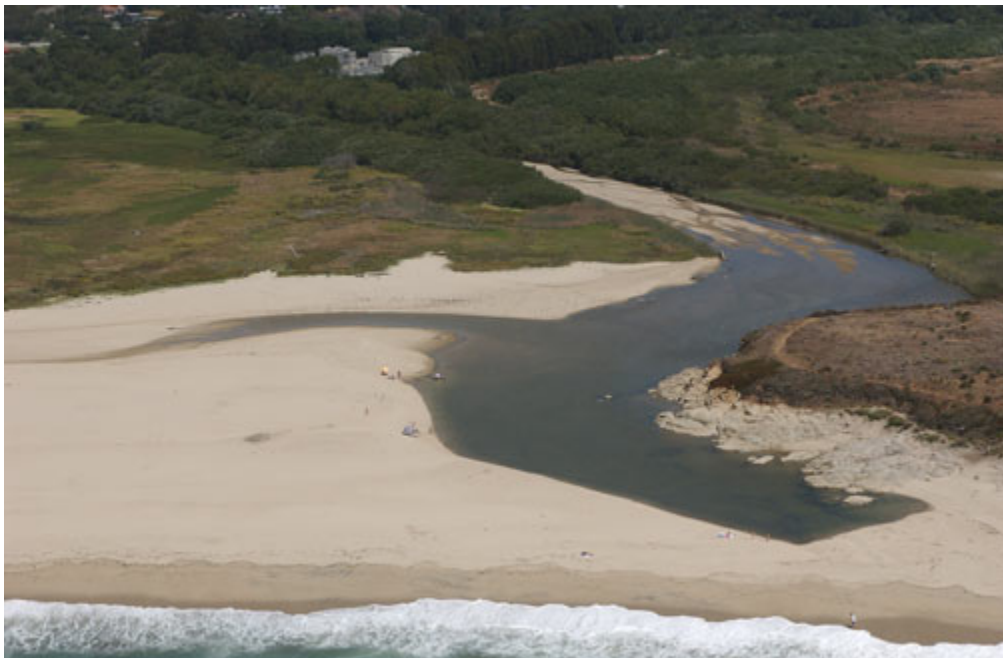
Figure 5. 2003 aerial photo showing the rock basement of south channel.

When the river migrated to the south it tended to flow along the back beach over a rock sill. An example is in 1995.

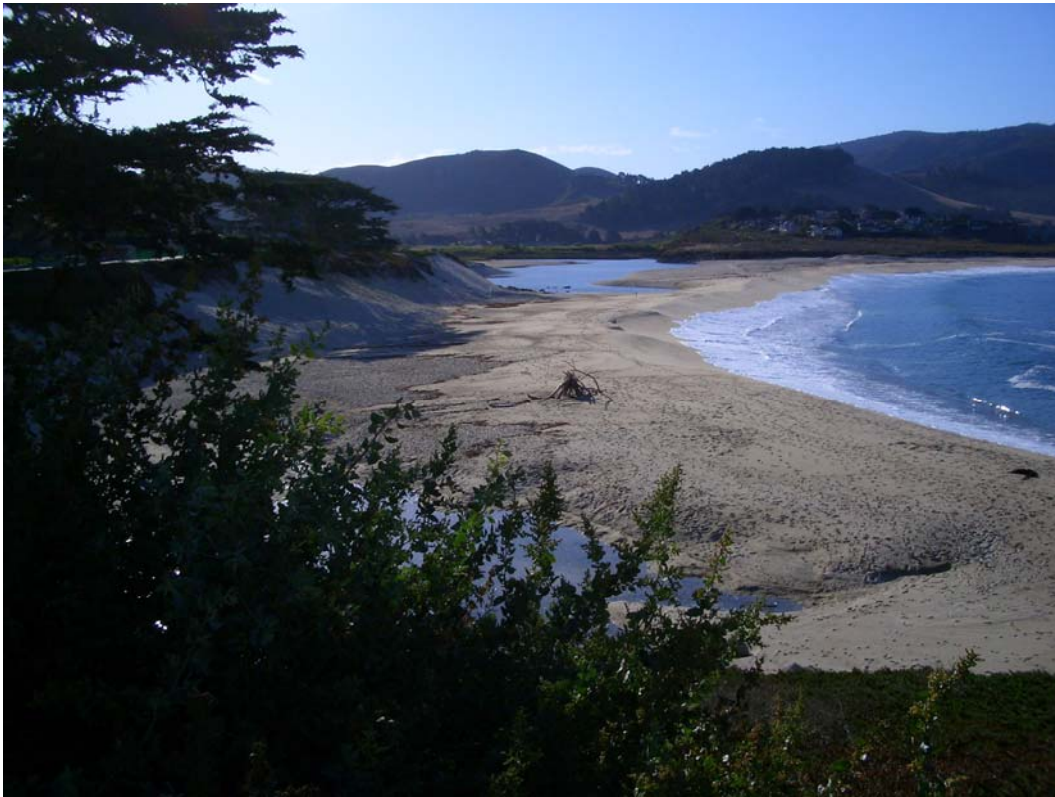
Figure 6. Photo taken 30 September 2005 showing evidence of overtopping of berm (rack line back of berm and water in the back beach) and the narrow distance between lagoon and ocean.

1 October 2005 until it rains- The beach and berm will continue to grow. The berm is presently being overtopped at each high tide even for moderate waves. This is good as this is how the berm is built up. However, I do not anticipate that the northern end of the beach and the back beach will recover from the damage of last year. The berm at this year's northern breach is very narrow (Figure 6) and is vulnerable to opening again with the first rains. It is noted that the Scenic Drive cliffs are not vulnerable to wave erosion unless the breach is to the north.
