Carmel River Beach Shoreline History

Ed Thornton
Naval Postgraduate School

April 9, 2005

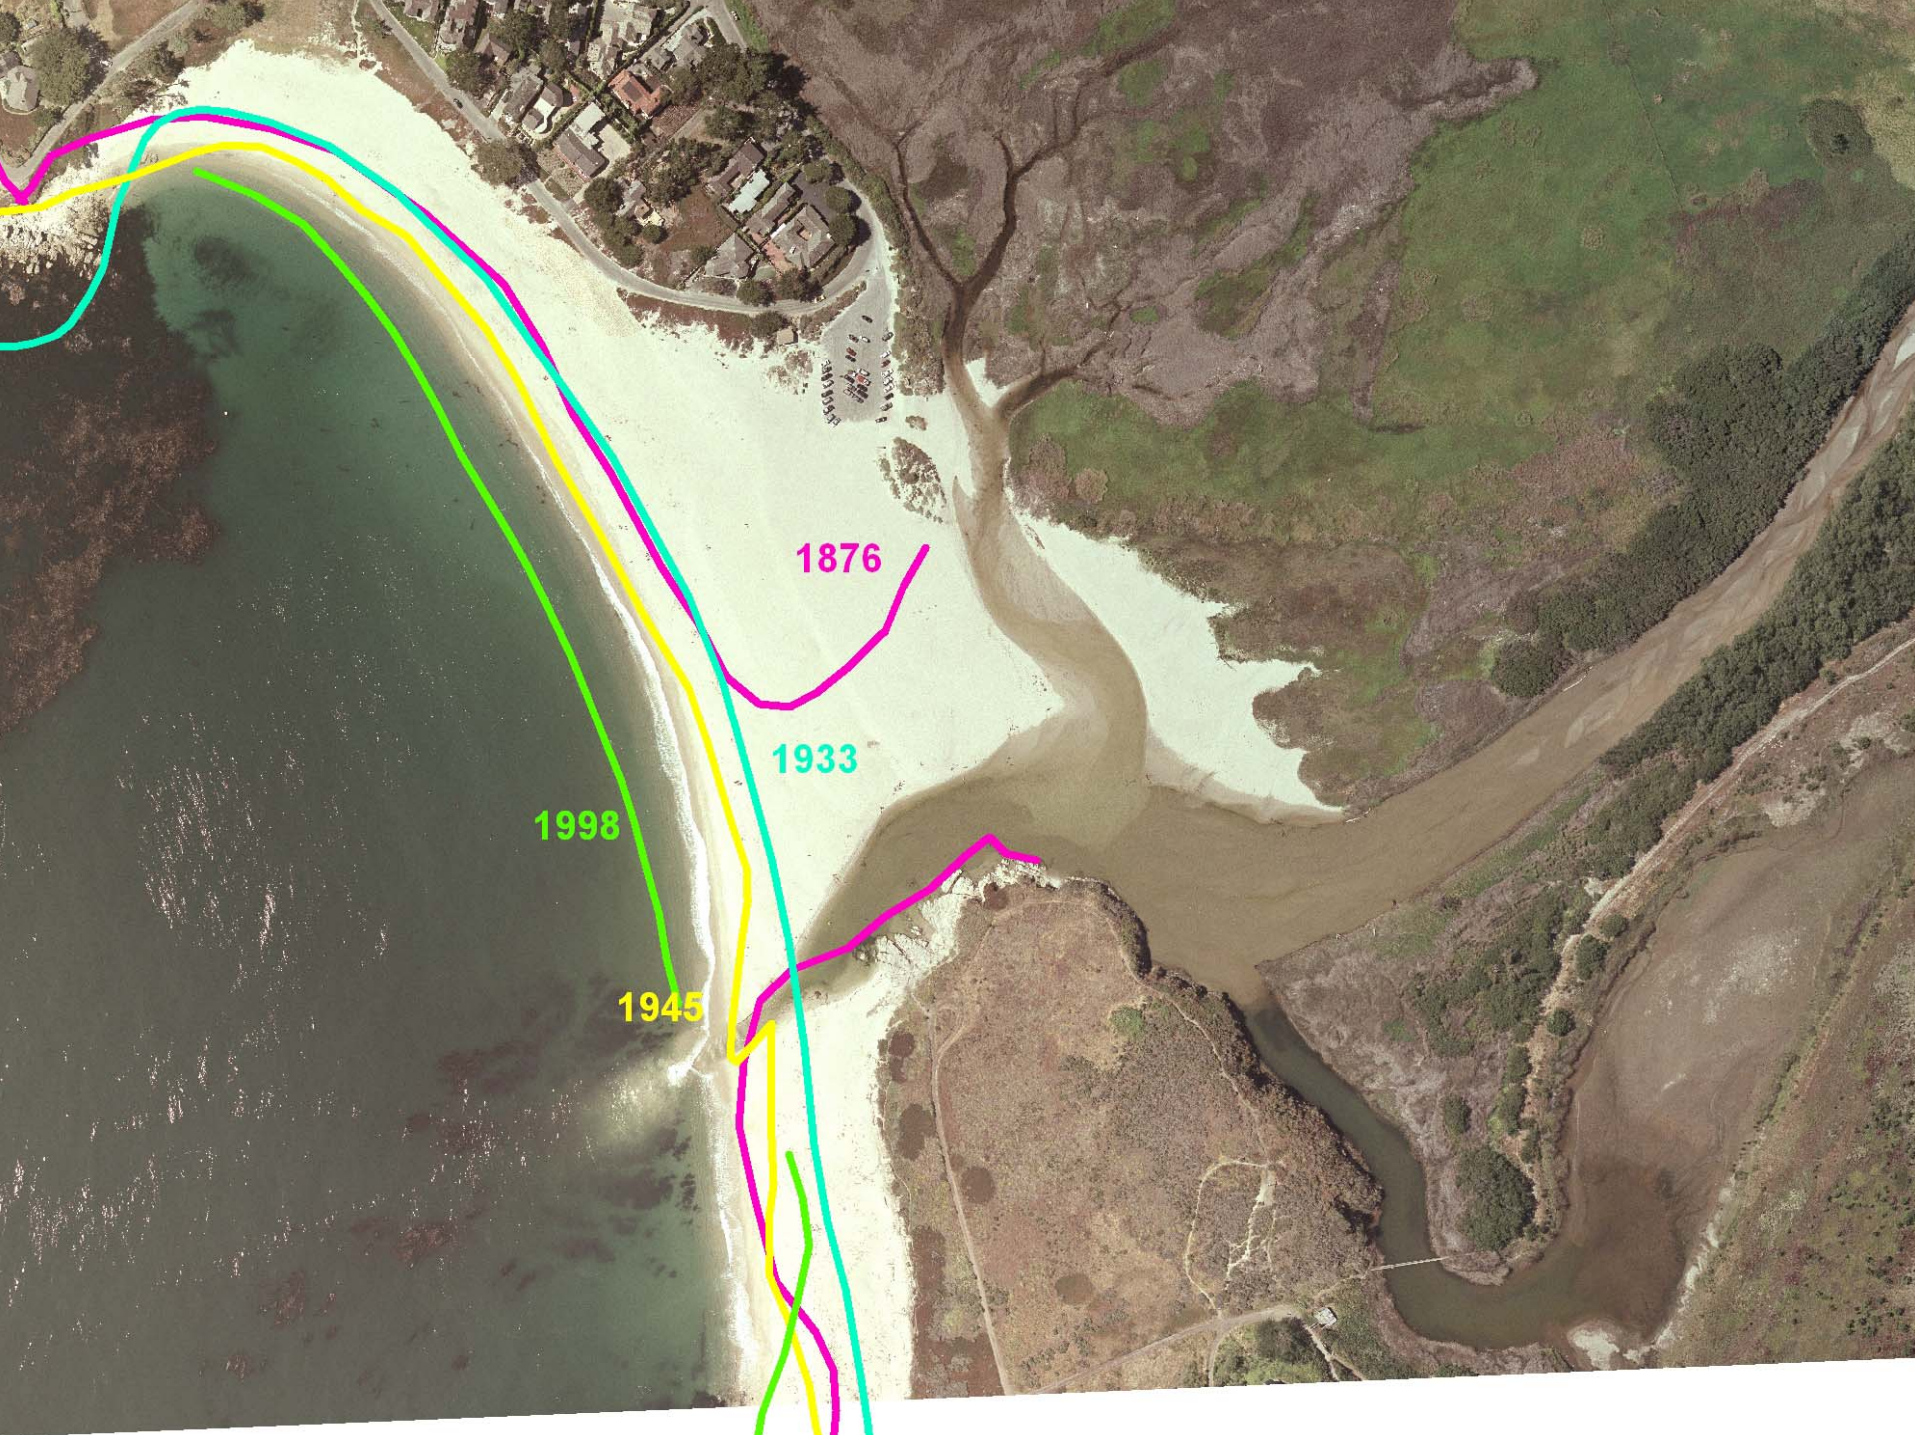
1876

1933

1998

1945

Uncertainty of T-sheet surveys +/- 10m

Seasonal variability ?

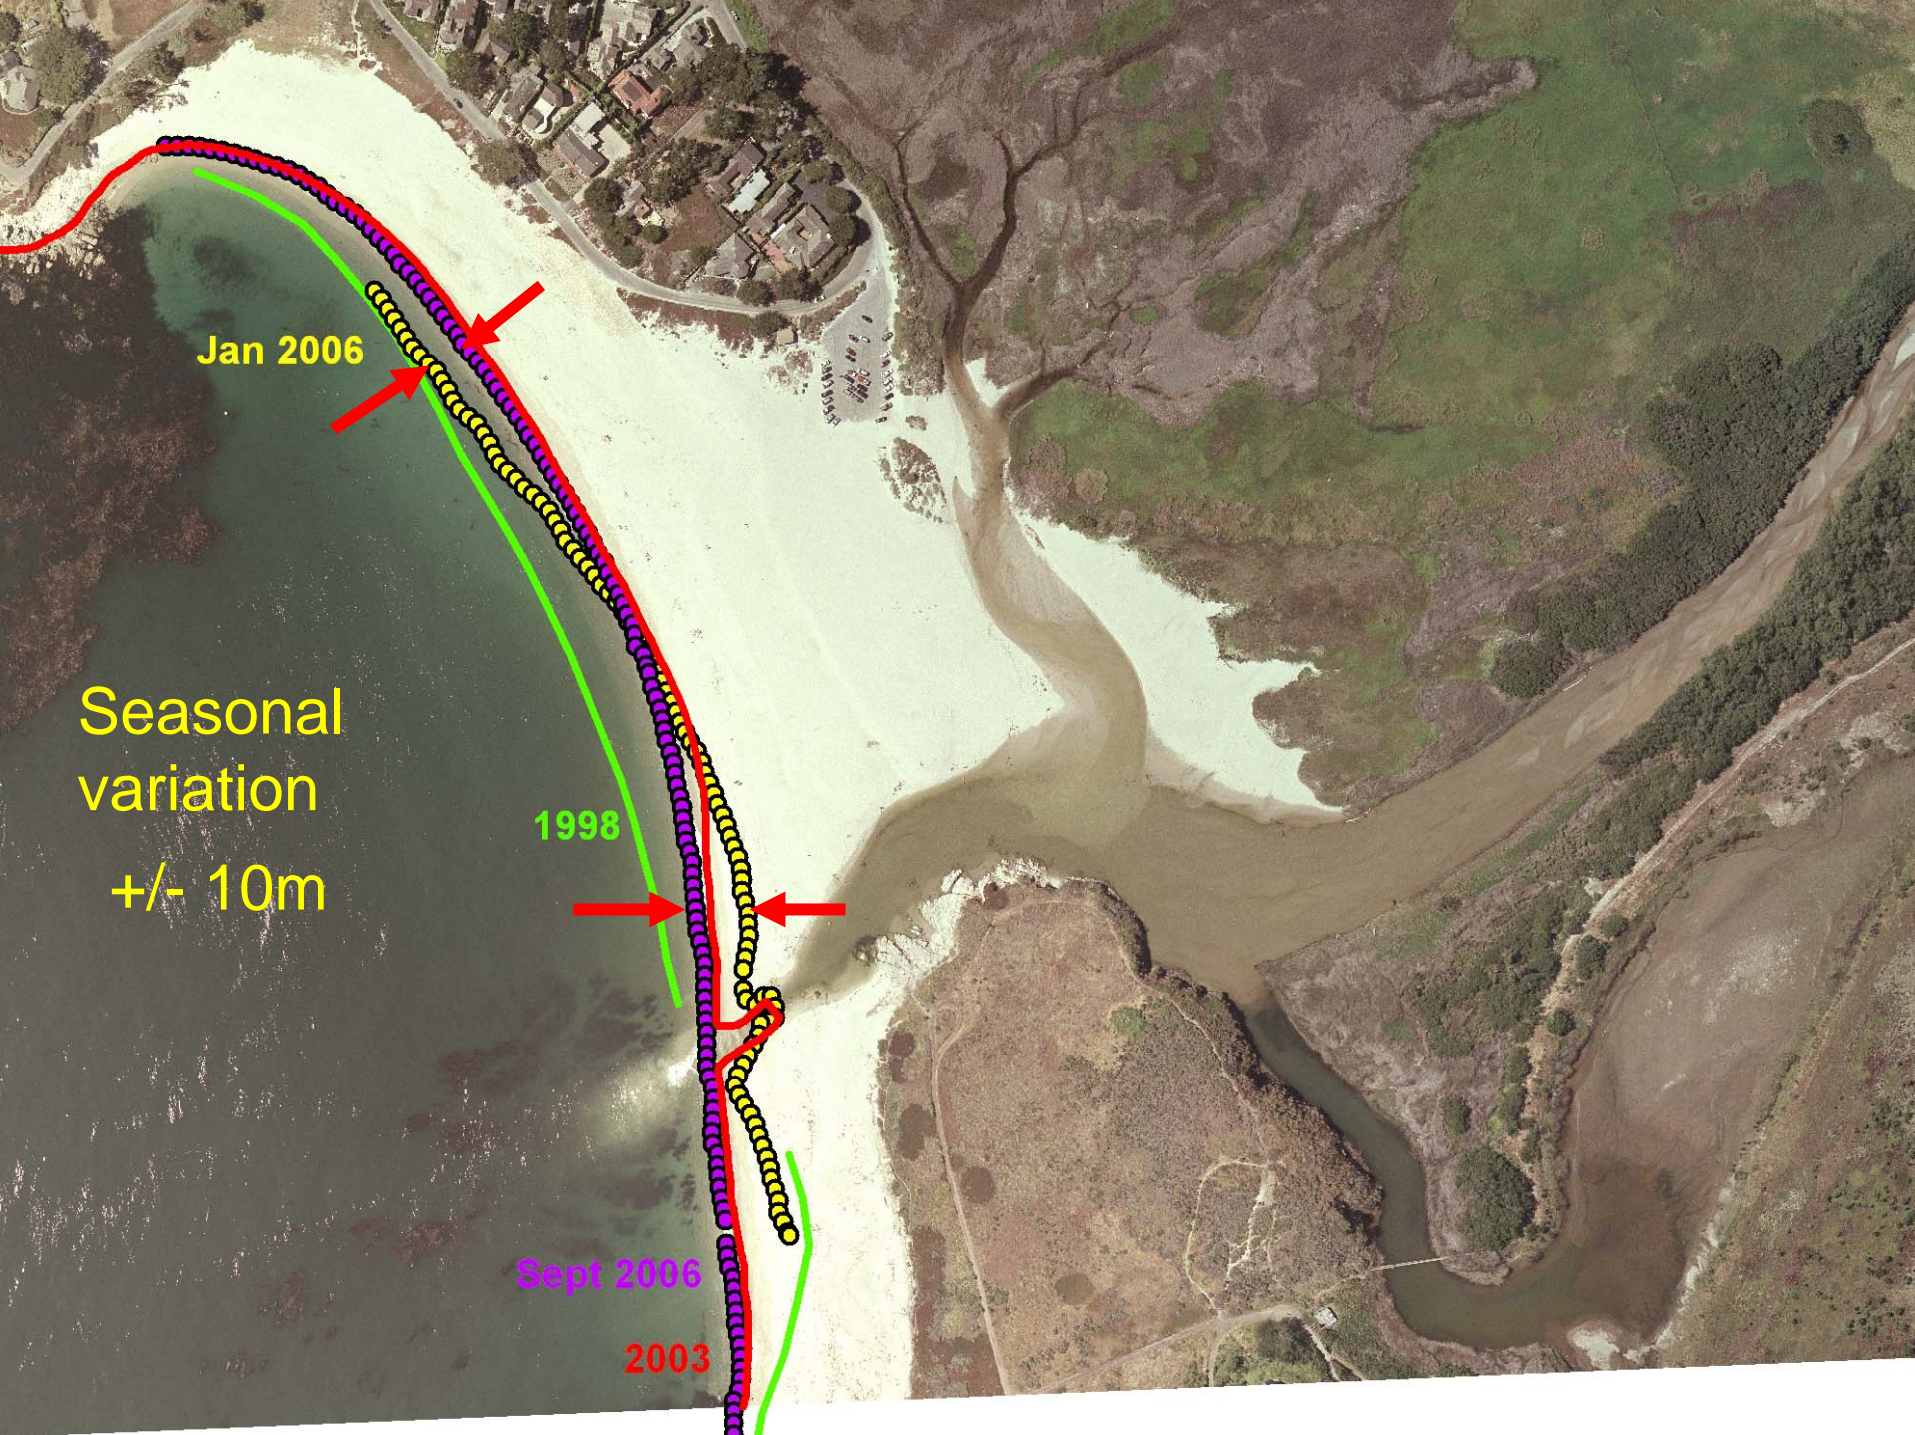
Jan 2006

Seasonal
variation
+/- 10m

1998

Sept 2006

2003

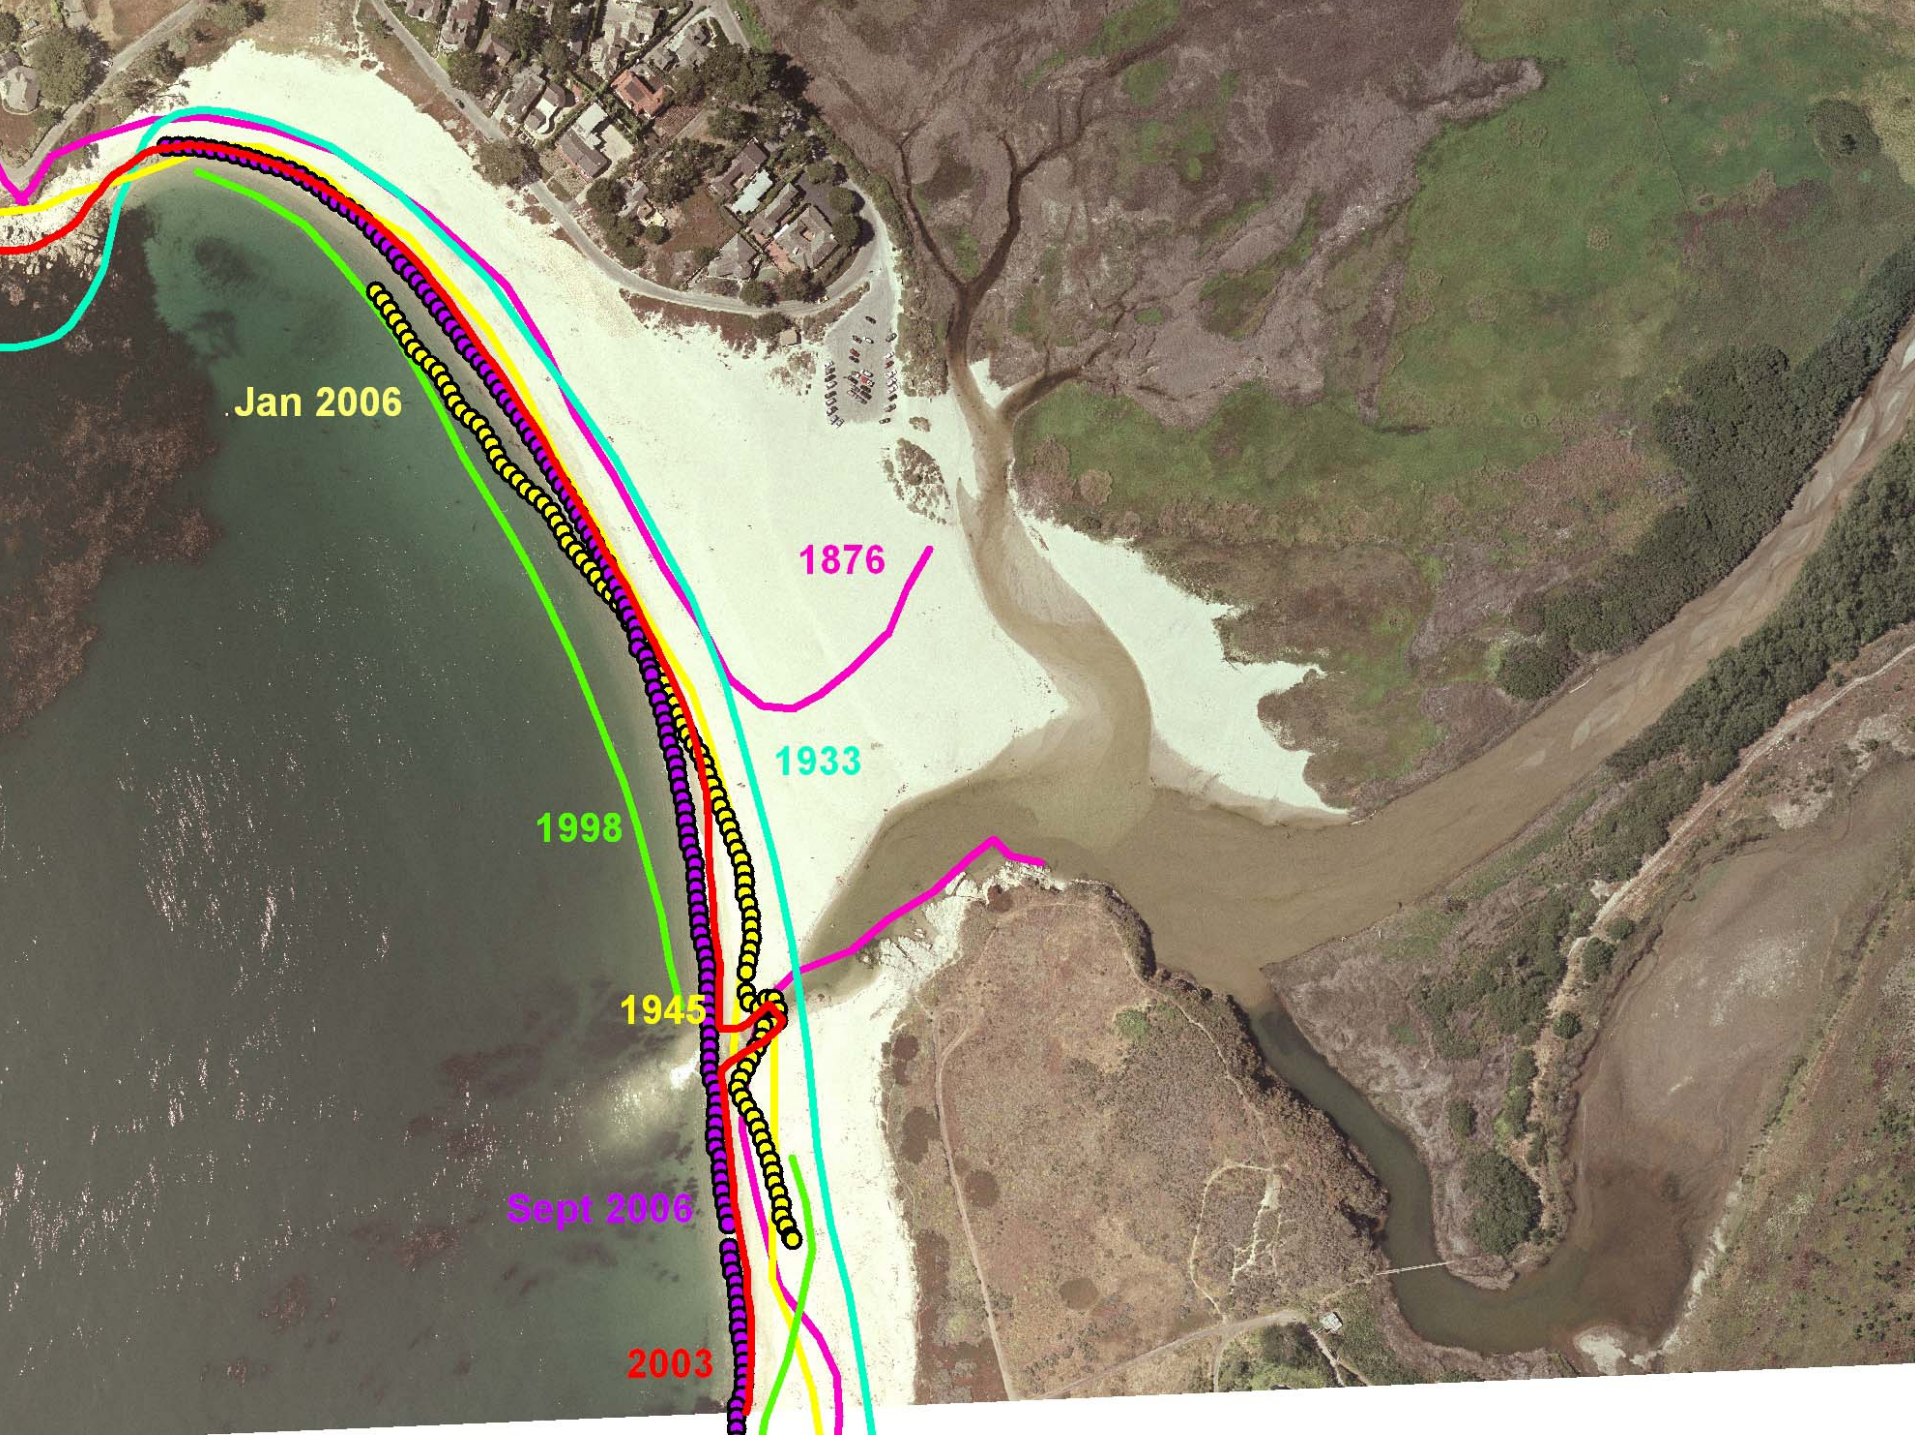
Jan 2006

1876

1933

1998

1945

Sept 2006

2003

The shoreline has been *remarkably* stable over the last 300 years
