**2004 SOQUEL CREEK LAGOON
MANAGEMENT AND ENHANCEMENT PLAN UPDATE**

The **CITY OF CAPITOLA**
420 Capitola Avenue
Capitola, California 95010

June 2004

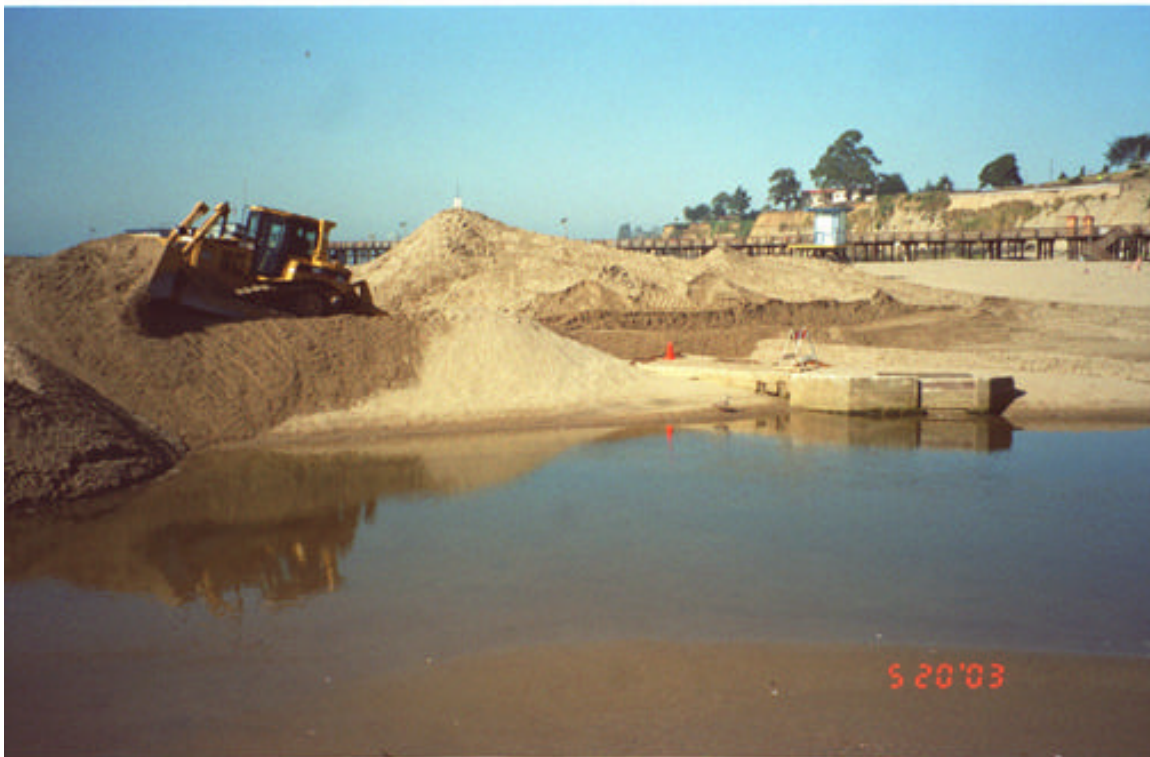
Photo 1. Sandbar Construction Typically Done Before Memorial Day Weekend

The original 1990 Management Plan prescribed how to construct the sandbar, when to make the flume passable for steelhead migration, and how to breach the sandbar in the fall in an emergency to prevent flooding. The Plan prescribed how to maximize survival of smolting steelhead as they passed through the lagoon. It provided guidelines to protect young steelhead using the summer lagoon as nursery habitat. The plan recommended ways to minimize the pollutants entering the

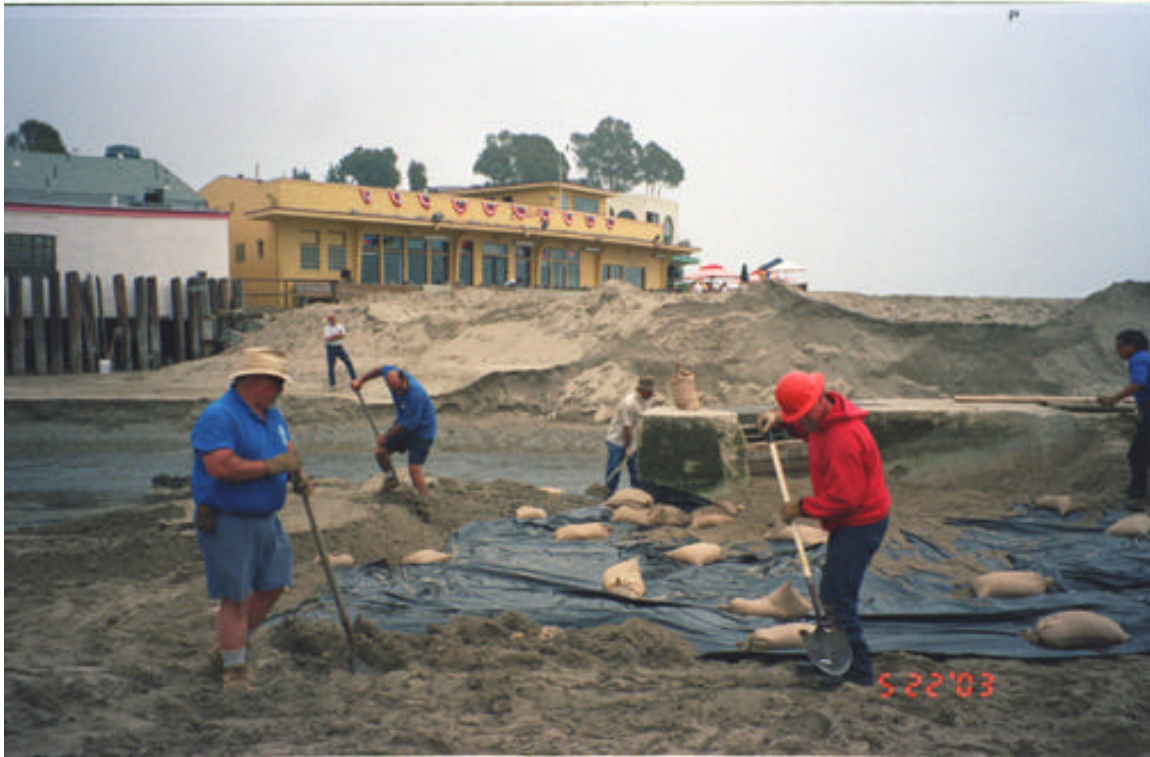
Photo 2. Public Works Personnel Prepare the Flume Inlet Prior to Sandbar Closure

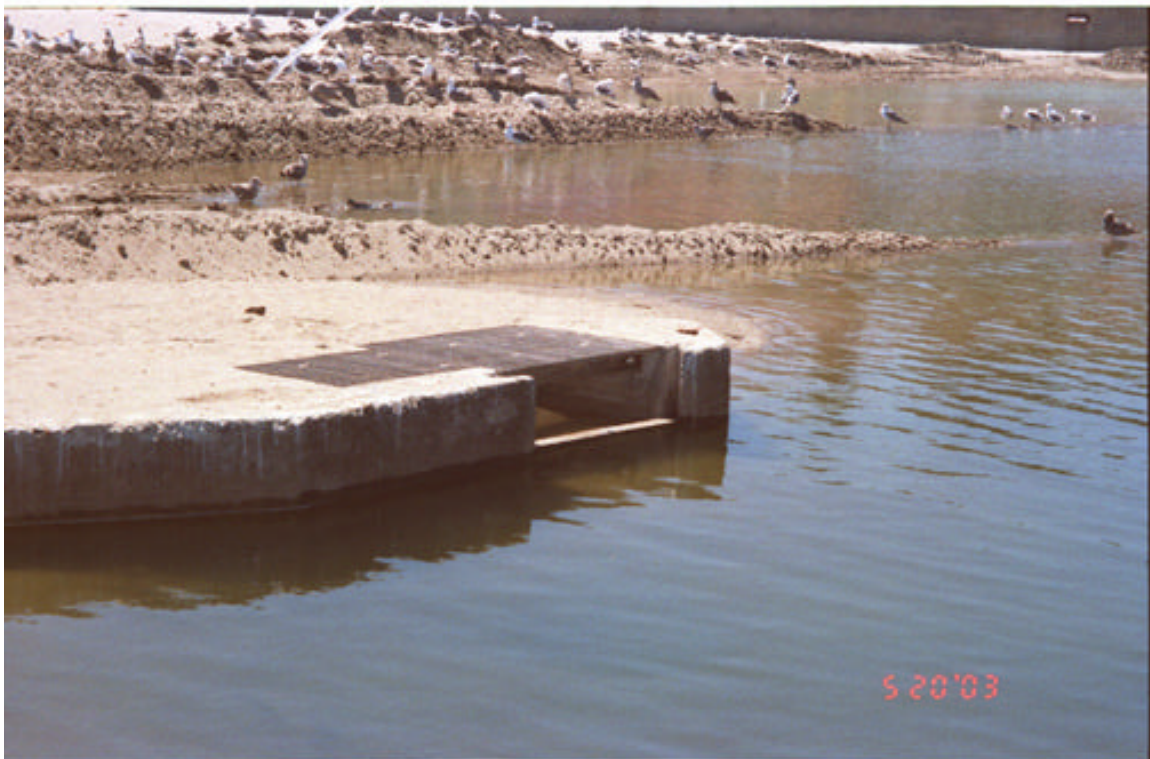
Photo 5. Newly Installed Opening on the Ceiling of the Flume Inlet in 2003

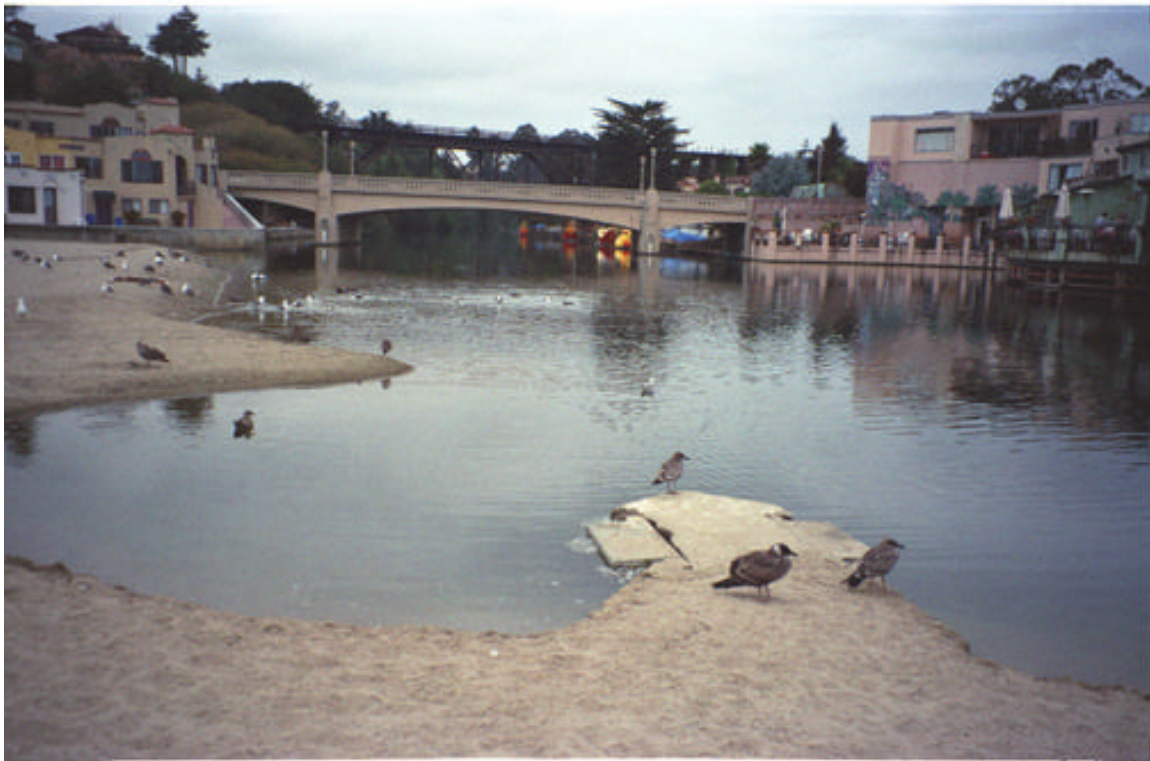
Photo 6. Shrouds on Flume Inlet, Prior to Begonia Festival, September 2001

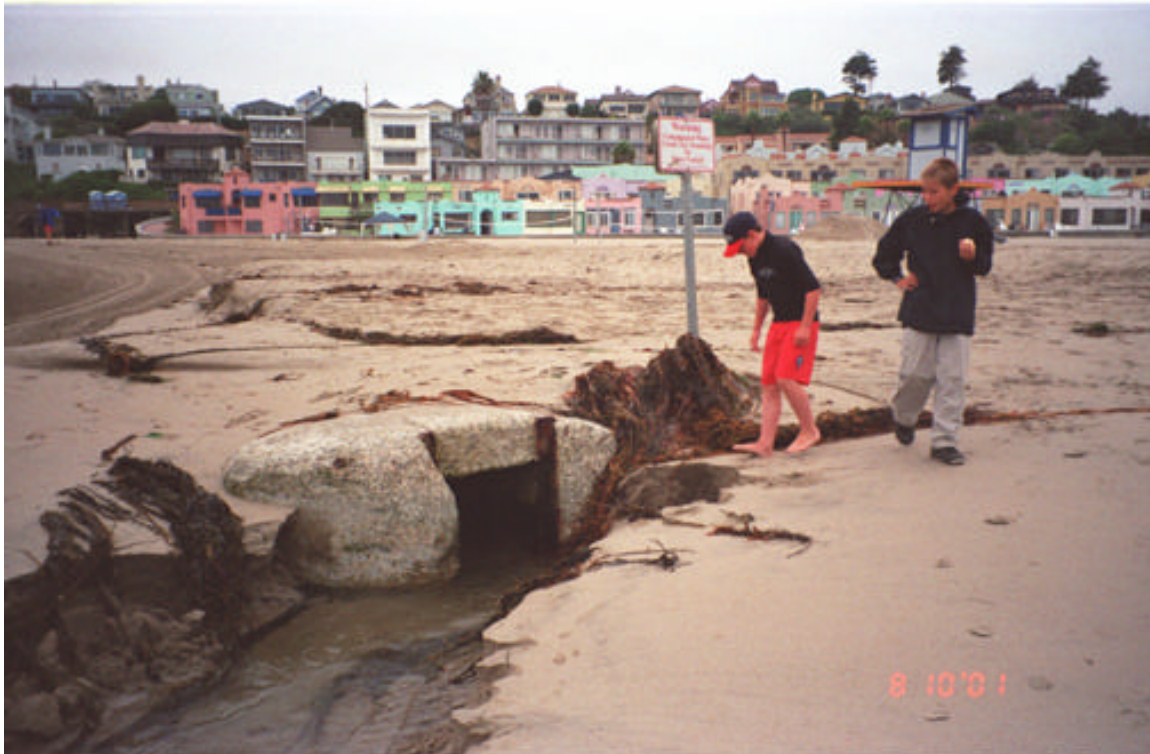
Photo 7. Flume Exit to the Monterey Bay in August 2001

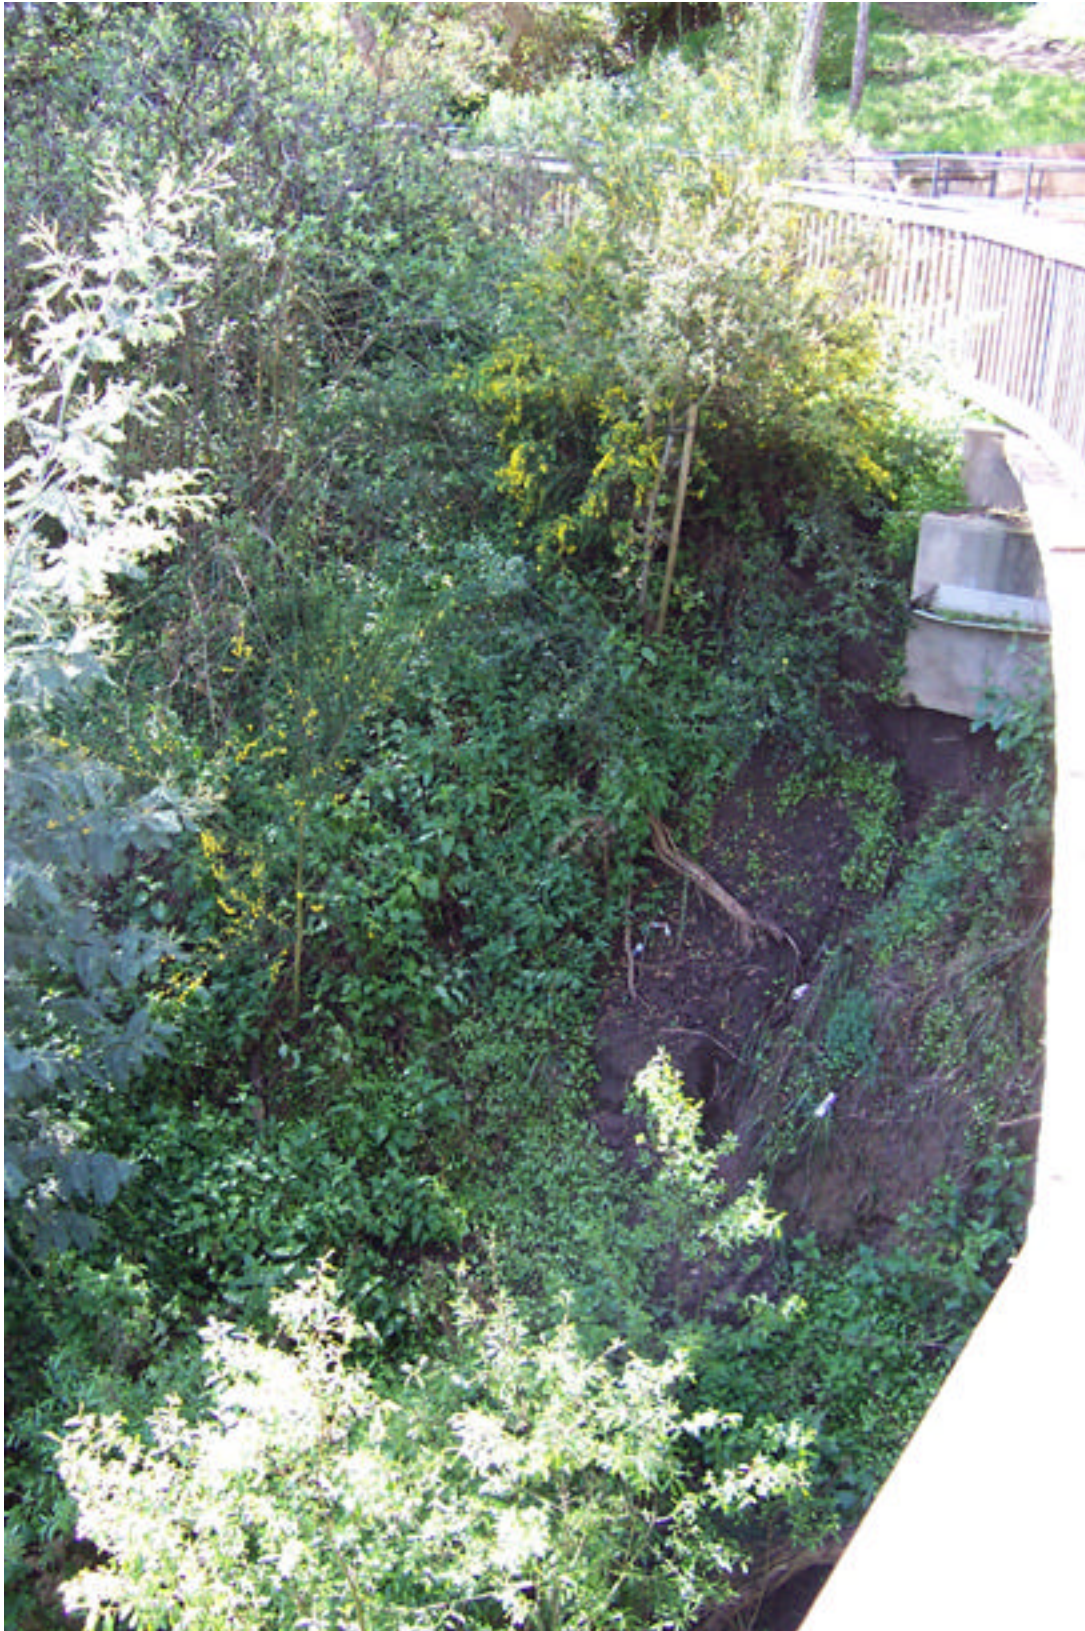
Photo 18. Undermined Peery Park Bridge Abutment

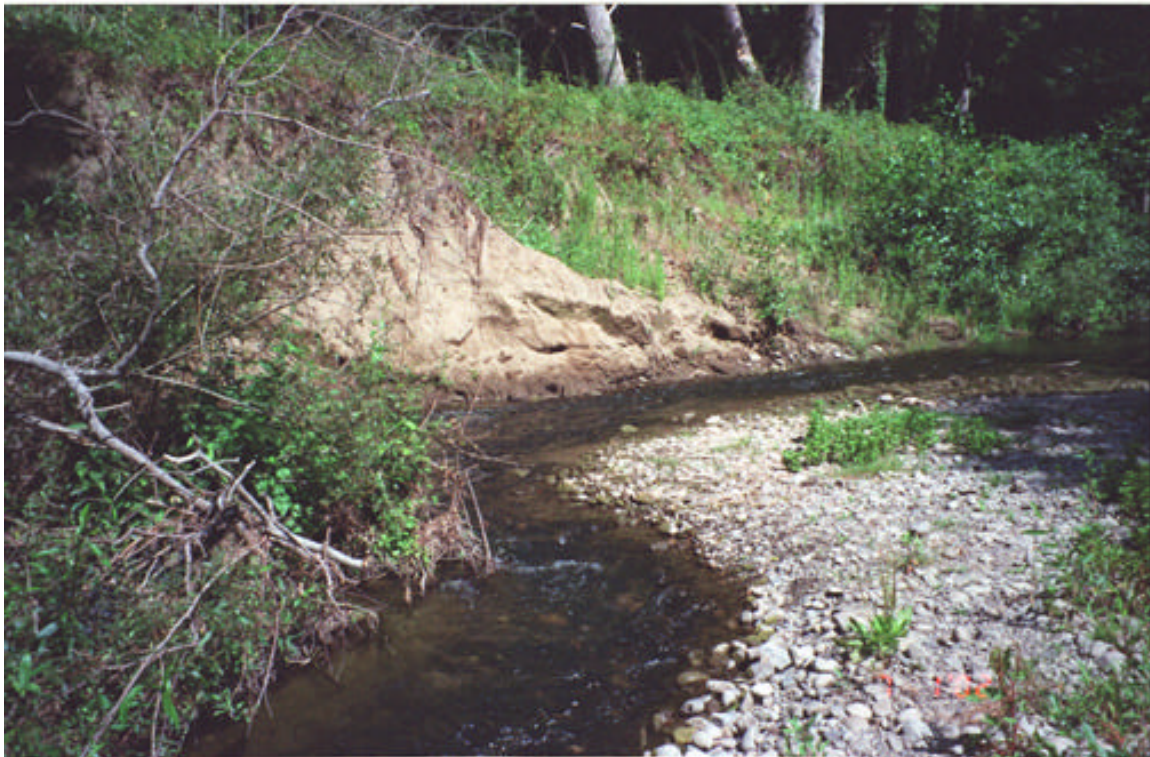
Photo 20. Eroding Streambank on Soquel Creek in the Nob Hill Reach Above the Lagoon in 2002

Situation: The west bank of Soquel Creek as it approaches the lagoon has experienced substantial erosion over the past 4-5 years (**Photo 20**; page 89; **Figure 5**; page 162). Several mature cottonwoods that existed on the terrace above the creek have fallen into the channel. Several others are in danger of being lost if the erosion continues. More tree canopy will be lost and water temperatures may be expected to increase, as more riparian shading is lost. Water temperatures in the lagoon are already warm in the summer lagoon, and further loss of riparian forest will exacerbate this water quality problem. Also, Soquel Creek Lagoon has been designated by the State Water Quality Control Board as a sediment-impaired reach. Further streambank erosion immediately upstream of the lagoon will result in further impairment.

The primary reason for present day erosion of the west bank through the Nob Hill reach (between the bedrock outcrop adjacent to the sewage lift station and Highway 1) is the current location of the bar along the eastern bank, as illustrated in **Figures 6 and 7** (pages 163-164). At high flows, this bar diverts flow towards the western bank, thereby providing the energy to erode the bank. This bar is theorized to have migrated downstream from the position of bar 2 as

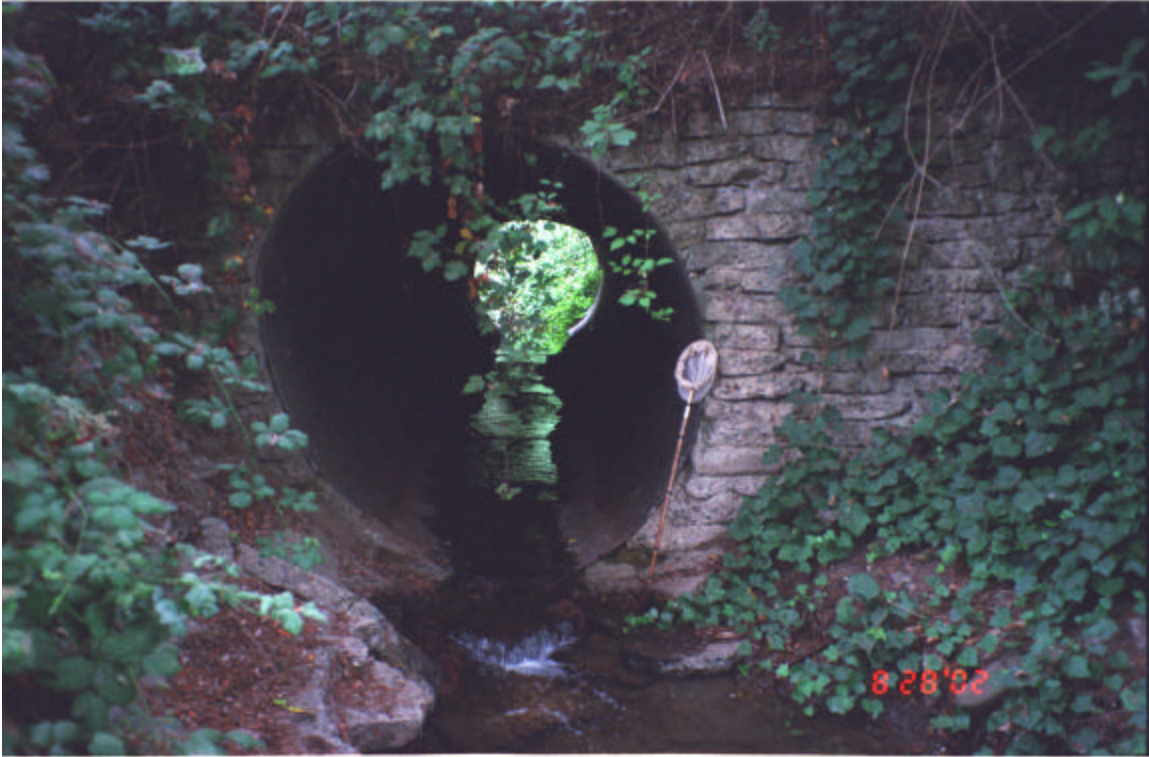
Main Street Bridge Culvert, Bates Creek

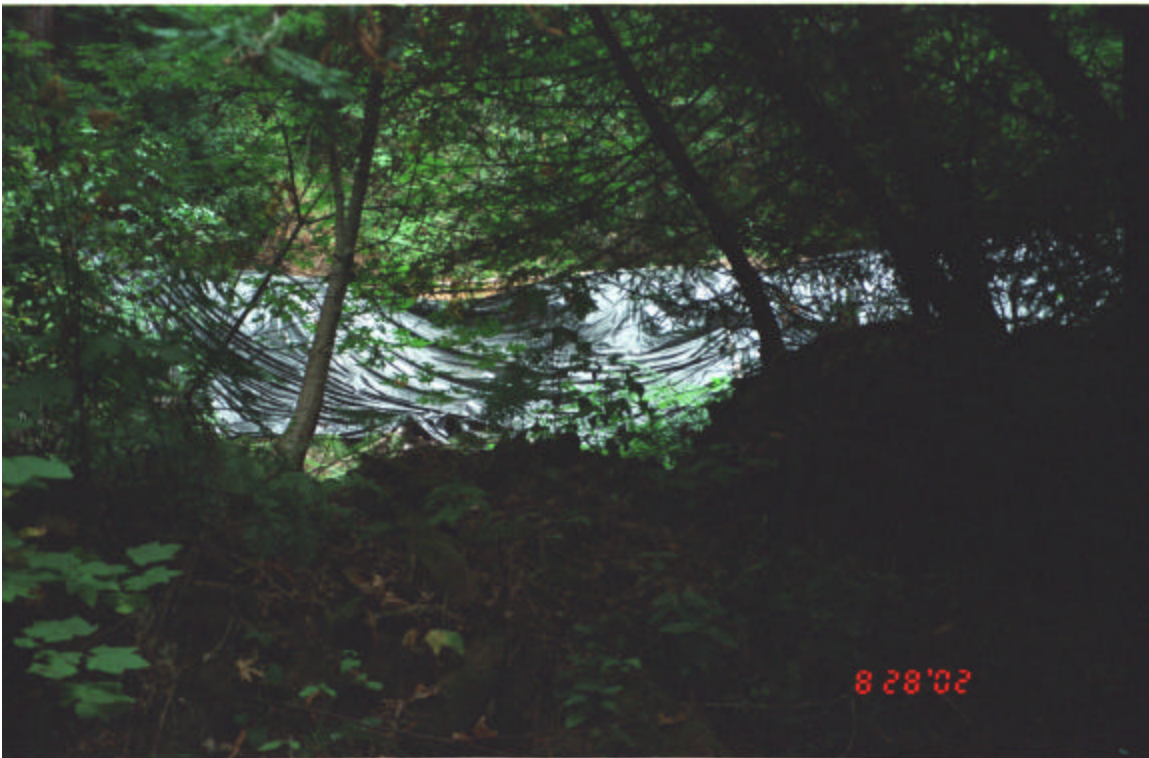
Bates Creek Landslide #1 below Dirt Road Cut

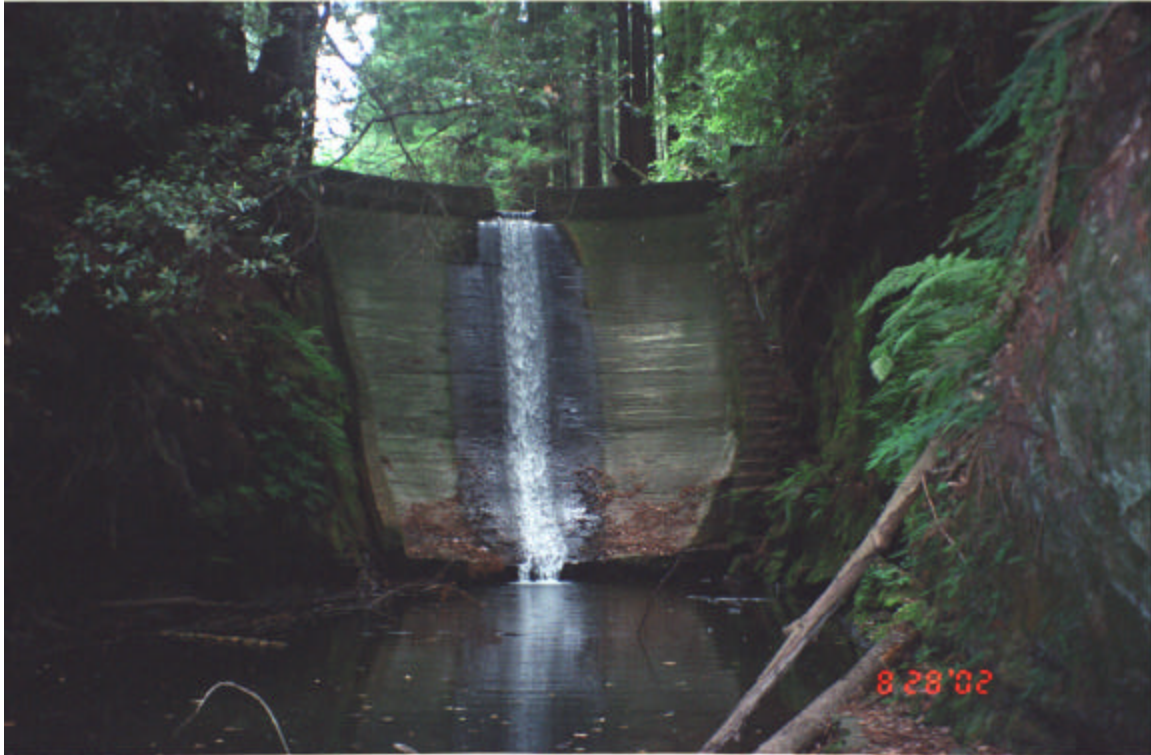
Bates Creek Dam (26 ft high), 6,900 ft Above Main Street 28 August 2002

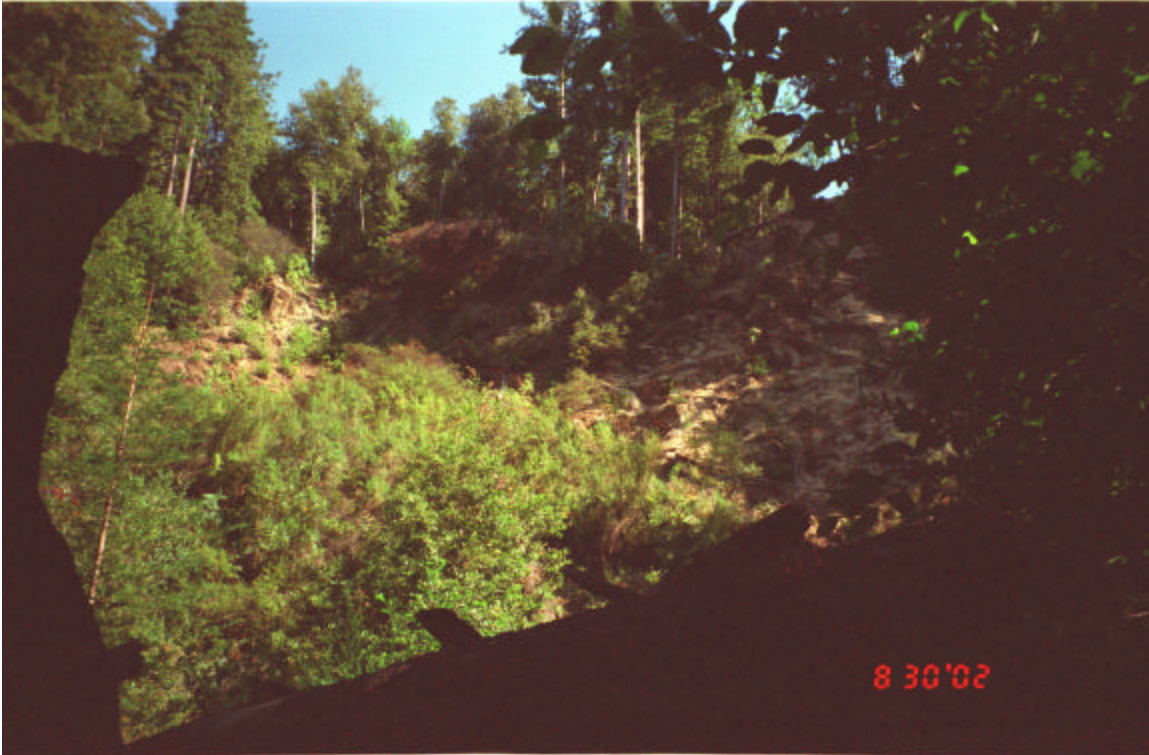
**West Branch Landslide #26, 200-250 ft high, 422 ft wide, Active, 12,350 ft
Above Olsen Rd 30 August 2002**

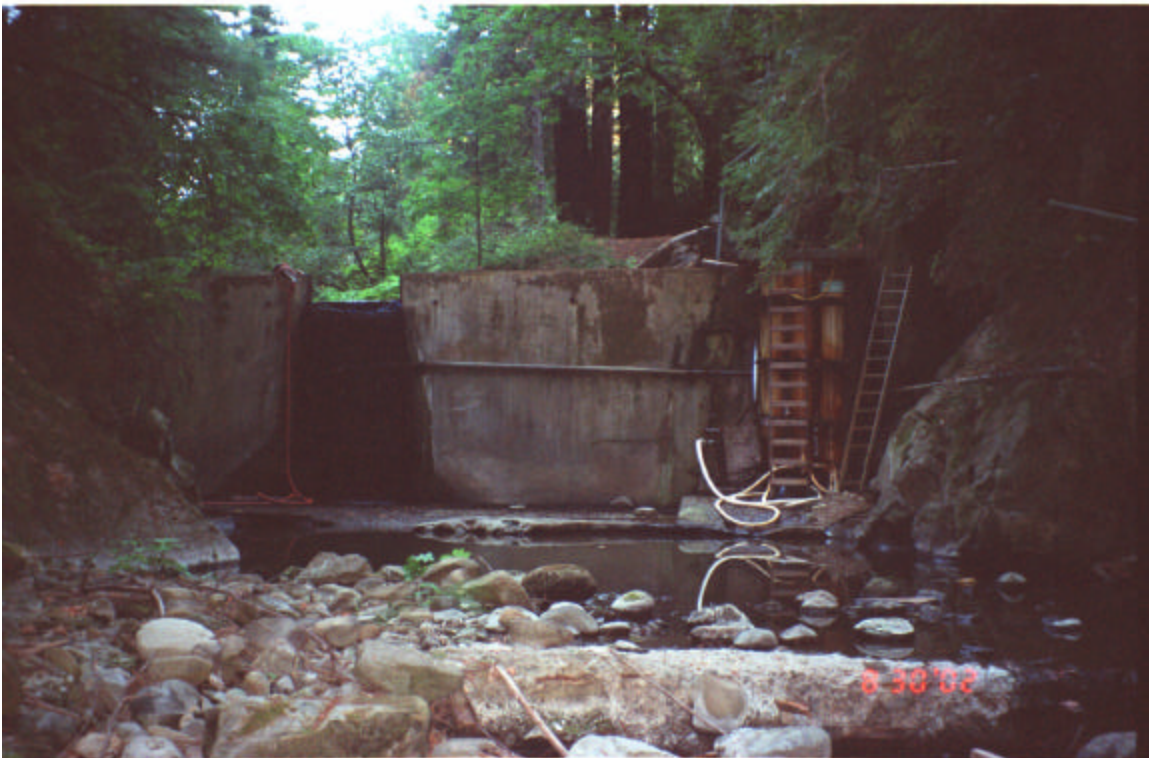
**West Branch- Laurel Mill Dam (Concrete) 12 ft High at Notch, 45 ft Wide
30 August 2002**

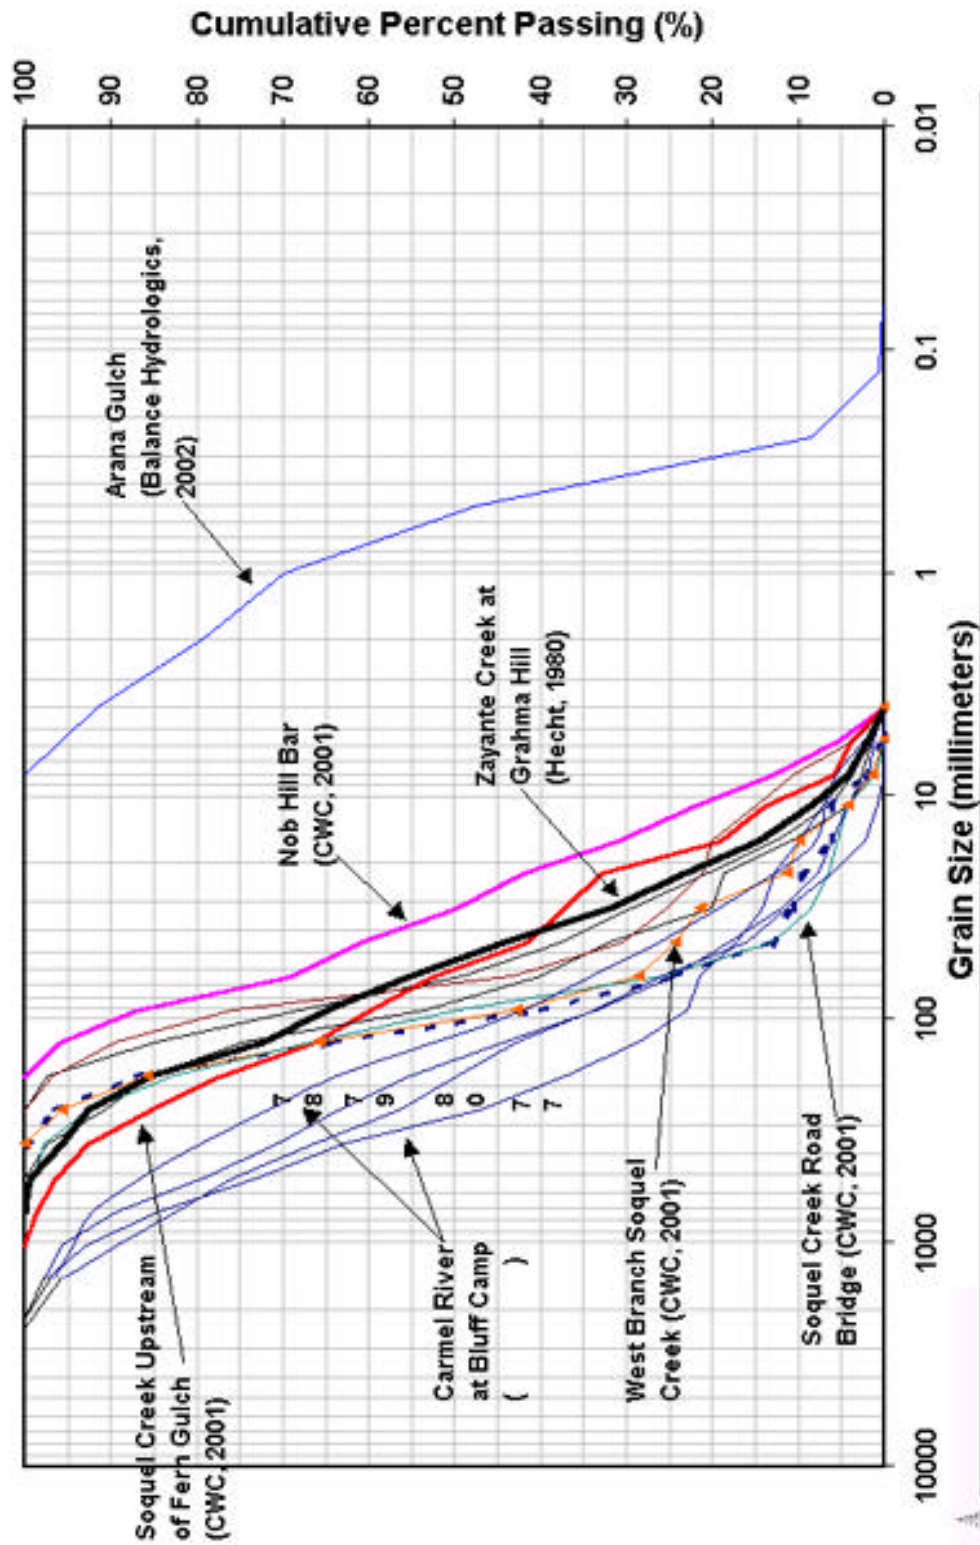
Figure 9: Surficial bed material size distribution for 8 locations in Soquel Creek with distributions for the Carmel River, Arana Gulch and Zayante Creek also shown.
 Surficial bed material was sampled in Soquel Creek during the fall of 2001 by the Coastal Watershed Council as a part of our joint watershed assessment efforts.

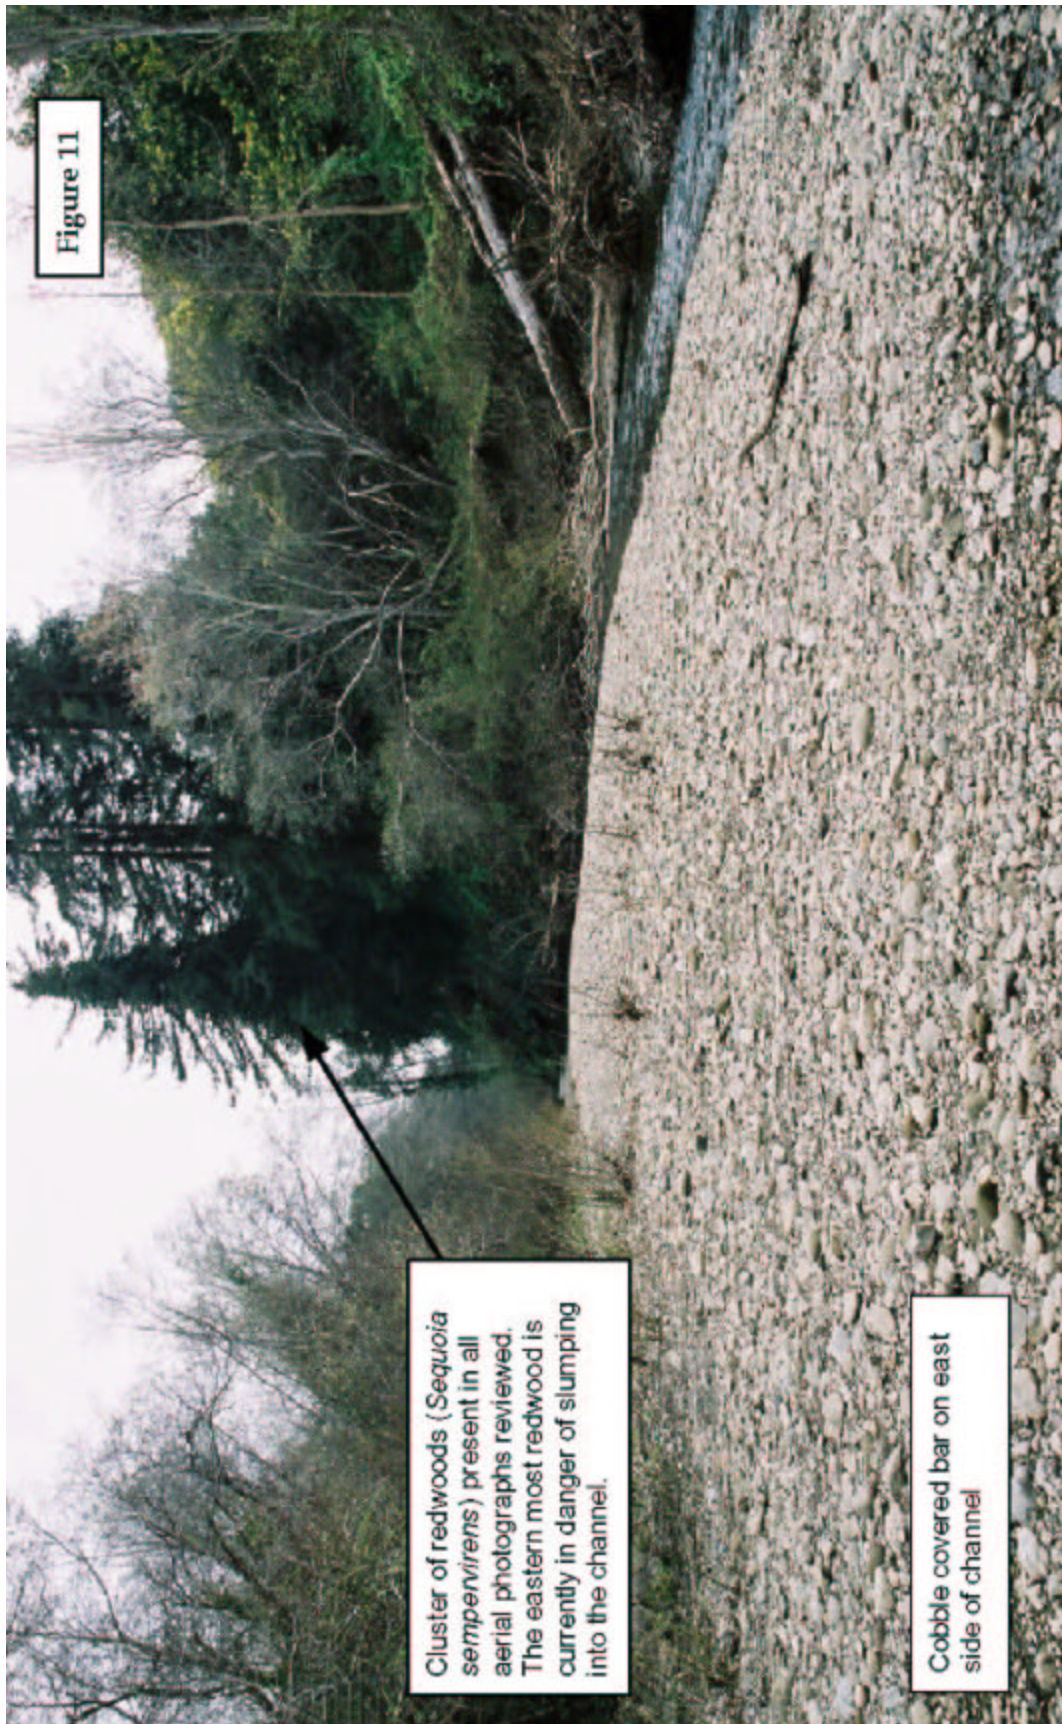
Figure 11

Cluster of redwoods (*Sequoia sempervirens*) present in all aerial photographs reviewed. The eastern most redwood is currently in danger of slumping into the channel.

Cobble covered bar on east side of channel

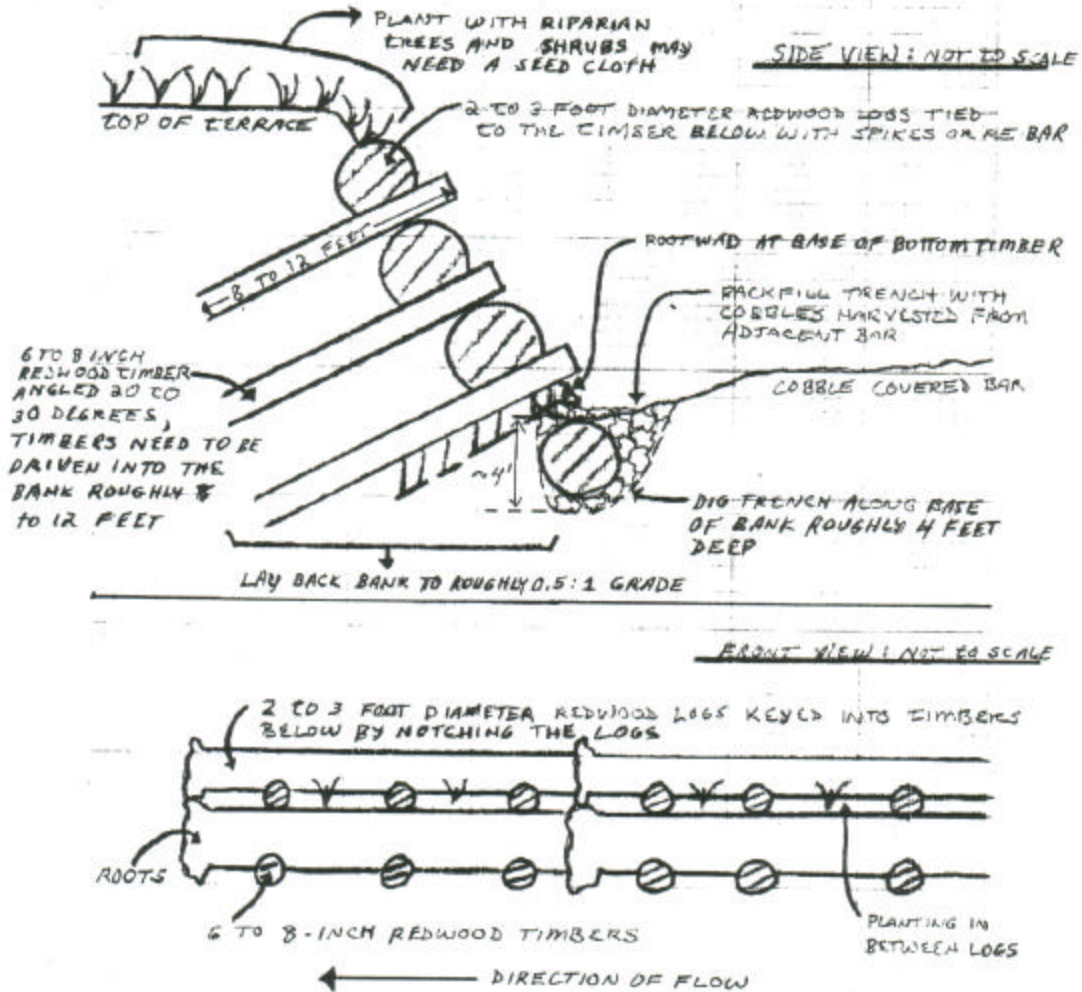
FIGURE 14: CONCEPTUAL CRIB WALL DESIGN

DESIGN NOT TO SCALE, INTENDED FOR PLANNING PURPOSES ONLY.
