Figure 1-1. TMDL Project Area - Tularcitos Creek subwatershed.

1.3 Pollutants Addressed

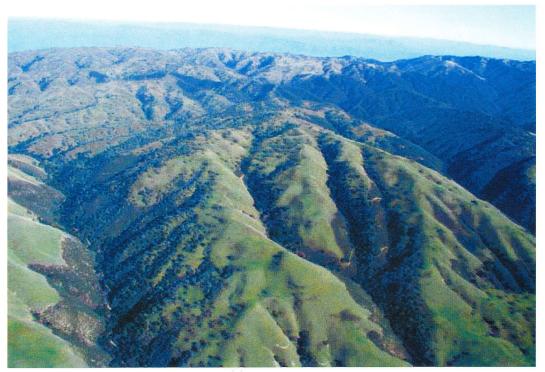
Figure 44: Rana Creek is drainage on the left. Oblique aerial photo toward the northeast.

The upper reaches of the Cachagua drainage and the sub-basins of the Tularcitos drainage are cut into the Sierra de Salinas, forming the northwestern flank of Carmel Watershed. The landscape, climate, ecosystems and land-use differ markedly from the Santa Lucia range described above. The land tends to be more arid, with significantly lower annual rainfall. Hastings Natural History Preserve at the mouth of Bear Canyon subwatershed reports a rainfall average of 21.3 inches/yr (HNHP, 2004). The landscape is also more accessible than along the Santa Lucia Range. The land has traditionally been used for cattle ranching, with the impacts of overuse locally apparent. The region has sparse ranches set in a broad, annual grassland, oak forest, and chaparral ecosystem (Fig. 44 rana fork; Appendix A–4).
