X. RIPARIAN HABITAT MITIGATION MEASURES

The goal of the Riparian Corridor Management Program is the rehabilitation, restoration, enhancement, and preservation of the streamside corridor along the Carmel River. As described below, several major sub-programs are carried out to achieve this goal.

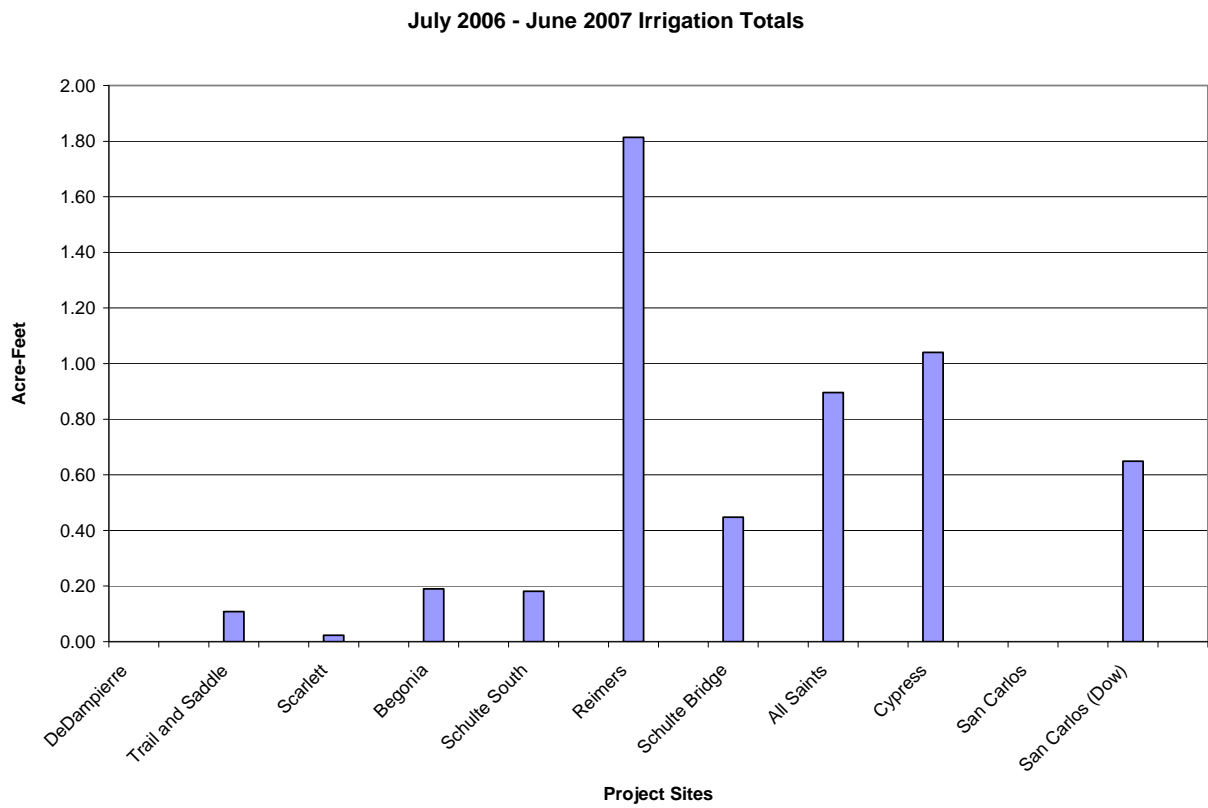
Figure X-1

Table X-2 and **Figure X-1** show water use for FY 06-07. Please note that these figures include irrigation during two separate irrigation seasons. For the fiscal year, 5.35 acre-feet (AF) of water were applied. The 2006 irrigation season began in May and continued through the end of November 2006. Total water use for the season was 5.34 AF. This compares to 6.30 AF during the 2005 irrigation season, and is considerably less than the 1994 irrigation total of 51.1 AF, when drought conditions prevailed.
