Large Woody Debris Assessment Carmel River

Summary

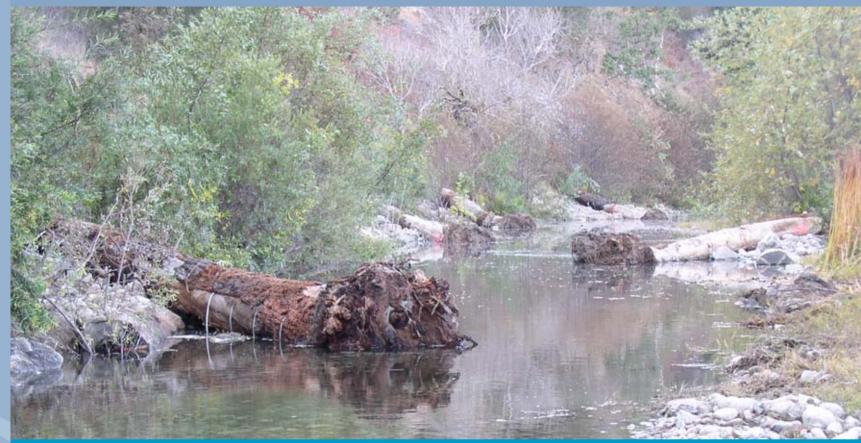
Large wood installation at deDampierre Restoration Project October 31, 2002

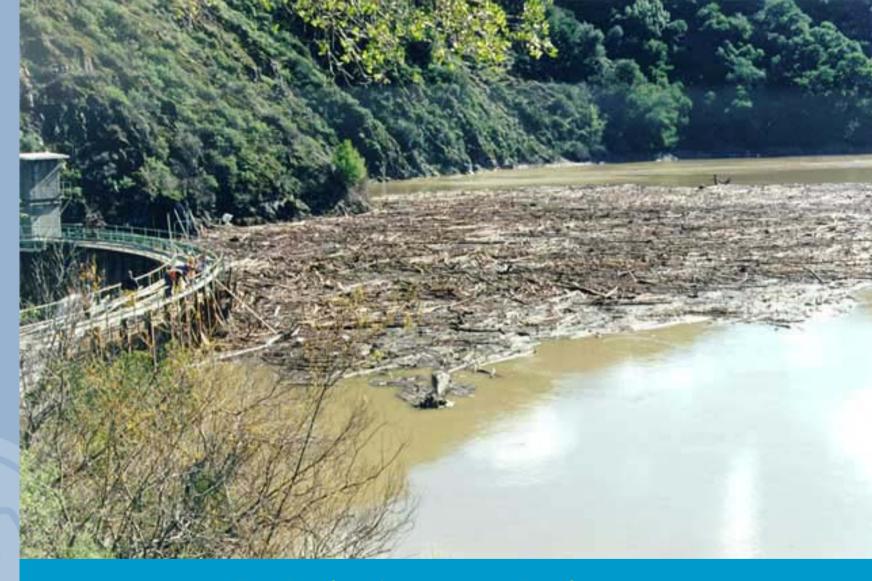
Debris Accumulation at San Clemente Dam and Reservoir February 9, 1998

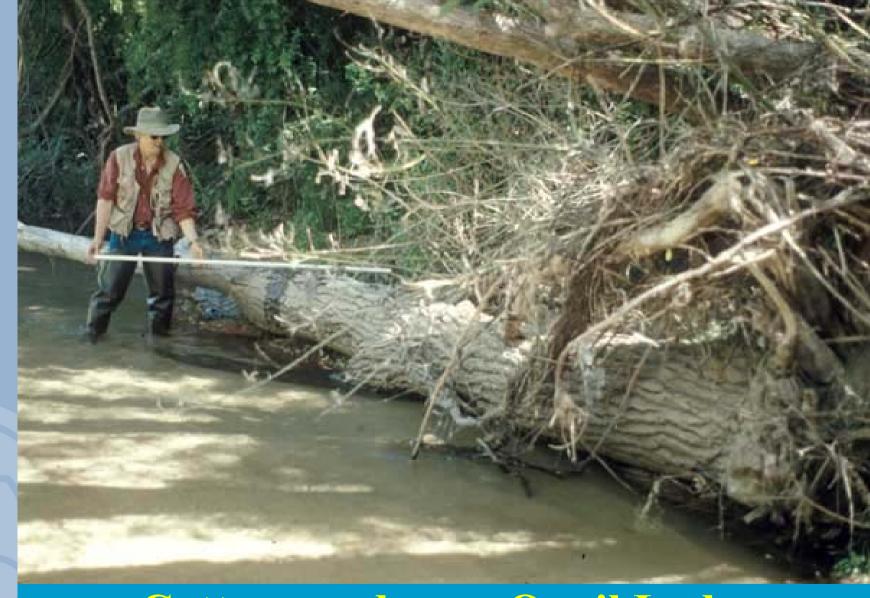
Cottonwood near Quail Lodge June 2001

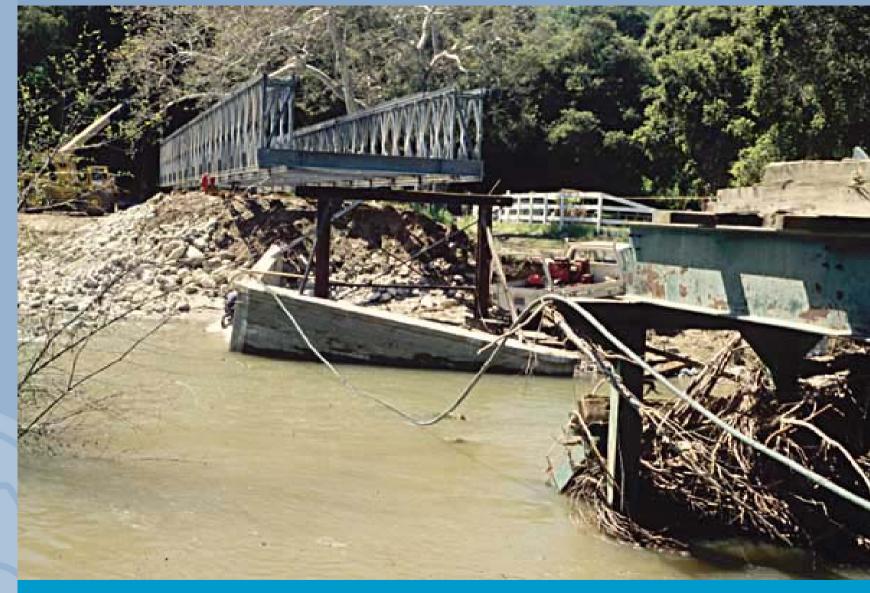
Bridge Failure, Stonepine Bridge April 1995

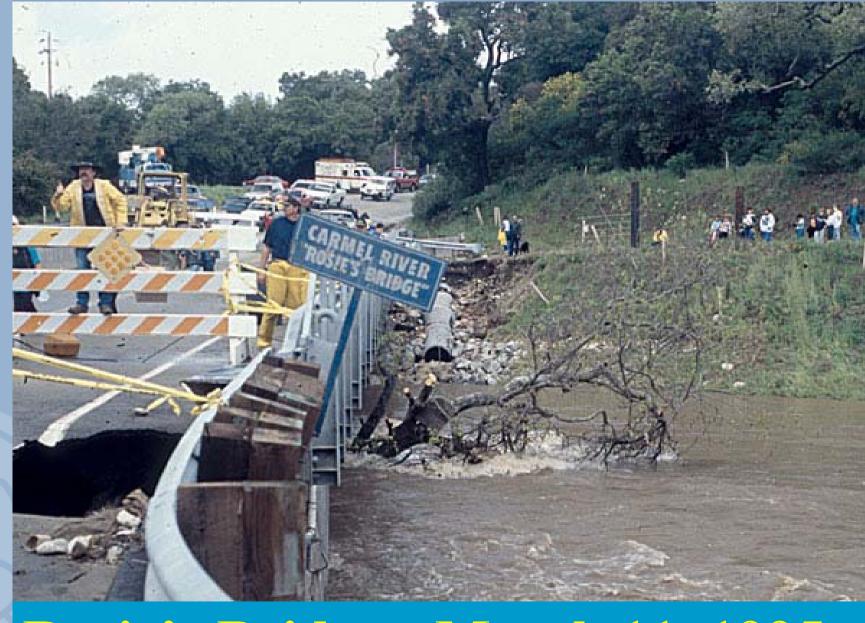
Rosie's Bridge - March 11, 1995

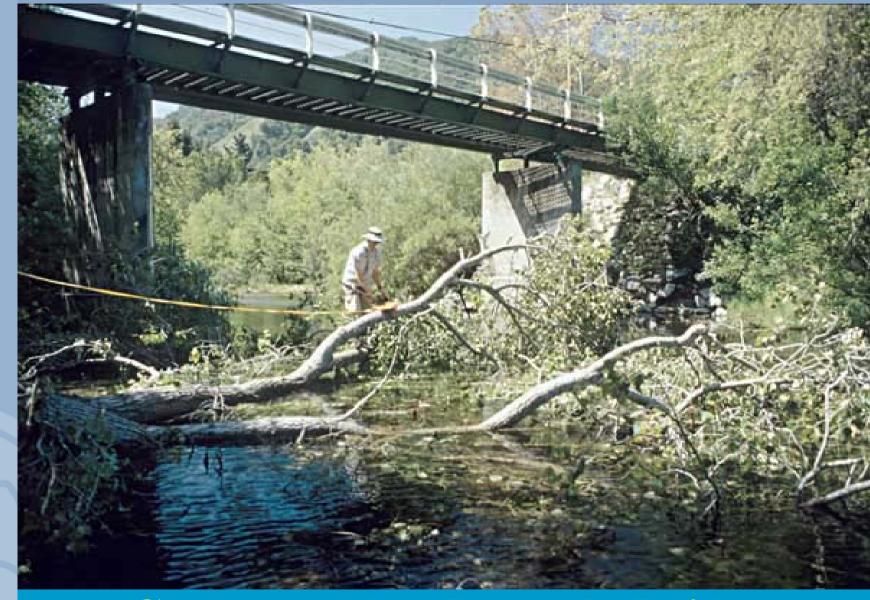
Cottonwood at Boronda Bridge May 2002
