**RIPARIAN CORRIDOR MONITORING REPORT**  
**CARMEL RIVER**  
**2008**

Thomas Christensen & Elizabeth Geisler  
Monterey Peninsula Water Management District  
5 Harris Court, Building G  
Monterey, CA 93940

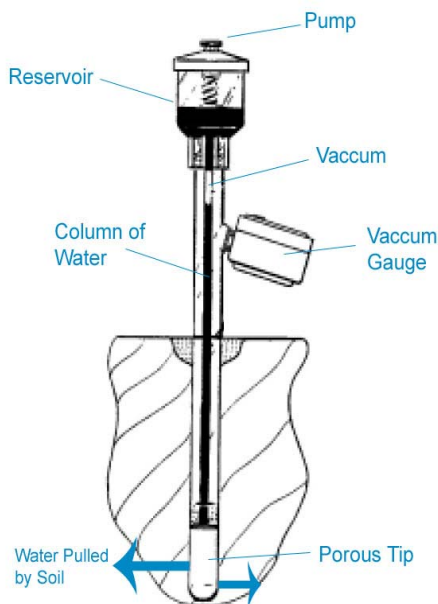
**Figure 2: A tensiometer consists of a sealed tube, a porous tip, a vacuum gauge, and a reservoir pump. The tube is buried with the porous tip at the bottom and water is hand-pumped into the tube from the reservoir. Once the column of water in the tube is filled, the device is left alone. Over time, the soil pulls the water out of the tube through a porous tip. A vacuum gauge then measures the attractive forces of the surrounding soil on the water filled column.**

Each station consists of two tensiometers buried so that the perforated ends are placed at 18 inches and 36 inches below the

surface (Fig. 2). These stations are located at different elevations above the river (toe, mid and/or upper terrace) in order to measure soil moisture at that elevation. A gauge reading is recorded in centibars and algacide treated water is pumped into the column to reset the gauge. During this monitoring season some gauges failed either due to gauge malfunction or loss of vacuum due to the liquid being completely pulled out of the reservoir. Data from malfunctioning tensiometers was left out of the graphs for clarity in this report.

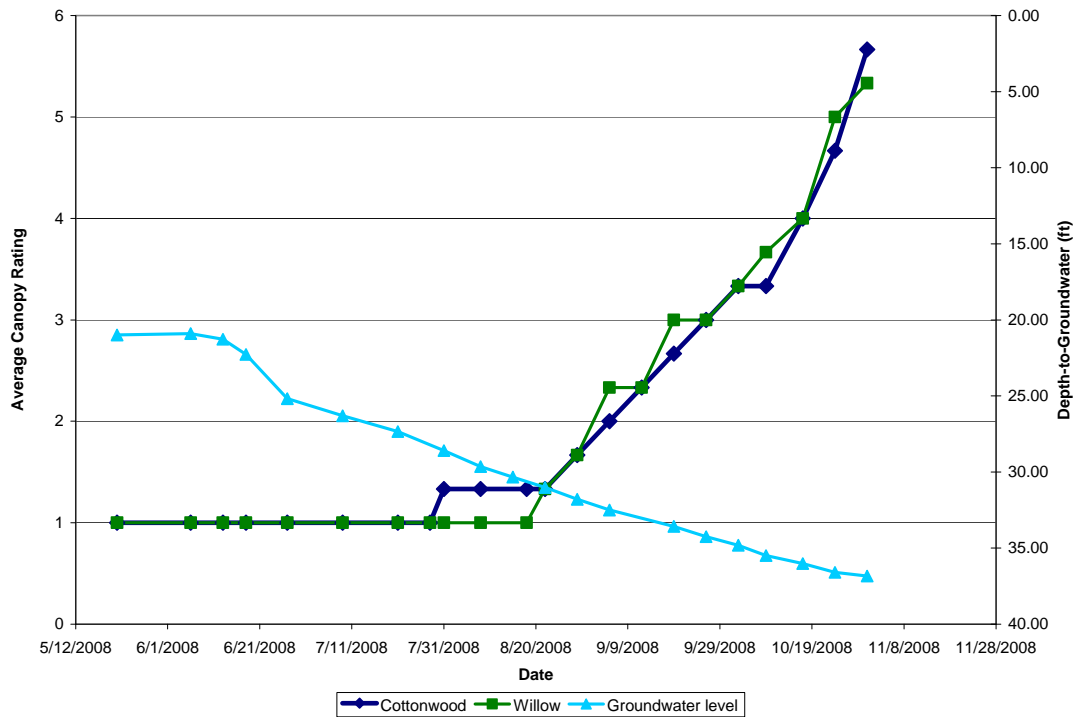
Figure 3: Average Weekly Canopy Rating for cottonwoods and willows at Cañada vs. depth-to-groundwater at the Cañada East monitoring well.

The monitoring season began with willows and cottonwoods both having an AWCR of 1.0, and ended the monitoring season with an AWCR of 5.3 and 5.7, respectively. The AWCR for willows steadily increased from mid August through October. The AWCR for cottonwoods increased from 1 to 1.3 in late July and remained constant until late August when the AWCR climbed to 1.7 (Fig.3). The cottonwood AWCR steadily increased from the end of August through October.

From May through October the depth-to-groundwater at Cañada East groundwater monitoring well dropped a total of 15.85ft from 20.99ft to 36.84ft below surface. (Fig.3) The greatest drop in depth was 2.91ft in 9 days.

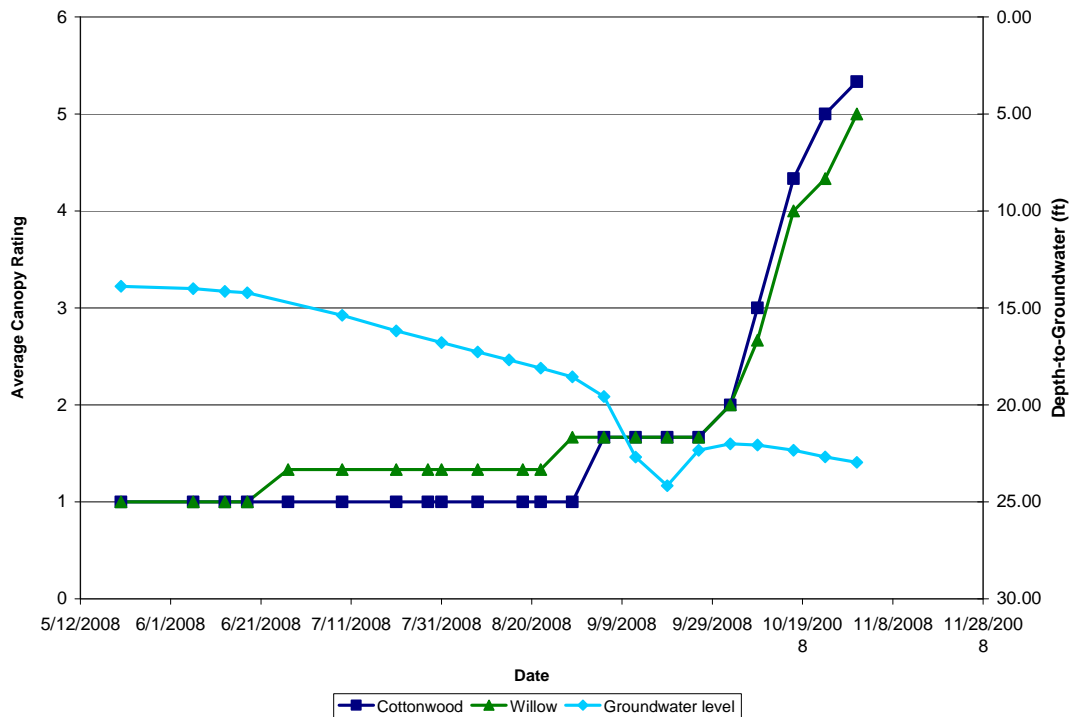
**Figure 4: Average Weekly Canopy Rating for cottonwoods and willows at San Carlos vs. depth-to-groundwater at the San Carlos monitoring well.**

Willows and cottonwoods at the San Carlos site both began the monitoring season with an AWCR of 1.0 and ended the monitoring season with an AWCR of 5.0 and 5.3, respectively. The AWCR for willows increased to 1.3 in late June, and remained constant until mid August when it rose to 1.7. The willow AWCR remained stable at 1.7 until the end of September, and then increased steadily through October. The AWCR for cottonwoods increased from 1.0 to 1.6 in the first week of September and was constant until the end of September when it rose to 2.0. Thereafter, the AWCR steadily increased into October (Fig.4).

From May through October the depth-to-groundwater at San Carlos Deep monitoring well dropped a total of 9.07ft from 13.89ft to 22.96ft below the historical floodplain (Fig.4). The greatest drop in depth occurred in early September when the water level dropped 3.12ft in 7 days.

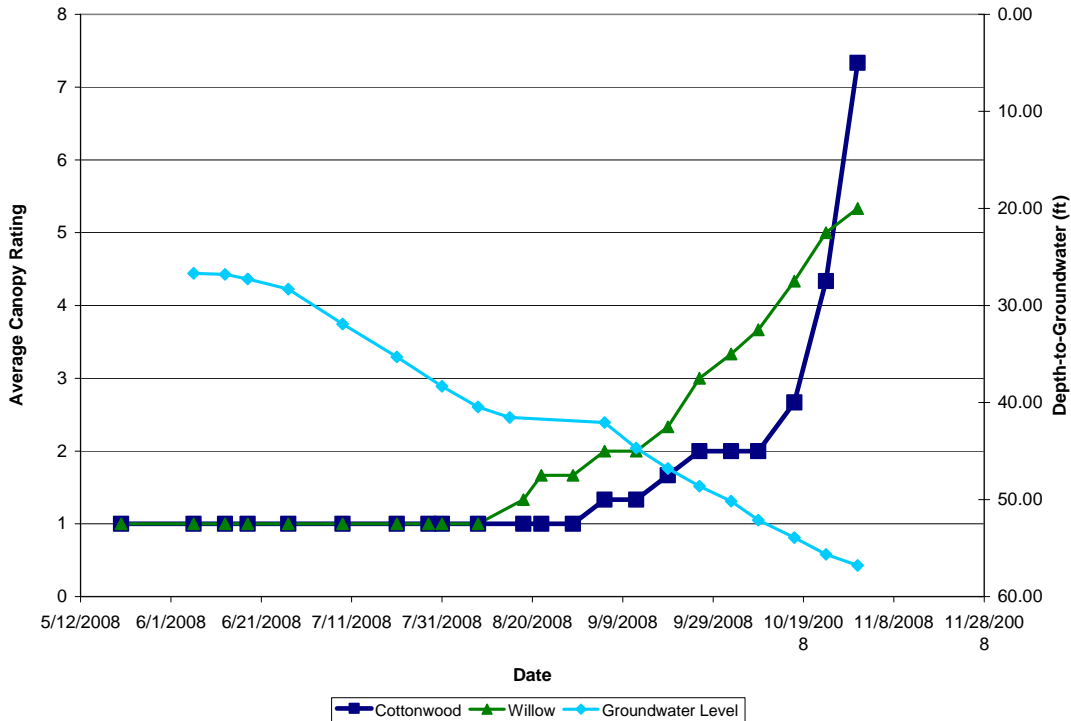
**Figure 5: Average Weekly Canopy Rating for cottonwoods and willows at Valley Hills vs. depth-to- groundwater at the Williams South monitoring well.**

Monitored willows and cottonwoods both began the monitoring season with an AWCR of 1.0 and ended the monitoring season with an AWCR of 5.3 and 7.3, respectively. The AWCR for willows began to increase in the second week of August and continued to rise through October, reaching an AWCR of 5.3. The AWCR for cottonwoods gradually increased beginning in late August, had a brief stable period at 2.0 in early October, and then jumped to a level of severe stress, an AWCR of 7.3, in the last couple of weeks of October. (Fig.5).

The depth-to-groundwater at Williams South monitoring well dropped a total of 30.10ft from 26.69ft to 56.79ft below surface May through October (Fig.5). The greatest drop in depth was 3.59ft in 12 days.

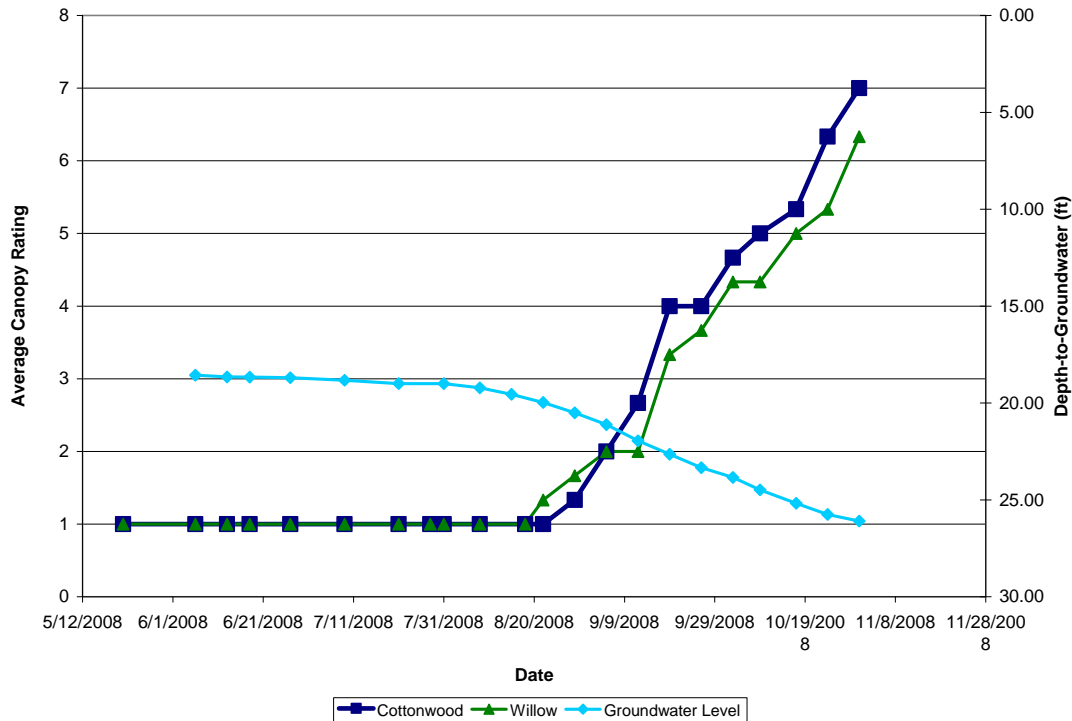
**Figure 6: Average Weekly Canopy Rating for cottonwoods and willows at Schulte vs. depth-to- groundwater at the Reimers monitoring well.**

Monitored willows and cottonwoods both began the monitoring season with an AWCR of 1.0, and ended the monitoring season with an AWCR of 6.3 and 7.0 respectively. The AWCR for willows was constant at 1.0 until late August when it increased to 1.3 and then continued to climb steadily to 6.4 in October. The AWCR for cottonwoods also began to rise in late August and continued into October, reaching an AWCR of 7.0 (Fig.6).

May through October the depth-to-groundwater at Reimers monitoring well dropped a total of 7.53ft from 18.56ft to 26.09ft below surface (Fig.6). The greatest drop in depth was 0.83ft in 7days.

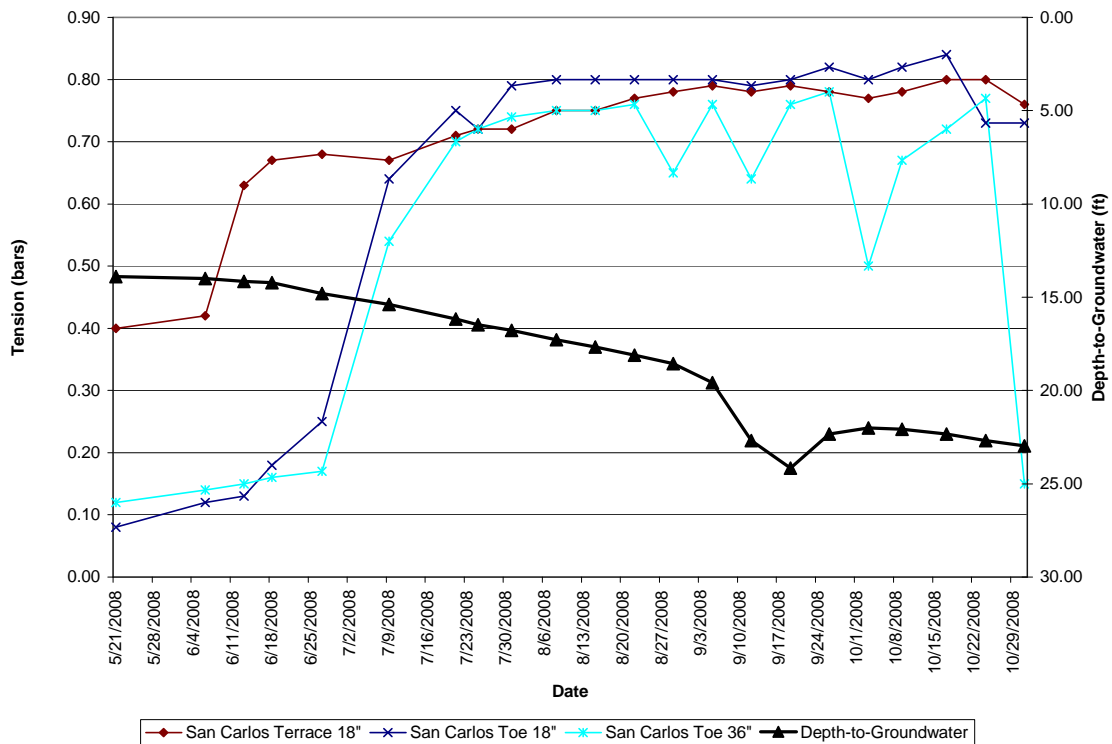
Figure 7: San Carlos toe and terrace tensiometer soil moisture values vs. depth-to-groundwater at San Carlos monitoring well.

Tensiometer values at the toe (close to river channel bottom) began at approximately 0.08 bars (18") and 0.12 bars (36") in early May. The toe 18" tensiometer peaked at 0.84 bars and ended the season at 0.73 bars. The toe 36" tensiometer peaked at 0.77 bars. Tensiometer values at the terrace (above river channel) were limited to the data from the 18" tensiometer because the 36" tensiometer was nonfunctional. The 18" terrace tensiometer began at approximately 0.41 bars in early May, climbed to a peak of 0.80 bars in late October, and ended the season at 0.76 bars (Fig. 7).

At San Carlos, there is a relationship between depth-to-groundwater and tensiometer values. The data shows that from mid May to mid September the depth-to-groundwater gradually increased and the tensiometer readings increased gradually revealing a drying trend in soil moisture.

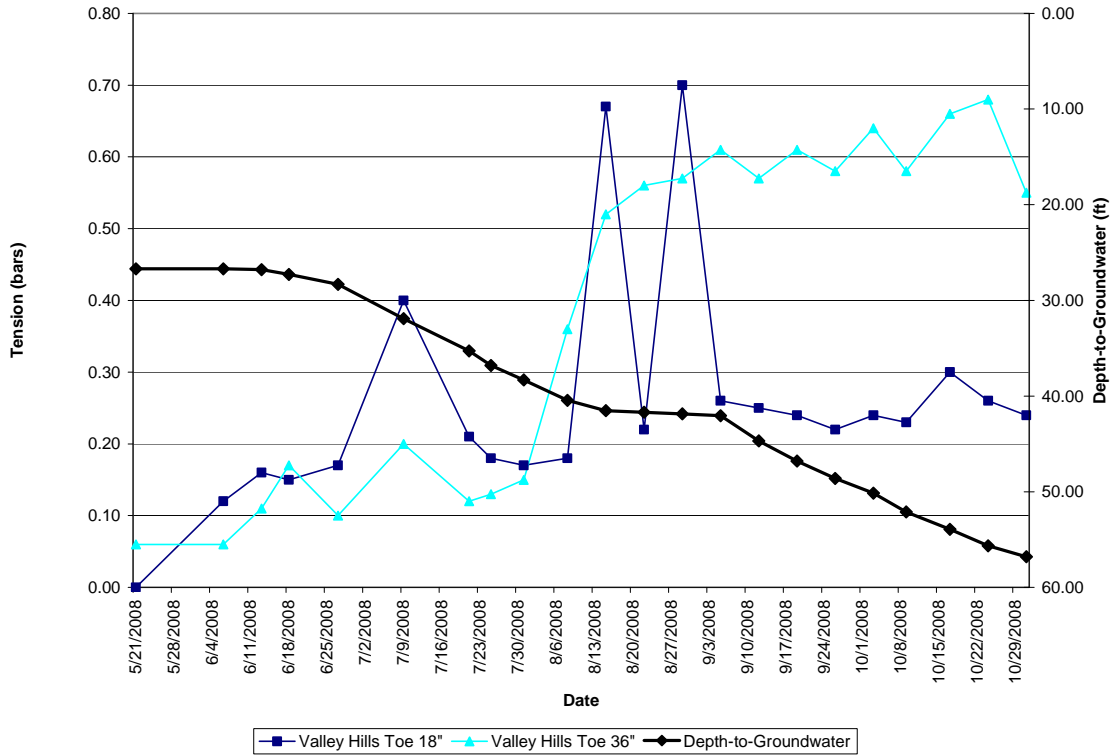
Figure 8: Valley Hills toe and terrace tensiometer soil moisture values vs. depth-to-groundwater at Williams South monitoring well.

Tensiometer values at the toe (close to river channel bottom) began at 0.00 bars (18") and 0.06 bars (36") in early May. The toe 18" tensiometer peaked at 0.70 bars and failed shortly after. The toe 36" tensiometer peaked at 0.68 bars and ended the season at 0.55 bars (Fig. 8). Tensiometer values at the terrace (above river channel) were left out of the charts because they continuously failed (vacuum tension broke and gauge fell to 0 bars) under the extremely dry conditions. It is worth noting that the terrace tensiometers began the season at 0.74 bars (18") and 0.32 bars (36") and continued to increase until late June when both tensiometers failed.

Tensiometer malfunction made it problematic to see the relationship between soil moisture and depth to groundwater at Valley Hills. However, we know that depth to groundwater in the riparian zone influences soil moisture and the data does show that the soil was very dry at this location by August.

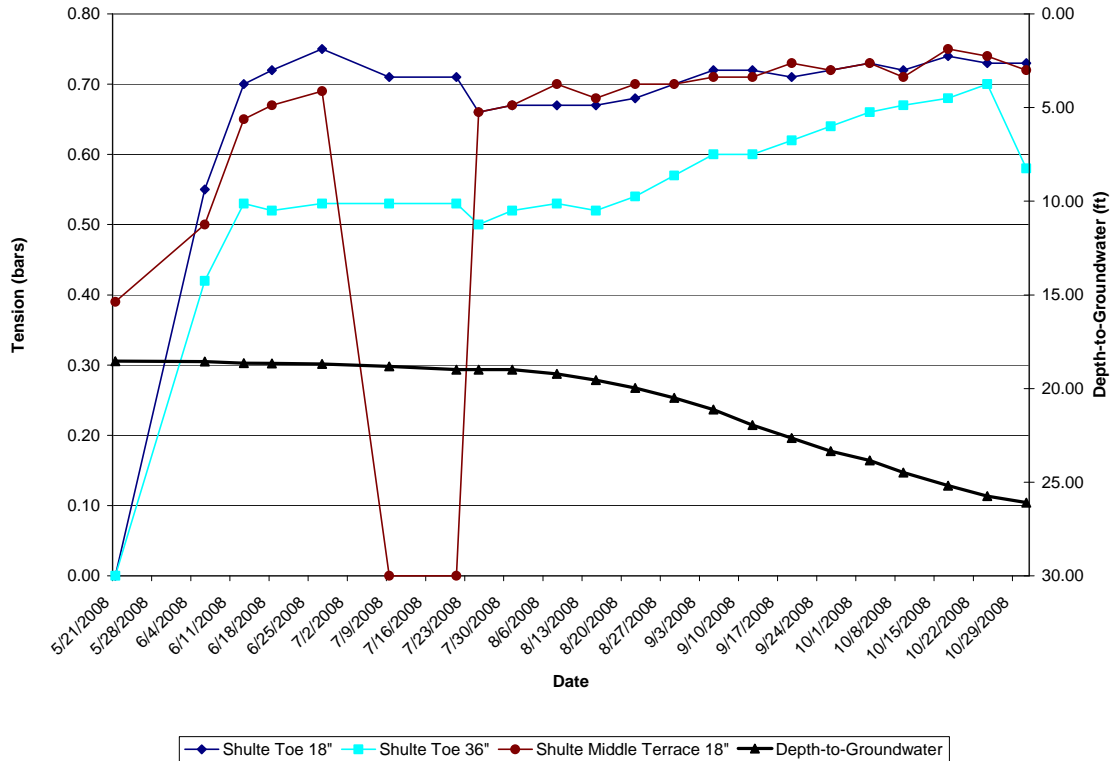
Figure 9: Schulte toe and terrace tensiometer soil moisture values vs. depth-to-groundwater at Reimers monitoring well.

Tensiometer values at the toe (close to river channel bottom) began at approximately 0.0 bars (18") and 0.0 bars (36") in mid May. The toe 18" tensiometer peaked at 0.75 bars and ended the season at 0.73 bars. The toe 36" tensiometer peaked at 0.70 bars and ended the season at 0.58 bars. Two other sets of tensiometers were monitored at Schulte, one at a mid terrace level and one at an upper terrace level. Among these tensiometers, one was nonfunctional at the beginning of the season, and two others broke vacuum mid-season as the soil dried out. Data from the one surviving tensiometer was included in the results. The mid terrace 18" tensiometer began the season at 0.39 bars, peaked at 0.75 bars, and ended the season at 0.72 bars (Fig. 9).

Schulte also demonstrates the general trend between tensiometer values and the depth-to-groundwater where as the depth-to-groundwater increases so do the tensiometer values.

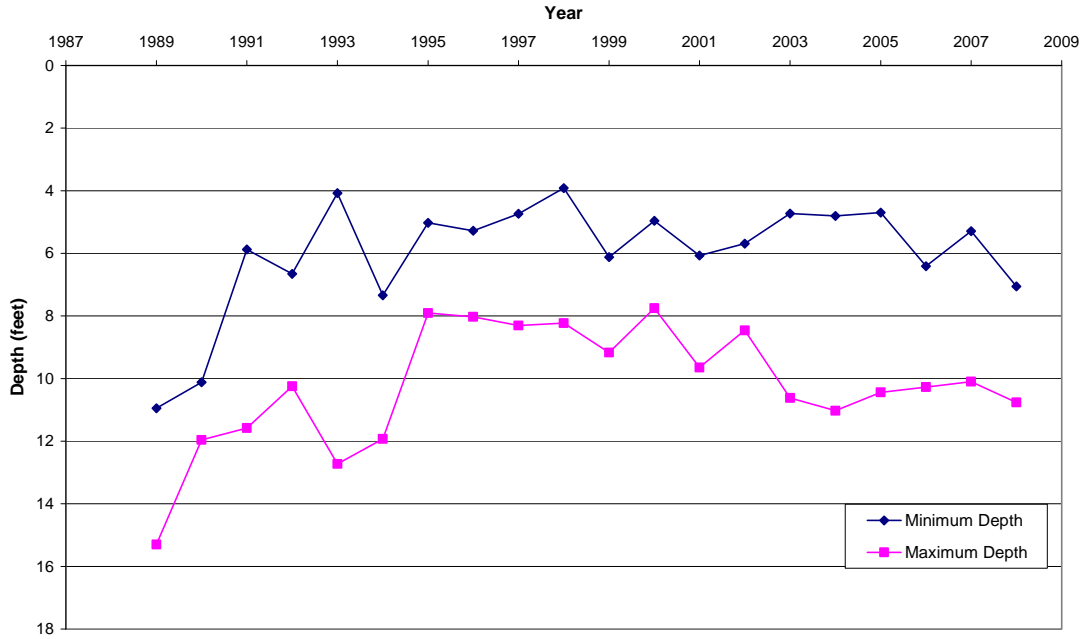
**Highway 1 Monitoring Well (T16S/ R1W-13Lc) Annual Minimum and Maximum Depth to Groundwater Values in Feet**

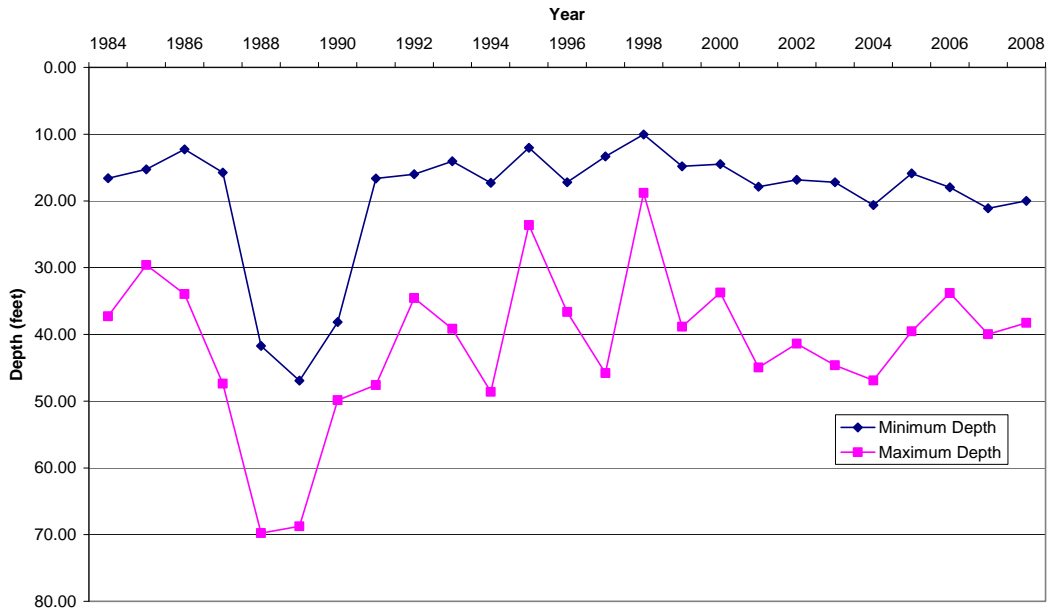
**Cañada East Monitoring Well (T16S/R1E-17Lb) Annual Minimum and Maximum Depth to Groundwater Values in Feet**

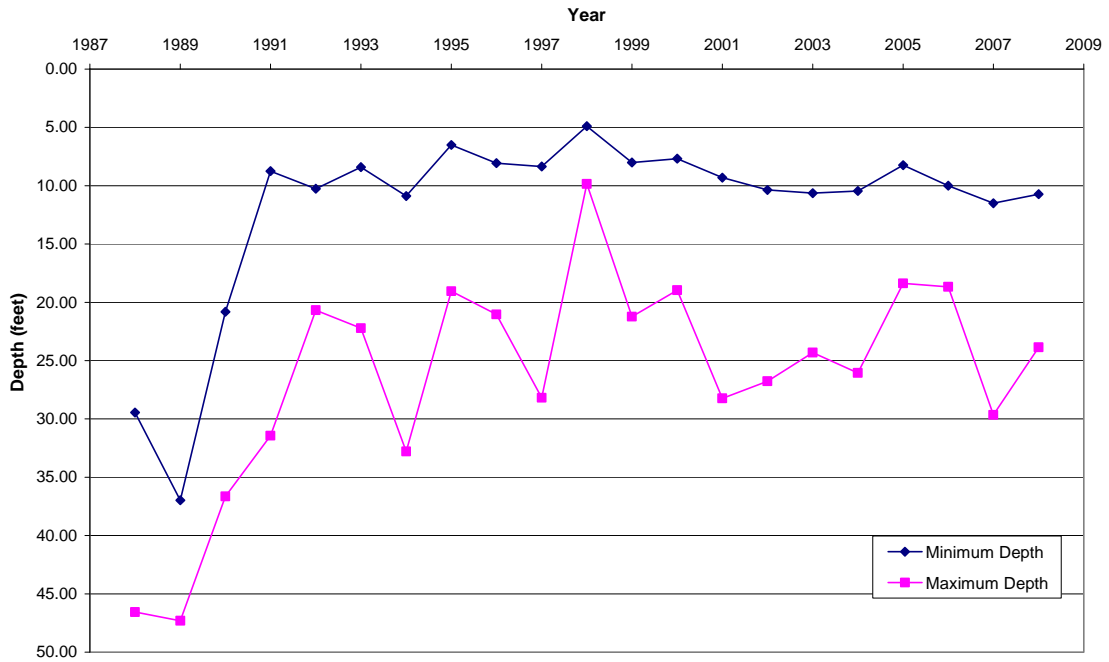
**Rubin Monitoring Well (T16S/R1E-17Jd) Annual Minimum and Maximum Depth to Groundwater Values in Feet**

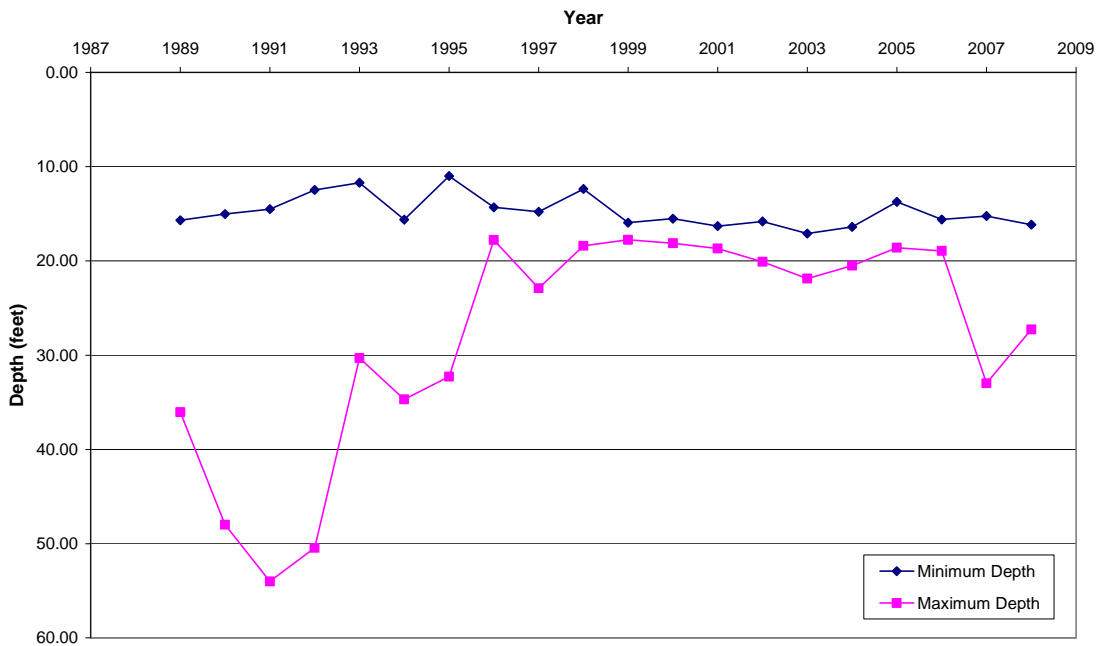
**Reimers Monitoring Well (T16S/R1E-23La) Annual Minimum and Maximum Depth to Groundwater Values in Feet**

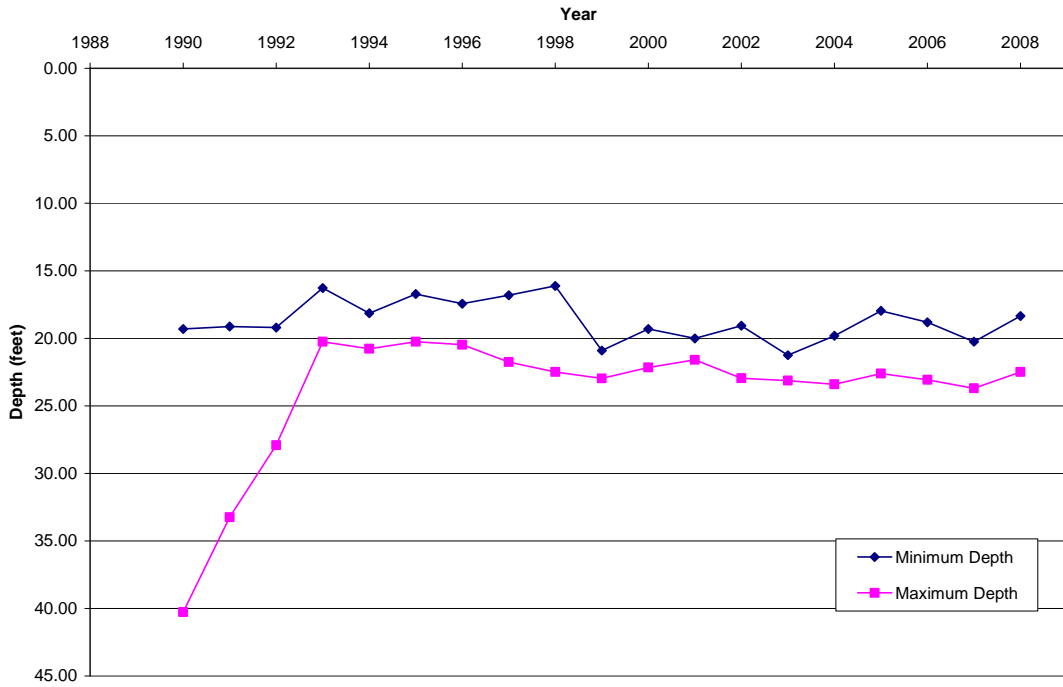
**Coyote Monitoring Well (T16S/R2E-19Nx) Annual Minimum and Maximum Depth to Groundwater Values in Feet**

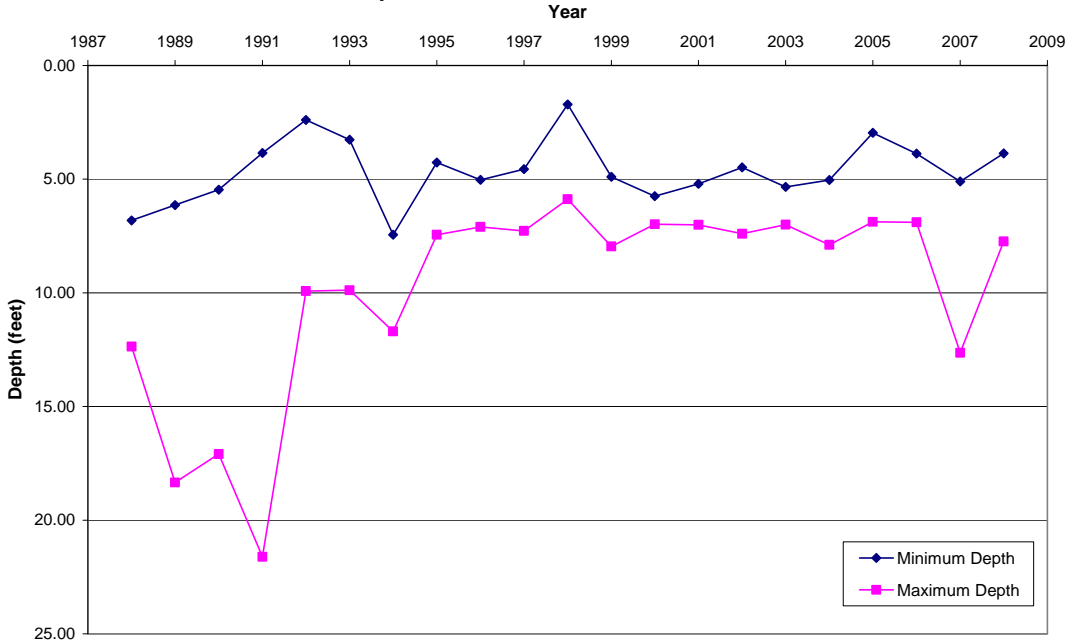
**DeDampierre Monitoring Well (T17S/R2E-03La) Annual Minimum and Maximum Depth to Groundwater Values in Feet**
