**RIPARIAN CORRIDOR MONITORING REPORT  
CARMEL RIVER  
2004**

Paul Watters, Thomas Christensen & Jessica Wheeler  
Monterey Peninsula Water Management District  
5 Harris Court, Building G  
Monterey, CA 93940

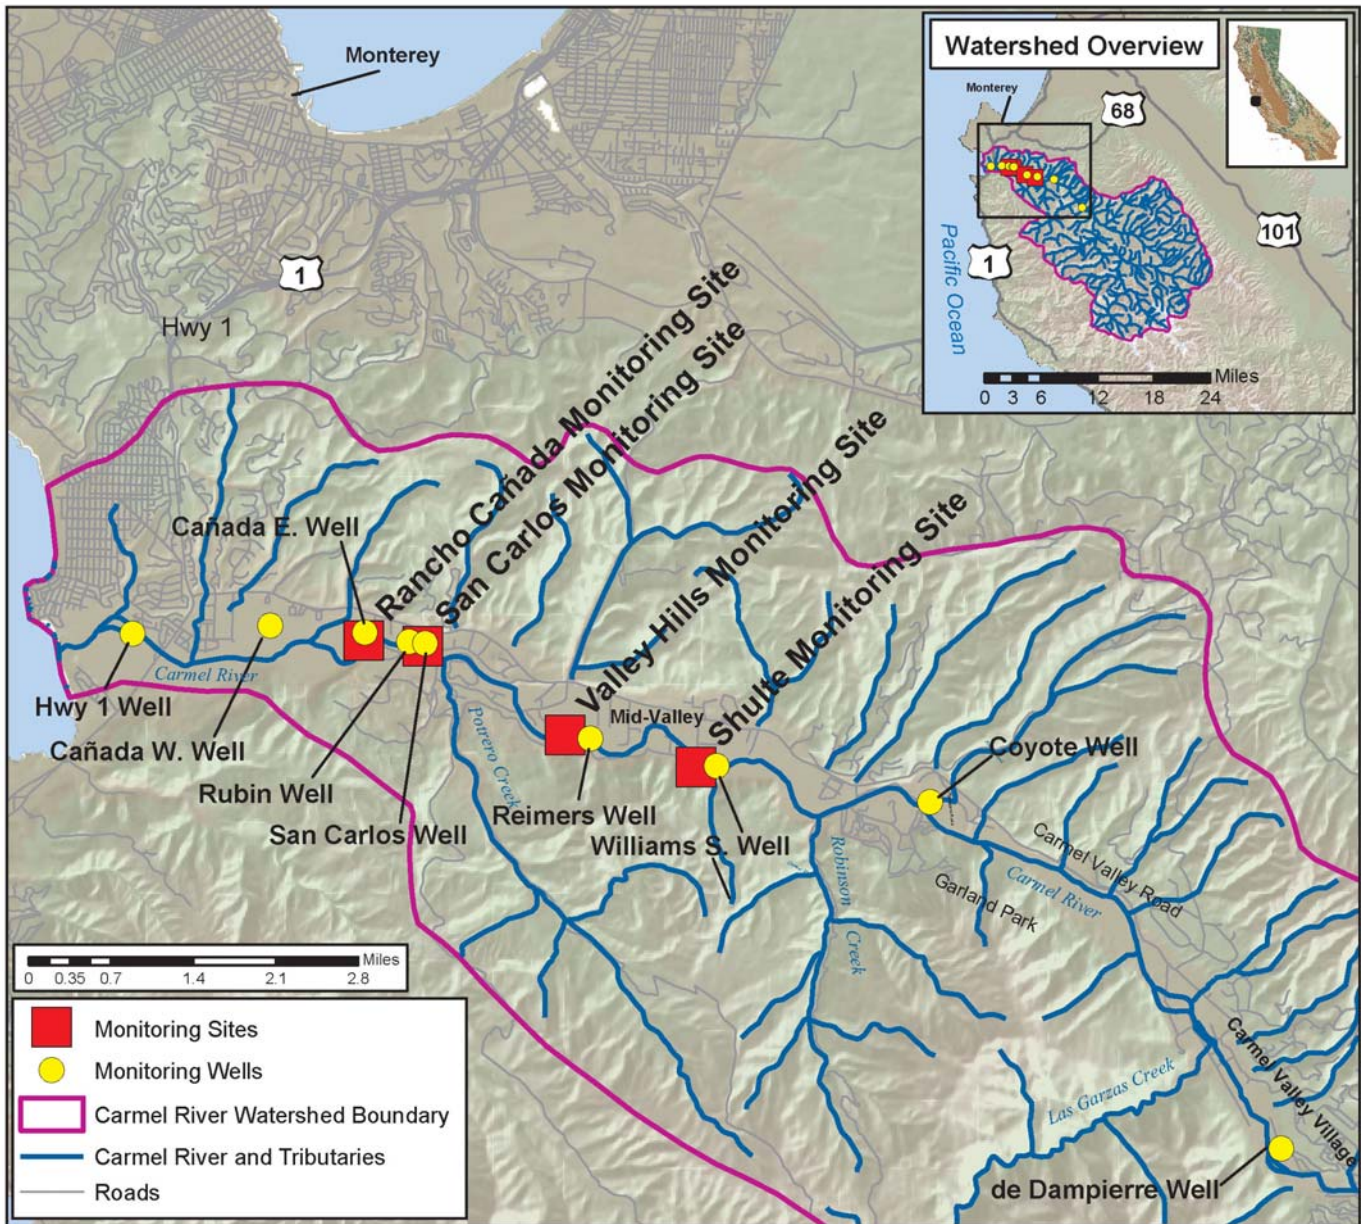
Figure 1. The four vegetation monitoring sites and the Carmel River watershed

The 36-mile-long Carmel River drains 255 square miles of the central coast of California. The watershed includes the Santa Lucia Mountains to the south and the Sierra del Salinas Range to the north. Bedrock in the basin consists mainly of Sur Series crystalline rock (granite, gneiss, schist), Monterey Shale and sandstone (Page and Matthews, 1984). Mean annual rainfall varies from about 14 inches along the northeast perimeter of the basin to over 40 inches in the high peaks (up to approximately 5,000 feet in elevation) of the southern portion (James, 1999). Upper reaches on the Carmel River flow through steep-sided canyons, while the lower 16 miles is a relatively flat alluvial valley to the ocean. The average annual runoff at the San Clemente Dam site is 69,000 acre-feet (James, 2003). Bankfull flow is 2,200 cubic feet per second (cfs) near the mouth. On March 10, 1995, the river discharge peaked at 16,000 cfs, which is the largest event ever recorded on the Carmel River. The MPWMD has maintained four vegetation monitoring sites: Rancho Cañada, San Carlos, Valley Hills, and Schulte (Figure 1).

The Rancho Cañada monitoring site is located 3.24 miles upstream of the Carmel River mouth in the vicinity of Cal-Am's Cañada production well. This well has the capacity to pump up to 5 cubic feet per second and can negatively effect riparian vegetation. The north bank is comprised of relatively young riparian vegetation that is part of restoration efforts by the Rancho Cañada Golf course. The south bank is a more mature stand of willows and cottonwoods. Both banks are steep with high terraces. Pre-dawn leaf moisture stress samples taken at this site include three willows, and three cottonwoods. This site has a monitoring well but no tensiometers.

The San Carlos monitoring site is located 3.60 miles upstream of the Carmel river mouth. This site encompasses one of the largest mature riparian areas remaining in the lower Carmel Valley. It consists of a high terrace with large black cottonwoods and relatively steep banks consisting mostly of red and arroyo willows. Cal-Am has a production well at the site that is capable of pumping 2.45 cubic feet/second but has not been in production since November 8<sup>th</sup>, 2002, since the Monterey County Environmental Health Department determined it to be under the influence of surface water. This prevented Cal-Am from using this well until they can provide surface water treatment. This well could be put back into production as Cal-Am has investigated treatment of the water. Irrigation at this site began in 1989 to offset impacts to riparian vegetation. The San Carlos site includes two tensiometer stations and a monitoring well. Pre-dawn leaf moisture stress samples include three willows and three cottonwoods.

The Valley Hills monitoring site is located 5.60 miles upstream of the Carmel River mouth. This restoration site, installed in 1992, is 1,500 linear feet along the river channel and is located adjacent to agricultural lands. The Cypress production well is adjacent to the site and can negatively effect riparian vegetation. The Valley Hills monitoring site includes two tensiometer stations and pre-dawn leaf moisture stress samples that include three cottonwoods and four willows.

The Schulte river monitoring site is located 6.70 miles upstream of the Carmel River mouth. This restoration project was completed in January of 1988 and consisted of 3,200 lineal feet of channel realignment and floodplain modification. The Schulte production well is adjacent to the monitoring site and can negatively effect riparian vegetation. The Schulte project includes three tensiometer stations and a monitoring well. Pre-dawn leaf moisture stress samples include four willows and three cottonwoods.

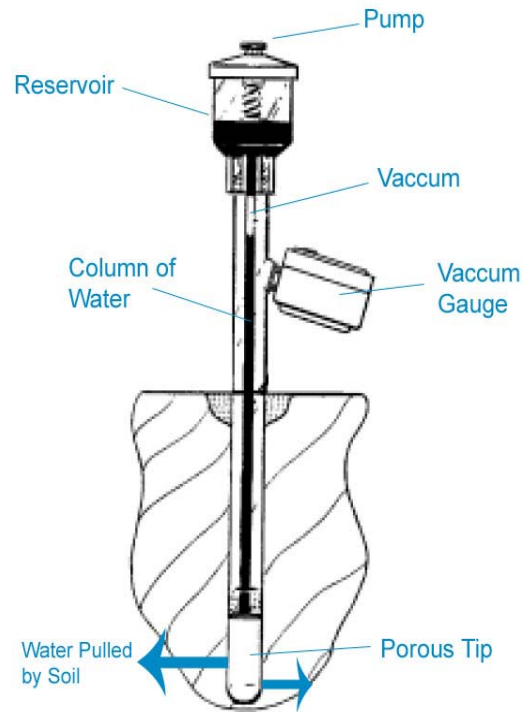
Figure 2. Tensiometer

Tensiometers (Figure 2) are used at three vegetation monitoring sites (San Carlos, Valley Hills, and Schulte) to determine soil moisture. The tensiometers consist of a sealed tube, a porous tip (at the bottom of the tube), a vacuum gauge, and a reservoir pump. The tube is buried with the porous tip at the bottom and water is hand-pumped into the tube from the reservoir. Once the column of water in the tube is filled, the device is left alone. Over time, the soil pulls the water out of the tube through a porous tip. A vacuum gauge then measures the attractive forces of the surrounding soil on the water filled column. Tensiometers work on the principle that the drier the soil is; harder it pulls on the water filled in the column. Eventually, the pull of the soil will reach equilibrium with the vacuum inside the tube and an accurate measure of soil tension can be read from the vacuum gauge. Soil tension is inversely proportional to available moisture and gives an indication of how much moisture is available for plant health.

The tensiometers used have two different lengths (18" & 36" below the surface), and are buried in pairs (one station contains one pair of each; 18" and 36") so that the perforated ends are placed at 18 inches and 36 inches below the surface. These stations are located at different elevations above the river in order to measure soil moisture at that elevation.

Maintenance of tensiometers includes pumping of algacide treated water into the column and refilling the reservoirs at least once every two weeks, generally done after readings are taken.

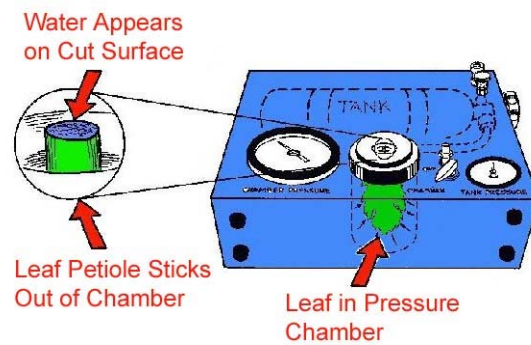
Figure 3. Pressure Bomb Instrument  
Illustration Courtesy of PMS Instrument Co.

The trees' moisture stress is quantified through the use of a PMS Instruments Model 670 pressure bomb (plant water status console) using the following methods: First, newer-growth leaves are collected from specified trees in the pre-dawn hours for a single monitoring site. Next, for each leaf, a clean cross-sectional slice is made across the petiole of the leaf. The leaf petiole is fit tightly, cut side up, into a rubber stopper and then sealed with 'silly' putty. Then, the leaf is placed within the model 670's nitrogen pressure chamber with the petiole sticking out of the pressure chamber within view of the operator. The operator slowly increases the pressure in the chamber while simultaneously observing the tip of the petiole with a hand-lens. When the operator observes water being forced out of the petiole (leaf), the operator immediately stops increasing the pressure and records the pressure in the chamber as it reads on the model 670's dial gauge (bars). The above method is then performed for all leaves within several minutes of their collection.

The above is performed before dawn when stomata are closed and water in the leaf is a function of available soil moisture (McNiesh, 1988). The greater the pressure required to force moisture from the tree leaf, the more stress the tree is experiencing; the amount of pressure it takes to force the free water from the petiole is a measure of the amount of water available within the plant for life processes. The established laboratory stress index stated in the Woodhouse study shows that "severe" stress is recognized when the results for willows rise above 7.5 bars and when readings for cottonwoods rise above 10.0 bars (Woodhouse, 1983). Woodhouse recommends, "Irrigation should begin when pre-dawn water potential falls to within two bars of these critical values."

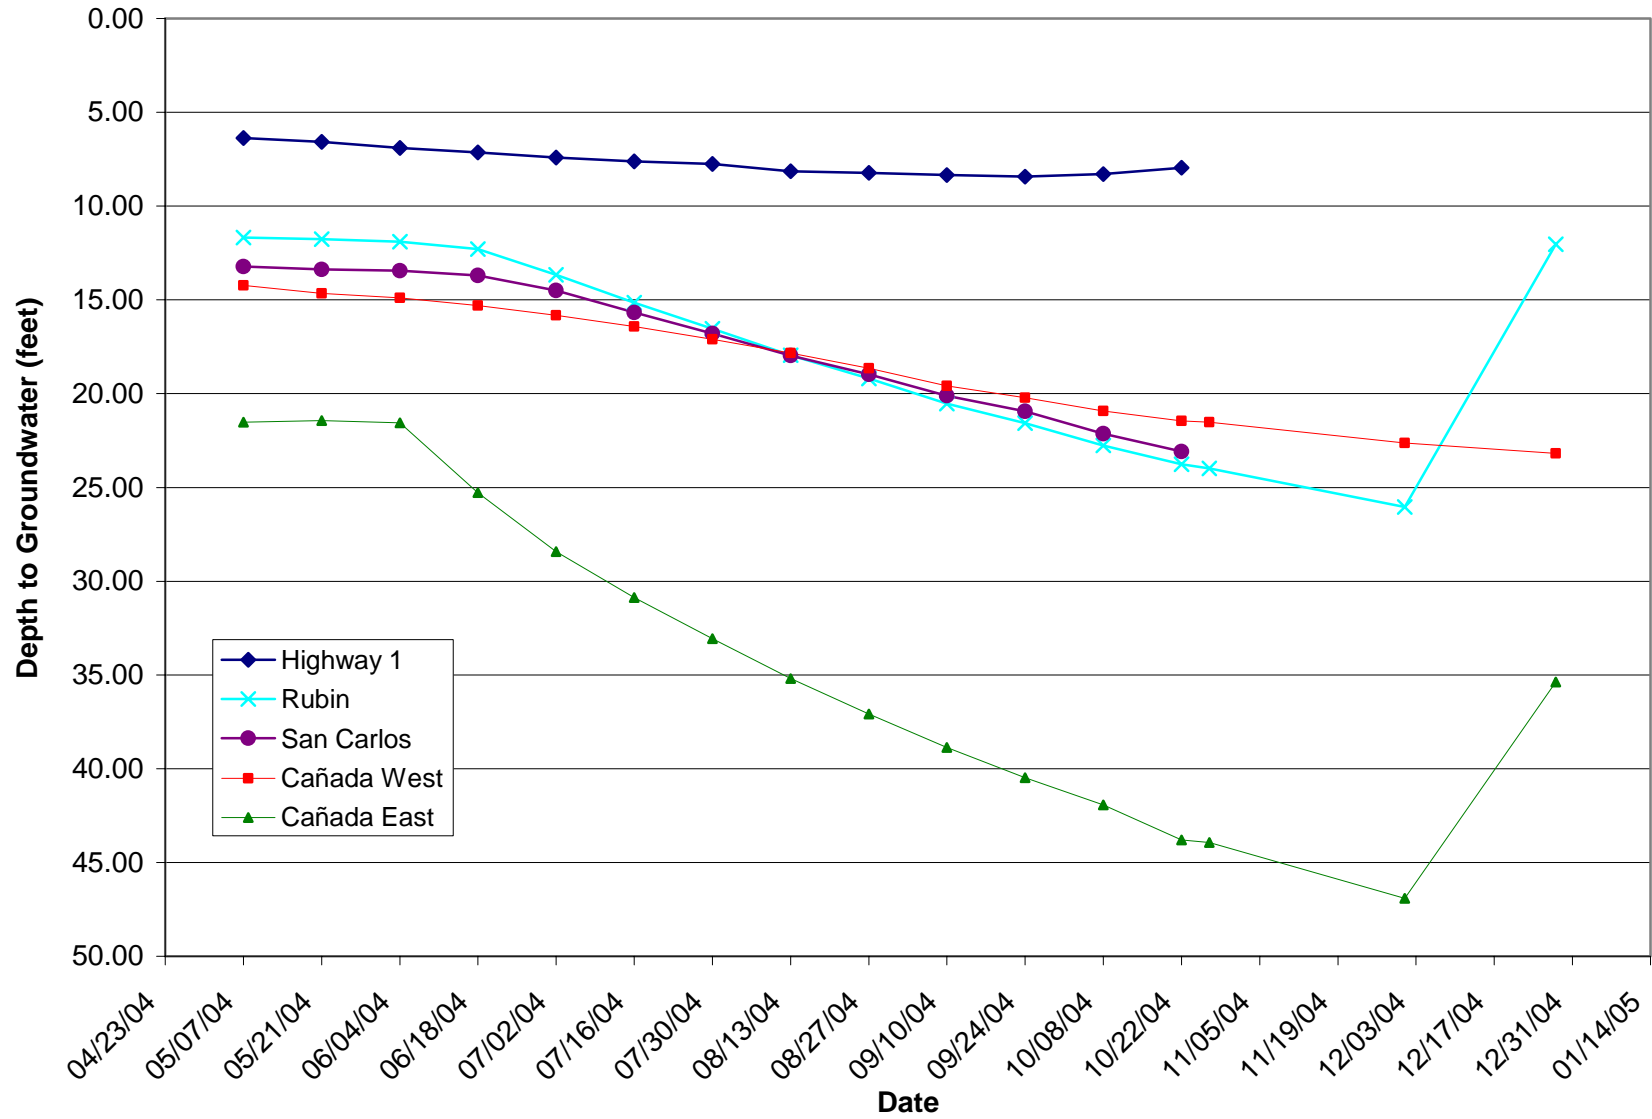
Figure 4. Carmel Valley Alluvial Aquifer Depth to Groundwater: Lower Section

The following monitoring wells; Cañada, Rubin, San Carlos, and Williams South show an increase in depth to groundwater over time especially as the river dried up in early June (Figure 4). Within a period of seven months (May through October) the aquifer level dropped 16.35 feet overall at the Williams South well and 22.28 feet overall at the Rancho Cañada well. Reasons for this steady drop in groundwater values are attributed to constant pumping of Cal-Am's production wells resulting in the lack of recharging river flow within this reach. The streambed remained dry due to the pumping and lack of rainfall until the first significant storms established streamflow all the way to the Carmel River Lagoon on December 27, 2004.

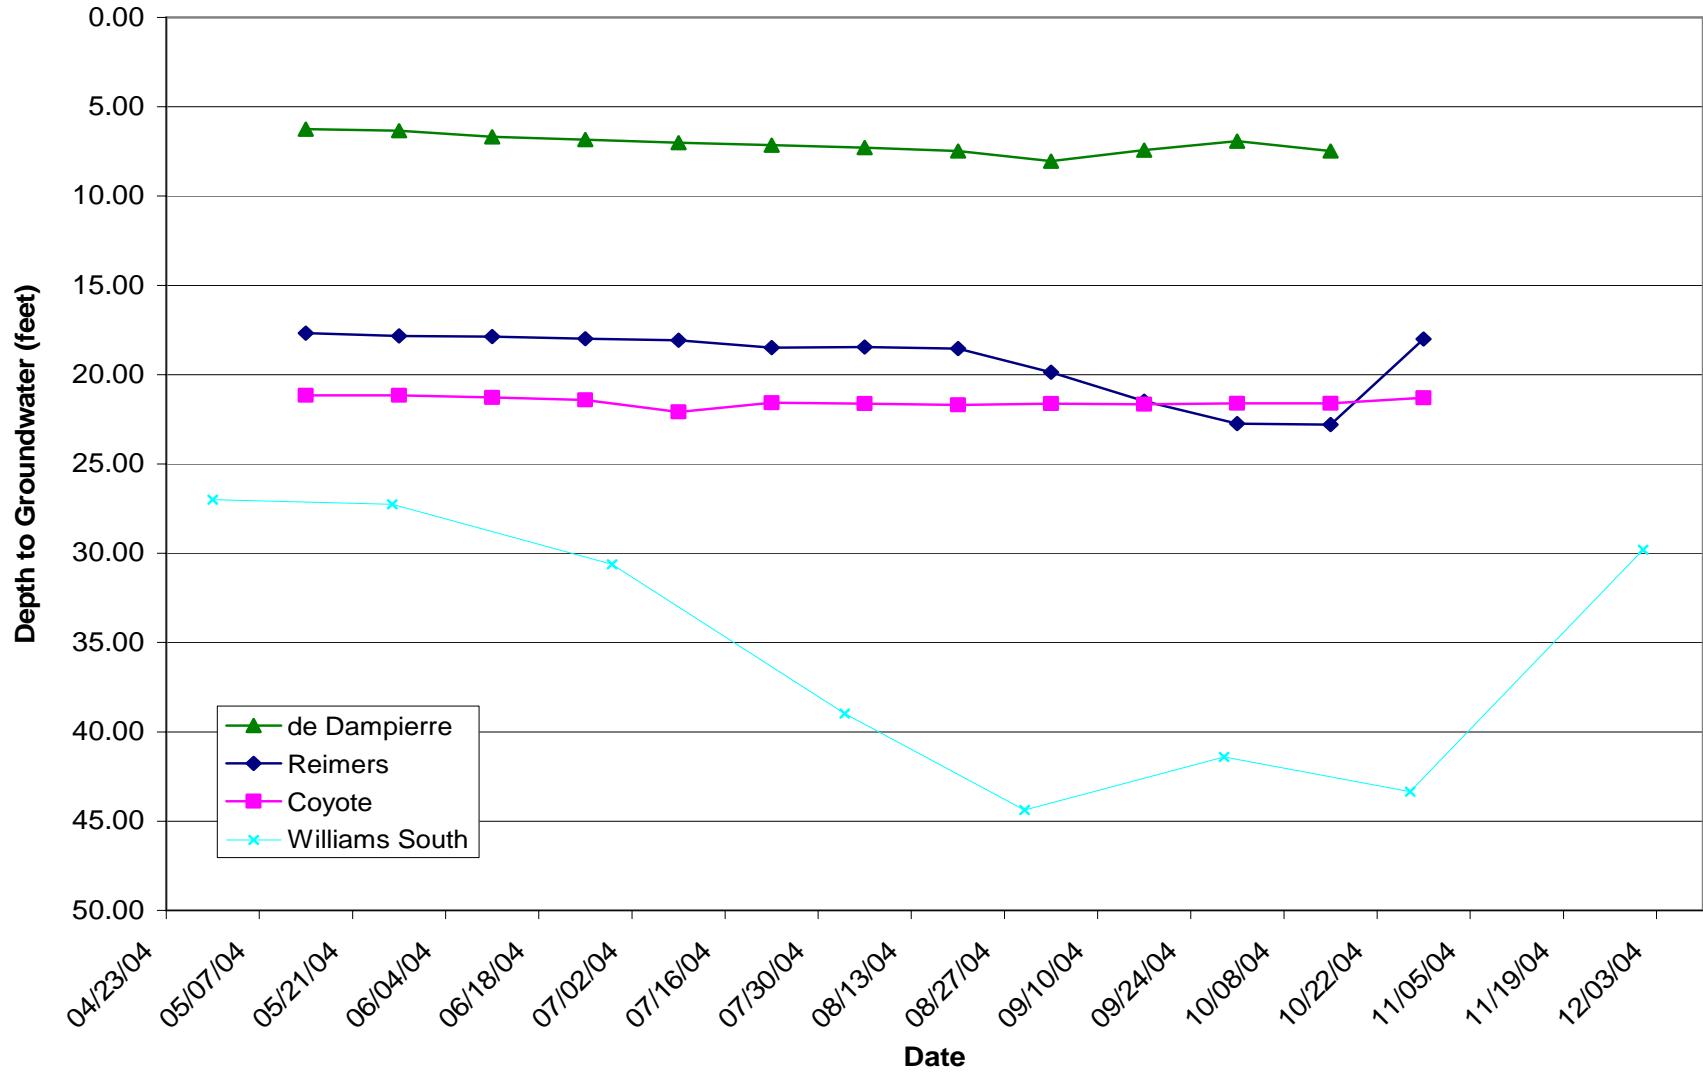
Figure 5. Carmel Valley Alluvial Aquifer Depth to Groundwater: Upper Section

In contrast to these above-mentioned monitoring wells, the 'upstream' monitoring wells (at DeDampierre, Coyote, and Reimers) show little overall change in depth to groundwater values (Figure 5). The consistent values at these upstream groundwater level monitoring sites are a function of perennial flow, and reduced pumping of the nearby production wells.

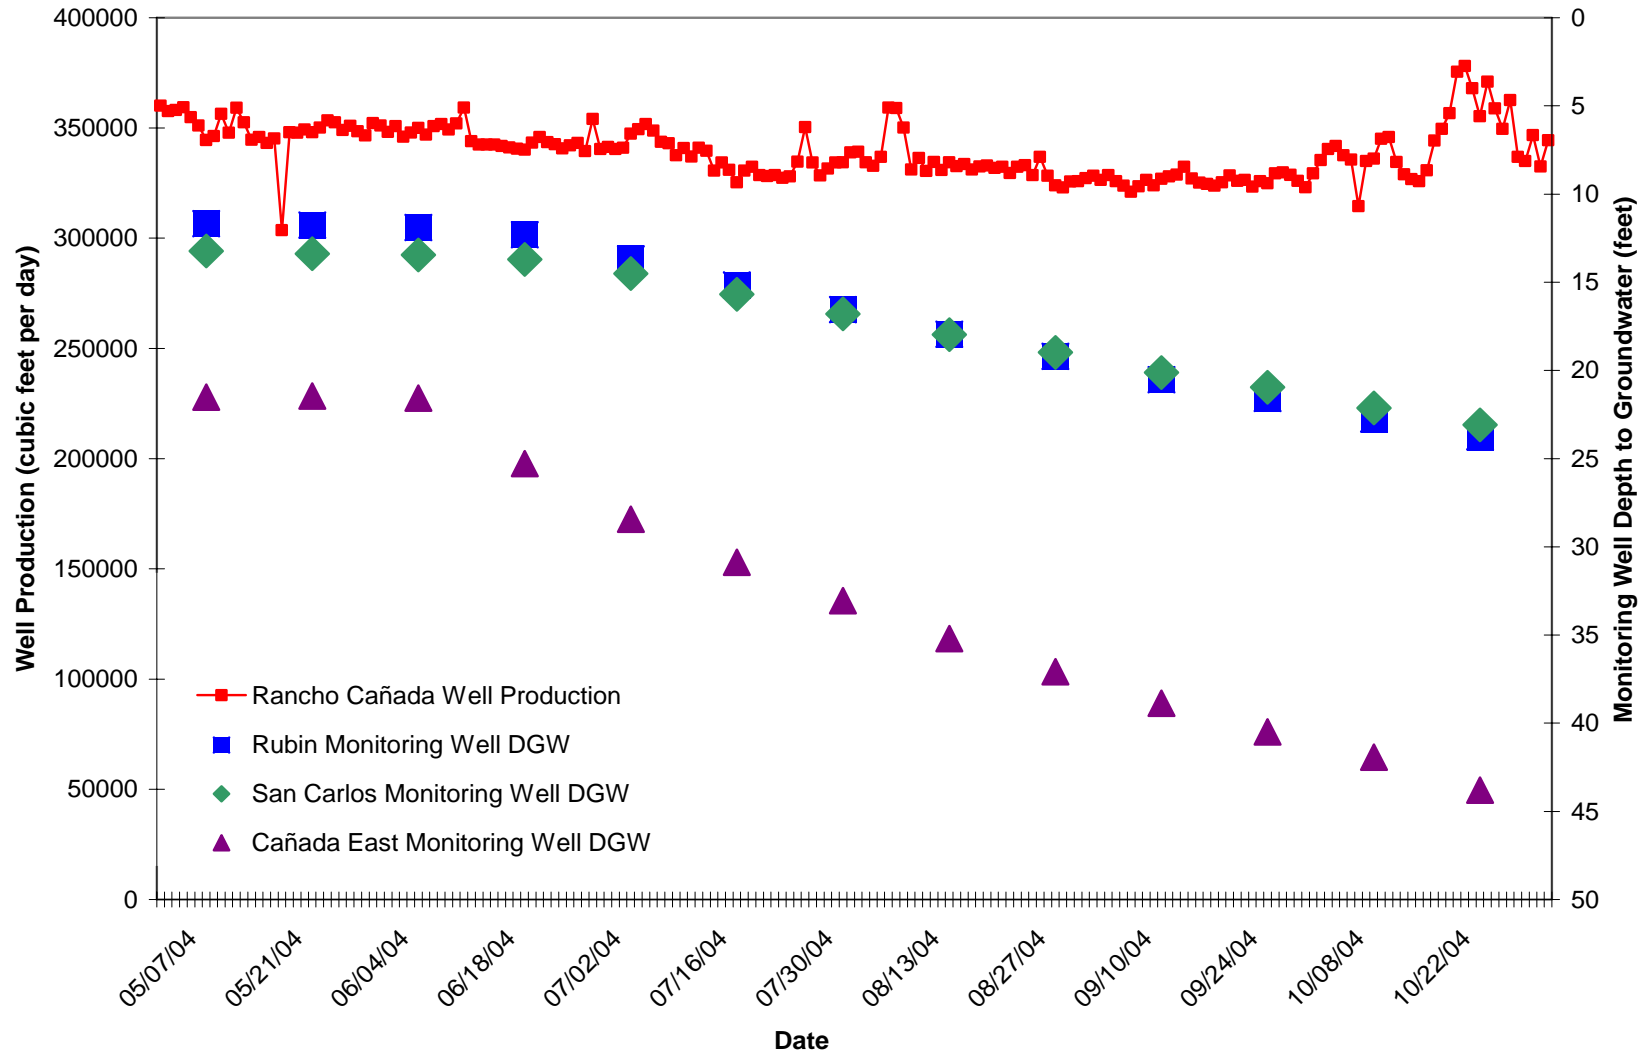
Figure 6. Rancho Cañada Well Production Correlated with Nearby Depth to Groundwater

The plot of Cal-Am's Rancho Cañada production well verses the depth to groundwater values at the adjacent Rubin, San Carlos, and Rancho Cañada monitoring wells (Figure 6) shows the drop in depth to groundwater is proportional to the pumping of municipal production wells. The general trend shows as production remained consistent during the heavy demand period of May through October, the depth to groundwater continuously dropped after the river dried up in early June at the nearby Via Mallorca Bridge.

Figure 6 also shows the 'cone of depression'; a regional drop in the water table that increases in depth as it approaches the production well. The San Carlos and Rubin monitoring wells are further from the Rancho Cañada production well than the Cañada East Monitoring well, of which shows a much greater drop in depth to groundwater.

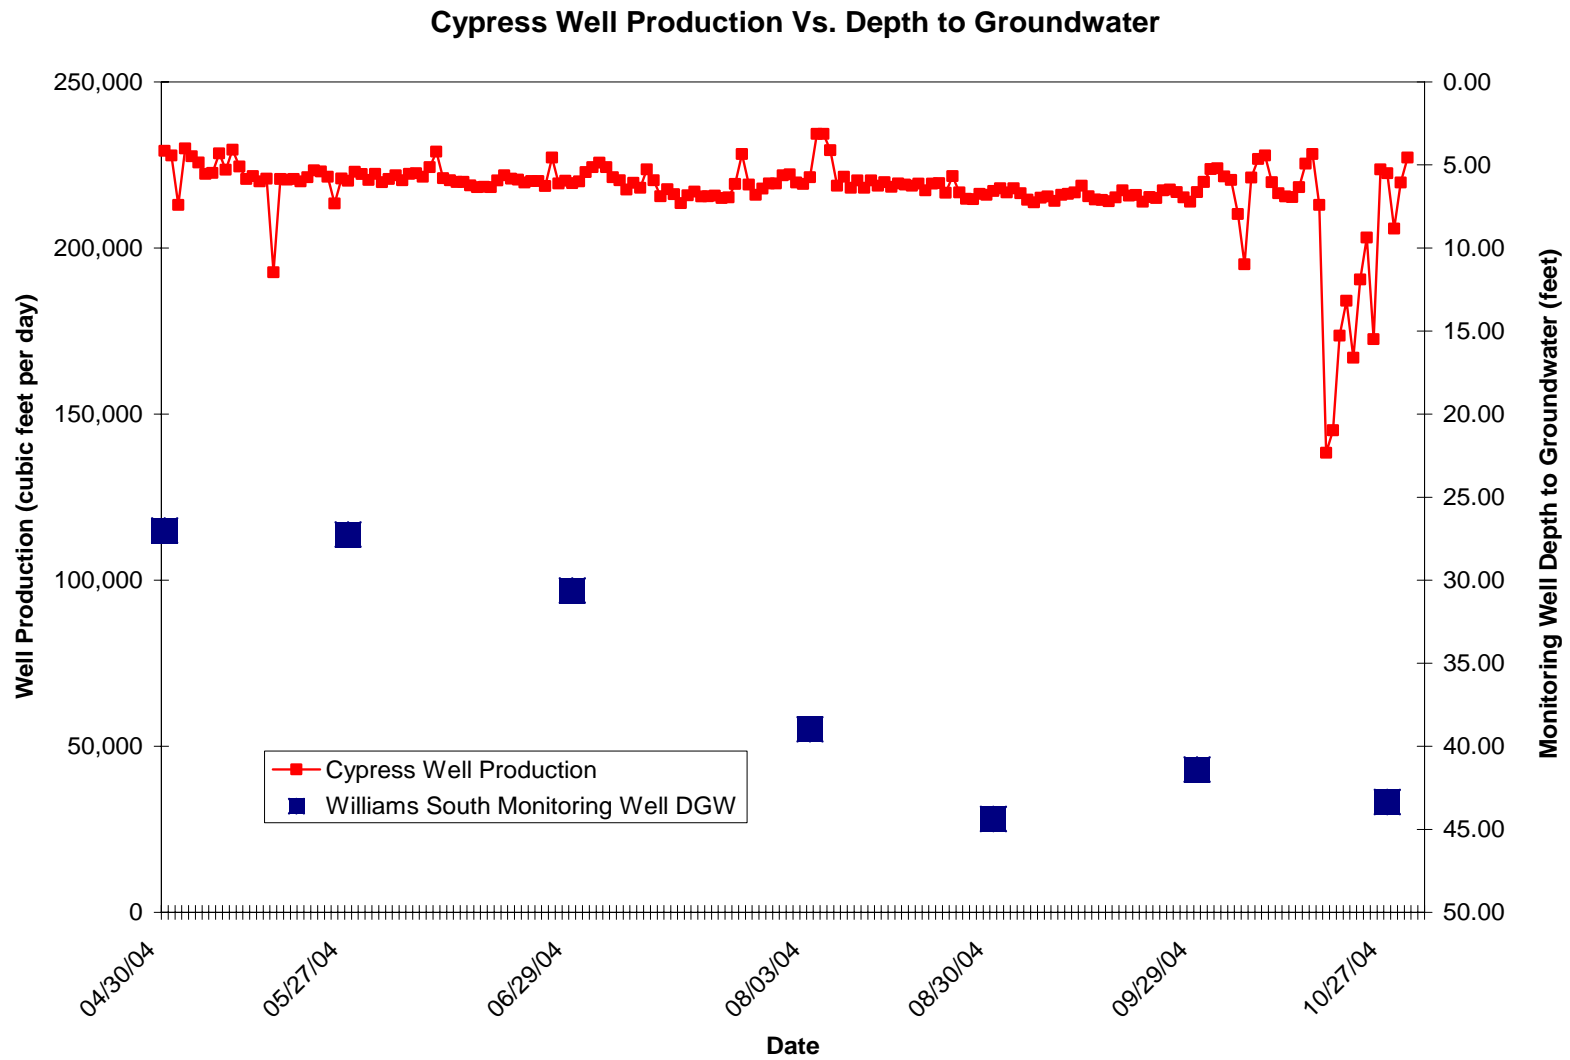
Figure 7. Cypress Well Production Correlated with Nearby Depth to Groundwater

Figure 7 shows a steady drop in depth to groundwater at the Williams South monitoring well, located adjacent to the cypress well. Groundwater levels dropped to over 40 feet below the wooded terrace, and remained there throughout the remainder of the summer.

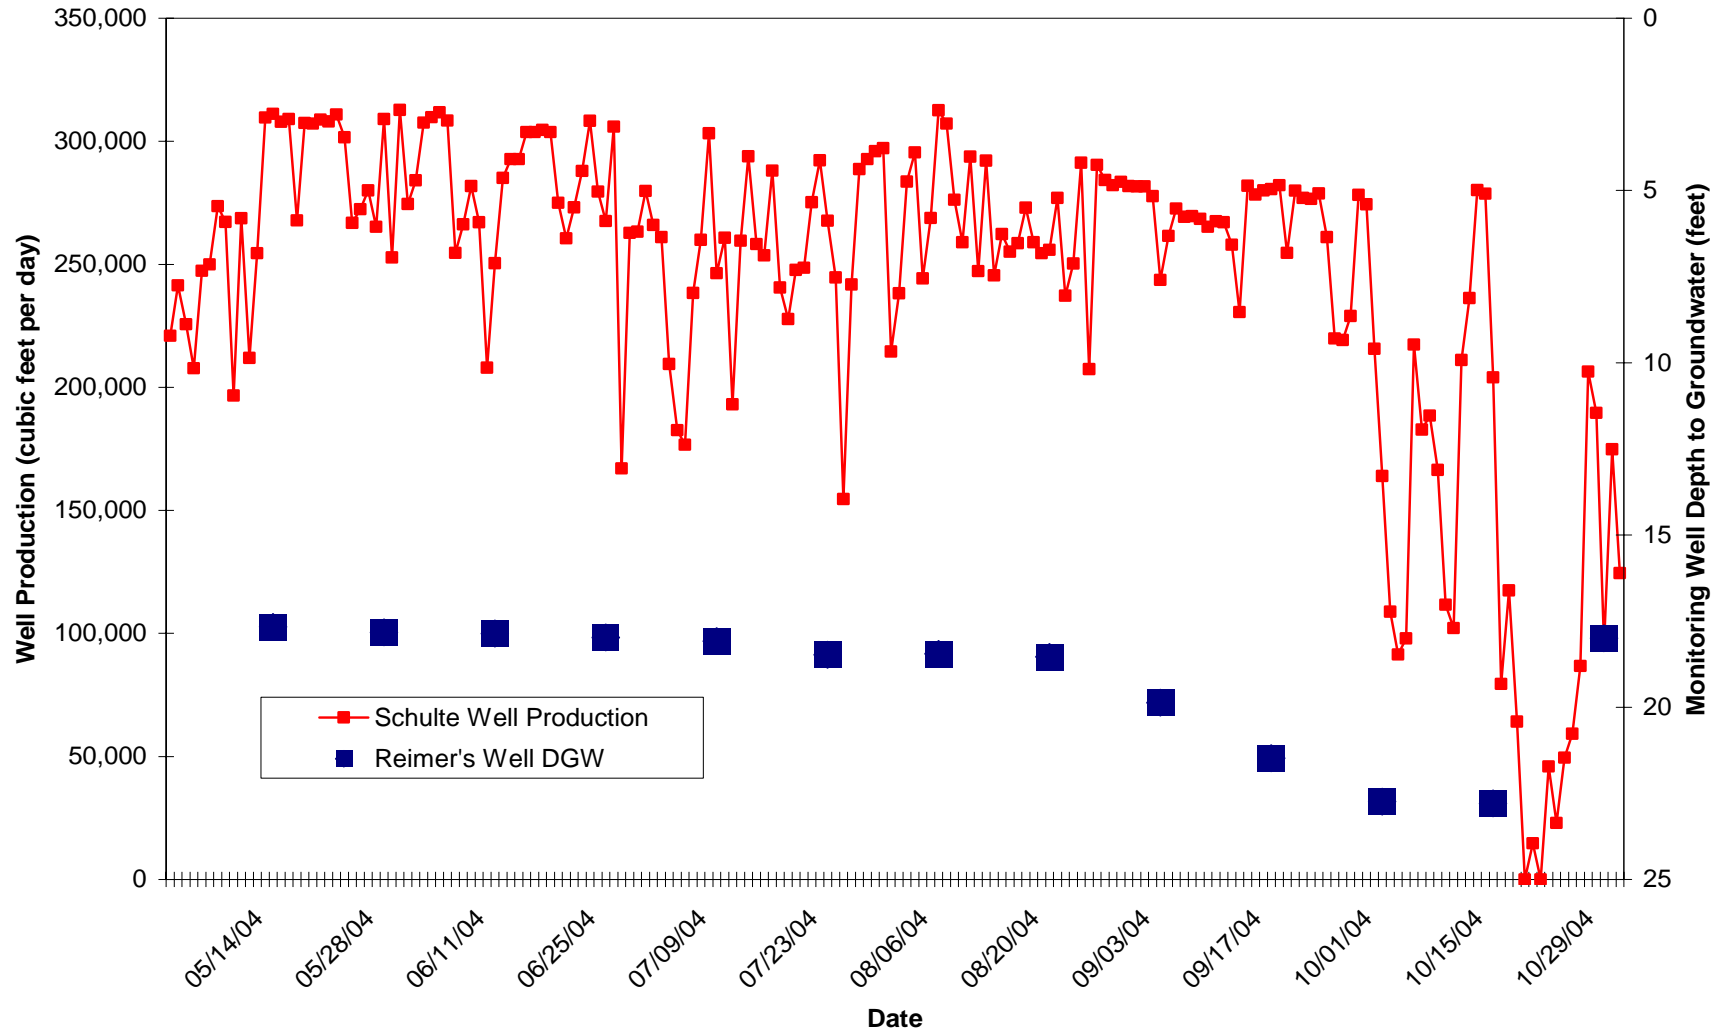
Figure 8. Schulte Well Production Correlated with Nearby Depth to Groundwater

A direct relationship between municipal pumping and depth to groundwater is illustrated in Figure 8; Shulte Well Production Vs. Depth to Groundwater at Reimer's well. Depth to groundwater dropped more than 4.5 feet after the river dried up through the Shulte area in July, due to pumping at Cal Am's Shulte production well. However, in October, production was, for some reason or another, halved then reduced to fractions of what it had been for the previous months. Without this extraction, the cone of depression quickly disappeared and by the end of the month, the water table rose to levels seen previous to the river drying.

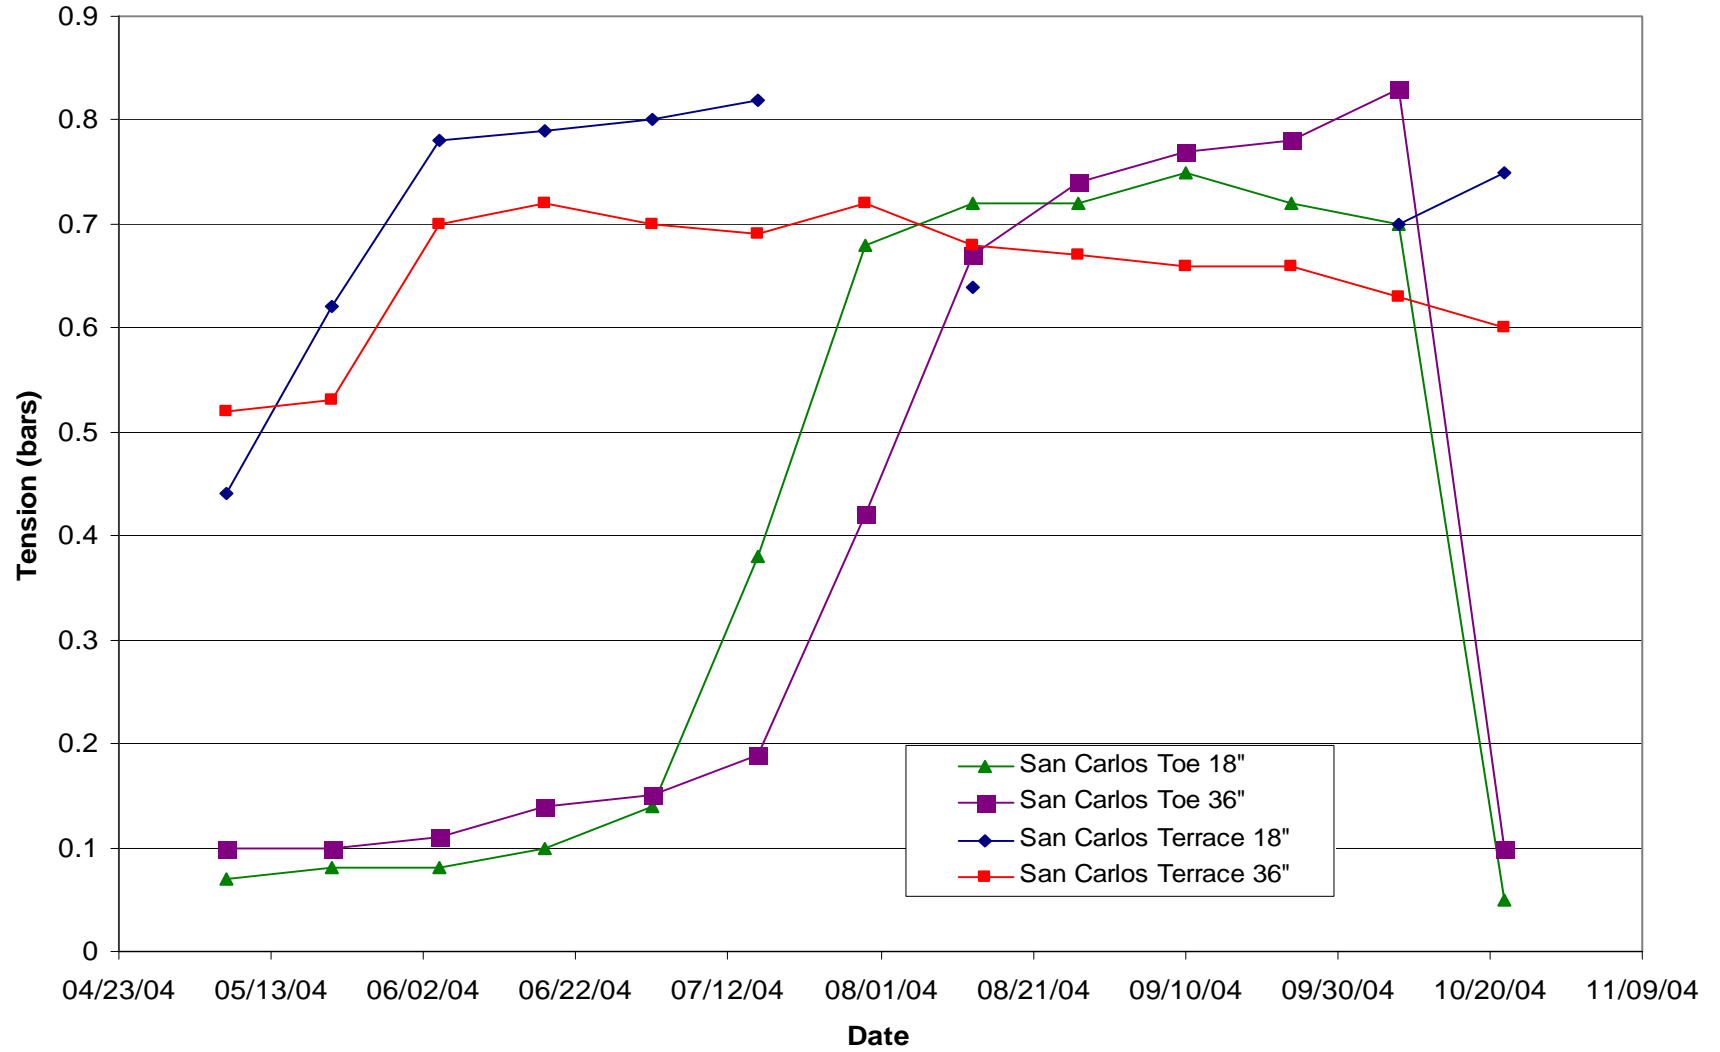
Figure 9. Soil tension at the San Carlos Site

Tensiometer values at San Carlos begin at approximately 0.08 bars (toe station, close to river channel) and 0.50 bars (terrace station) in early May and rose steeply to 0.75 bars by August (Figure 9. San Carlos Site Tensiometer Soil Dryness Values). Analyses of these graphs (Figures 9-11) are useful in determining the duration of specific moisture conditions. For example at the San Carlos site the tensiometer readings remained in a steady pattern for the terrace station while the toe station showed a rapid change in soil moisture which is related to the river channel drying up at the site. Station low is located near the river while station high is located up on the terraces. This explains the large variations between the two stations from the start. In comparison, soil moisture at the Valley Hills site demonstrated the same pattern. Each station shows a general pattern (Figure 10. Soil Tension at the Valley Hills Site).

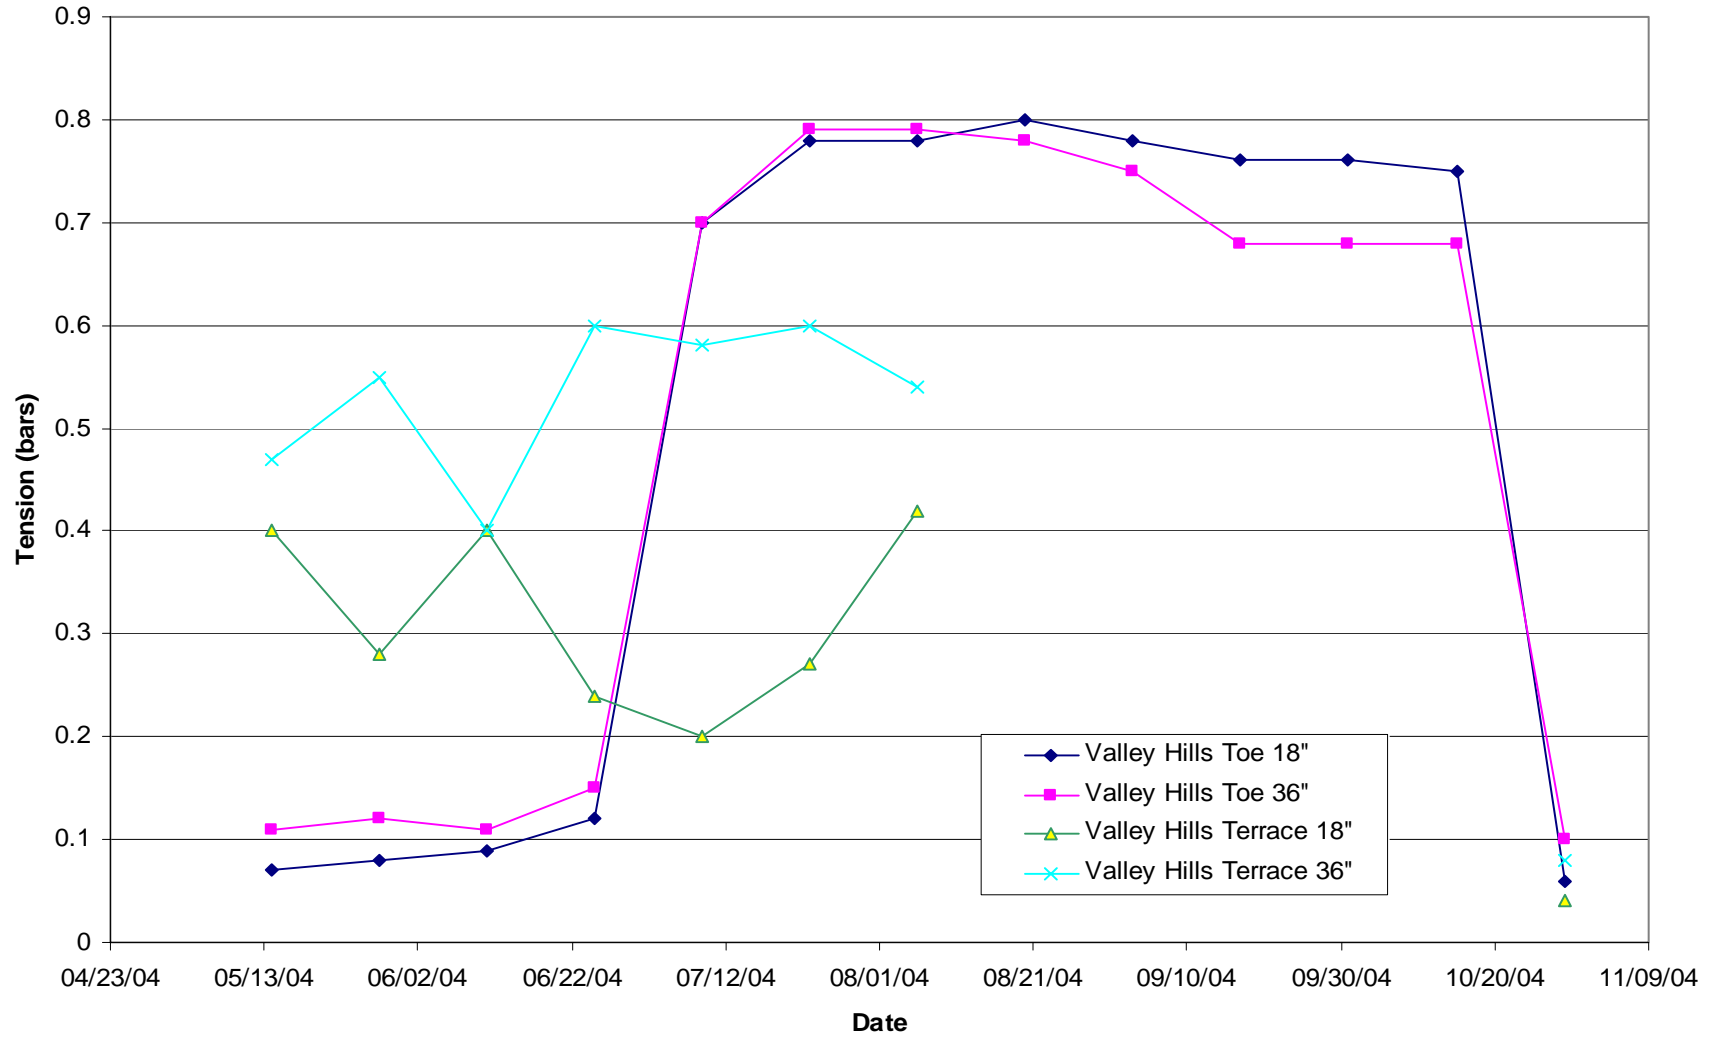
Figure 10. Soil tension at the Valley Hills Site

The relationship between river flow and soil moisture is demonstrated in Figure 10. Soil tension remained low (soil was moist) throughout May and early June when there was river flow and a healthy water table associated with that flow. In late June, heavy groundwater pumping by Cal Am drew down the water table in the area, river flow subsequently ceased, and the soil dried out (see Figure 7). Soil tension at the toe tensiometer stations (near the river) rose abruptly from  $\approx 0.10$  bars to  $\approx 0.80$  bars- the wilting point for most plants. Dryness values remained high until late October when it finally rained.

Values for terrace tensiometers at the Valley Hills Monitoring site (Figure 10) do not reflect the actual dryness experienced by nearby monitoring trees. These tensiometers would not hold a vacuum at all from mid-August until the late October rains. This could be attributed to extreme tension of which would be powerful enough to break seals on the tensiometers, air spaces around the shaft of the tensiometer, or that conditions were drier than these tensiometers are designed to operate in. Tensiometers can also fail when all of the liquid is completely sucked out of the vacuum shaft and it can no longer hold a vacuum. Tensiometer failures can be seen in discontinuous data in the plots of Figures 9 & 11 as well. These failures all have been on terrace tensiometers where the soil is drier.

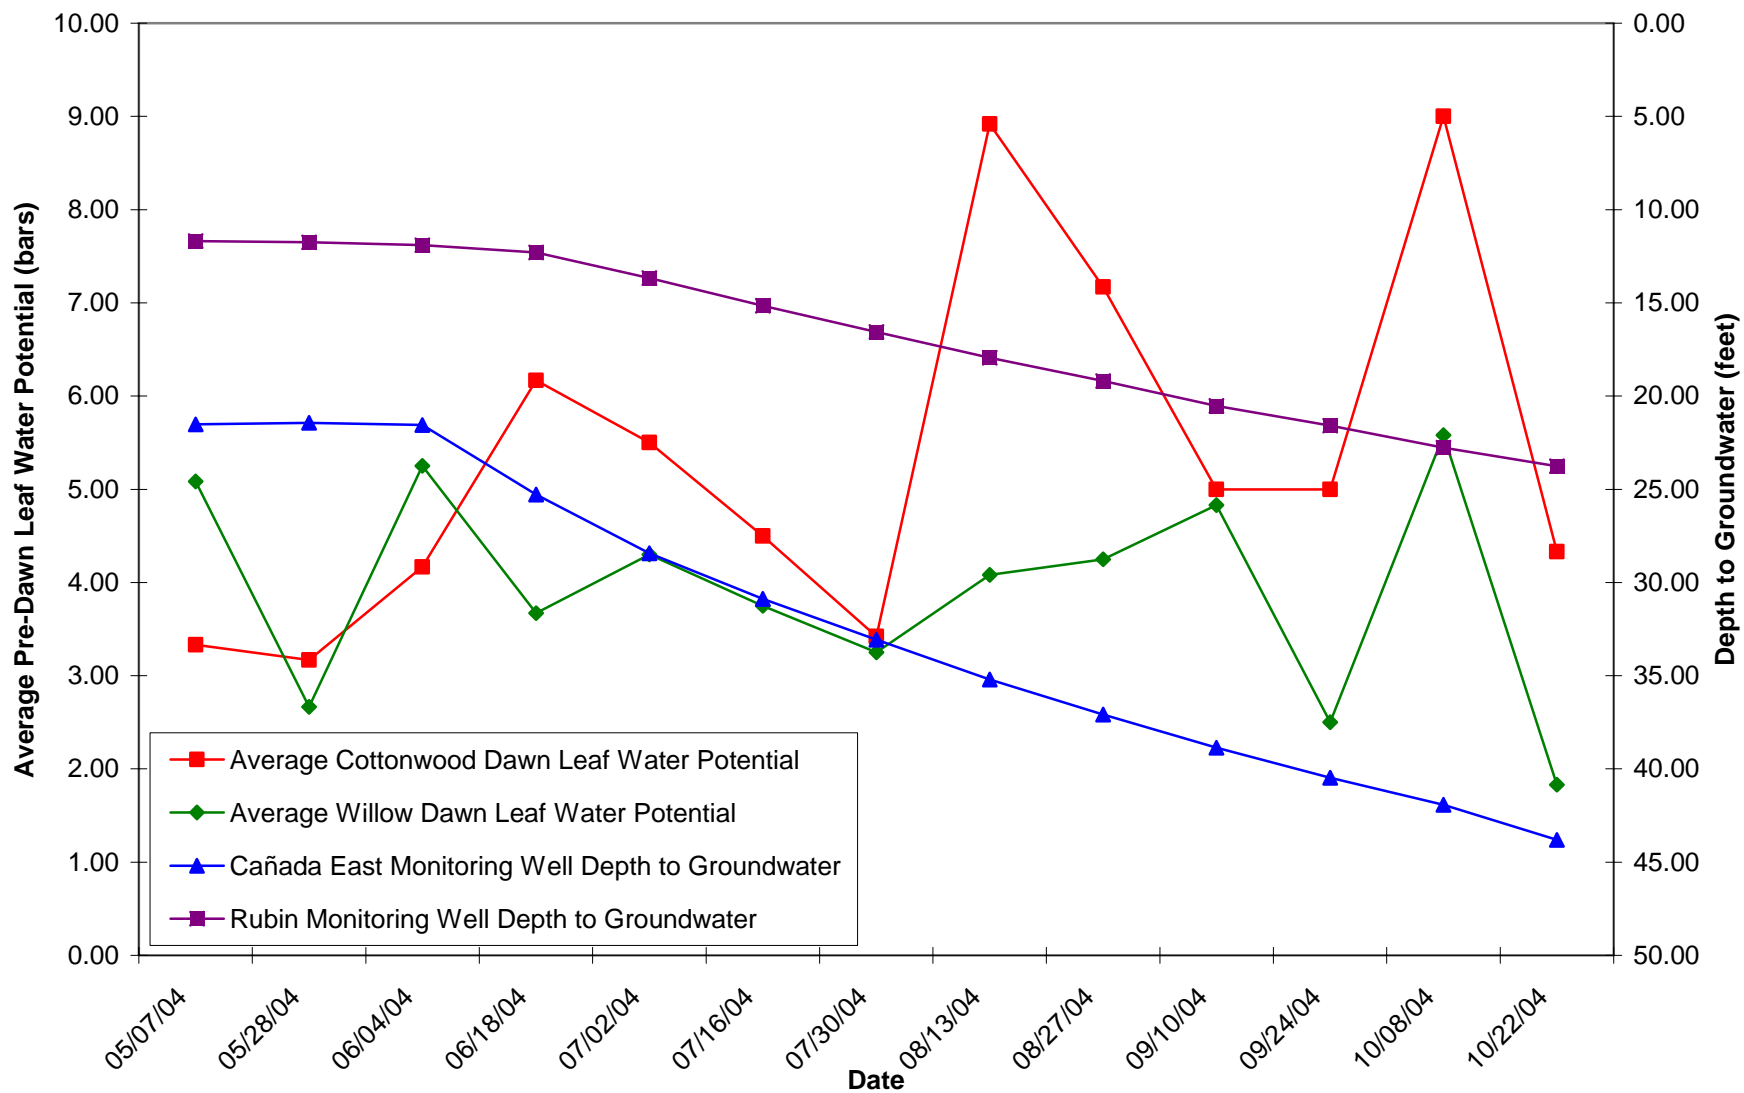
Figure 12. Plant Stress Correlated with Groundwater Availability at the Rancho Cañada Site

Similar patterns are shown in Figures 12 and 14, pre-dawn leaf water potential rises sharply as the depth to groundwater falls subsequent to the river drying. Note that the river dries from downstream to upstream as the groundwater, which provides the support for the surface flow, is diverted by production wells. In

order from lowest to highest the river dries (and groundwater falls) first at the Cañada site, then at San Carlos, Valley Hills and finally Schulte. This pattern is reflected in Figures 12 through 14 as average pre-dawn leaf water potential rises and depth to groundwater drops.

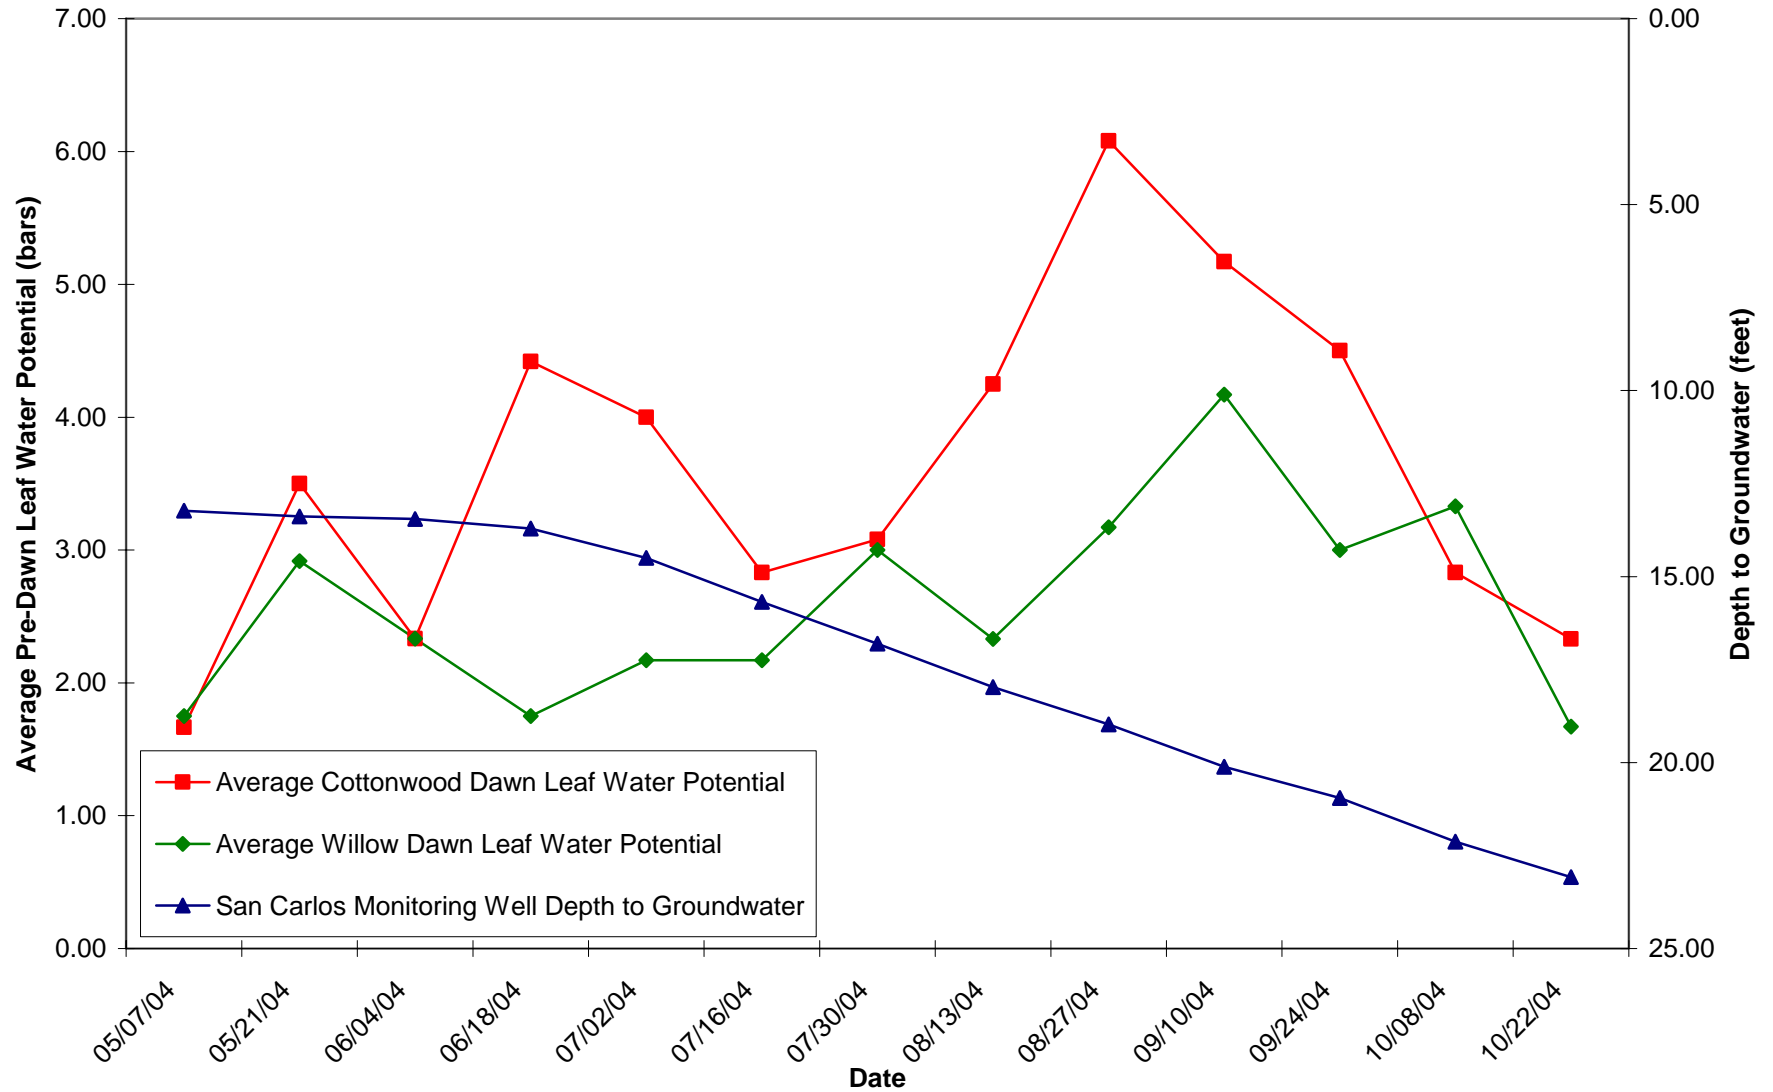
Figure 13. Plant Stress Correlated with Groundwater Availability at the San Carlos Site

The San Carlos graph illustrates that average pre-dawn leaf water potential values rise as depth to groundwater values fell (Figure 13). By July, river flow ceased within the San Carlos reach, which led to an overall rise in pre-dawn leaf water potential values (bars) starting from mid-July and continuing through October, when the first storm systems returned ample water to the trees monitored.
