**RIPARIAN CORRIDOR MONITORING REPORT  
CARMEL RIVER  
2004**

Paul Watters, Thomas Christensen & Jessica Wheeler  
Monterey Peninsula Water Management District  
5 Harris Court, Building G  
Monterey, CA 93940

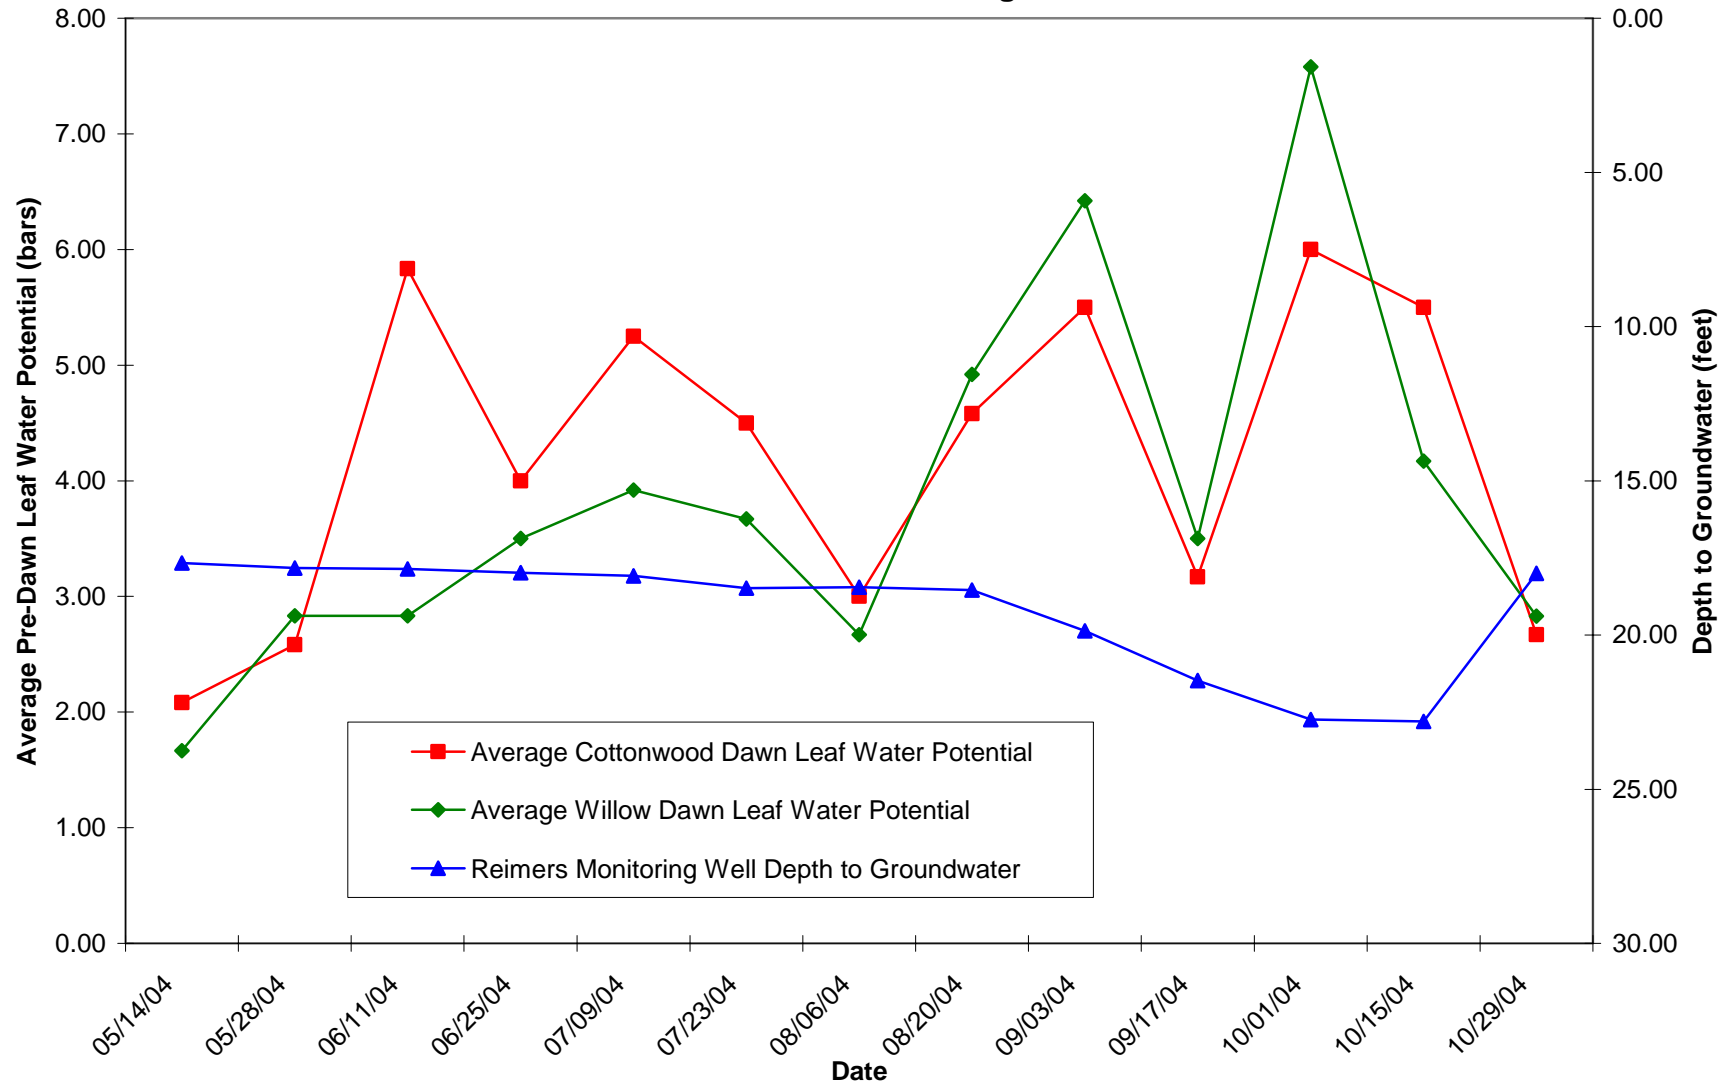
Figure 14. Plant Stress Correlated with Groundwater Availability at the Schulte Site

Similar patterns are shown in Figures 12 and 14, pre-dawn leaf water potential rises sharply as the depth to groundwater falls subsequent to the river drying. Note that the river dries from downstream to upstream as the groundwater, which provides the support for the surface flow, is diverted by production wells. In

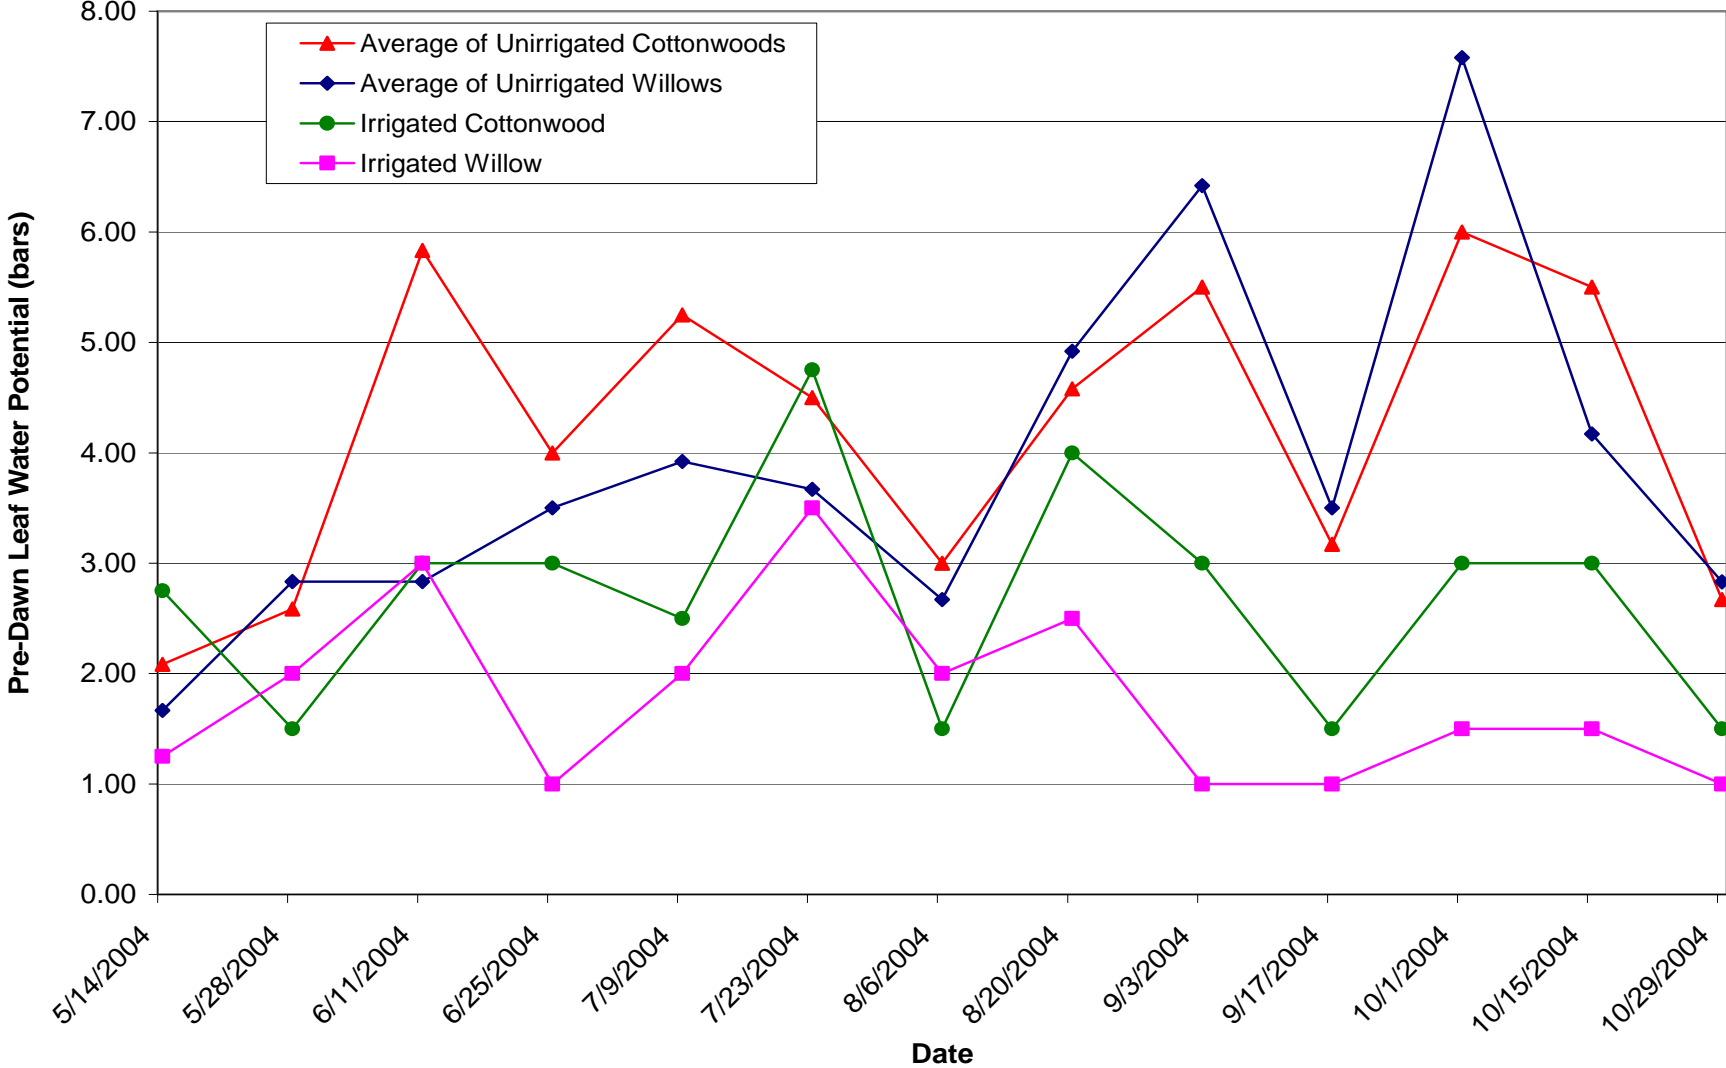
Figure 15. Effects of Irrigation on Monitored Trees at the Schulte Monitoring Site

As shown in Figures 15 & 16, trees irrigated weekly ('control' trees) show less stress than unirrigated trees. At the Schulte site average irrigated cottonwood stress was 2.69 bars versus 4.21 bars for the average unirrigated cottonwood; this shows 36% less plant moisture stress.

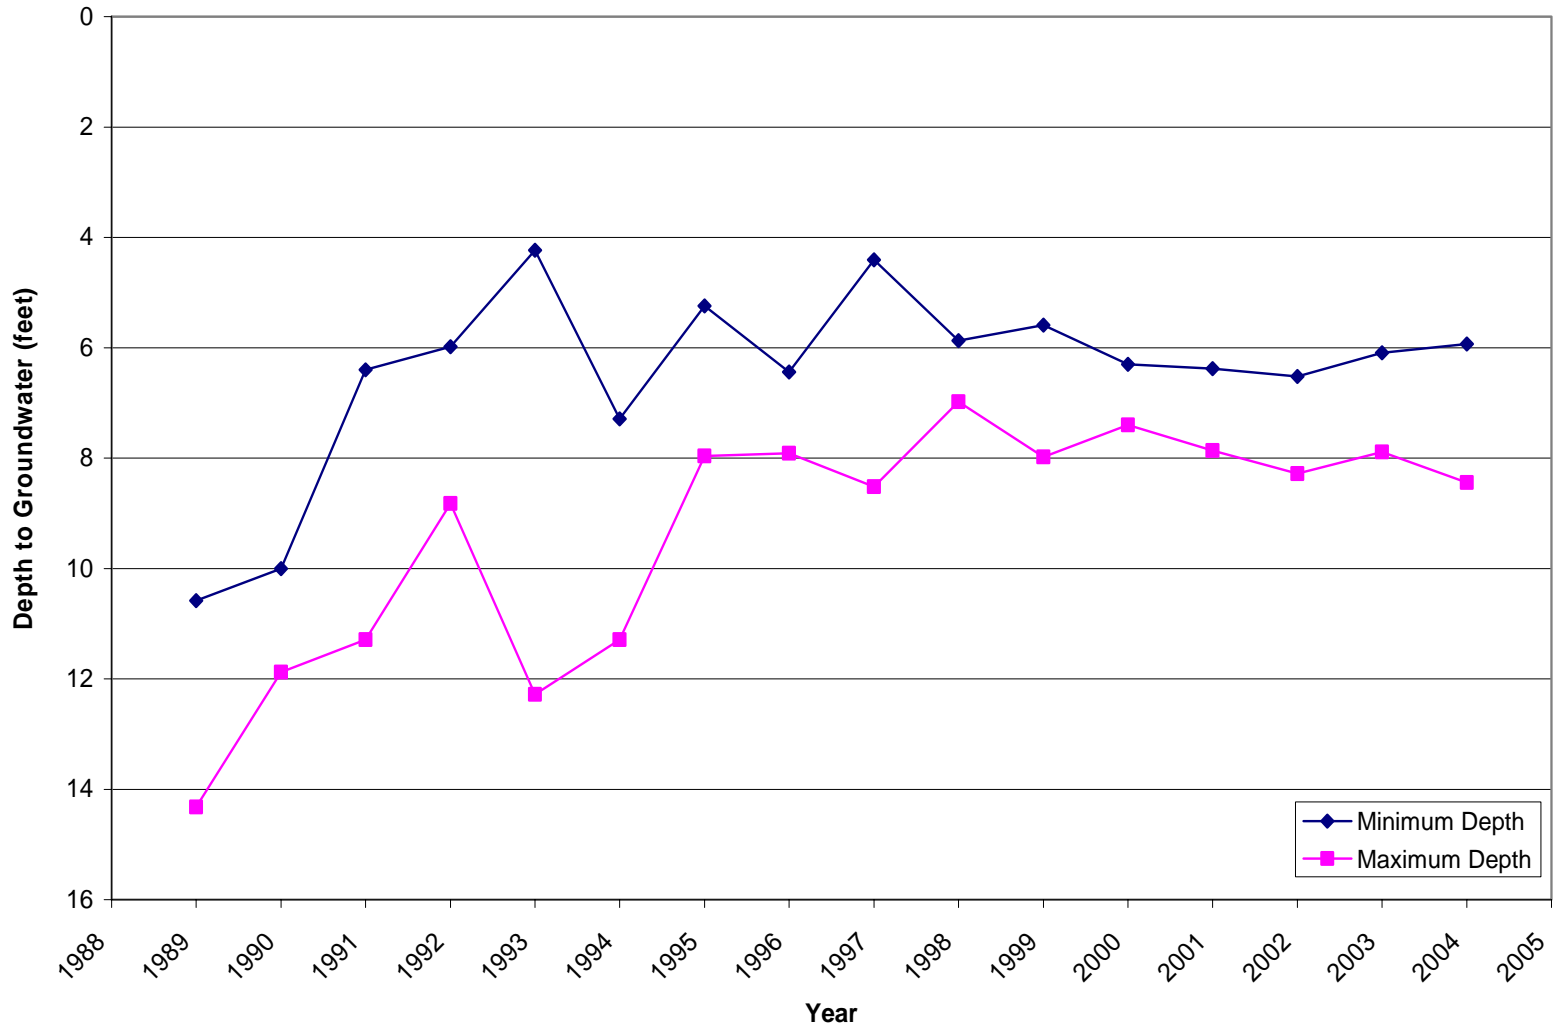
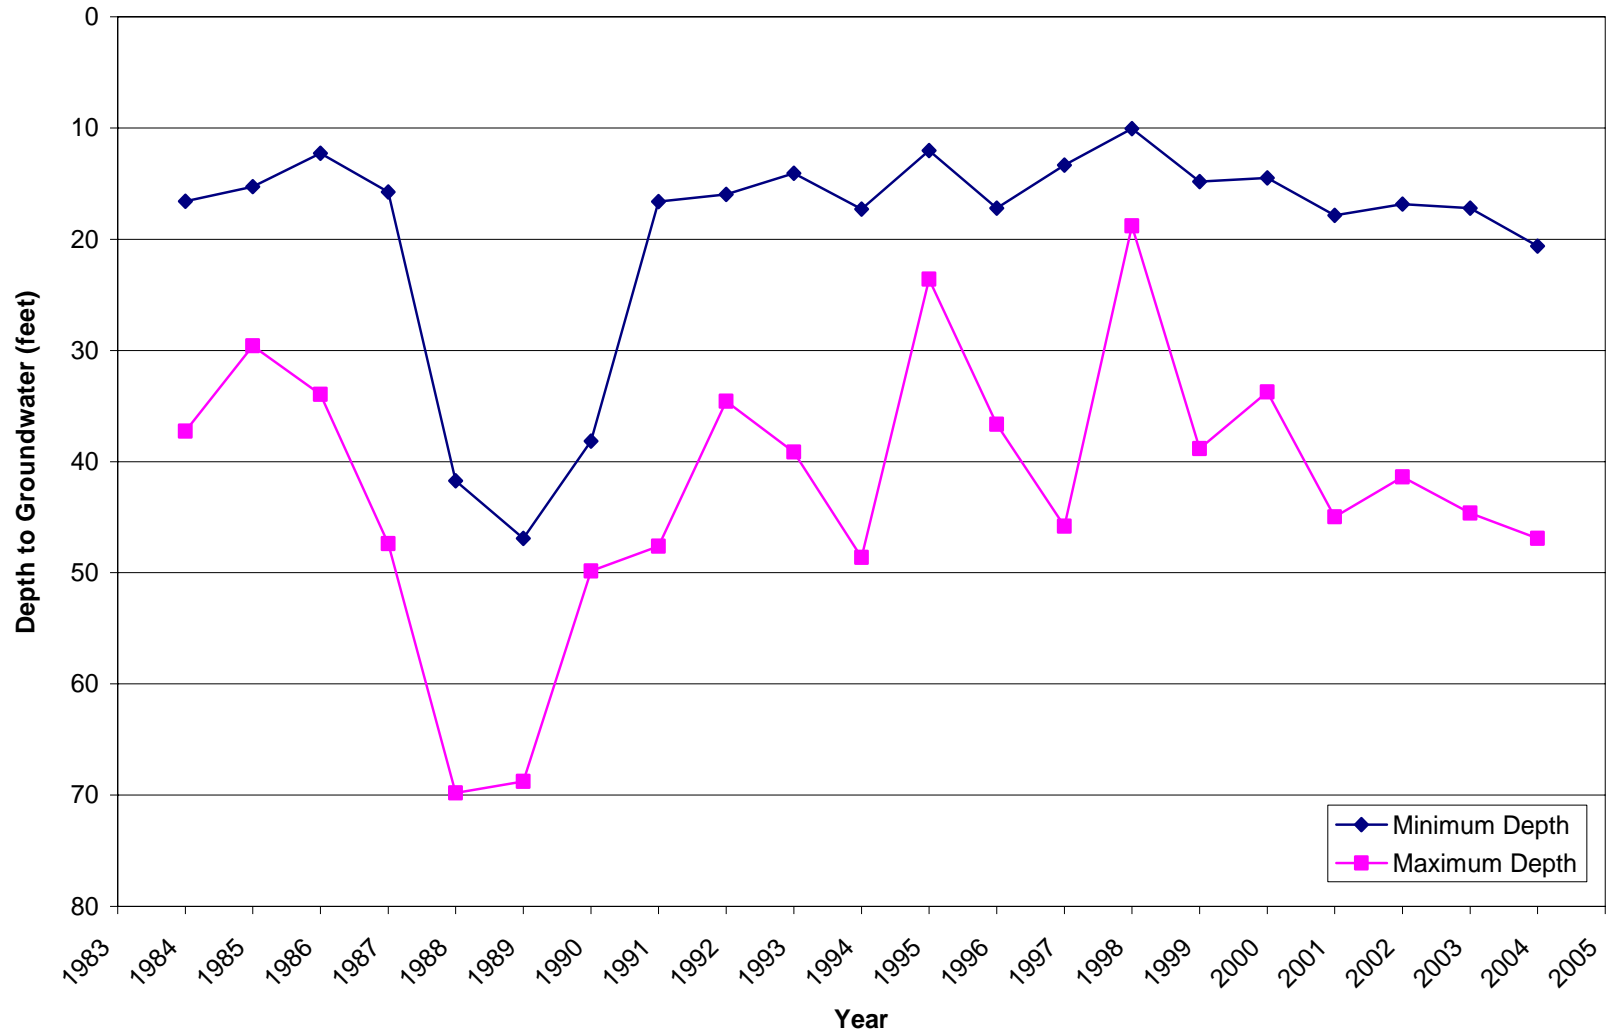
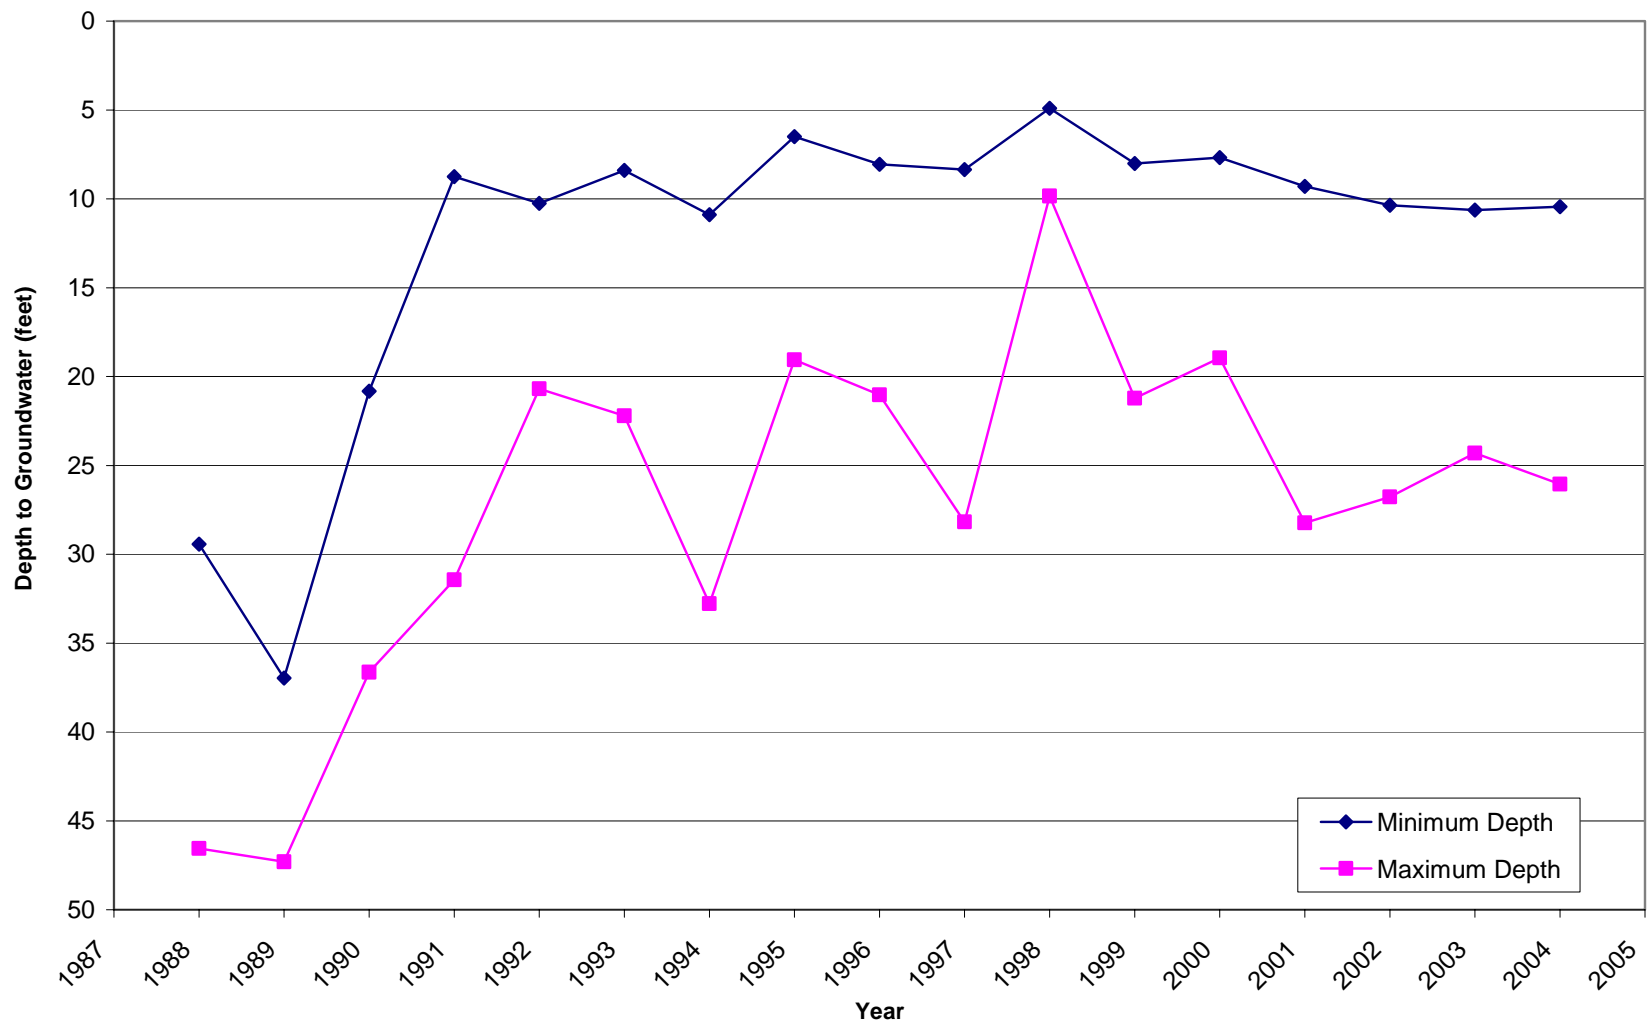
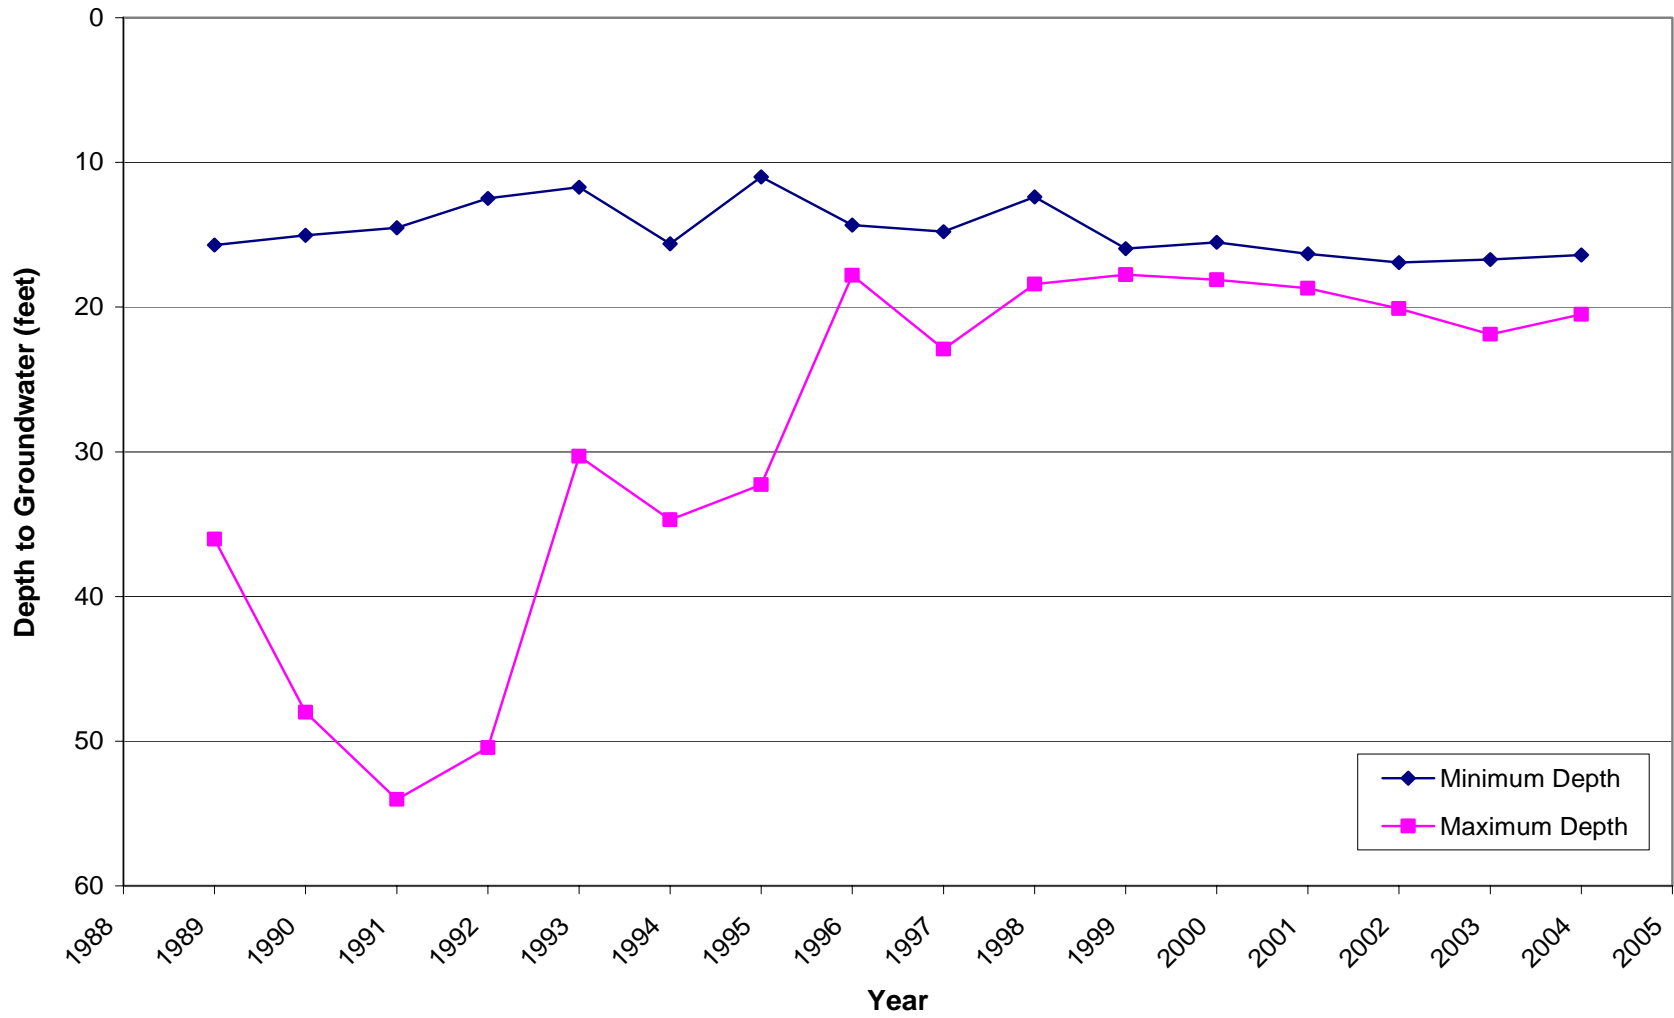
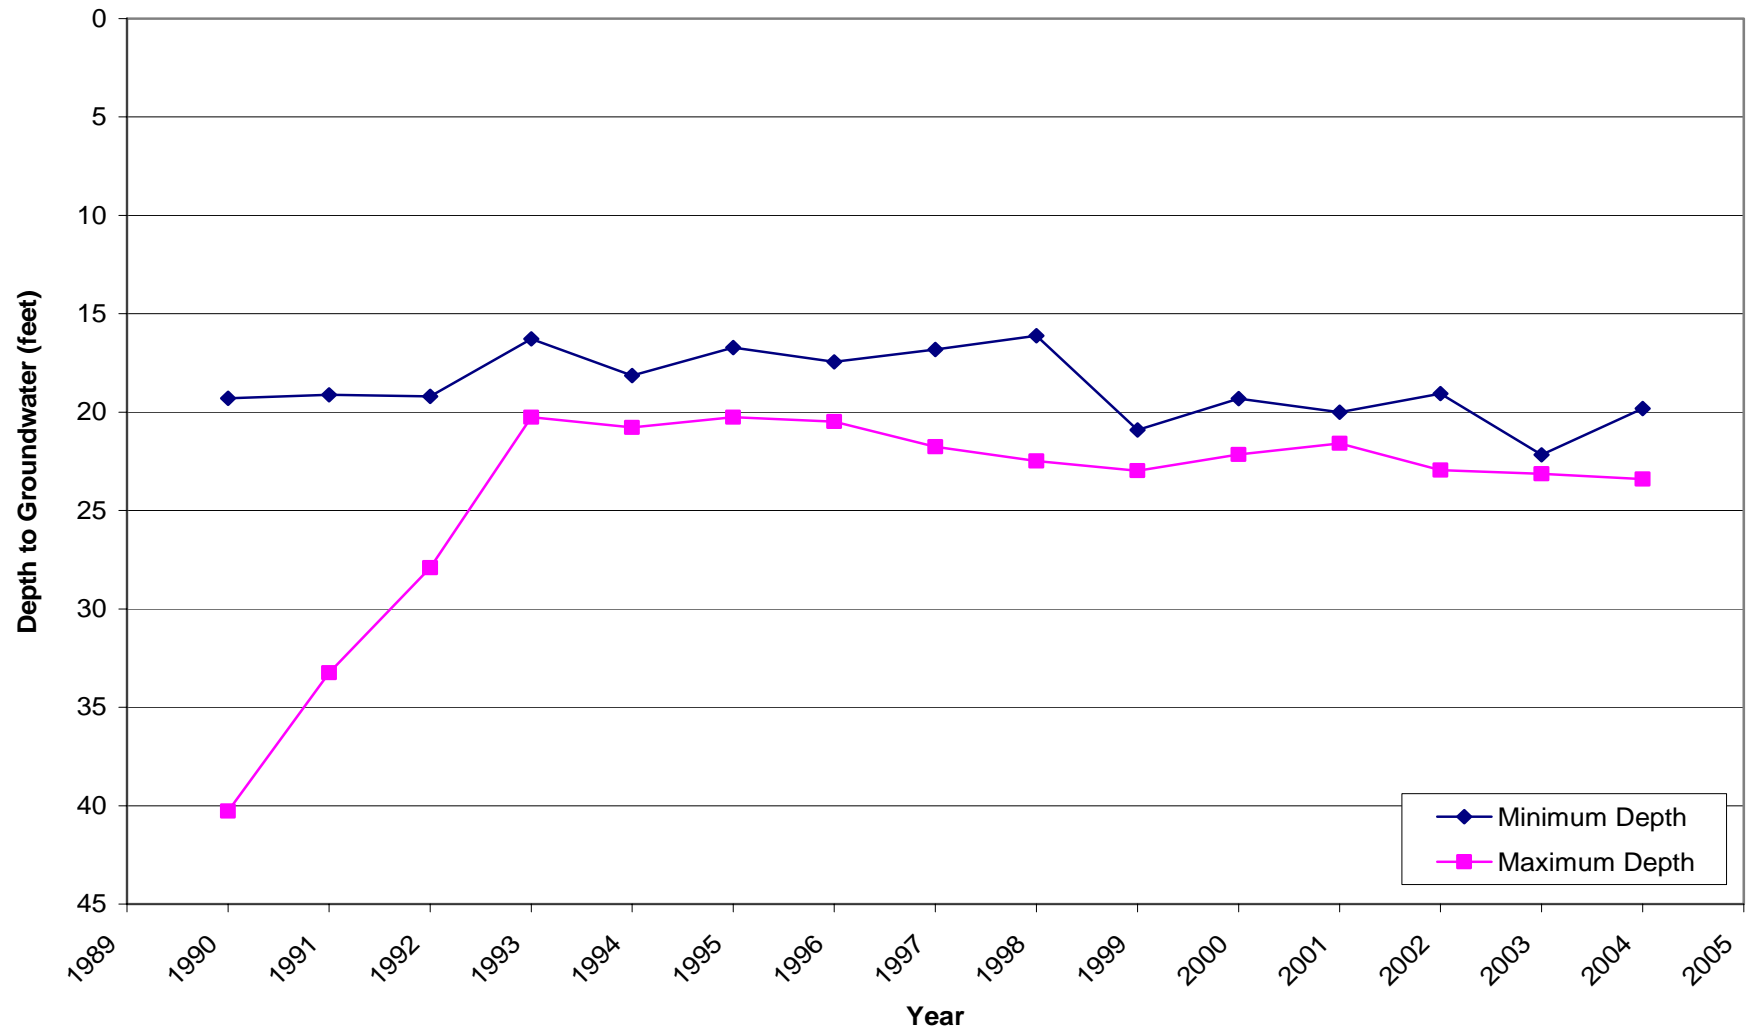
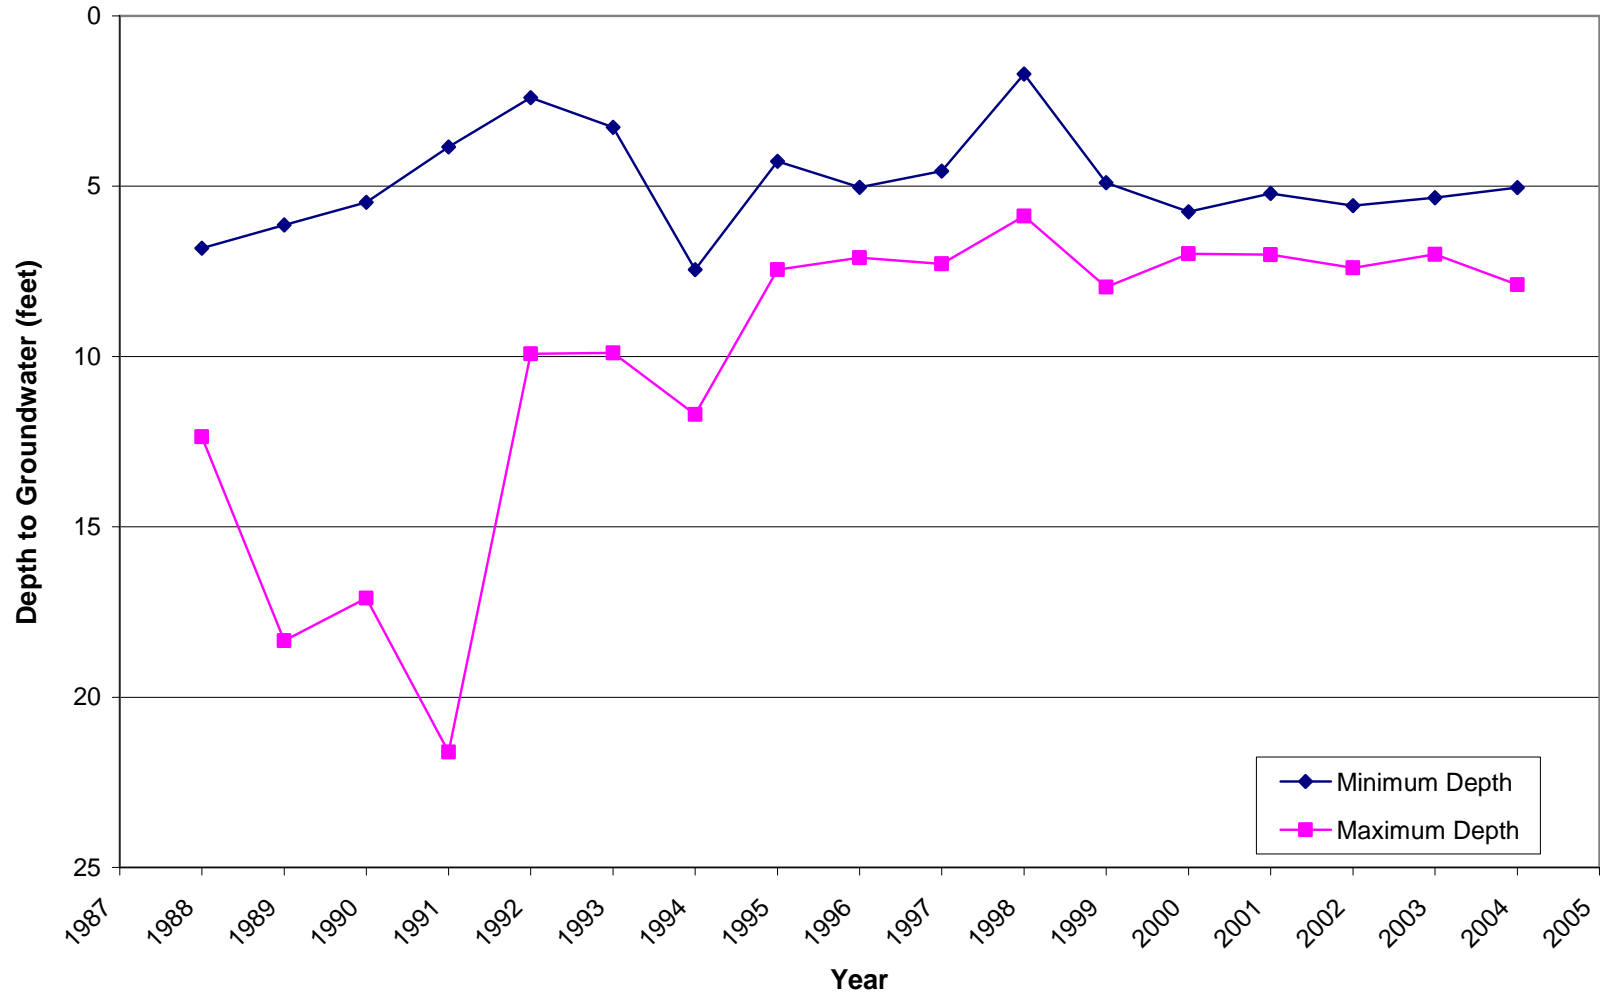
**APPENDIX A: Historical Depth to Groundwater for Selected Monitoring Wells**

Historic depth to groundwater values from 1988 through 2004 were plotted for six monitoring well sites; de Dampierre, Coyote, Reimers, San Carlos, Rubin, and Highway 1. These plots provide baseline data for each monitoring site, indicating minimum and maximum groundwater depths from 1988 through 2004 (See Appendix A for historic depth to groundwater plots). The annual variation in depth to groundwater is mostly a function of annual precipitation, stream flow, and municipal pumping regimes. Extreme groundwater levels that are observed to exceed historic maximum depth can justify the application of irrigation to mitigate stress on riparian vegetation.
