## Action Item 14

Consider Approval of Expenditures for Repair of Flood Damage at the Sleepy Hollow Steelhead Rearing Facility and Carmel River Resistance Board Weir, Authorize Withdrawals from the Flood/Drought Reserve, and Direct General Manager to Explore Reimbursement from FEMA, CAL Office of Emergency Services, or other sources, *if* available

# Update on Damage to the Carmel River Resistance Board Weir (steelhead counting station)

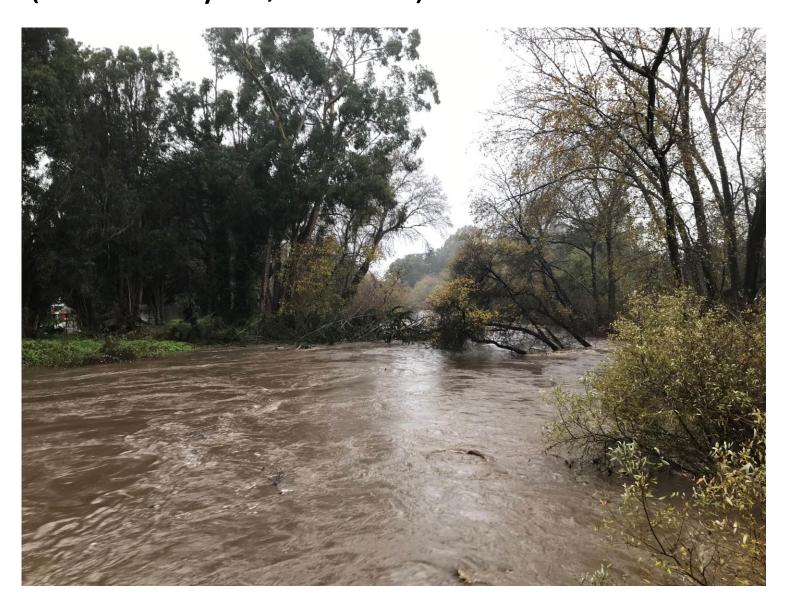
The weir under about eight feet of swift water (January 9, 2023)

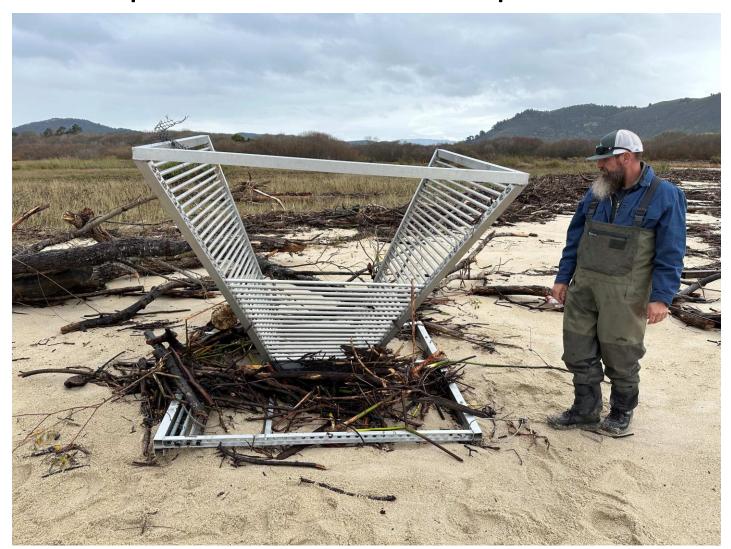
# High flows and debris damaged the panels and broke apart the box trap

- The river is still too high to make a complete assessment, but we think this is
- \$15,000 box trap
- \$2,000 bulkhead panel
- \$5,000 additional mid-panels (4 panels at \$1,250 per panel)
- \$800 for delivery
- \$5,000 Possible assistance from FishBio to help rebuild or the secure rail cable
- \$27,800 Estimated Total
