MONTEREY PENINSULA WATER MANAGEMENT DISTRICT

TECHNICAL MEMORANDUM 88-03

EVALUATION OF RESERVOIR SEDIMENTATION RATES
IN THE UPPER CARMEL RIVER WATERSHED

FEBRUARY 1989

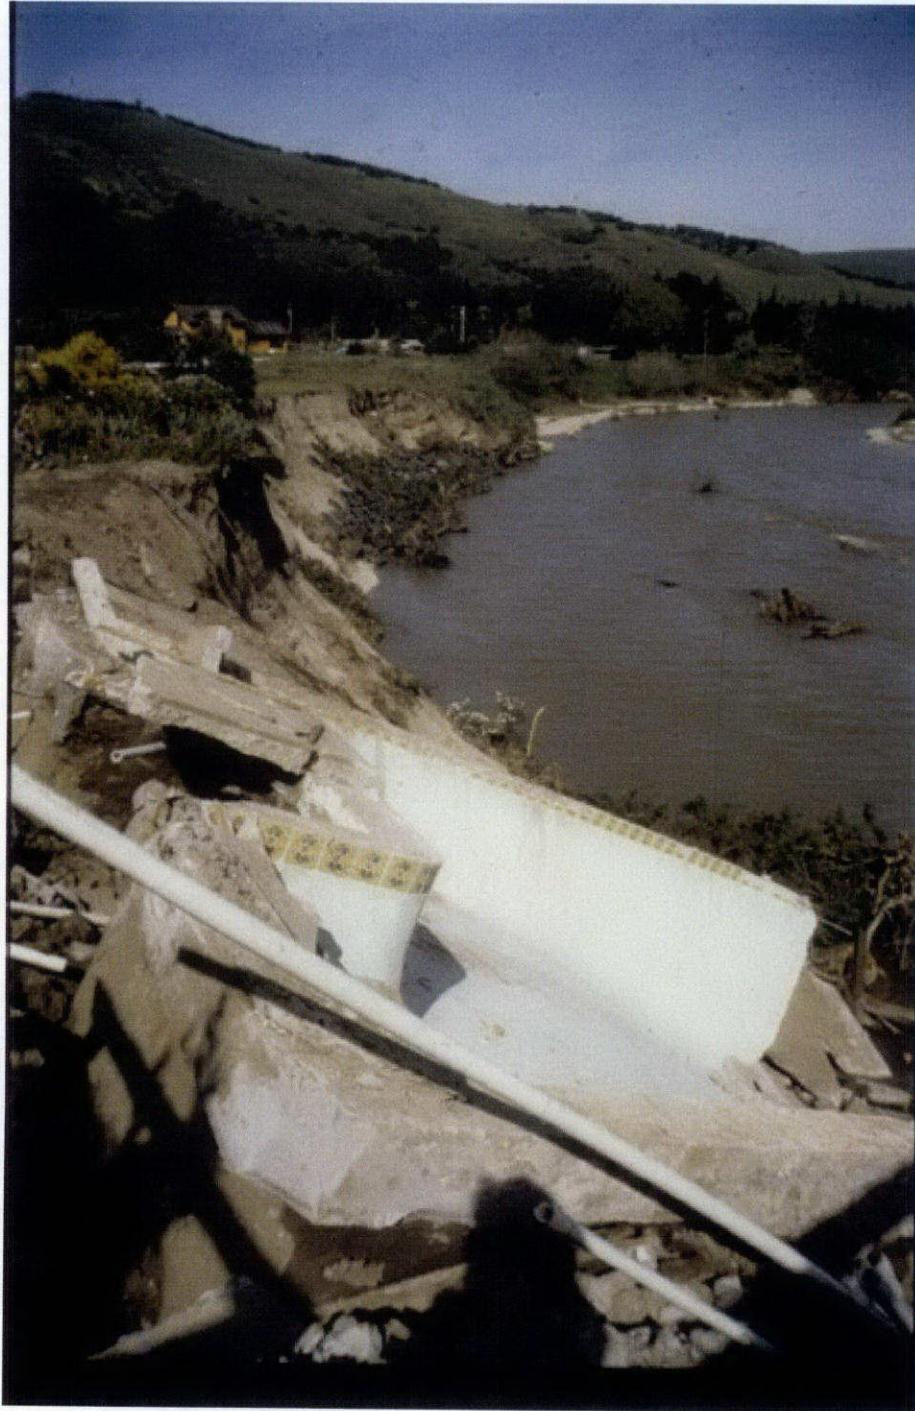
Figure 2 – Drummond Property

Above – ca spring 1982 – looking upstream along the Carmel River, near River Mile 6 at the remains of a back yard pool that was undermined. Note the use of car tires for streambanks protection (middle background).

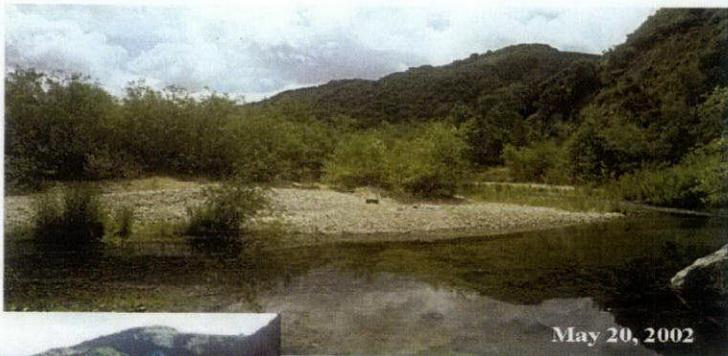
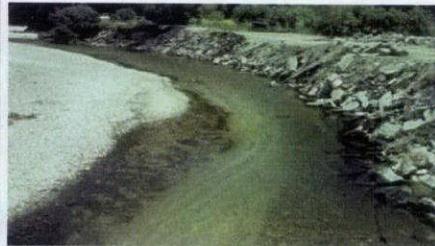
Figure 4 – Schulte Restoration Project

Looking
upstream from
Schulte Road
Bridge at RM 6.7

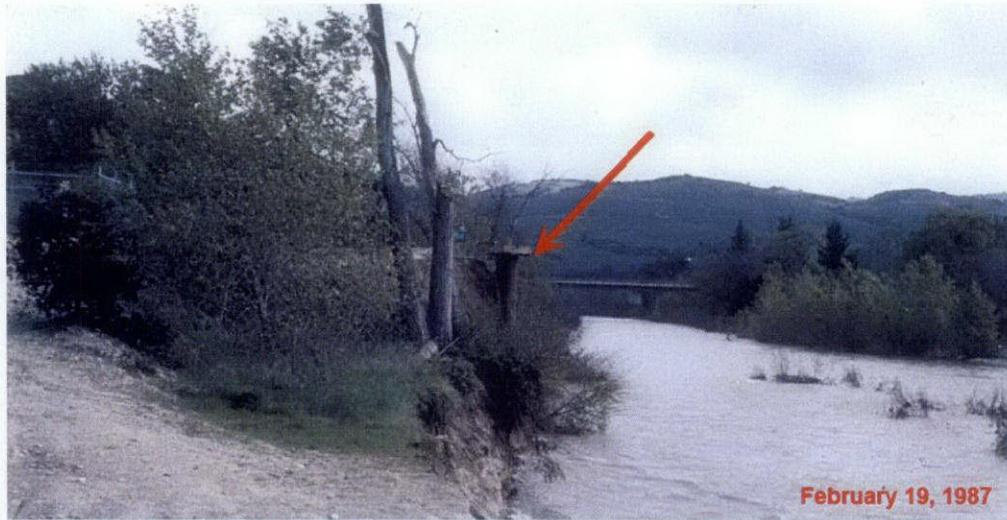
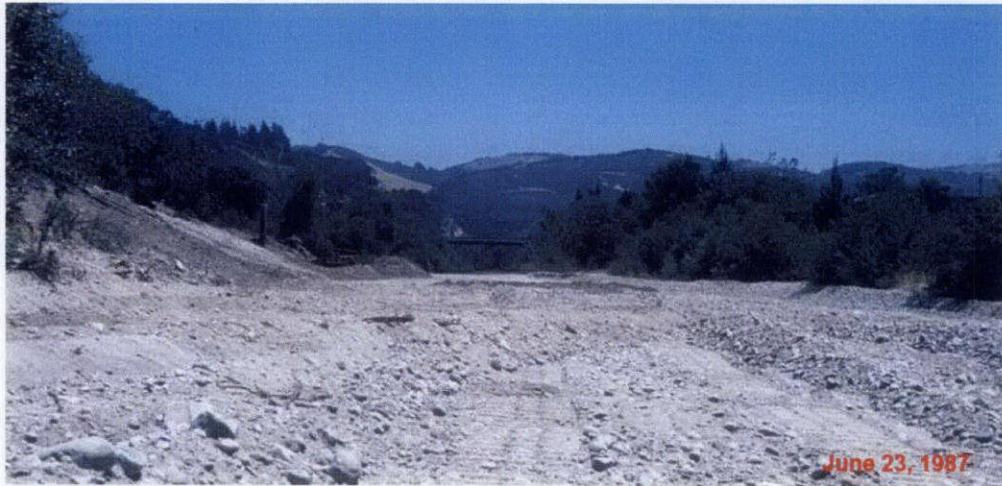
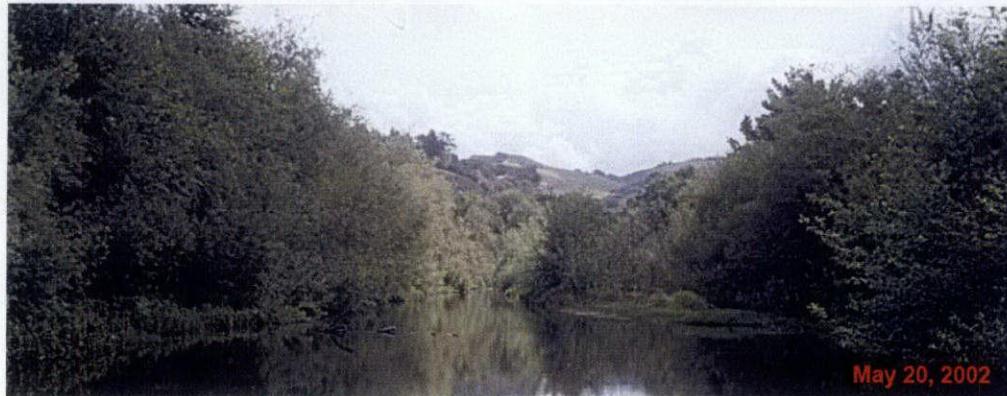
Figure 6 - Berwick Restoration Project at RM 8.2

24 Top – Looking upstream to one of Cal-Am’s Berwick wells (shown with arrow) with Robinson
25 Canyon Road bridge in the background. Middle – after stream restoration work was completed.
26 Bottom – 15 years after restoration work was completed.

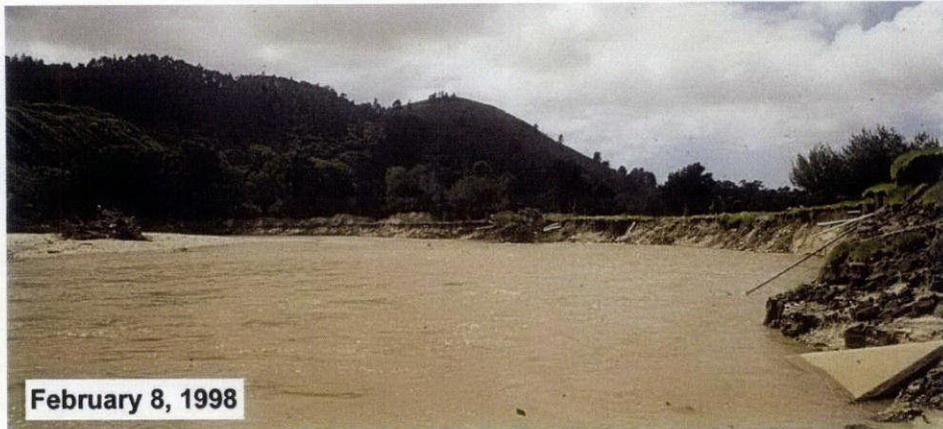
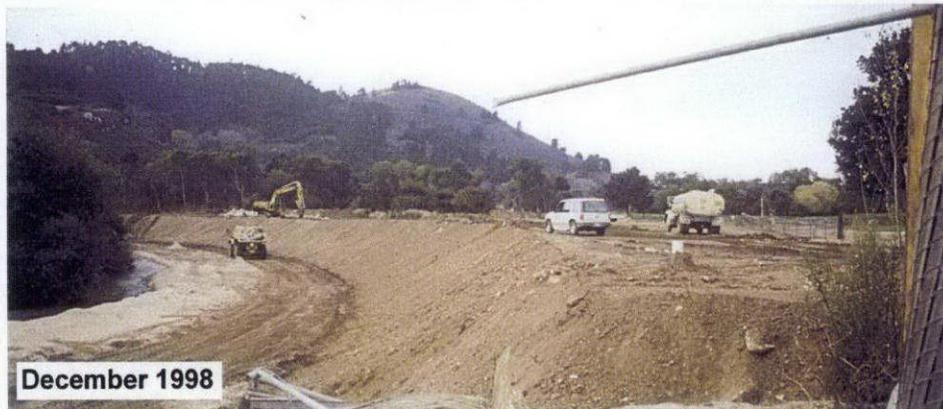
Figure 7 – Rancho Cañada

Top – Carmel River, looking downstream at RM 3, adjacent to Cal-Am Cañada well. Middle – during stream restoration work. Bottom – five years after completion of restoration work. Note stained boulders just above the bottom of the channel at the right of picture. This is from well blow-off water that contains iron-loving bacteria.

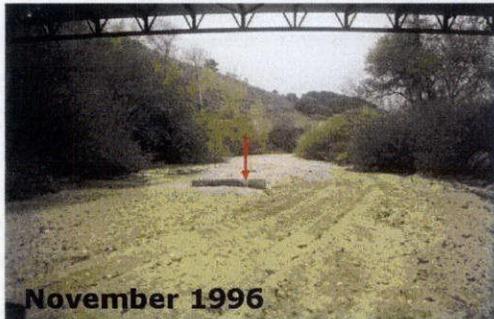
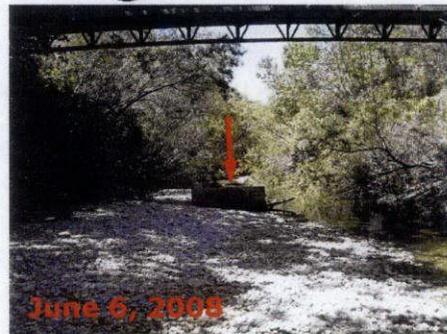
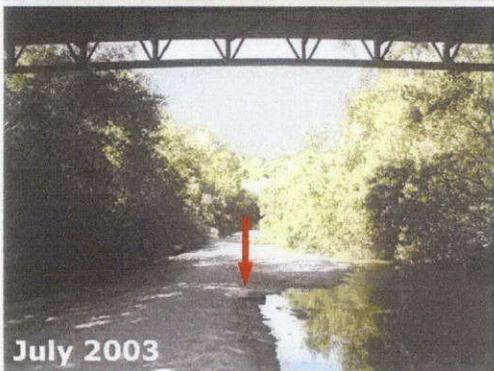
Rancho Cañada Bridge No. 5

Figure 11 – Channel Degradation (1 of 4)

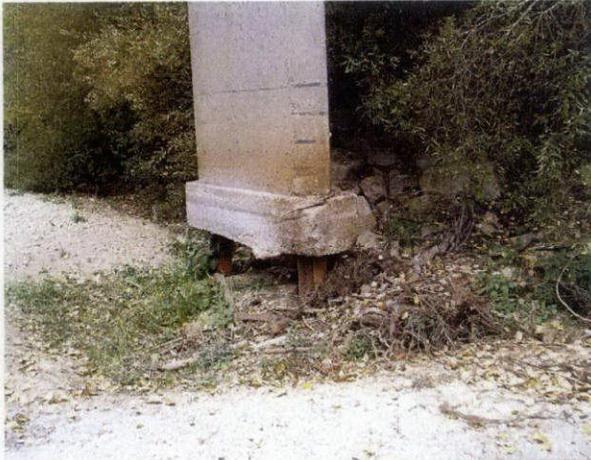
Rancho Cañada Bridge No. 2

Figure 11 – Channel Degradation (2 of 4)

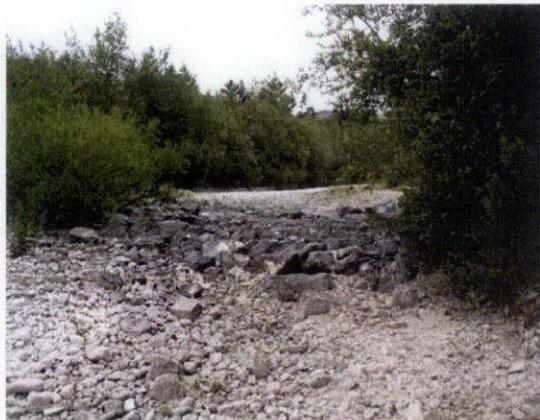
Valley Hills Grade Control

Figure 11 – Channel Degradation (3 of 4)

Looking upstream
Left – July 2004
Bottom – September 2007
