**Monterey
Peninsula
Water
Management
District**

The Monterey Peninsula Water Management District in cooperation with the University of California at Santa Cruz, Big Creek Lumber Company, the California Department of Fish and Game, and the Monterey Peninsula Regional Parks District installed five large wood habitat structures along 400 lineal feet of the Carmel River.

Installation of Large Wood Habitat Structures at the deDampierre Restoration Project

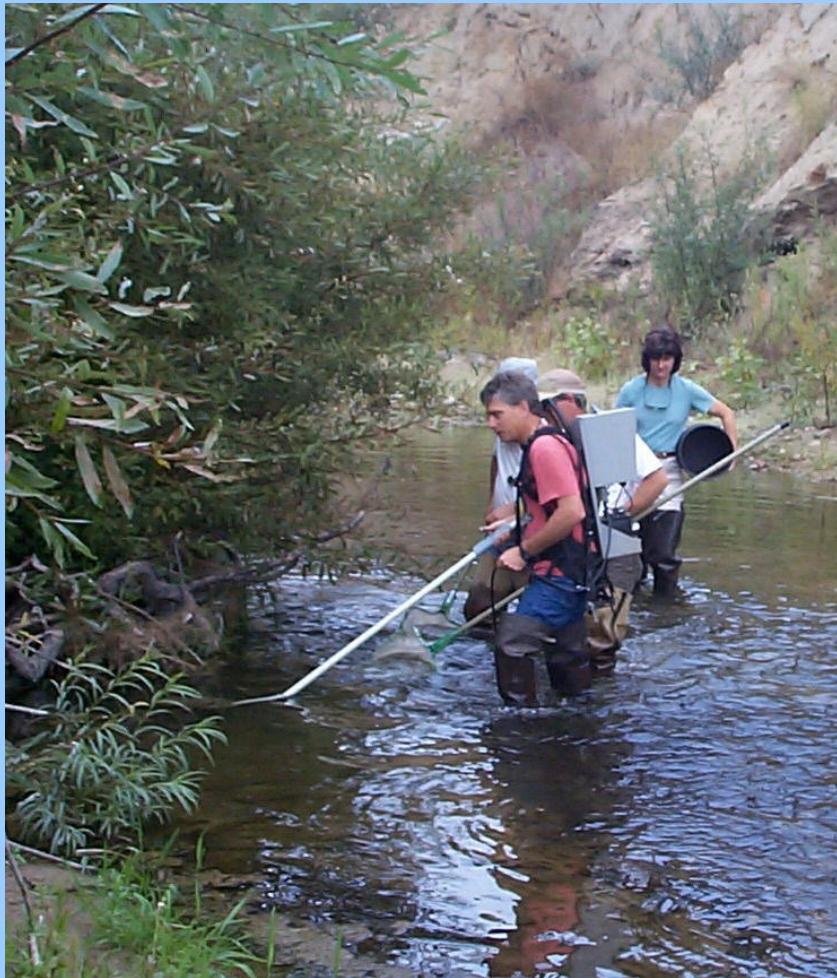
Using state of the art electro fishing equipment, an MPWMD crew (shown above) made four passes through the site prior to the beginning of construction. A total of 160 steelhead were captured and relocated.

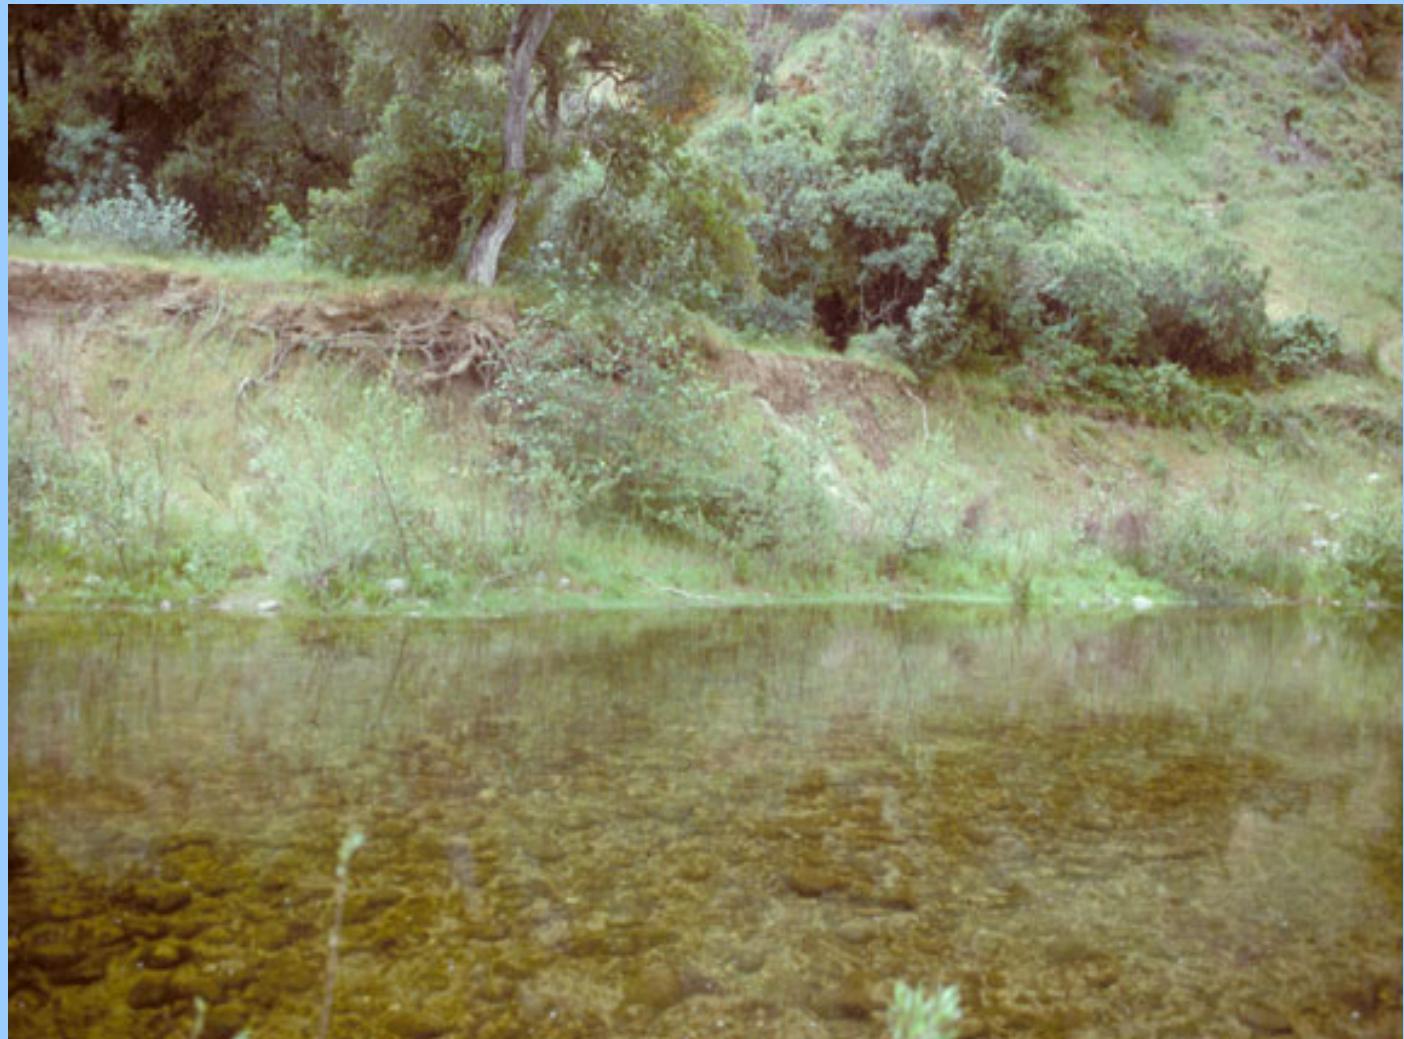
PROJECT SITE - MAY 2002

This reach of the river underwent significant bank erosion during 1995 and 1998 after winter peak flows of 16,000 cubic feet per second (cfs) and 14,500 cfs, respectively. The stream migrated laterally up to 200 feet during this period, resulting in the loss of streamside vegetation and several acres of adjacent mature riparian forest and oak-covered landslide and terrace deposits. The 700-foot long pool that remained was homogenous, covered with large cobbles, and nearly devoid of streamside cover.

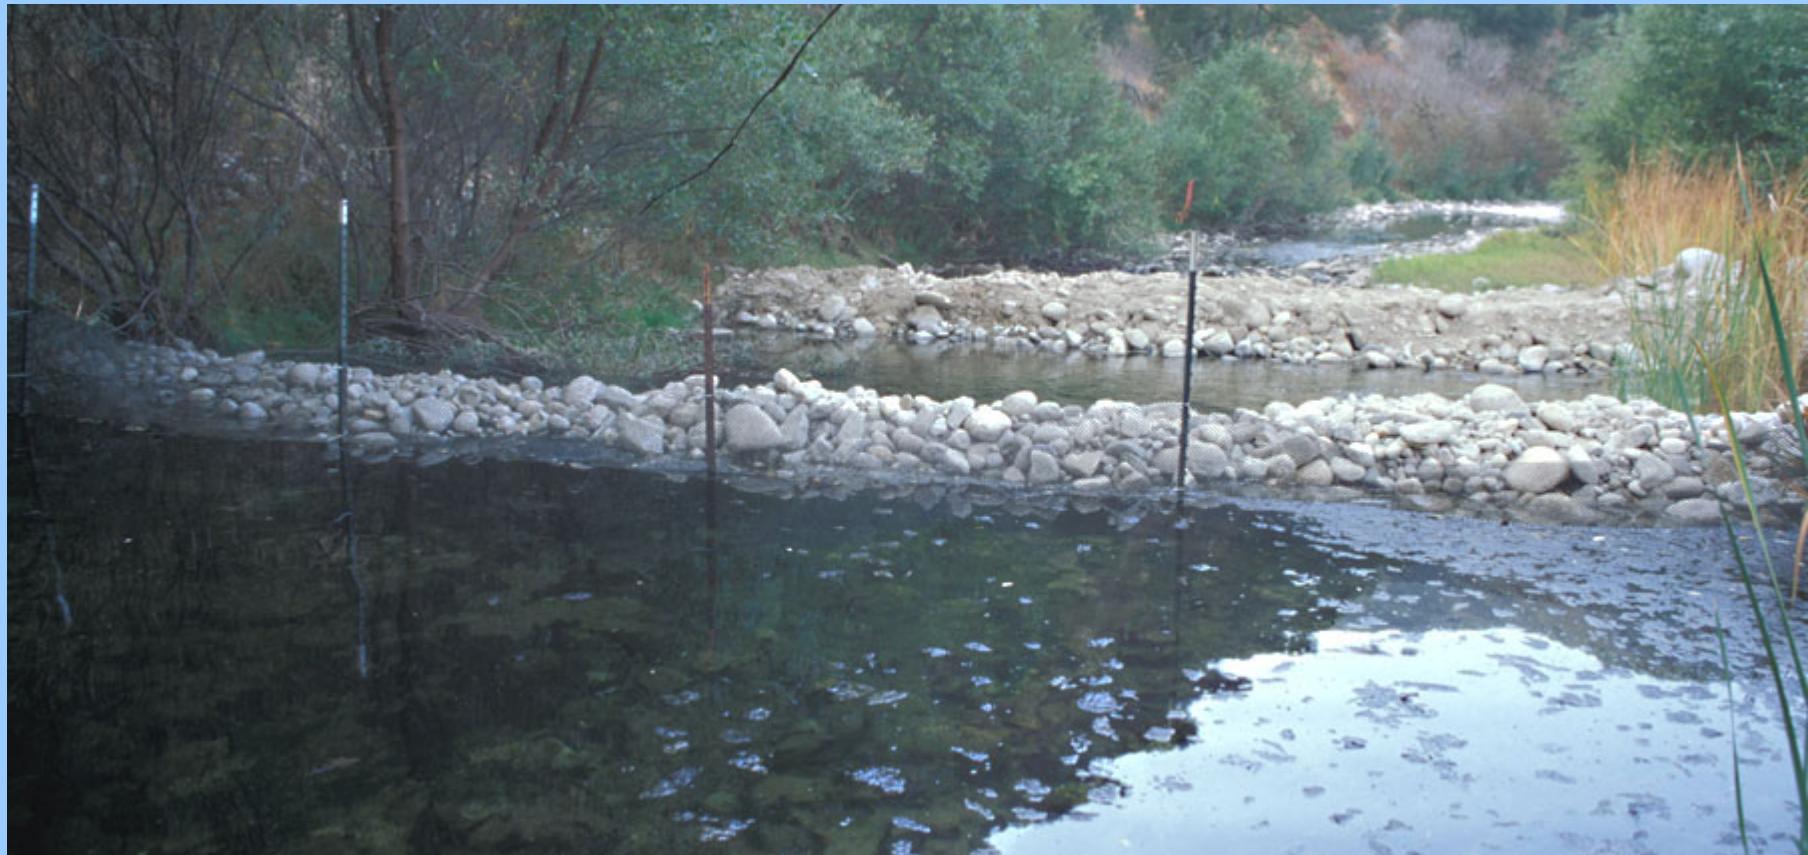
TEMPORARY ROCK DIVERSION DAMS

The low rock dam in the foreground, made of clean cobble and boulders found on site, prevents fish from entering a diversion channel (between the two dams), but allows algae and moss to pass through. A second dam, made from finer material found on site, diverts most of the flow from the main stem into the diversion channel. Flows ranged from about 5 to 8 cubic feet per second (cfs) during construction. Six fish were relocated out of the diversion at the end of the project.

Flow diversion reduced the volume of water in the work site (out of the picture to the left) and prevented sediment-laden water from moving downstream, except during initial diversion and backfill operations. A small crossing for vehicle access to the worksite can be seen just above the 24-inch culvert. Willow cuttings lining the left side of the diversion trench were laid immediately prior to backfilling. Placing cuttings down to groundwater level during low flows eliminates the need for irrigation during summer months. This reach of the river maintains perennial flow.

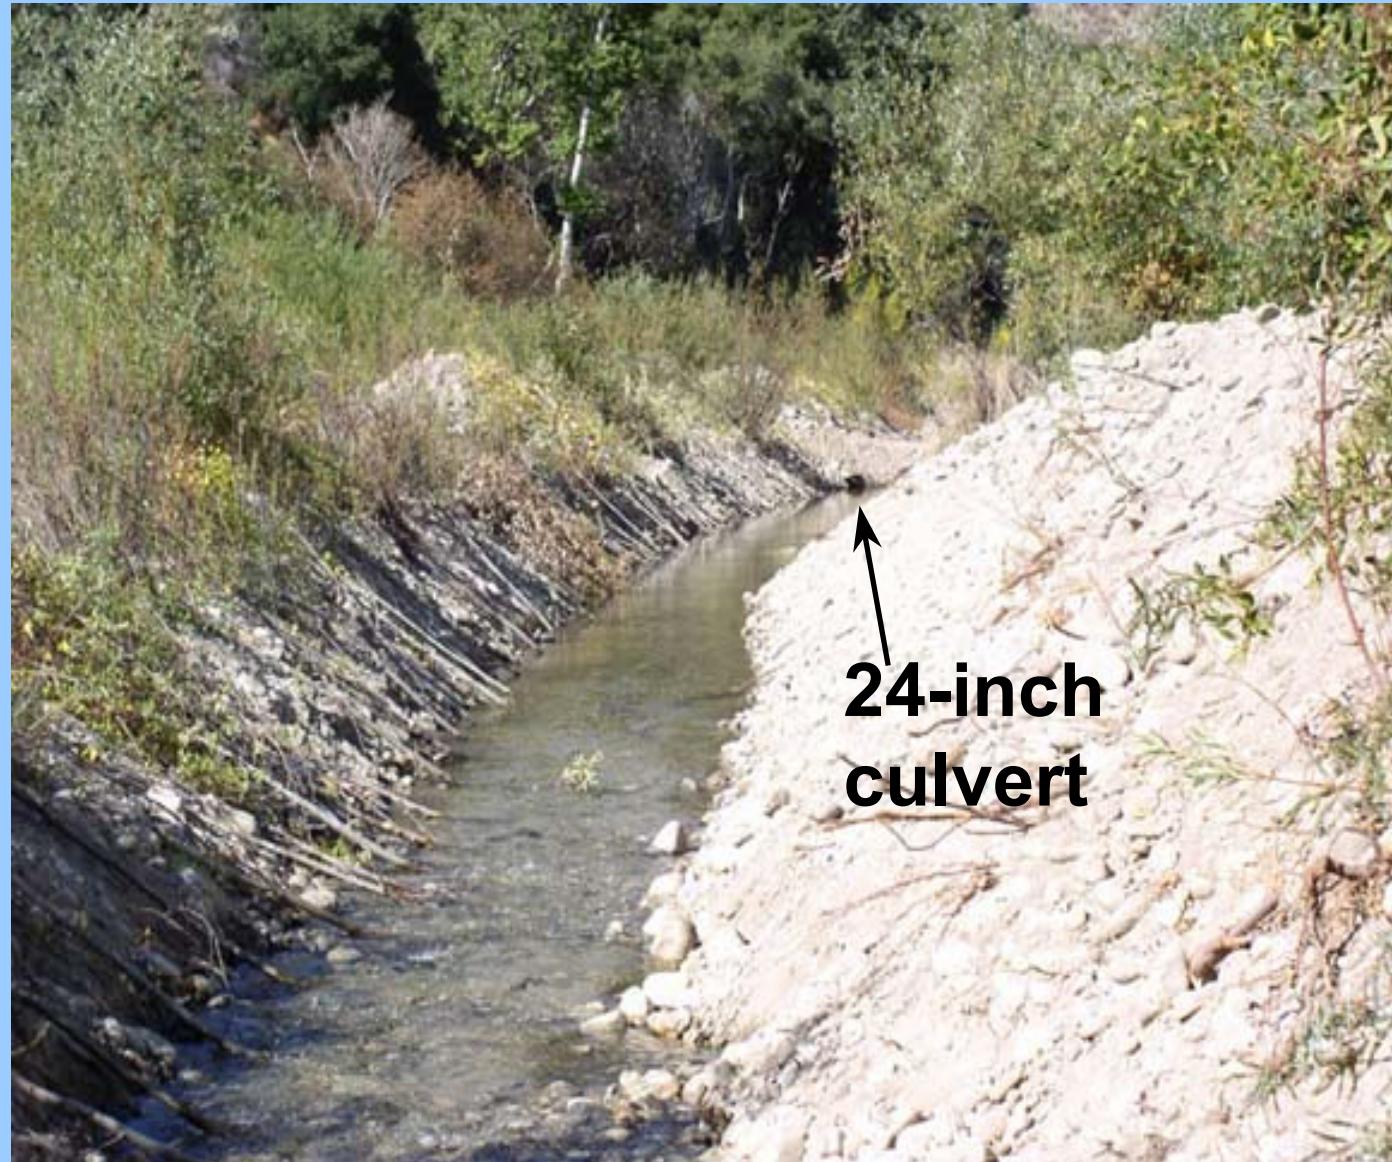
DIVERSION CHANNEL

**24-inch
culvert**

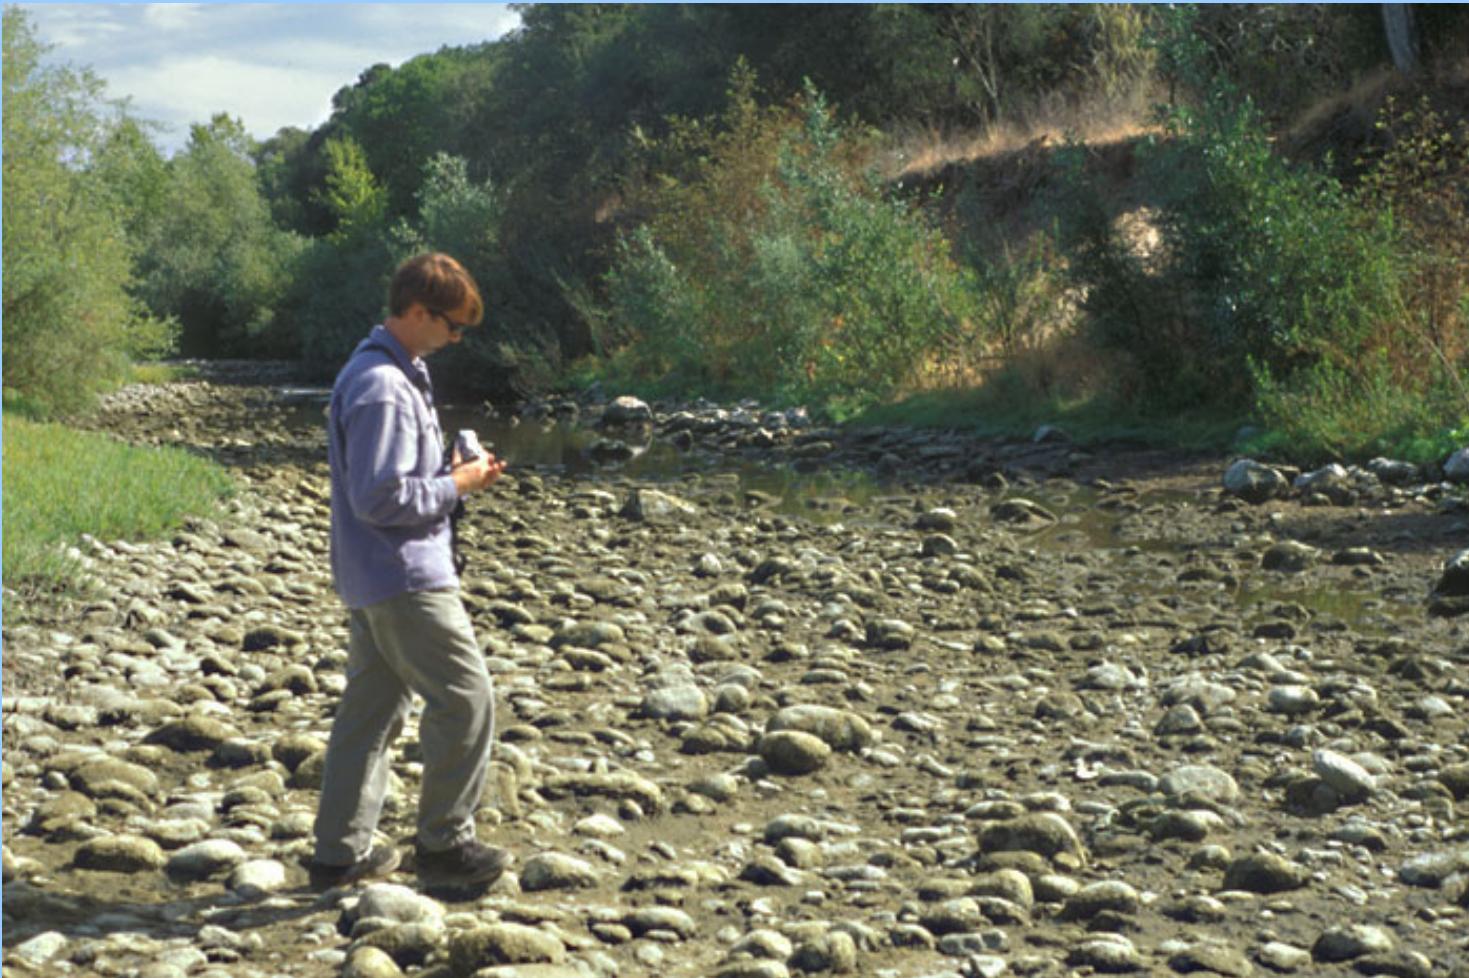
AFTER DIVERSION

Before construction of a diversion, flow covered the cobbles up to the grass seen to the left of Thomas Christensen (examining the underside of one of the cobbles). Main stem surface flow ceased completely 2,000 feet downstream (flow went subsurface), which reduced concerns about sediment impacts from construction. By diverting flow, the contractor was able to pump subsurface water out of construction areas.

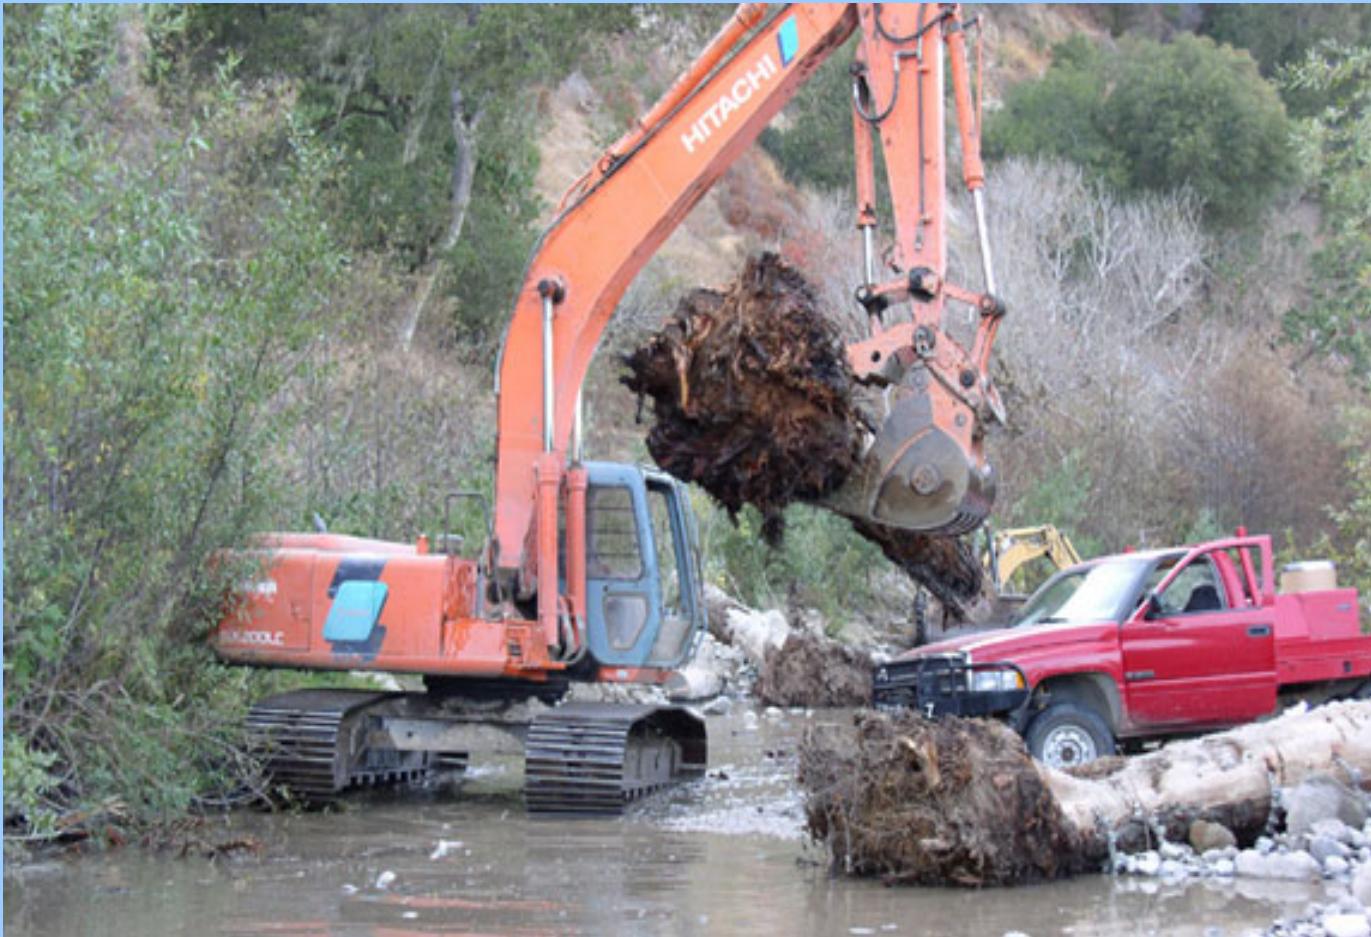
SITE CONDITIONS – OCTOBER 2002

Work started in early October 2002, during the lowest flow period. An estimated $\frac{1}{2}$ cfs infiltrated through the coarse alluvium. Work space in the channel bottom varied from about 30 to 60 feet wide. The Contractor (Carmel Valley Construction) estimated that the logs weighed up to eight tons. Large cobbles and small boulders made travel in the channel bottom a bumpy adventure for the excavator.

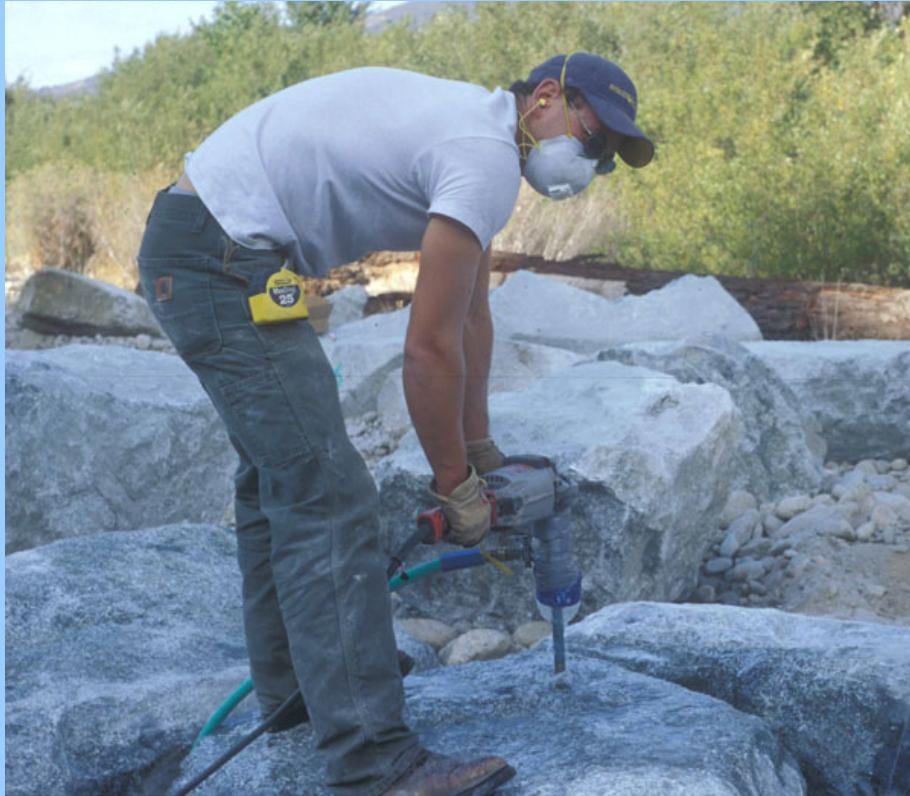
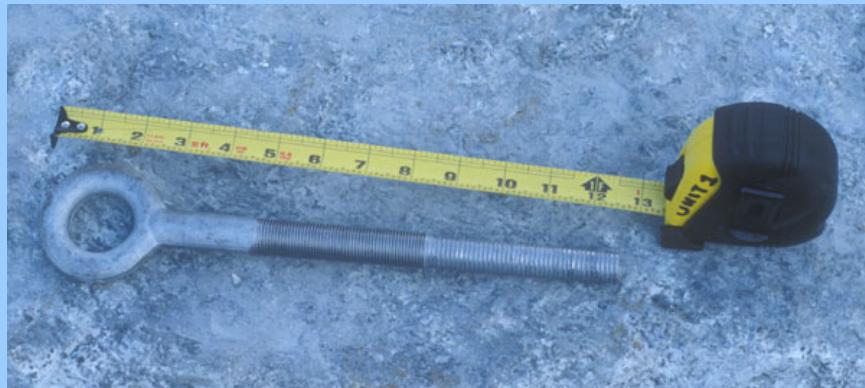
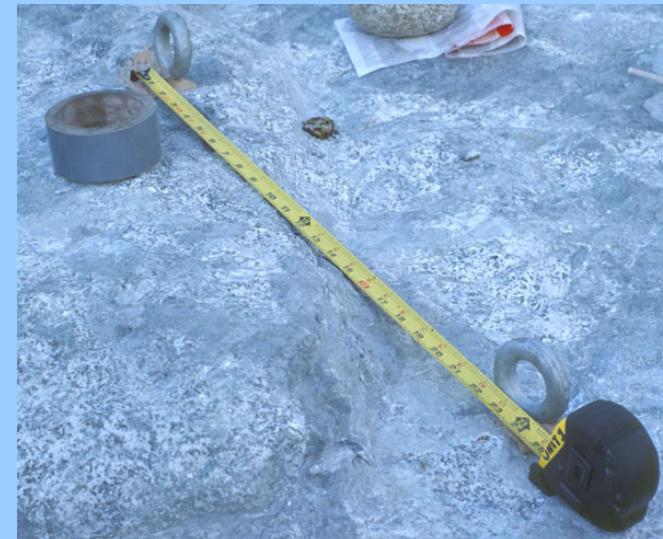
PREPARING BOULDERS

Will Drew uses an impact drill to make 7/8-inch holes, which were thoroughly cleaned with brush and water and air dried before anchor placement. Bolts were chosen over gluing cable directly into the boulders to fasten logs, as failure of the attachment system could not be tolerated. Hilti HY-150 adhesive was rated at 20,000 pound breaking strength for this application, which required custom work to extend the threaded portion of the anchor bolts (lower left, visible as dark portion of bolt). Bolts, four per boulder, were spaced two feet apart (below). Curing time for the glue ranged from about two to four hours.

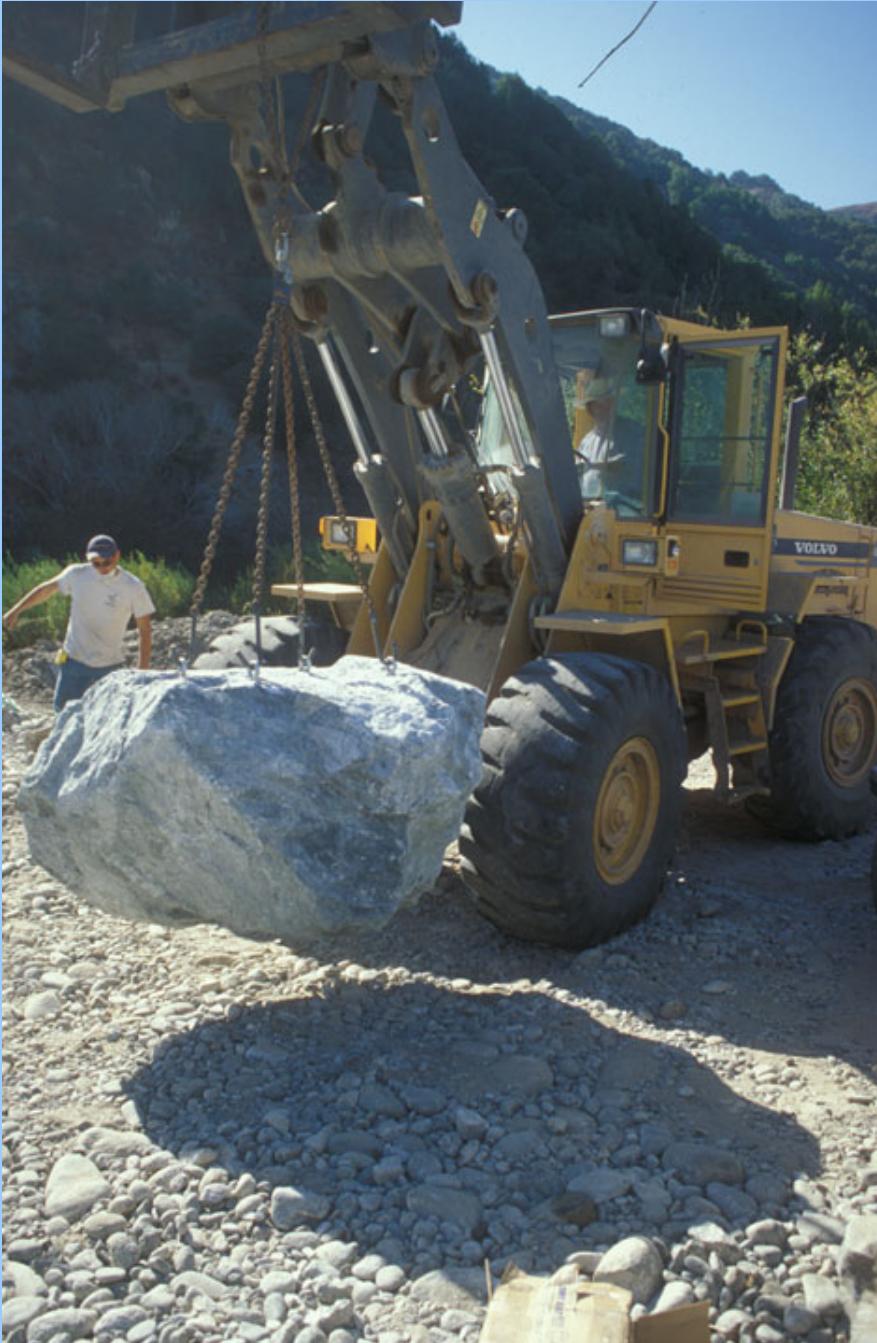
HAULING **BOULDERS**

One of the contract requirements was to pick each boulder up to test the strength of rock anchor bolts. Carrying boulders in the fashion shown at left bent the steel hooks used to lift the boulders as the loader bounced over large cobbles in the stream bottom. The contractor opted to haul boulders in the loader bucket and lift each boulder into place with an excavator, using the four hoisting chains shown at left.

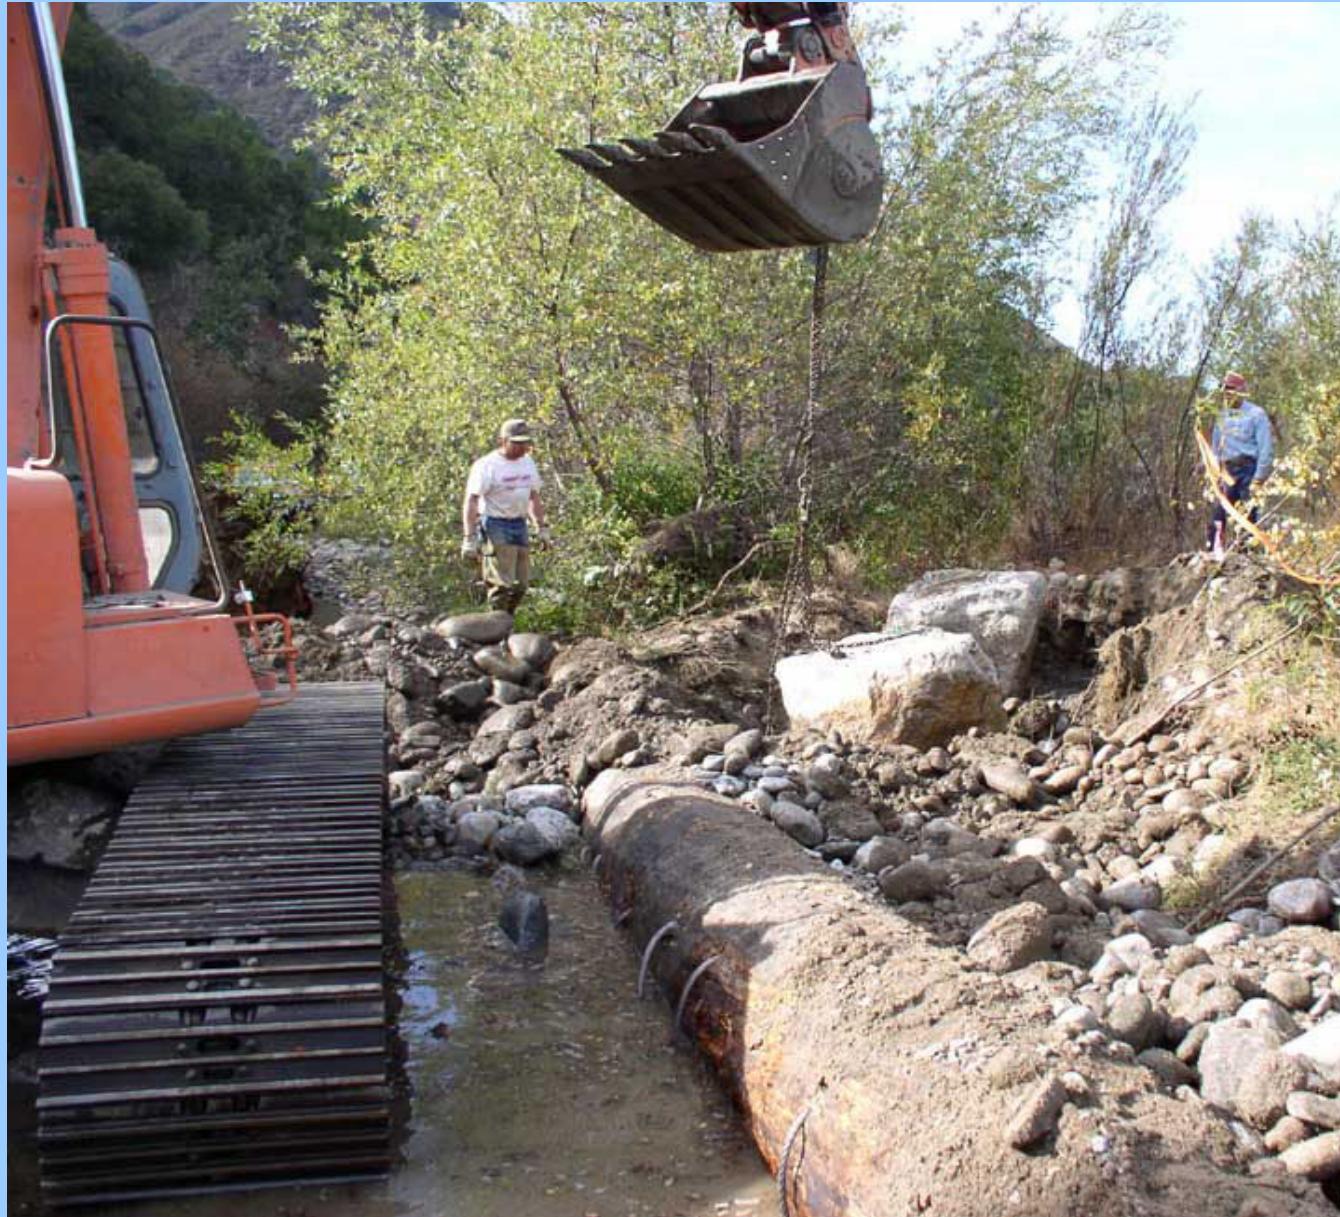
PLACING BOULDERS

Four to six-ton boulders were individually surveyed into place to provide a line of support and to anchor the logs. Here, the excavator is moving a boulder by hooking on to one of the four $\frac{3}{4}$ -inch cable anchors inserted in each rock.

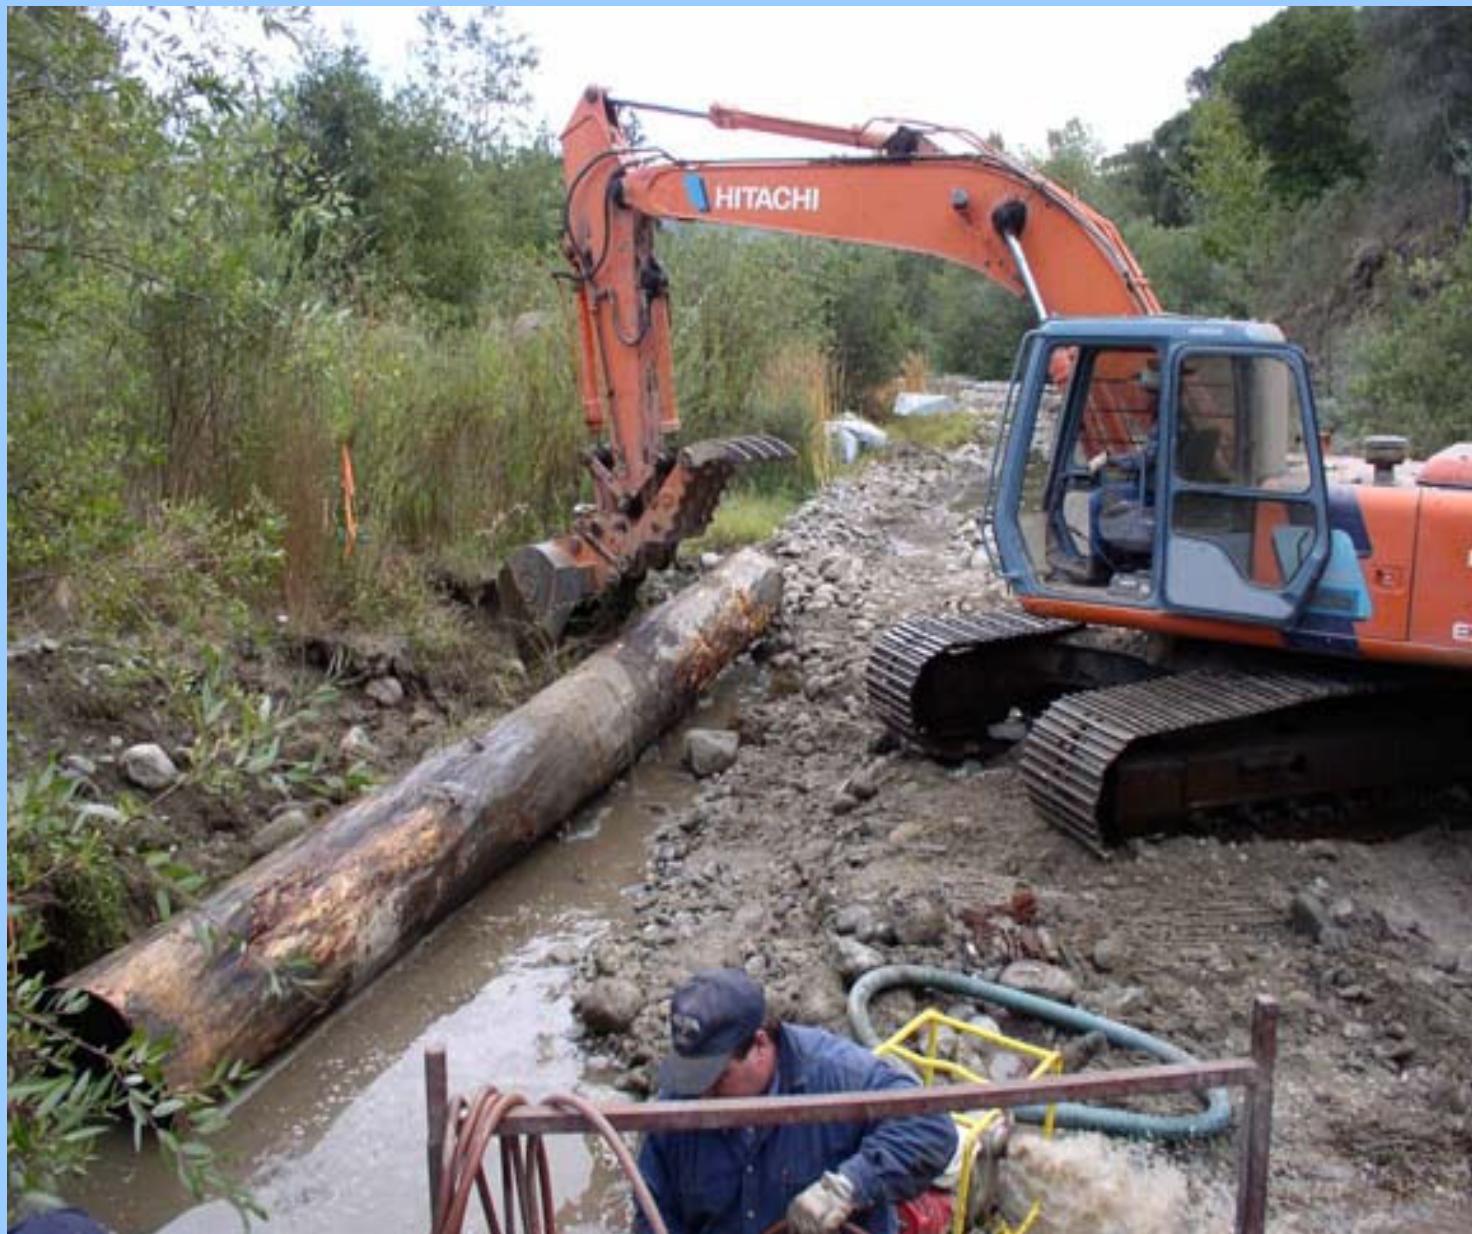
SETTING FOOTER LOG

A footer log was installed to encourage scour along the toe of the streambank. Although not visible in this photo, the footer log is anchored with four large boulders similar to the ones shown in the previous photo. Willow cuttings placed behind the footer log will be protected from scour during high flows.

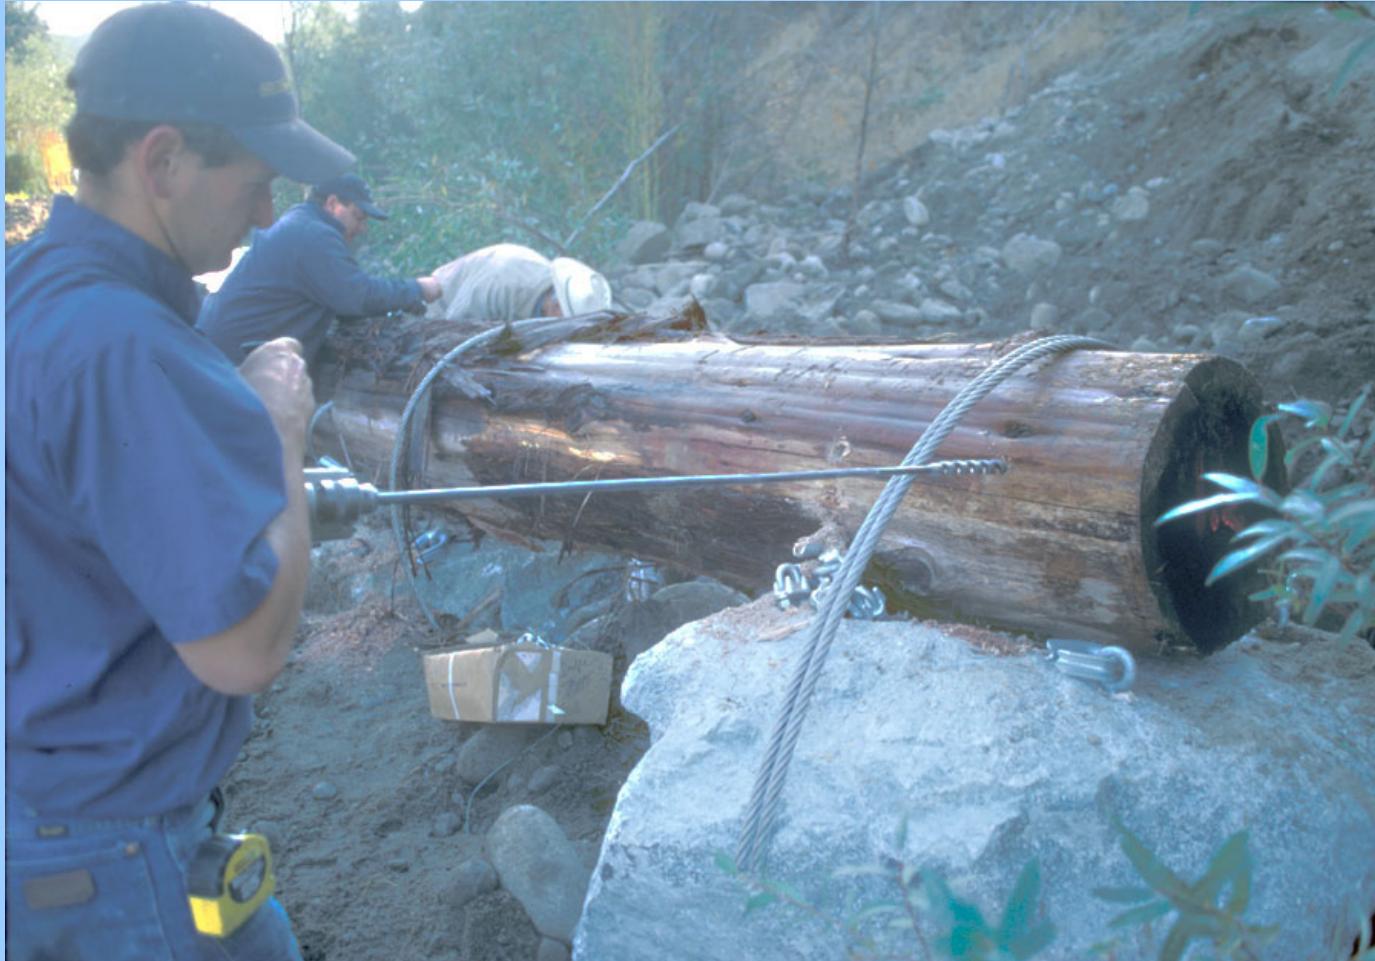
DRILLING HOLES FOR CABLING

Will Drew augurs through a redwood log. Cable is passed through the hole, around the log, through cable anchors glued into the boulder and clamped. Redundancy in the anchoring system (two cables per boulder) was a precaution made necessary by the potential cost of failure – one log loose in the river could cause a bridge washout or severe bank erosion.

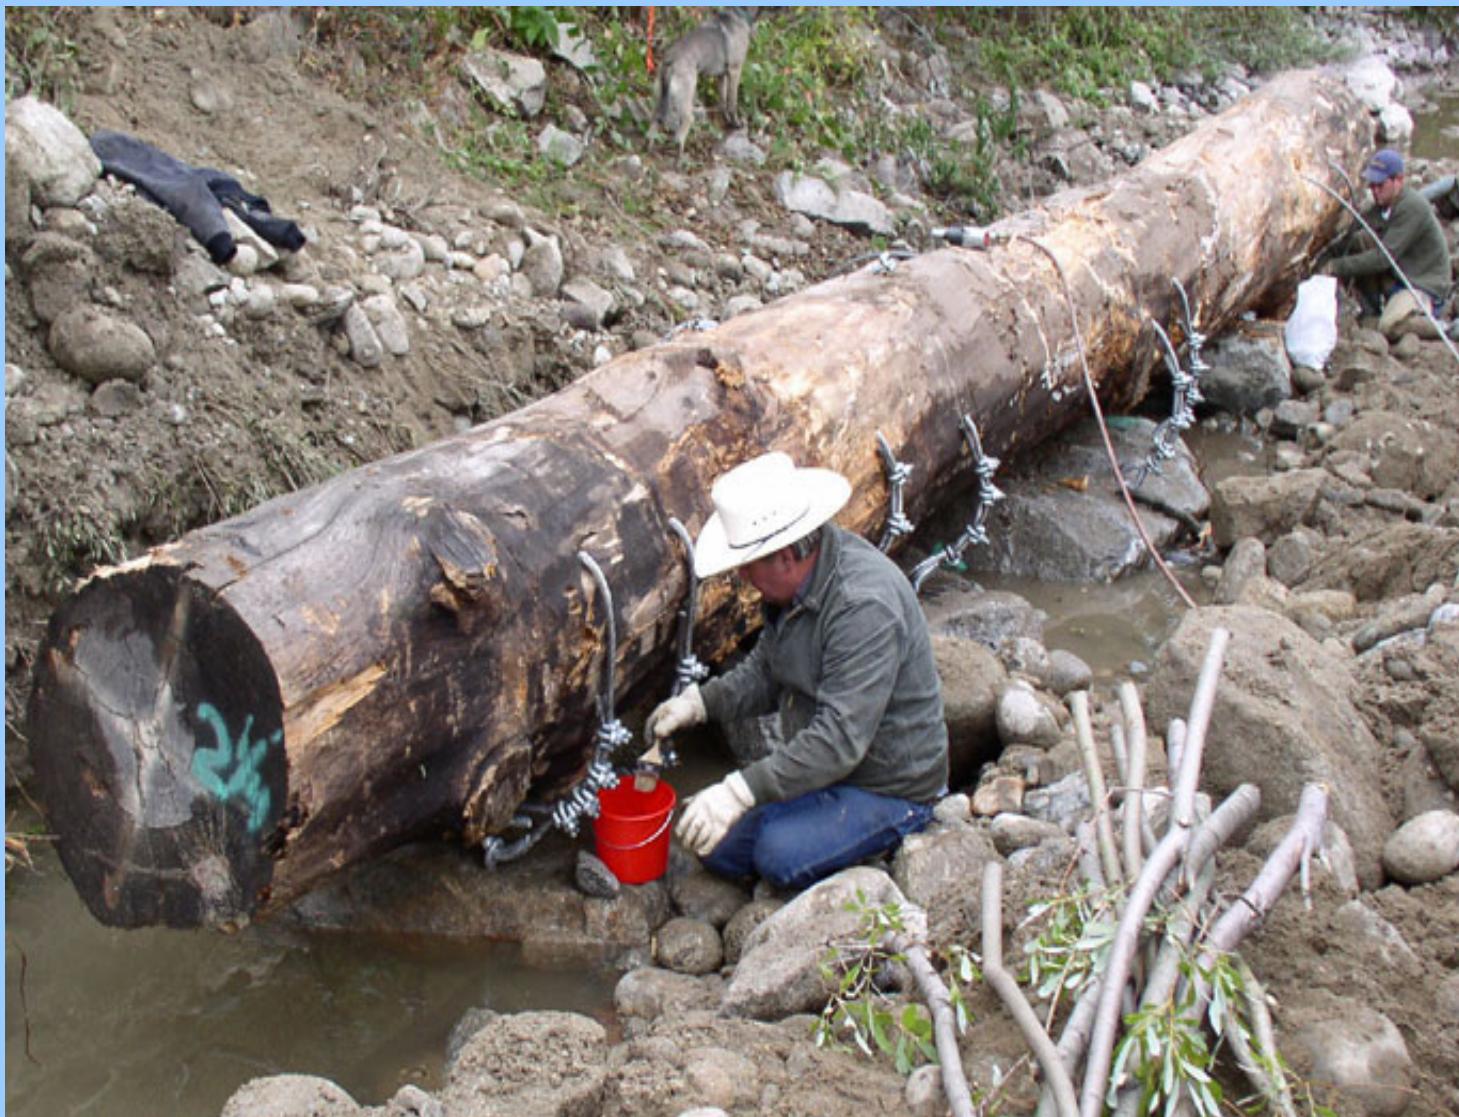
LOG CABLED IN PLACE

As indicated by the green paint on the end of this log, the diameter is 2.25 feet. The largest diameter log was nearly 3.25 feet at the equivalent of breast height (the logs never were vertical during the project). Logs were anchored to boulders using eight $\frac{3}{4}$ -inch stainless steel cables (two per boulder). Willow cuttings at the lower right were placed behind the log prior to backfilling.

Setting an eight-ton log and rootball in the right place requires experience and patience. Here, Gerry Paddock, the owner of Carmel Valley Construction, deftly places a 38-foot long log and rootball on top of four boulders. The log was placed at a 30 degree horizontal angle to flow. The log was also angled vertically to place $\frac{1}{2}$ of the rootball below the existing riverbed and the end of the log several feet up the bank. This orientation encourages bottom scour at the rootball and in the middle of the channel during frequent flows (1 to 3-year return), which range from about 1,000 cfs to 3,000 cfs at this location.

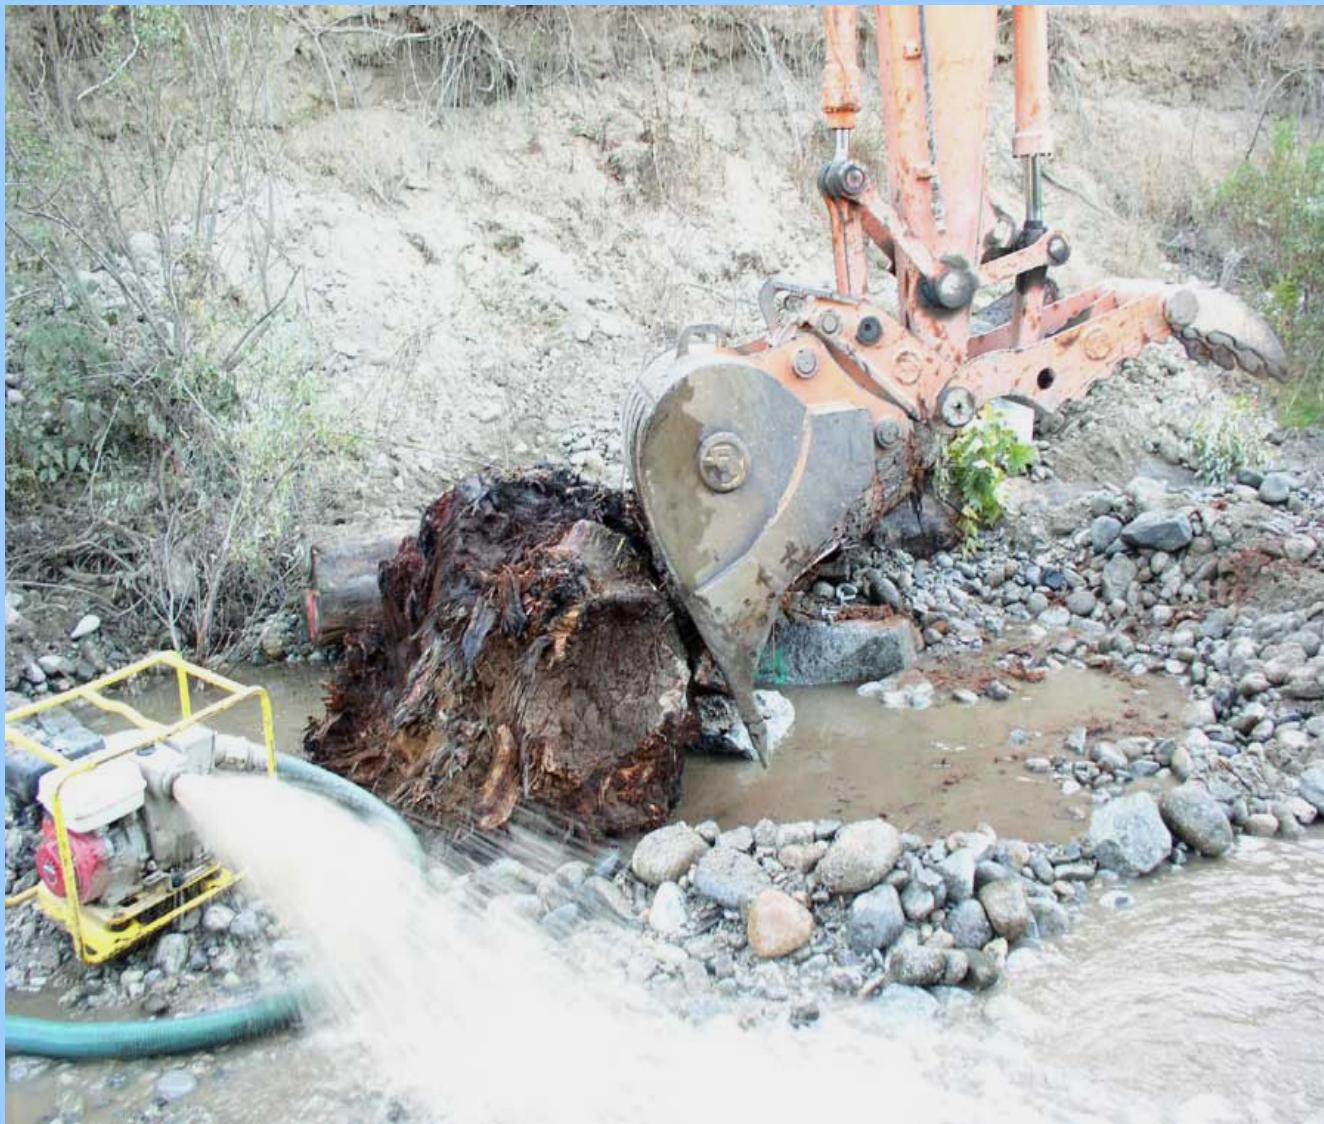
NUDGING the ROOTBALL into PLACE

The pump at the left is pumping about 250 gallons per minute or about 0.5 cfs. Channel bottom material was so coarse that water pumped out here infiltrated the alluvium approximately 300 feet downstream, before flowing back into the main stem.

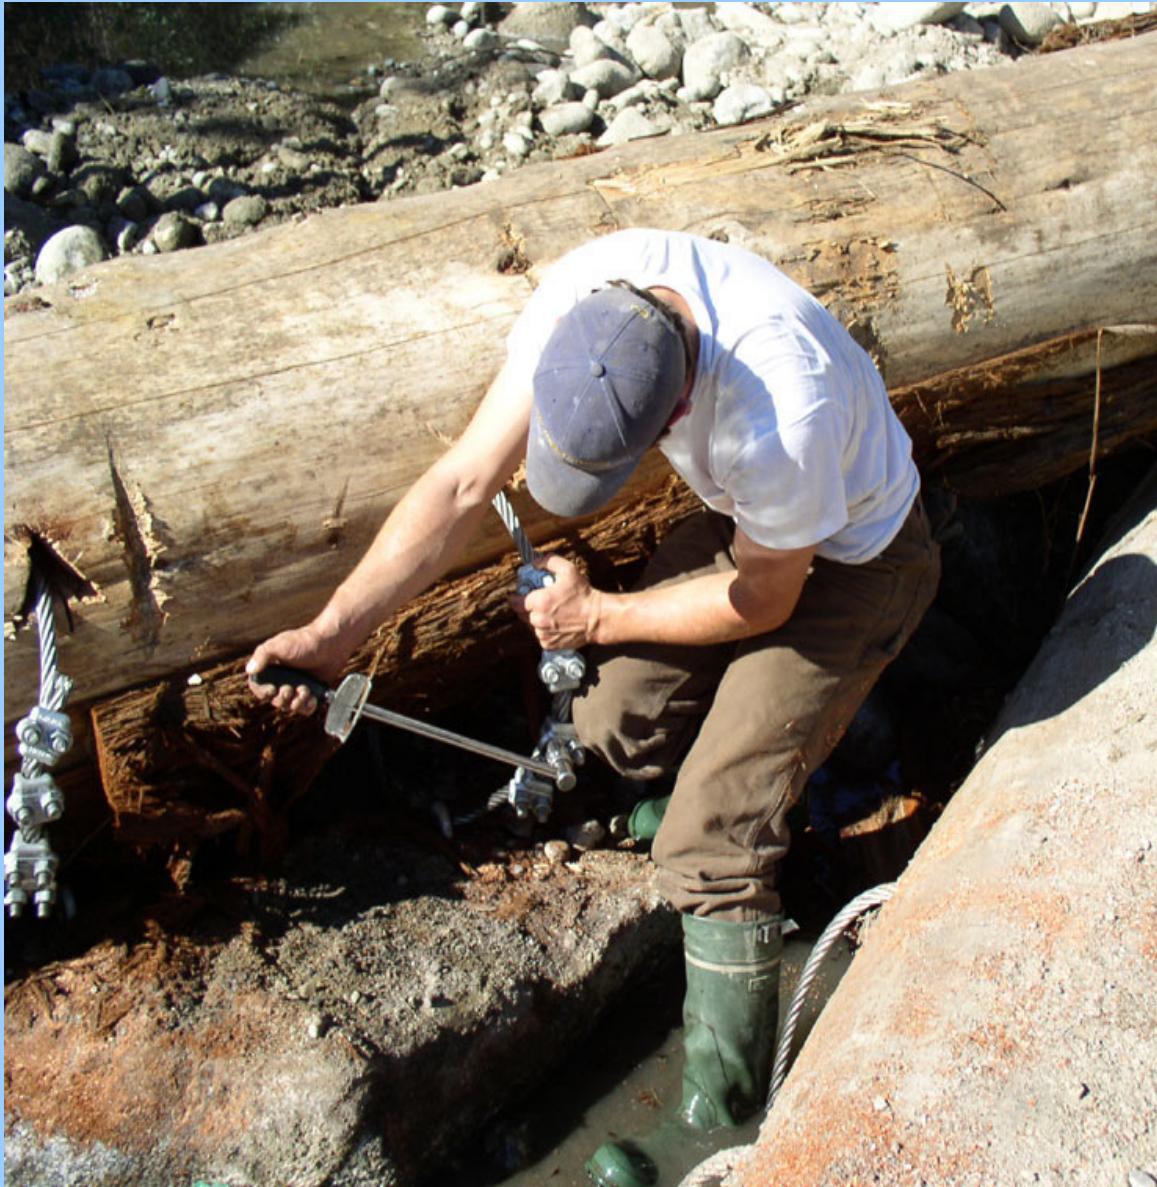
TIGHTENING CABLE CLAMPS

Will Drew checks the four $\frac{3}{4}$ -inch cable clamps placed on each cable. Torque was specified at 130 foot-pounds. Proper cabling was critical to the success of this project.
