**Monterey
Peninsula
Water
Management
District**

The Monterey Peninsula Water Management District in cooperation with the University of California at Santa Cruz, Big Creek Lumber Company, the California Department of Fish and Game, and the Monterey Peninsula Regional Parks District installed five large wood habitat structures along 400 lineal feet of the Carmel River.

Installation of Large Wood Habitat Structures at the deDampierre Restoration Project

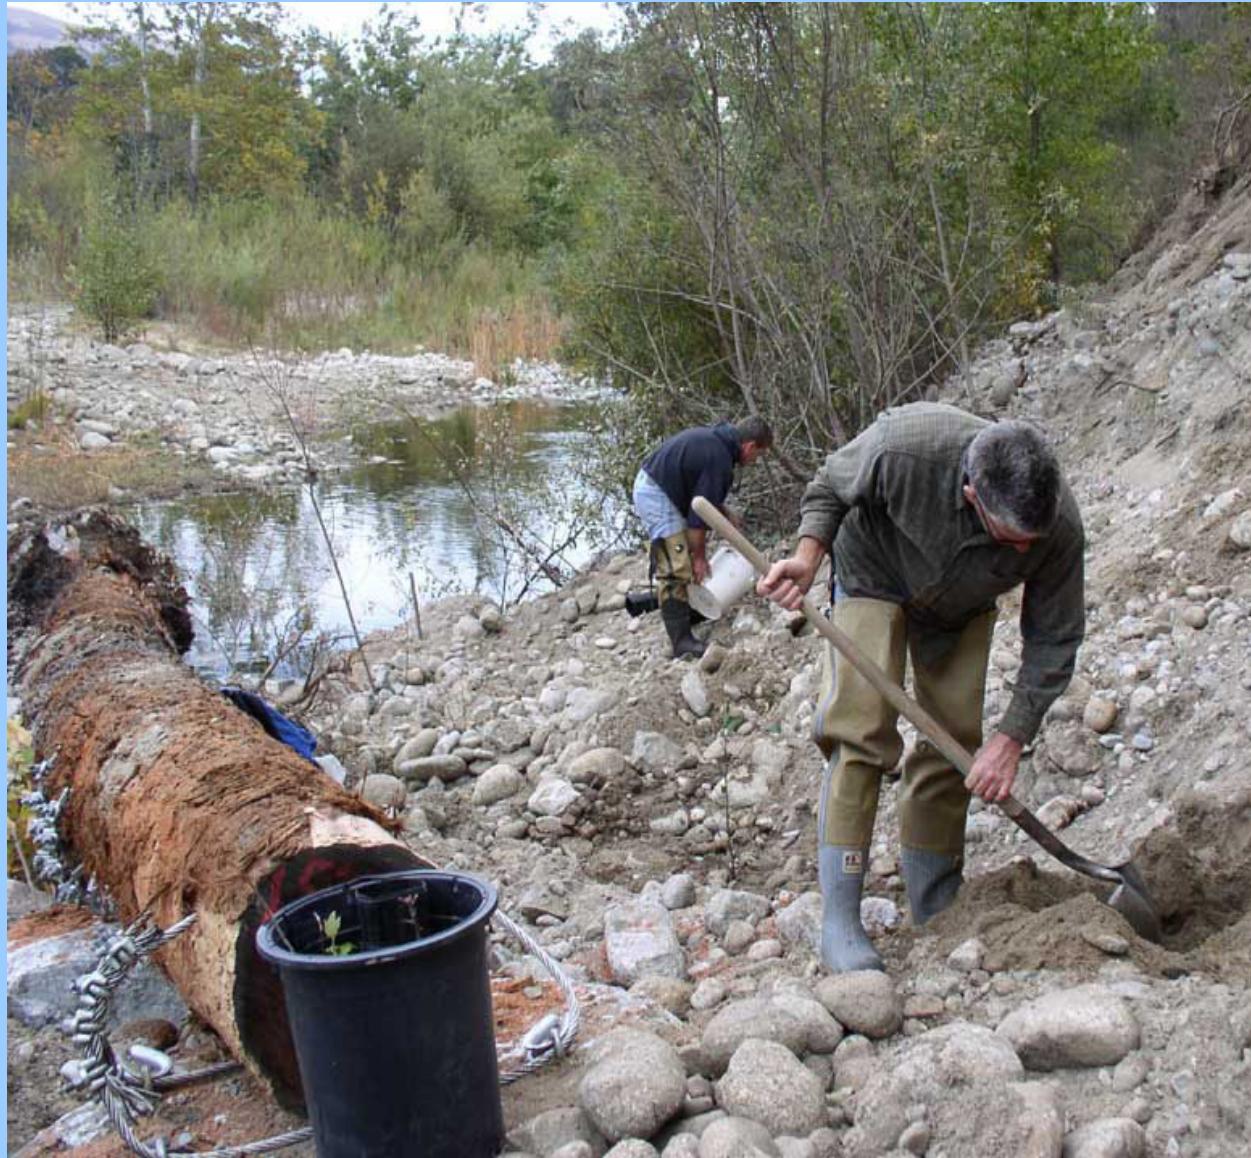
PLANTING NATIVE SEEDLINGS

Here, MPWMD river workers Matt Lyons and Mark Bekker plant gooseberry, sycamore, buckeye, and alder seedlings in areas disturbed by grading. Rains just one week after installation and close proximity to water mean that these plants, if they can survive winter flows in the first few years, are unlikely to need supplemental irrigation during the dry season.

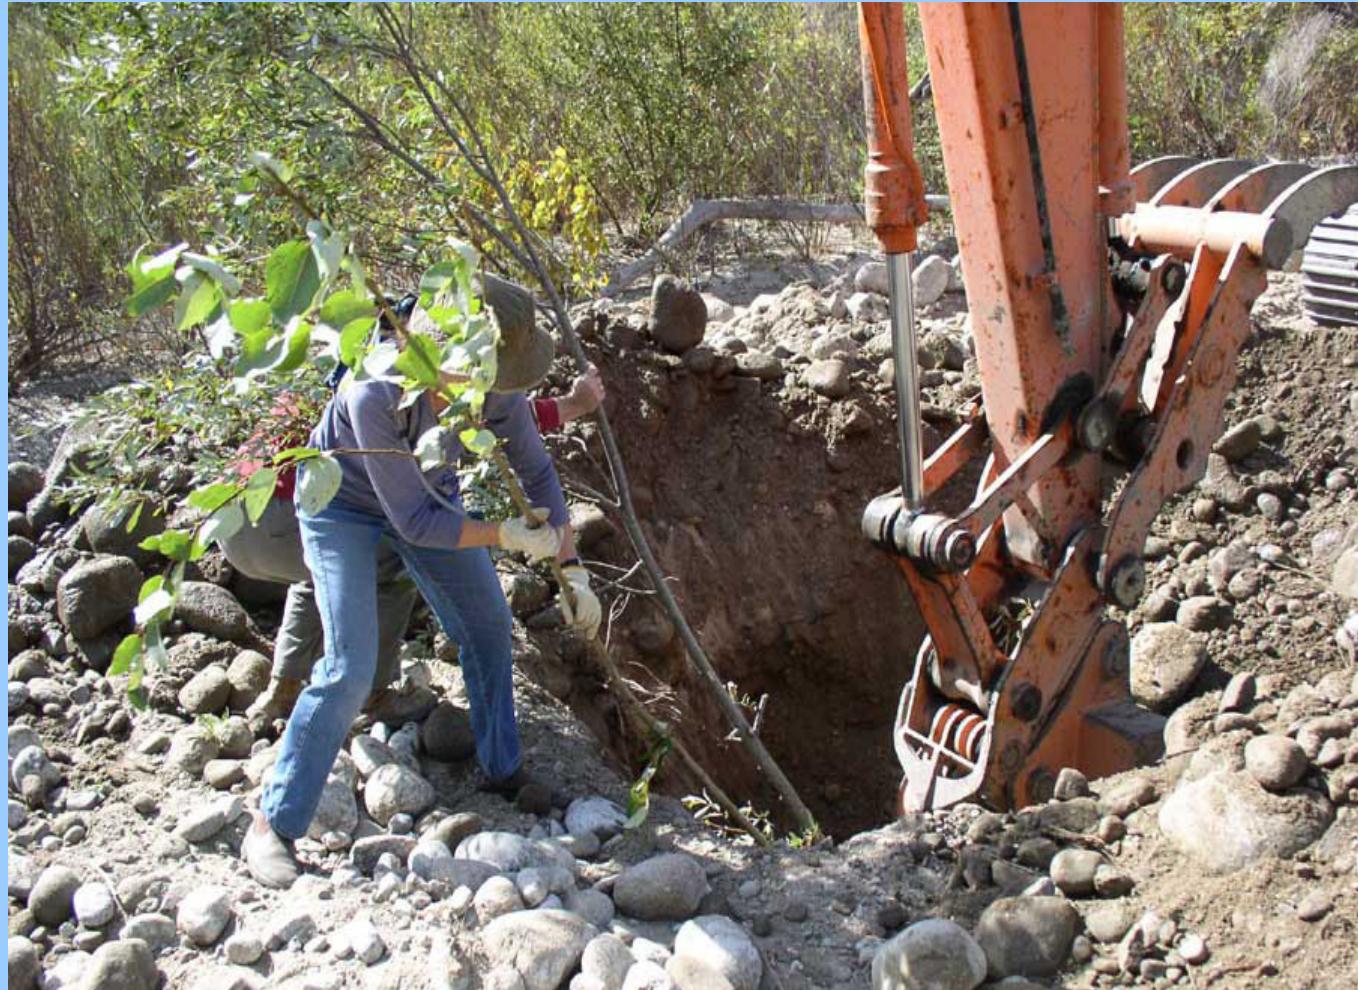
PLANTING CUTTINGS IN THE FLOODPLAIN

Digging a hole for a three-inch diameter willow or cottonwood cutting with a four-yard excavator bucket may seem like overkill, but the power of an excavator is needed to dig up the large cobble and boulders in the floodplain adjacent to the logs. The largest particle dug up during this project was in the one-ton range. Even a large backhoe with a three-foot wide bucket is not as effective as this excavator. Note the depth of the hole (about five feet), which allows the cuttings access to water year-round.

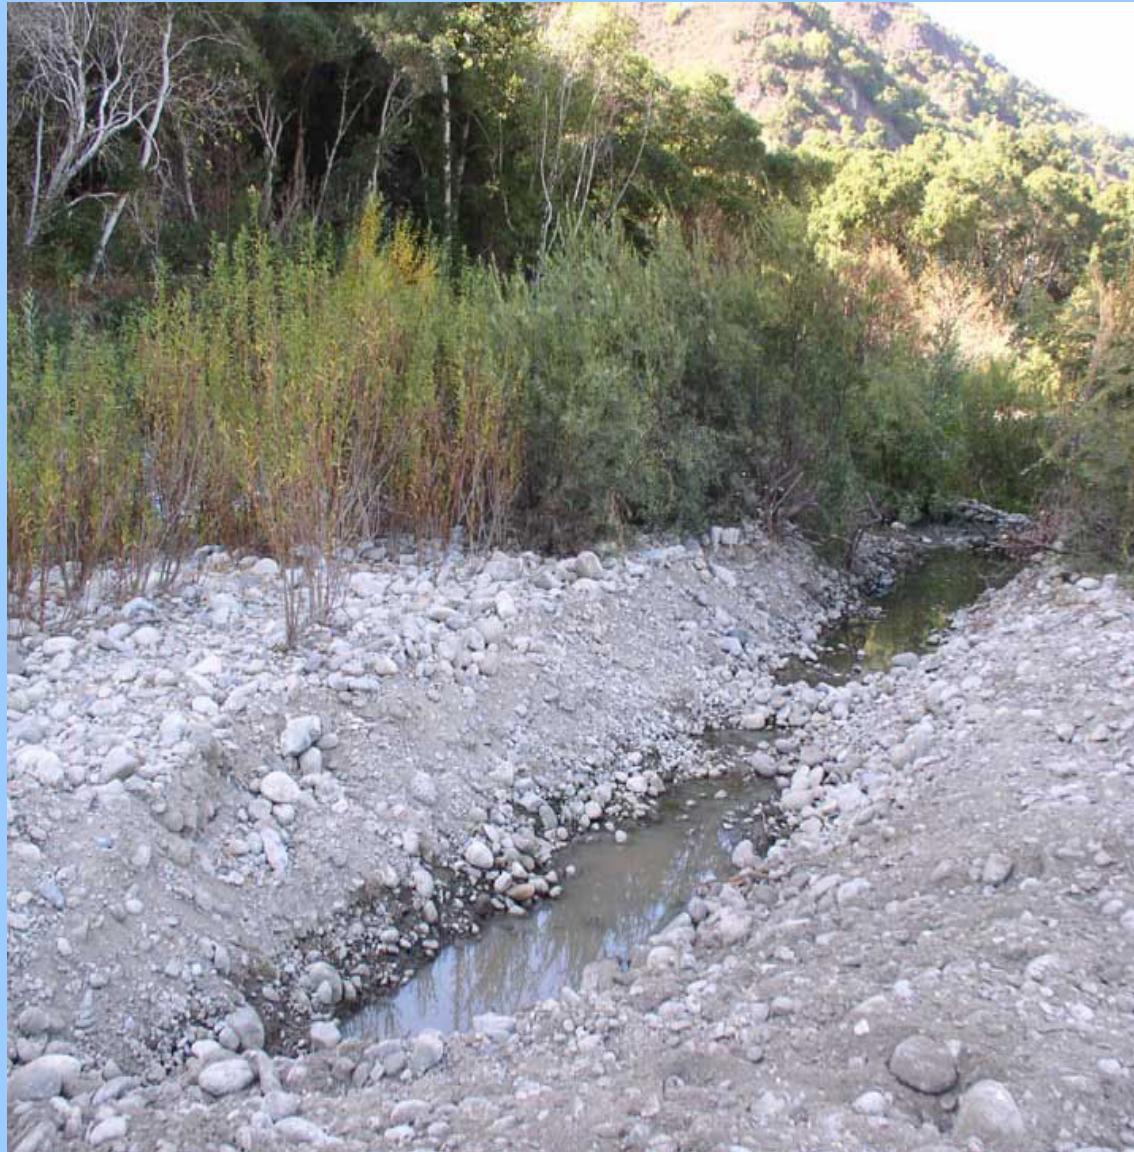
DIVERSION CHANNEL

The US Fish and Wildlife Service has encouraged MPWMD to create backwater areas capable of supporting California red-legged frogs in their various life stages. Here, the downstream 100 feet of the diversion channel was left unfilled in an attempt to create a backwater area. Flow in the main stem is from left to right along the vegetation in the center of the picture, although at flows in excess of 500 cfs, the low area in the foreground is likely to be completely inundated. This area will be monitored to see how effective this technique is at creating backwater habitat.

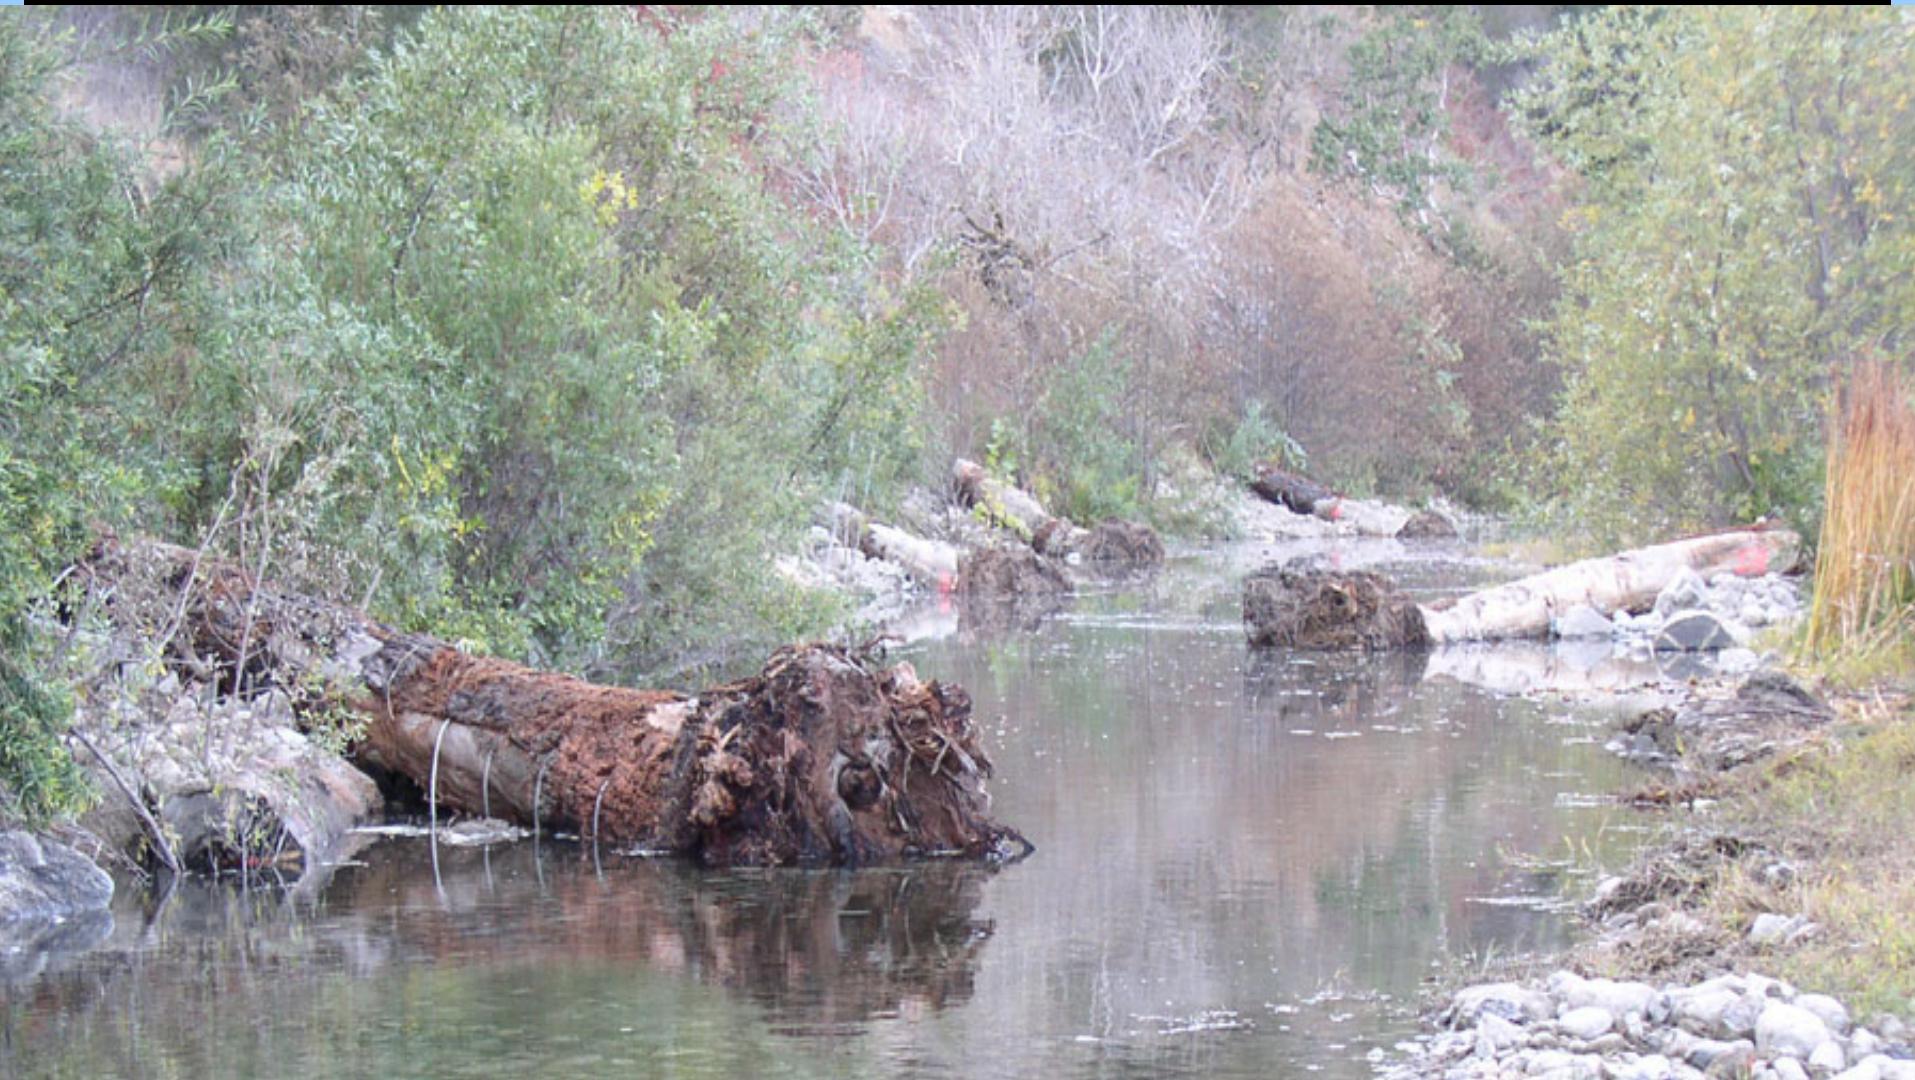
FINISHED PROJECT- OCTOBER 31, 2002

Work was completed one day before expiration of the permits on November 1, 2002. One week later, 10 inches of rain fell in the upper watershed, causing the river to flow at 400 cfs through this site. At last check, the logs were functioning as intended, causing scour near the rootballs and helping to sort gravels for steelhead spawning. Several young-of-the-year were spotted in deep areas near the logs.

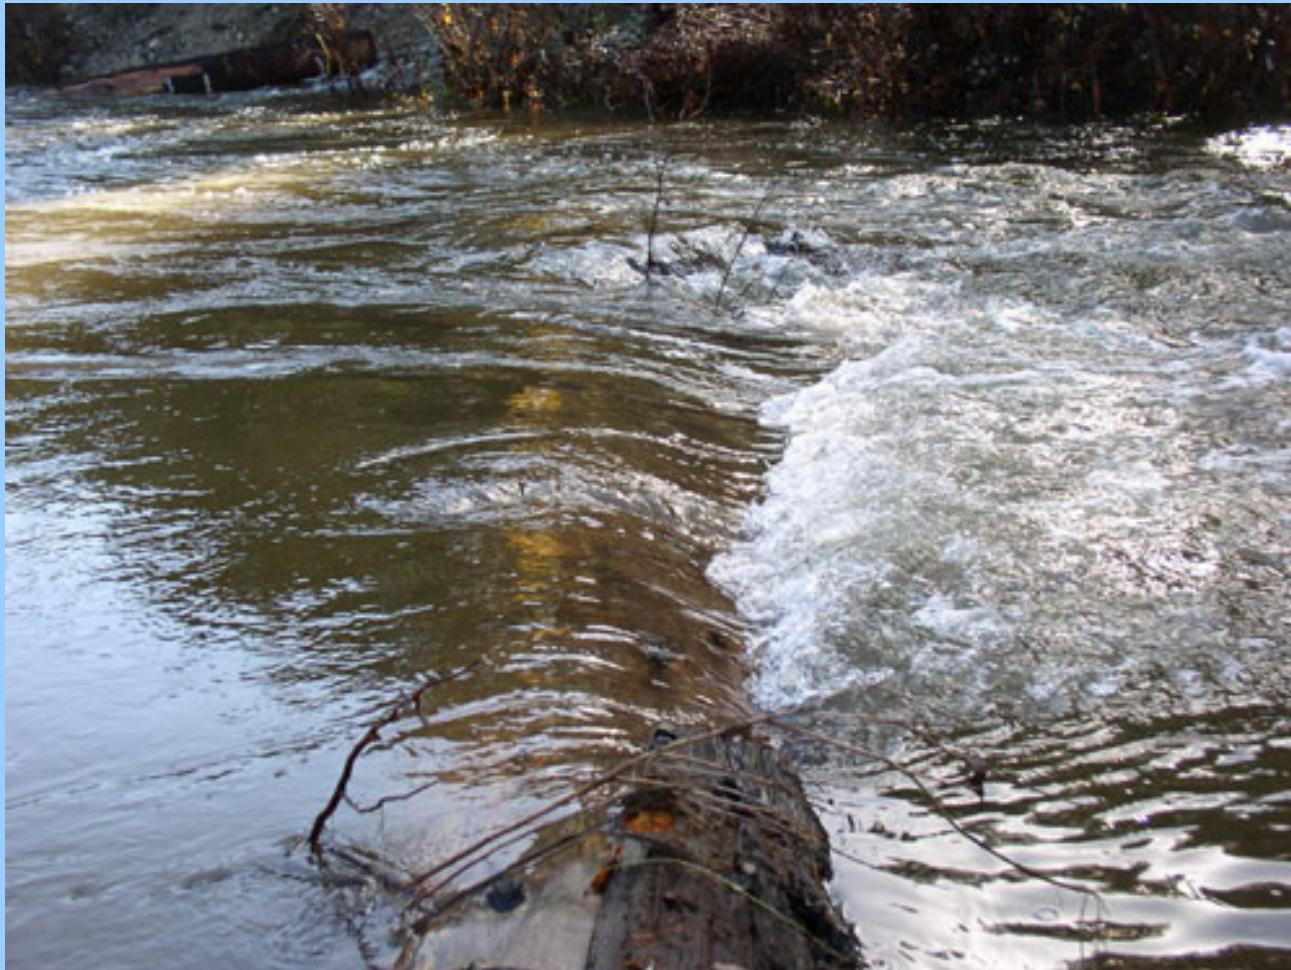
WINTER SCOURING ACTION

Here, flow of 500 cfs is moving from left to right and scouring the channel bottom near the rootball (upper center of photo) and under the log. A hydraulic jump can be seen on the downstream side of the log. At higher flows, the jump is drowned out and becomes a standing wave. Controlled energy dissipation is important in this reach, where chronic bank erosion threatens structures downstream, close to the banks.

MPWMD plans to resurvey the channel bottom during the summer of 2003 to document scouring effects.
