**ASSESSMENT OF STEELHEAD PASSAGE BARRIERS IN  
PORTIONS OF FOUR TRIBUTARIES TO THE CARMEL RIVER**

**Monterey Peninsula Water Management District  
IRWM - PROJECT 3**

**Final Project Report - July 2014**

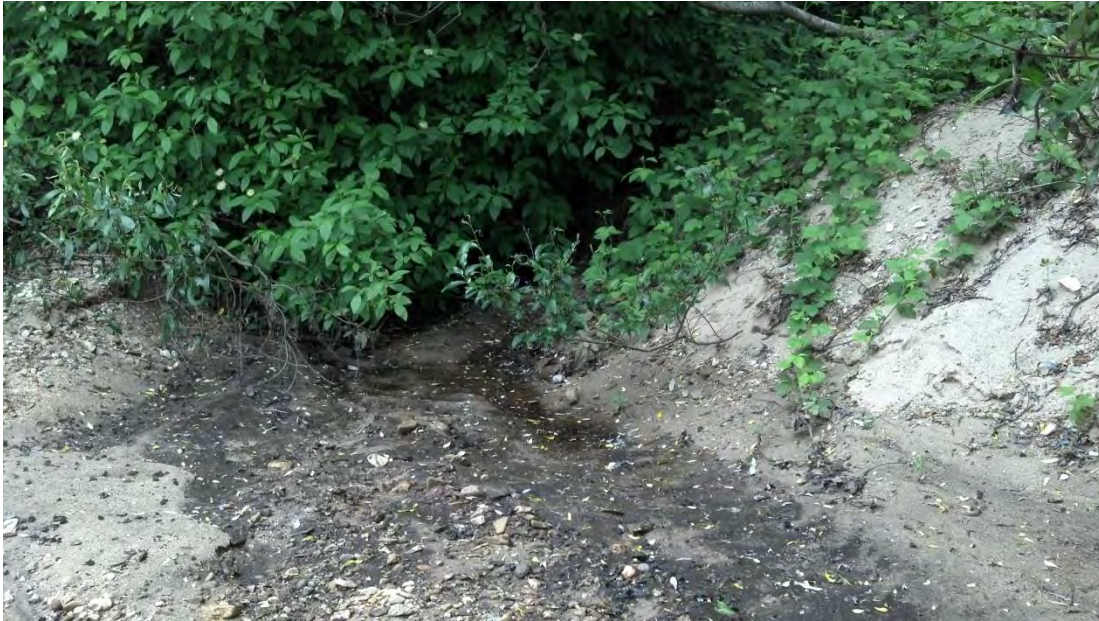
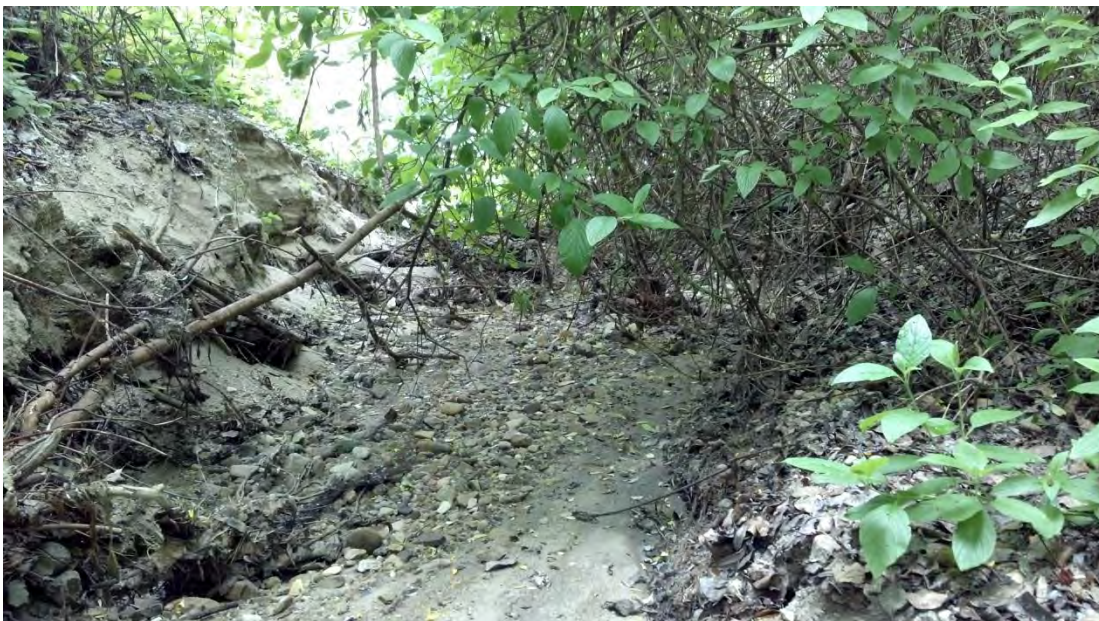
**Site PCB-1. Confluence - Potrero Cr. and Carmel River.**  
*Yellow* UTM: 10N 0601170/40444066

Confluence is overgrown with brush and is very shallow due to a built-up sand bar and eroding sand banks.

**Site PCB-1.** Potrero Cr/Carmel River confluence, looking upstream (u/s).

**Site PCB-1.** Potrero Cr/Carmel River confluence, looking downstream (d/s).

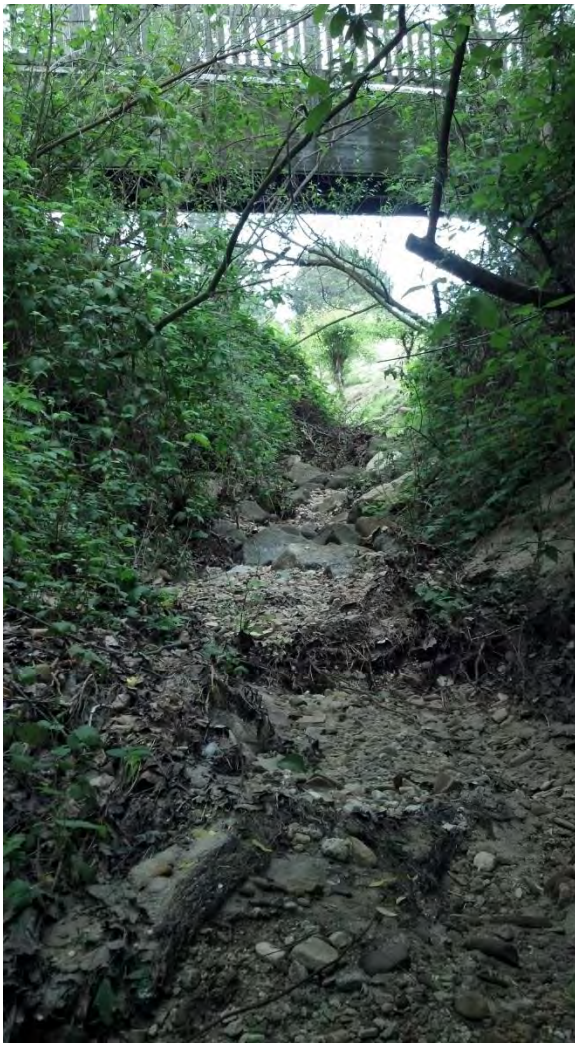
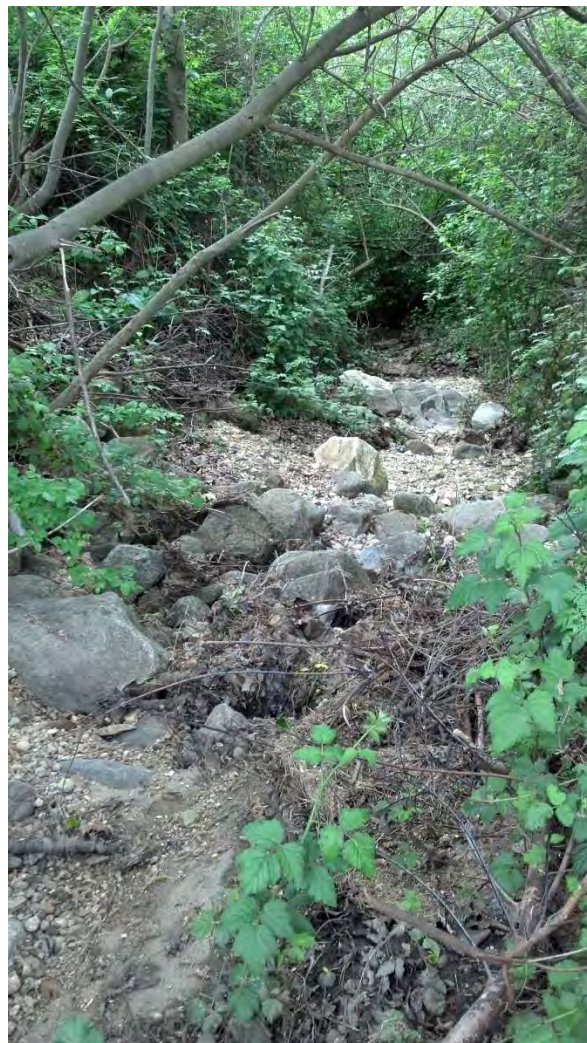
Creek bed is narrow and lined with 1-2' dia. boulders. Gravel and woody debris are lodged between boulders. Channel has ~1.5% grade.

**Site PCB-2a. Steep Riffle Channel - looking u/s from confluence.**

**Steep Riffle Channel - looking d/s from Golf course Foot Bridge**

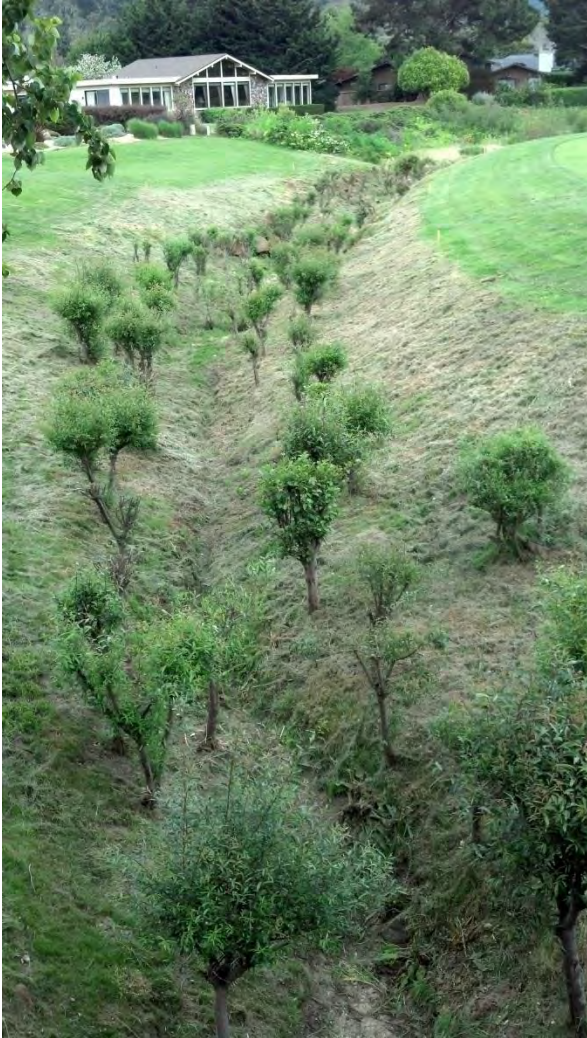
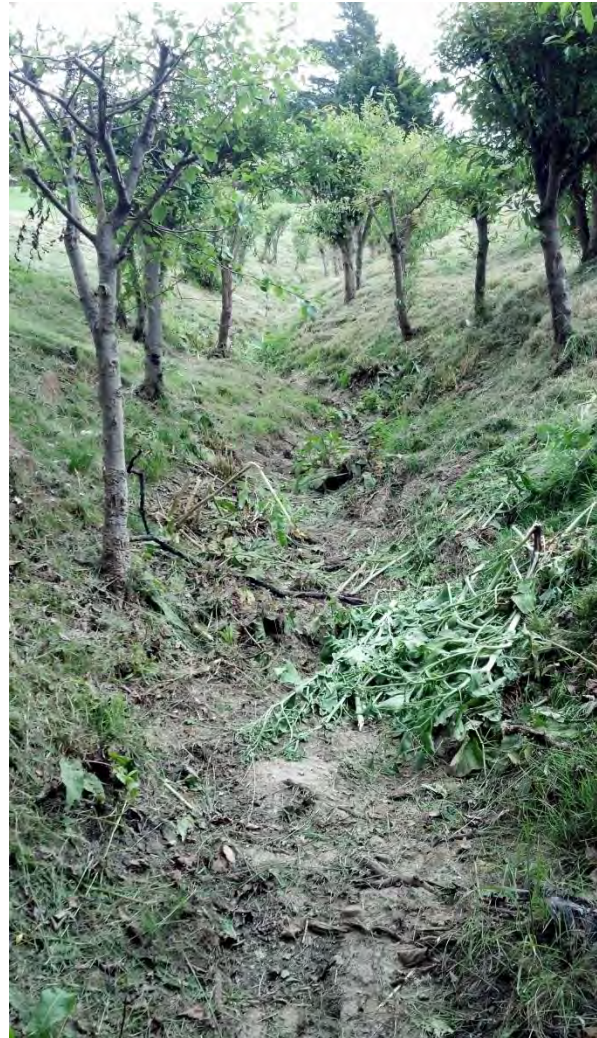
**2b) Foot Br. to Rock Weirs (~150')**  
UTM: 10N 0601192/40444590

No actual creek bed/channel, just a “V” notch through the grassy golf course fairway. A single row of willows has been planted along both banks but trees have been severely trimmed and offer no habitat or shade (bonsai). Grass and weed clippings have been thrown into channel.

**Site PCB-2b.** Lack of channel through golf course, from foot bridge looking u/s.

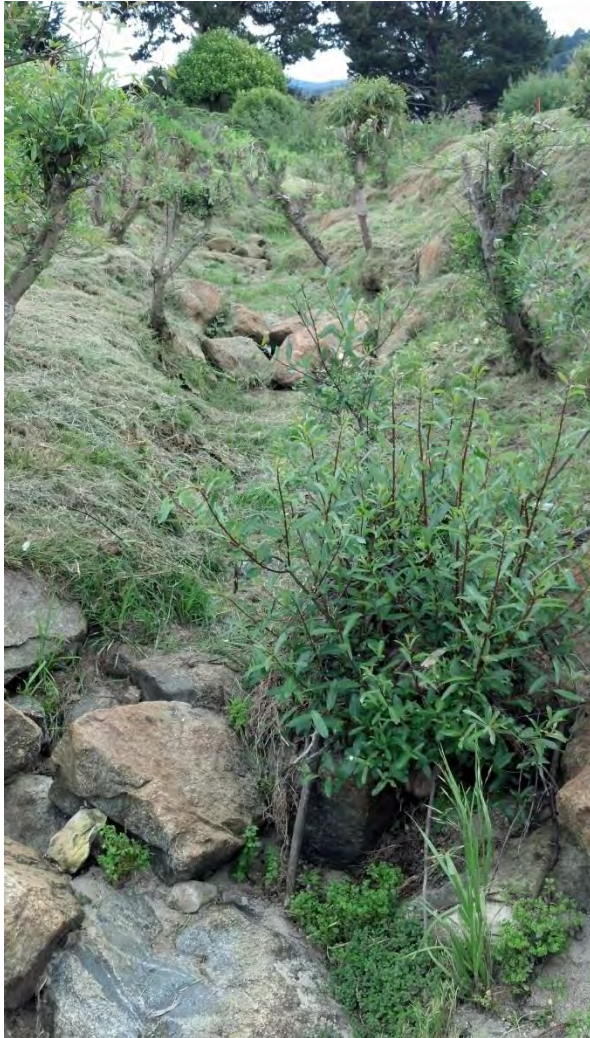
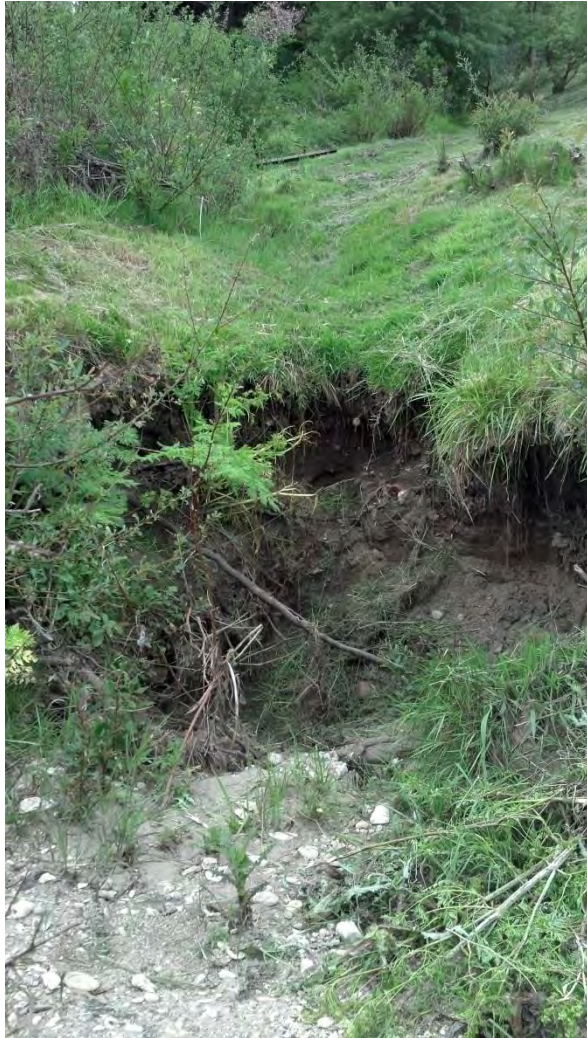
## 2c) Rock Weirs to Large Scour Hole (~100')

A steeper section with large boulder rock weirs every 20'. Scour hole (sink hole) is 4.5' deep, 6' diameter with a height difference of 2.5' between top and bottom lip of hole.

Site PCB-2c. Steep rock weirs

Site PCB-2c. Deep scour hole above rock weirs.

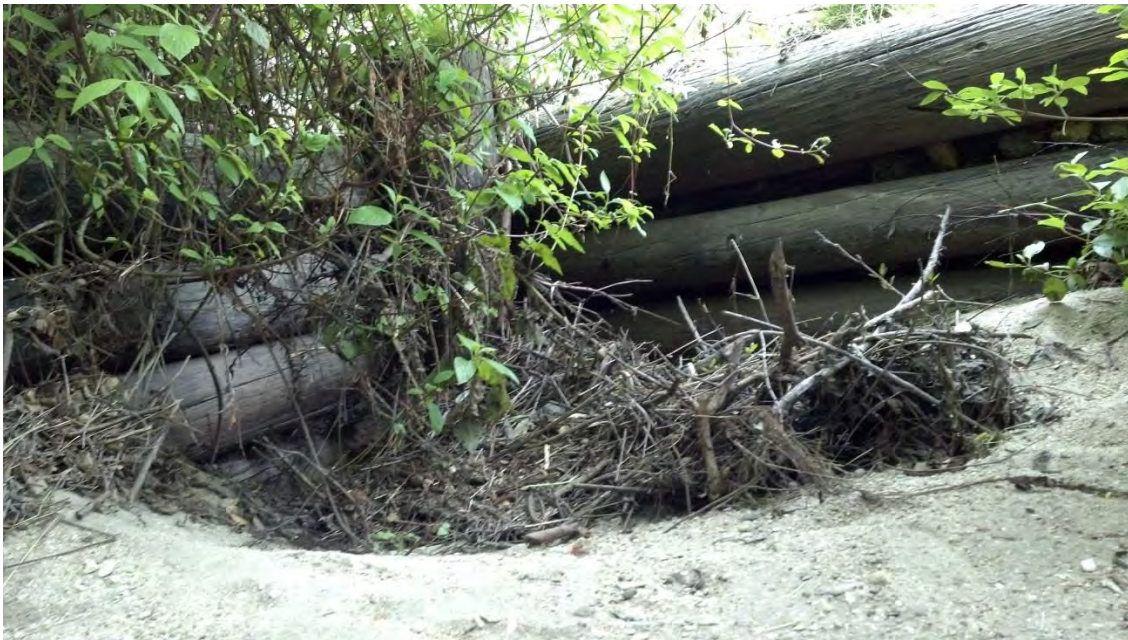
**2d) Scour hole to V-Notch Log Weir (~60')**  
UTM: 10N 0601184/40443877

No channel, just a 12" shallow cut through grass and brush. Log weir consists of 6, 12" diameter logs set in a sharp "V" pointing upstream. Scour hole, 4' deep, 1' diff. between weir top and bottom hole lip. Woody debris has collected in scour hole, and substrate is coarse sand.

Site PCB-2d. V-notch log weir, looking u/s.

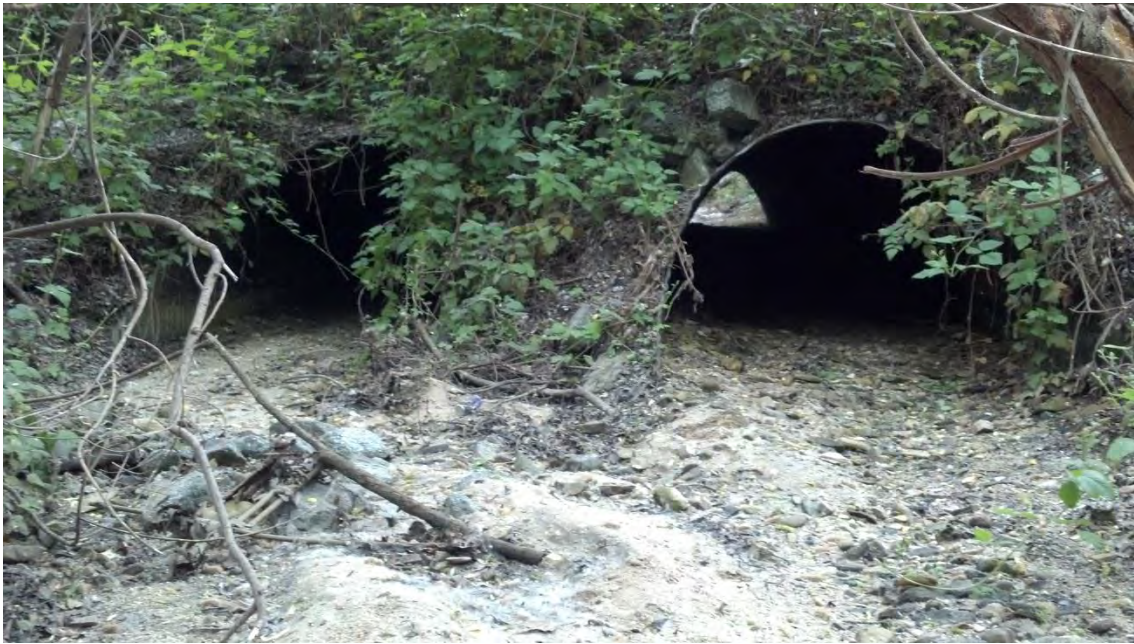
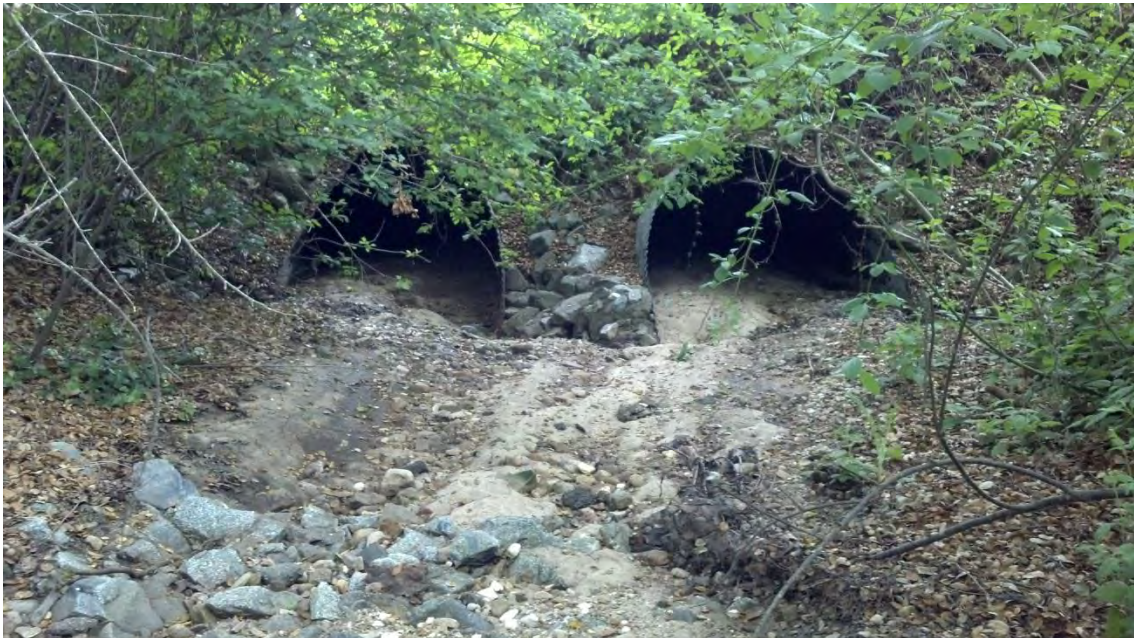
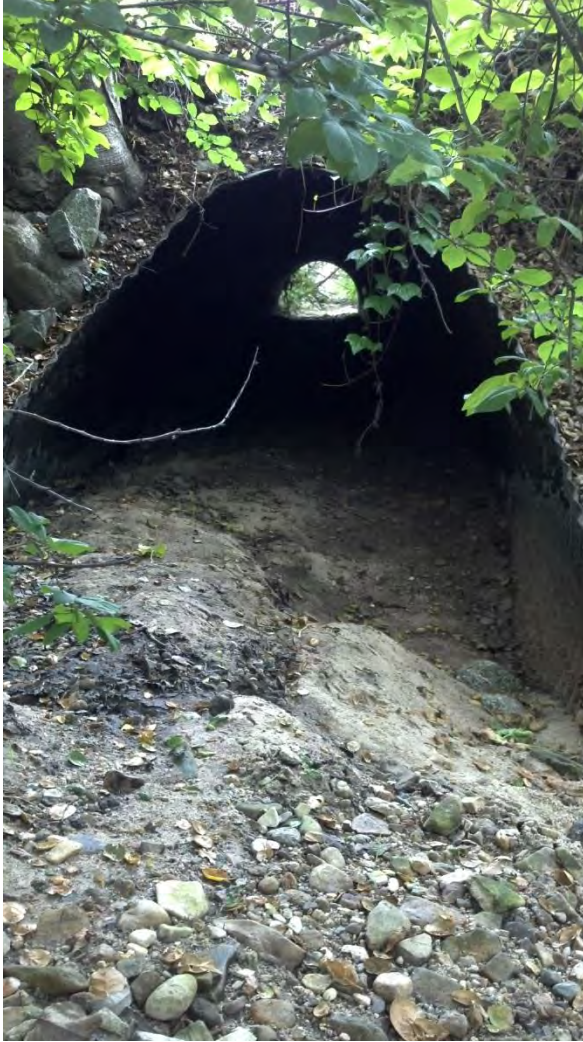
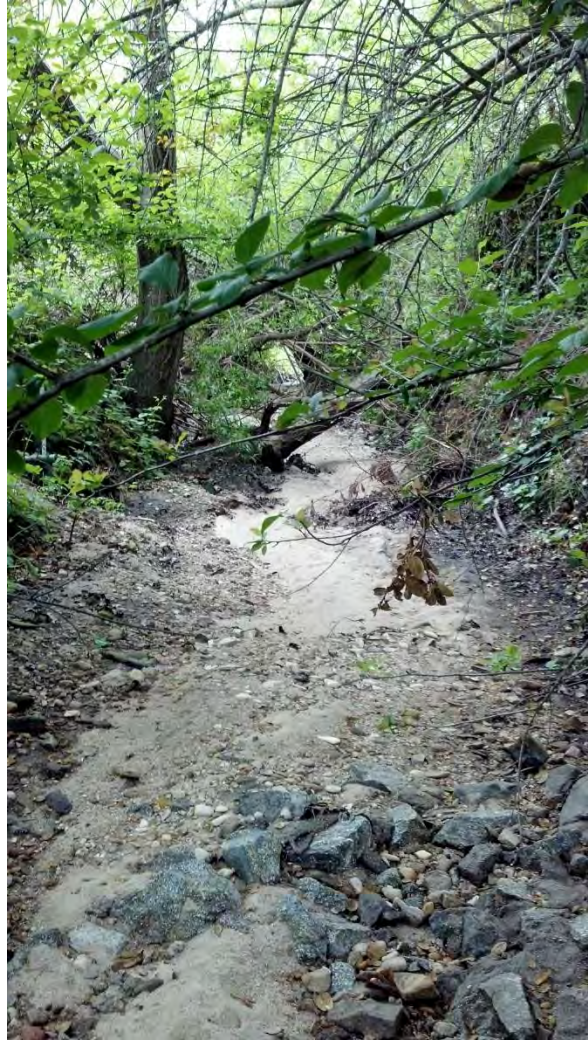
**Site PCB-3. Valley Greens Rd. Culverts (~100 yds.)**  
*Yellow* UTM: 10N 0601229/4043731 d/s end

Ten barriers were identified and surveyed on Potrero Creek (**Figure 2**). Of the four tributaries in this project, only Potrero Creek had culverts. Five locations along the creek have single or double culverts that were surveyed and analyzed with FishXing. All five are barriers to migrating steelhead with three of them being complete or nearly complete barriers at most flows (**Table 2**). The two sets of culverts under the Carmel Valley Athletic Club (CVAC) access roads are in very poor condition and are in dire need of removal or replacement to improve fish passage to the upper reaches of this tributary. The double culverts under Valley Greens Drive are under-sized and are frequently a velocity barrier.

Channel improves through this reach even with some LWD obstructions. There is a narrow band of riparian vegetation; substrate is a mix of sand and gravel.

Culverts: 2 corrugated metal arches (?), ~ 7' dia, 4' high, 80' long. Natural substrate bottom (sand/small gravel) but little variability; very little grade change; no scour pools.

**Site PCB-3. Valley Greens Rd. culverts - Looking upstream.**

**Site PCB-3. Valley Greens Rd. culverts - Looking downstream.**

**Site PCB-3.** Valley Greens Rd. – L/B culvert entrance and streambed looking upstream

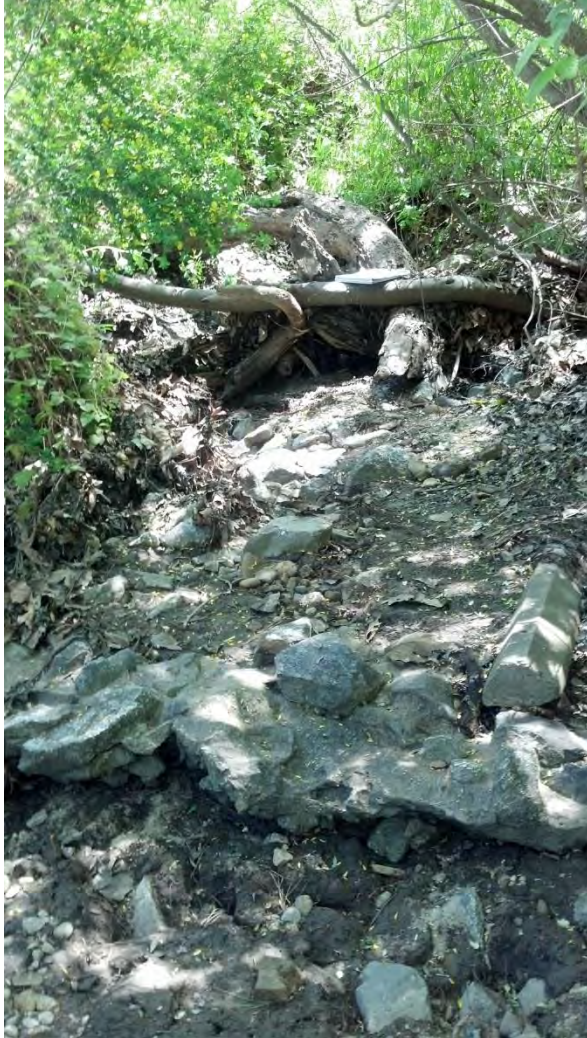
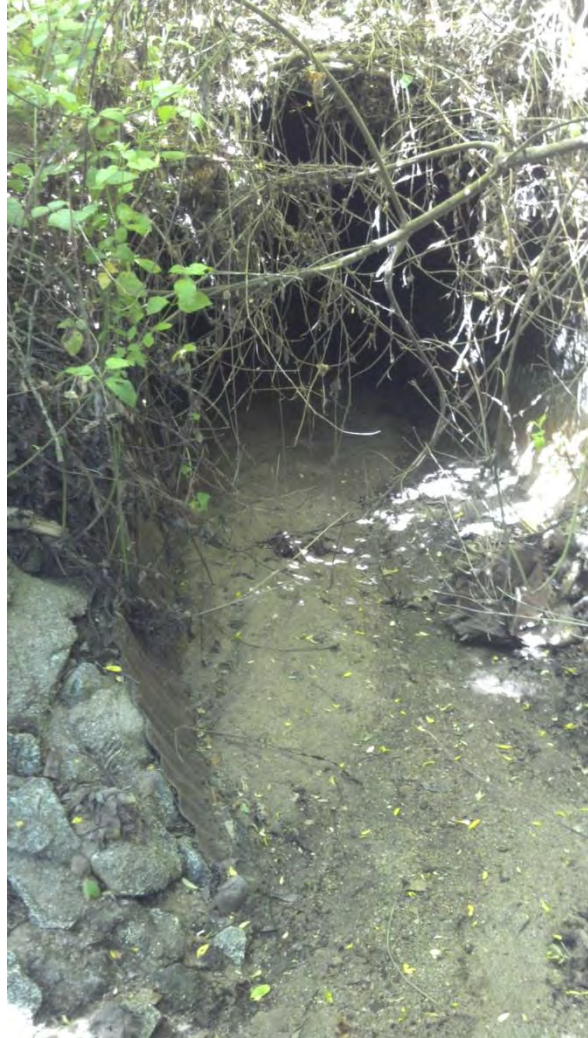
**Site PCB-4.**

Upstream of Valley Greens Road, the riparian vegetation gets thicker, but much of it is weedy. Substrate is muddy-sand and small riprap. Channel is confined.

- Photo 1) Riprap weir cemented across channel and log jam just d/s of culvert.  
Culvert outlet covered in vines. 6" of mud in pipe. Cement apron for 25'.
- Photo 2) Inlet to culvert. Granite riprap cemented on either side of inlet. 1' sand-mud.

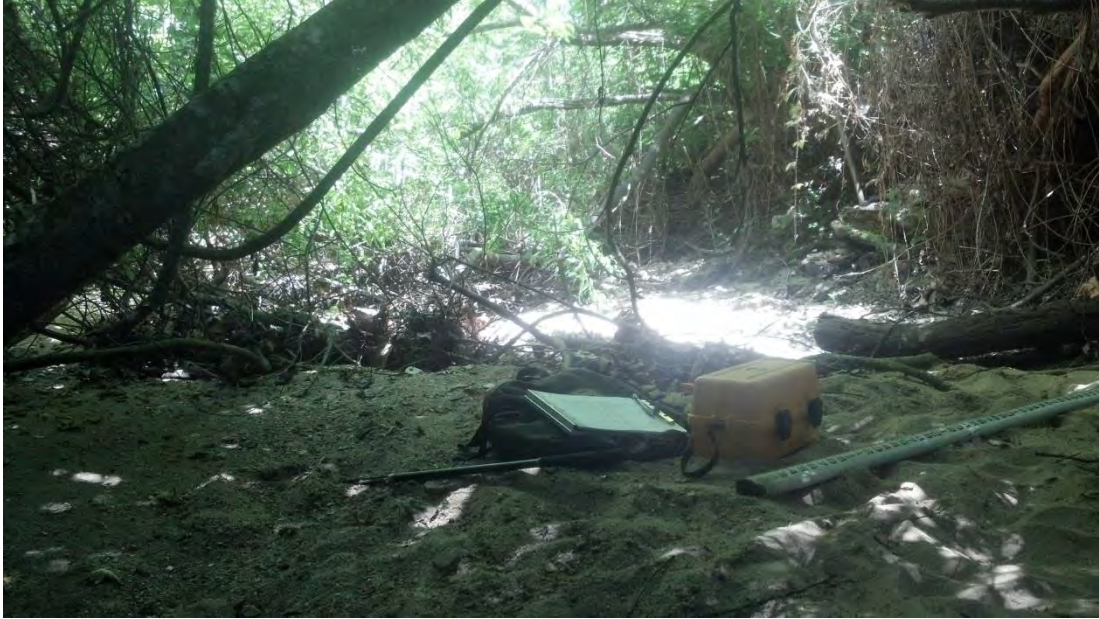
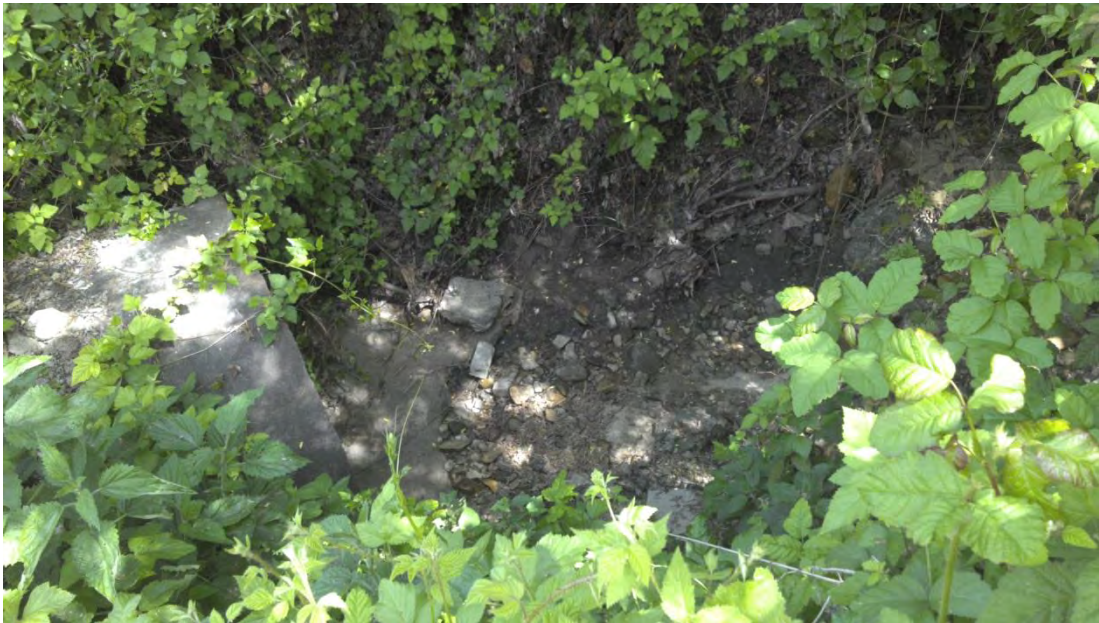
**Site PCB-5. CVAC culvert outlet and plunge pool.**

**Site PCB-5.** Plunge pool and d/s channel from culvert outlet.

**Site PCB-5.** Inlet and channel u/s of culvert.

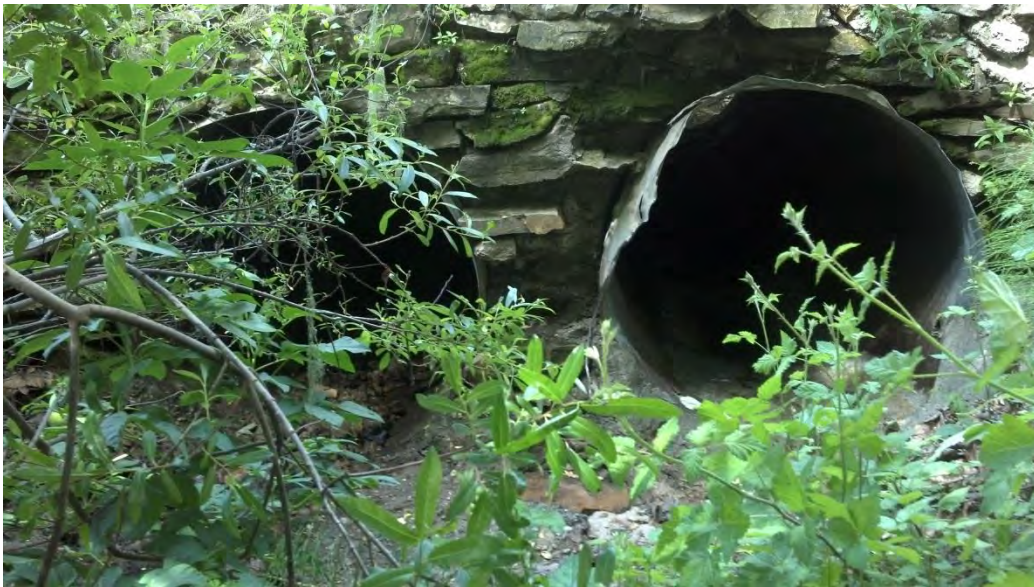
PCB-6. Inlets. Channel is more open here. Vegetation is vines/weedy/trees. Substrate is sand/small gravel and concrete rubble.

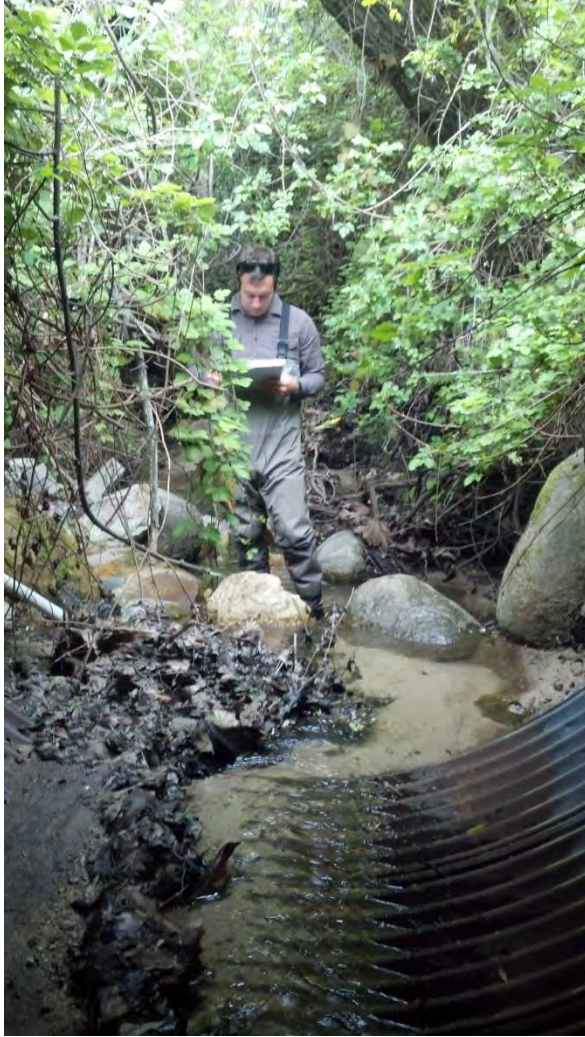
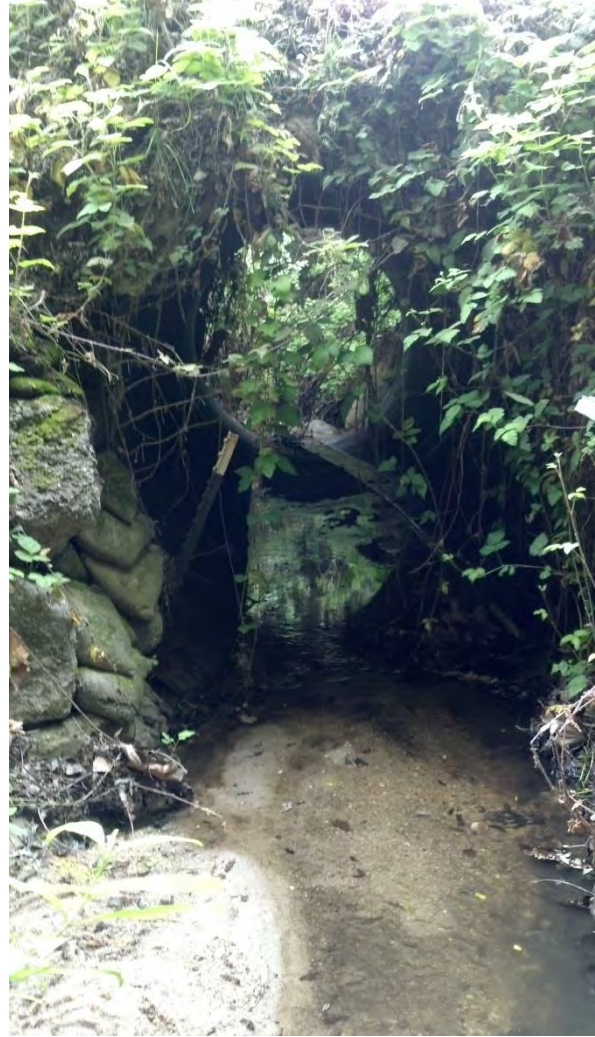
**Site PCB-7.** Photo #3. Looking d/s through culvert.  
Photo #4. Culvert inlet showing the narrow concrete and T-post entrance and sandy substrate.

PCB-7	Chamisal Pass	Culvert	Y	Yes	Yes	2.5	Keep eye on outlet, add structure to prevent down cutting.	
	PCB-8	Wild Boar Run	Bridge	G	No	No	2.1		
	PCB-9	Potrero Trail	Bridge	G	No	No	1.5		
	PCB-10	Potrero Trail	Bridge	G	No	No	1.0		
<b>San Clemente Creek</b> (~6.1 miles)	SCC-1 (a,b,c)	Confluence	Overgrown, log jams	Y	No	No	6.0	This reach is being redone with the SCD removal project.	
	SCC-2	Rancho San Clemente	Dam/Ladder/Spillway	R	No	No	**4 + 2.8	Replace old ladder with modern standards/design.	Poor condition, does not meet modern standards.
	SCC-2a	SCR / Dormody Rd.	Divided Lake/pond	Y	No	No	**3.9 + 2.8	?	
	SCC-3	SCR / Dormody Rd.	Inlet Culvert	G	No	No	3.8	Replace screens, modernize design.	
	SCC-4	SCR / Dormody Rd.	Summer Dam	R	Partial	No	**3.5 + 2.8	Remove.	
	SCC-5	SCR / Dormody Rd.	Bridge	G	No	No	3.2		
	SCC-6	SCR / Dormody Rd.	Bridge	G	No	No	3.2		
	SCC-7	SCR / Dormody Rd.	Summer Dam	Y/R	Yes	No	3.2	Remove.

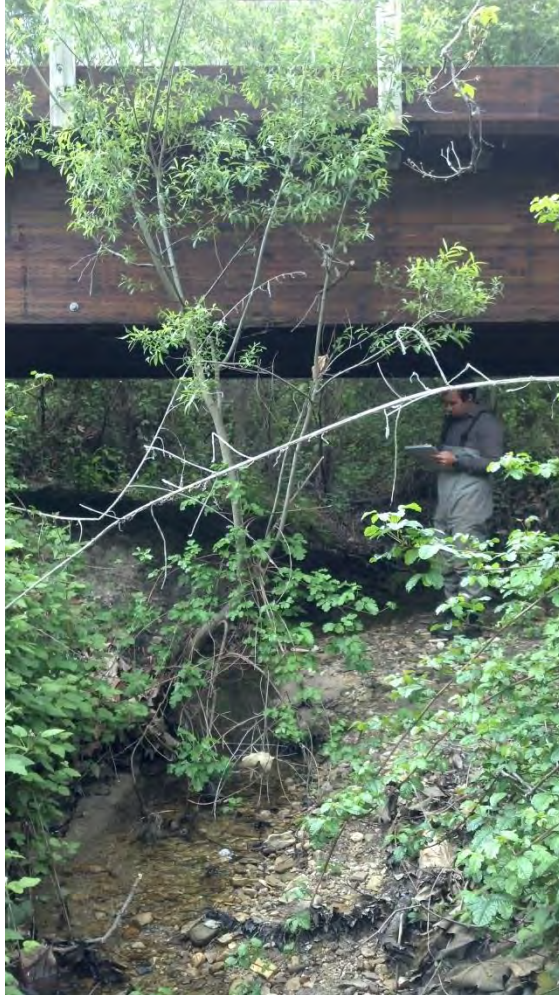
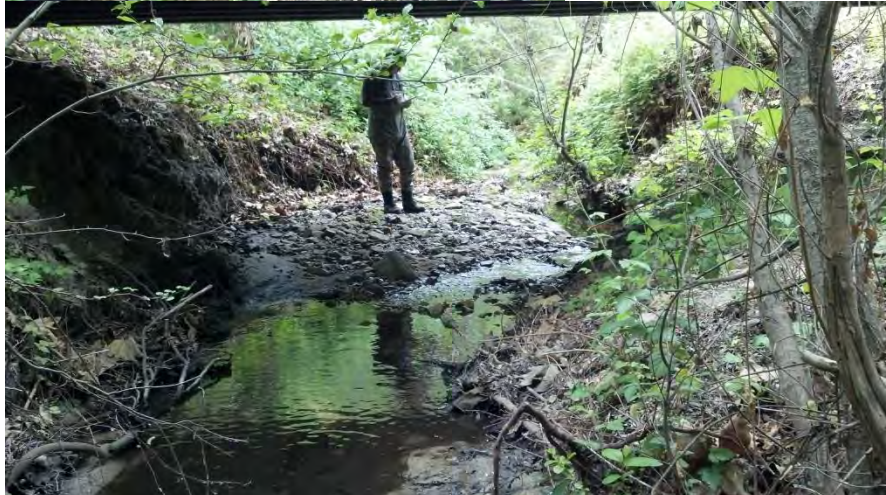
**Site PCB-8.**  
*Green*

New, clear-span bridge. Not blocking any flow.

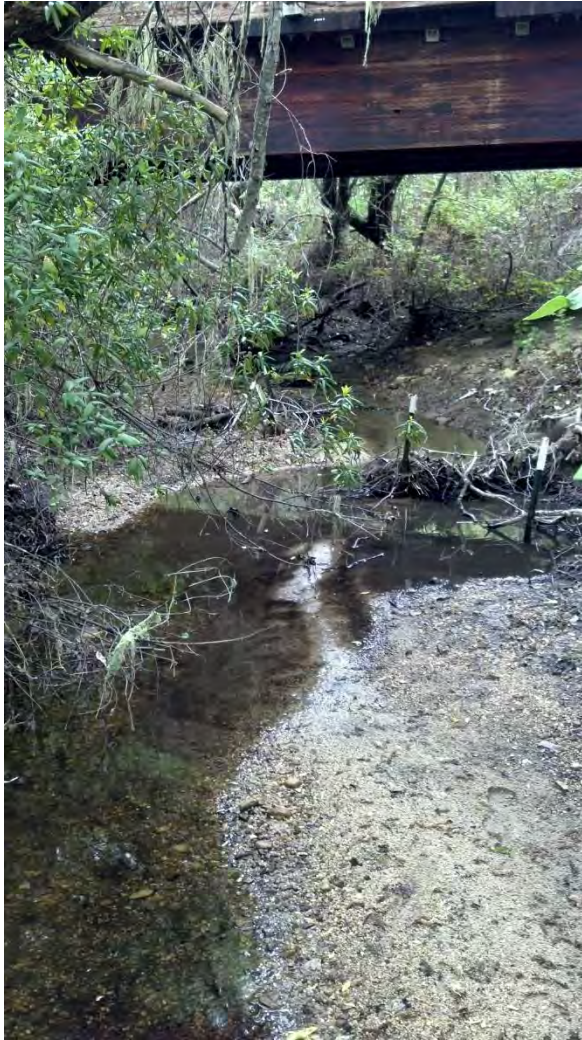
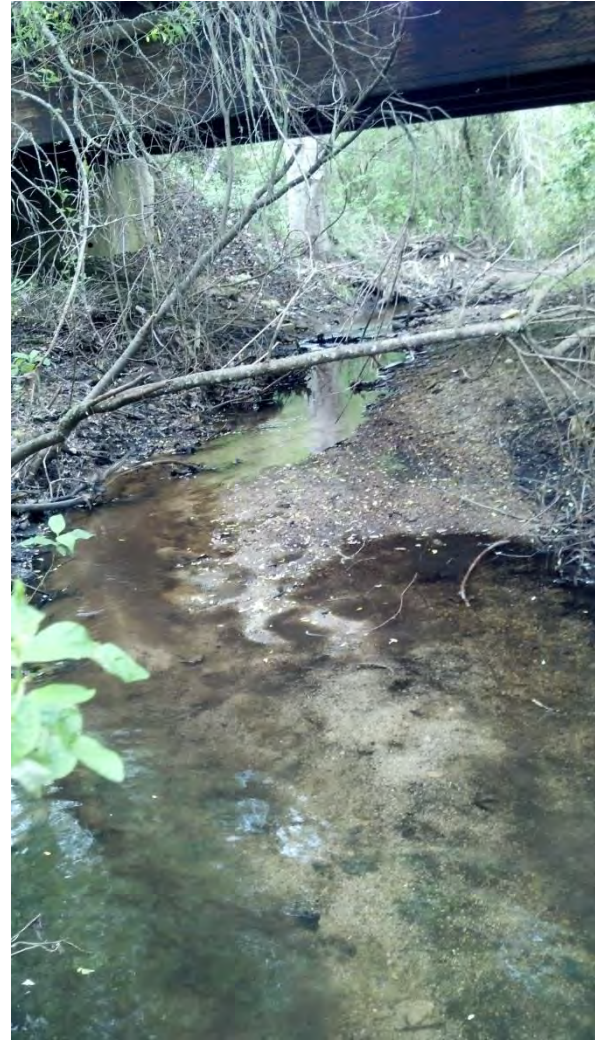
**Site PCB-9. Santa Lucia Preserve, Bridge. Potrero Trail Rd.**

New, clear-span bridge, substrate is very sandy and there is a line of T-posts across channel d/s of bridge but it's not blocking any flow.

**Site PCB-9.** Photo #1 looking u/s. Note T-posts. Photo #2 looking d/s, note sandy substrate.

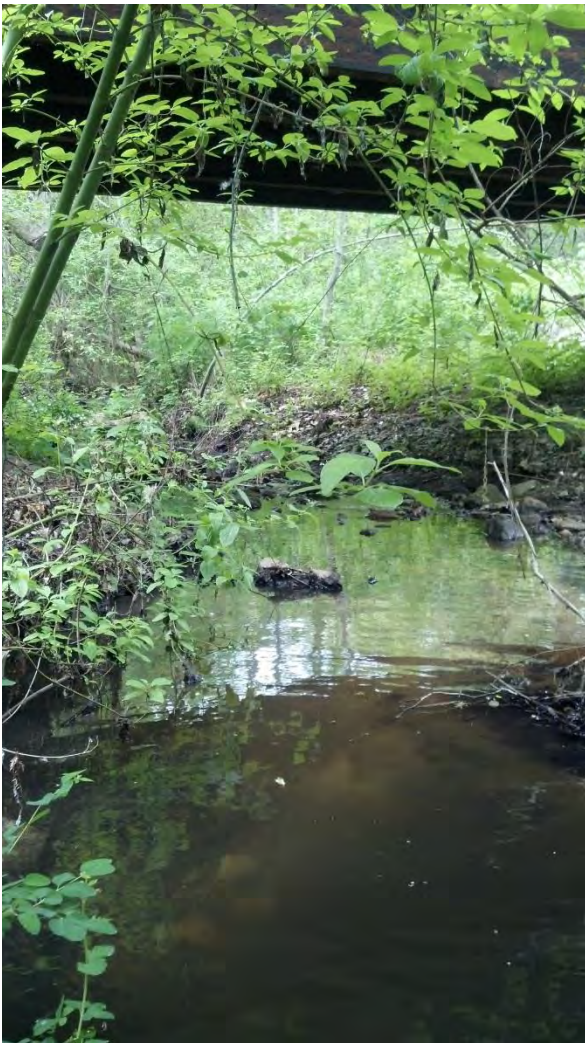
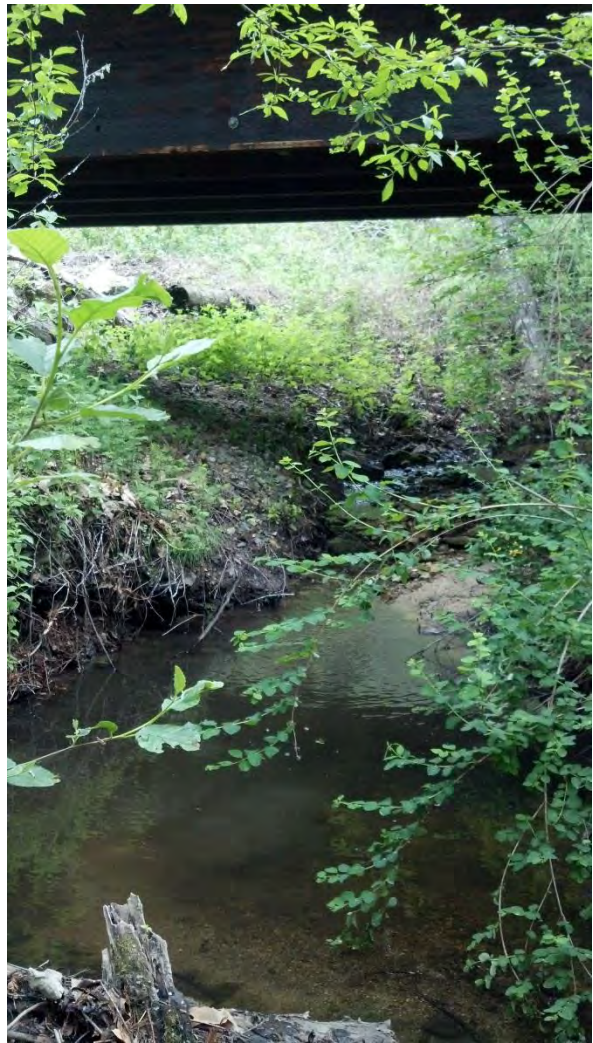
New, clear-span bridge. Not a barrier. Substrate is improving with more gravel/small rock and less sand. Also more pool and riffle habitat than further d/s.

Site PCB-10. Photo #1. Looking u/s.

Photo #2. Looking d/s.

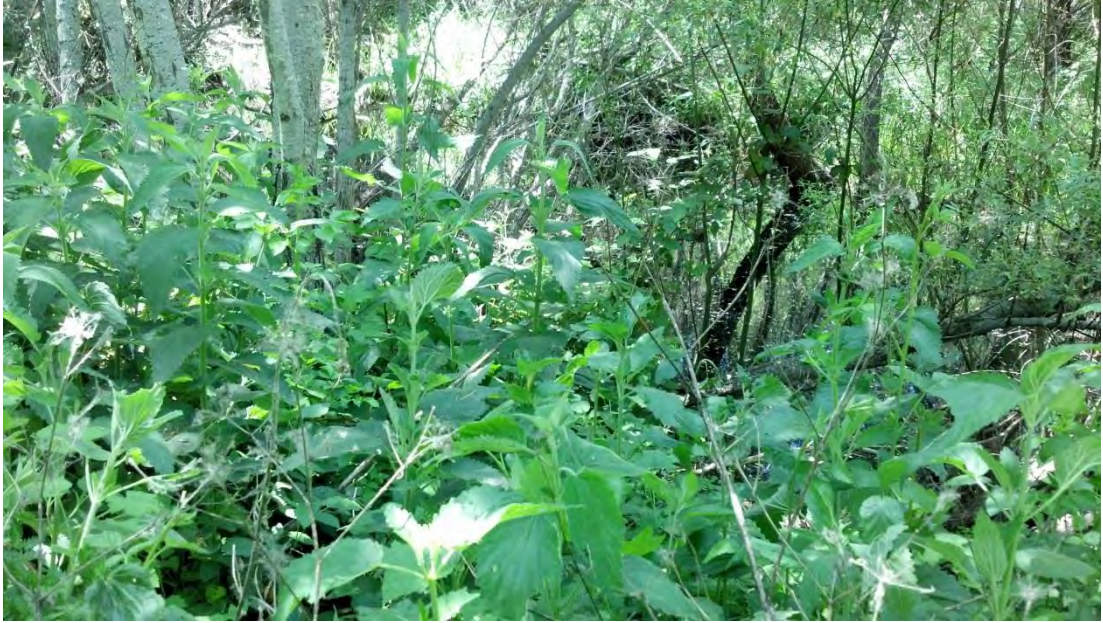
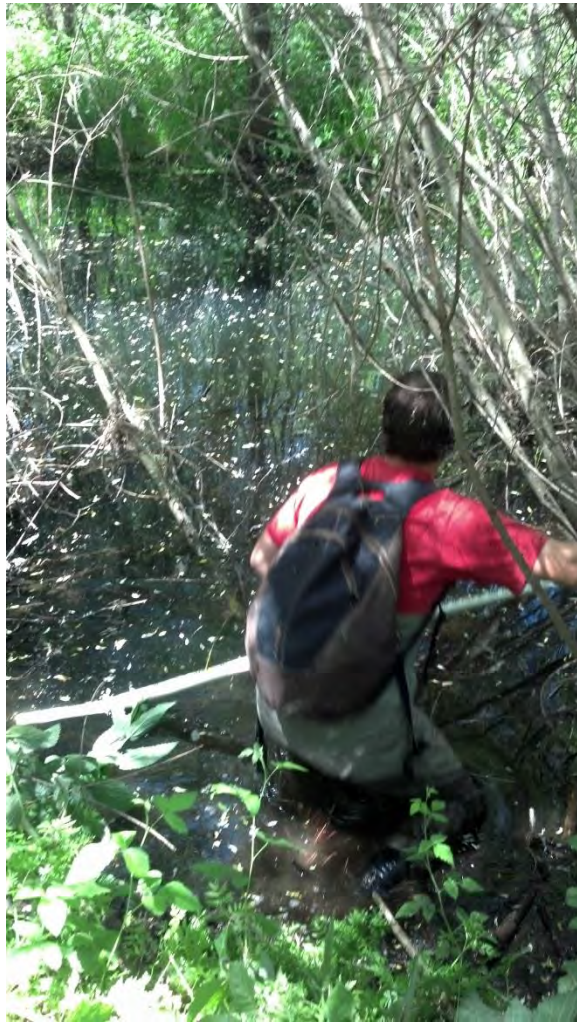
**Site SCC-1.** In 2012 the confluence was very overgrown with thick vegetation (see photos below) and was difficult to examine. In 2013, this entire reach was stripped of vegetation and is being reconfigured as part of the San Clemente Dam Removal Project.

**SCC-1a** - SCR inundation zone log jams. These log jams will be removed as part of the SCD removal project.

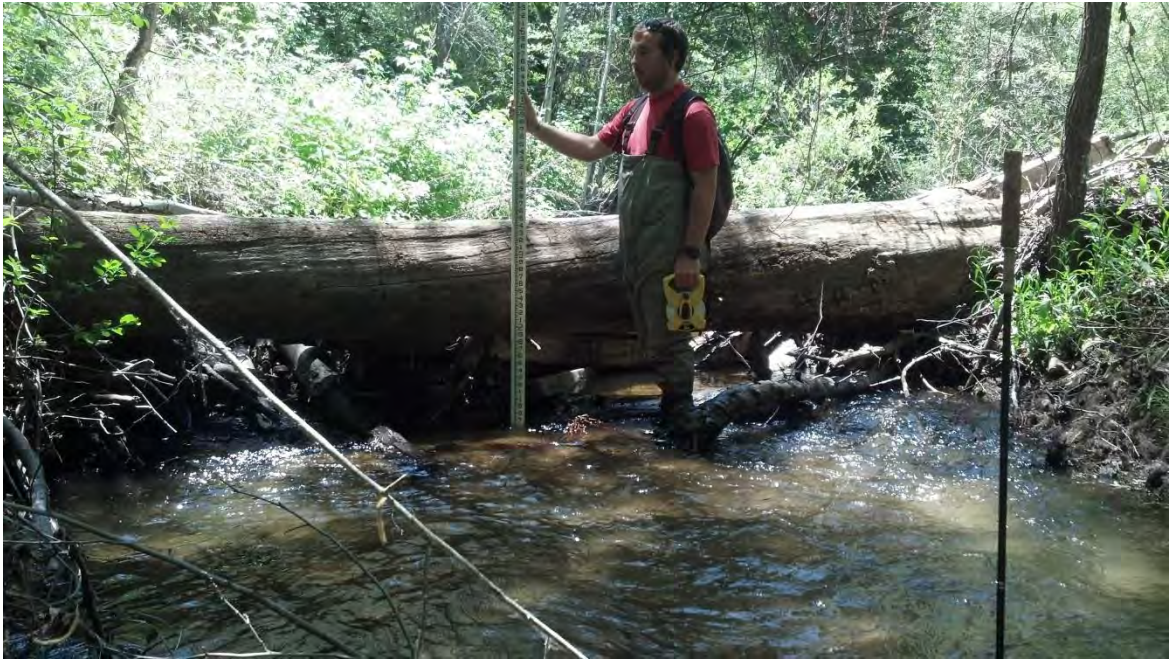
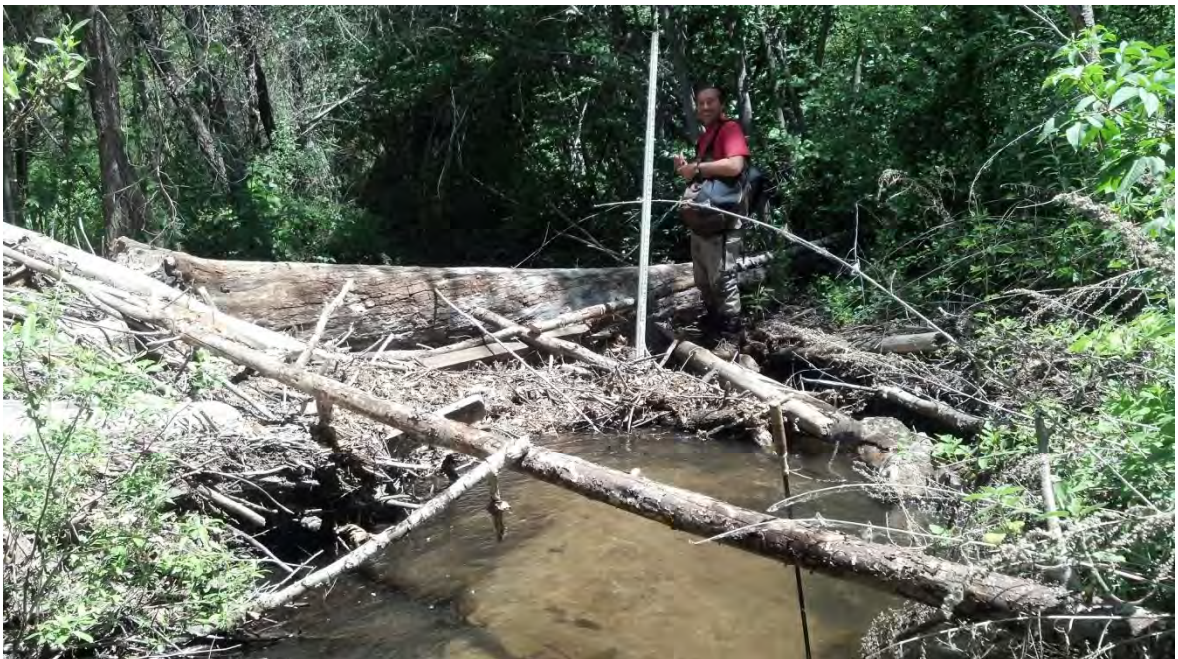
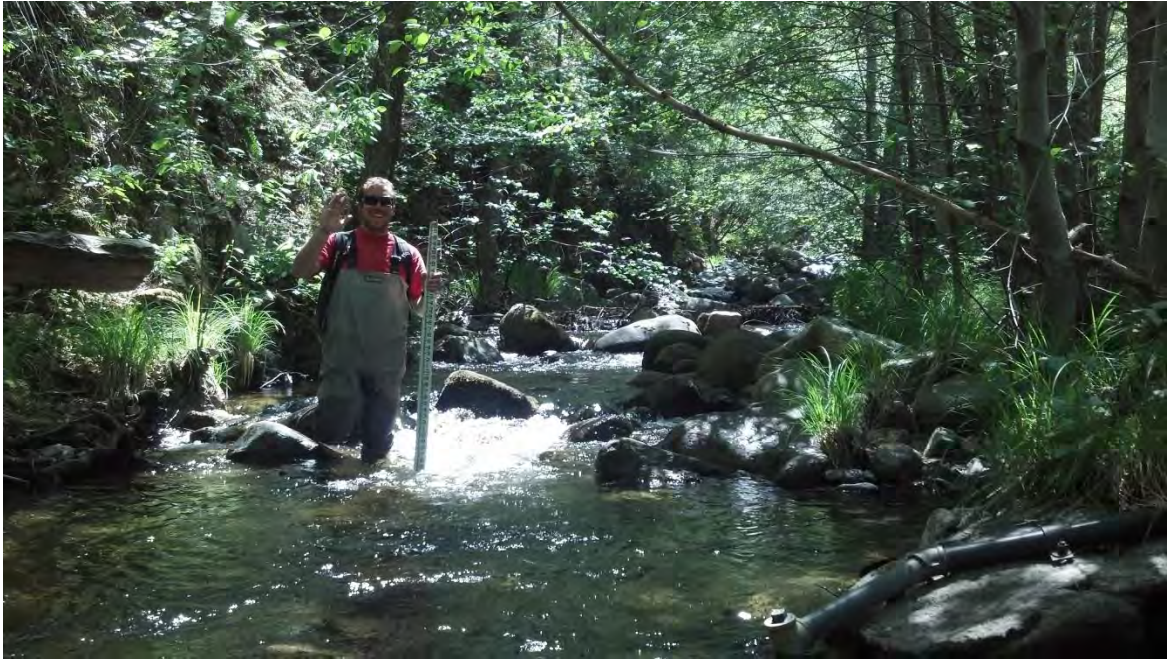
**SCC-1 and 1a,b,c** - The entire SCC inundation zone is being completely modified. The Carmel River will be re-routed through this canyon (in 2015) and all existing vegetation has been removed. It is unclear whether the existing SCC channel will be passable in the 2013/14 winter.

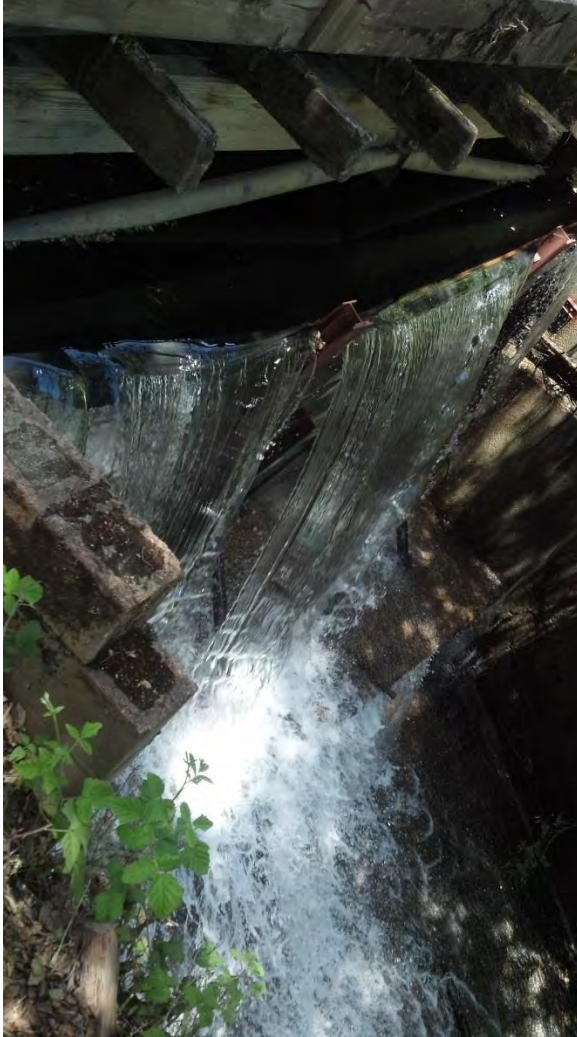
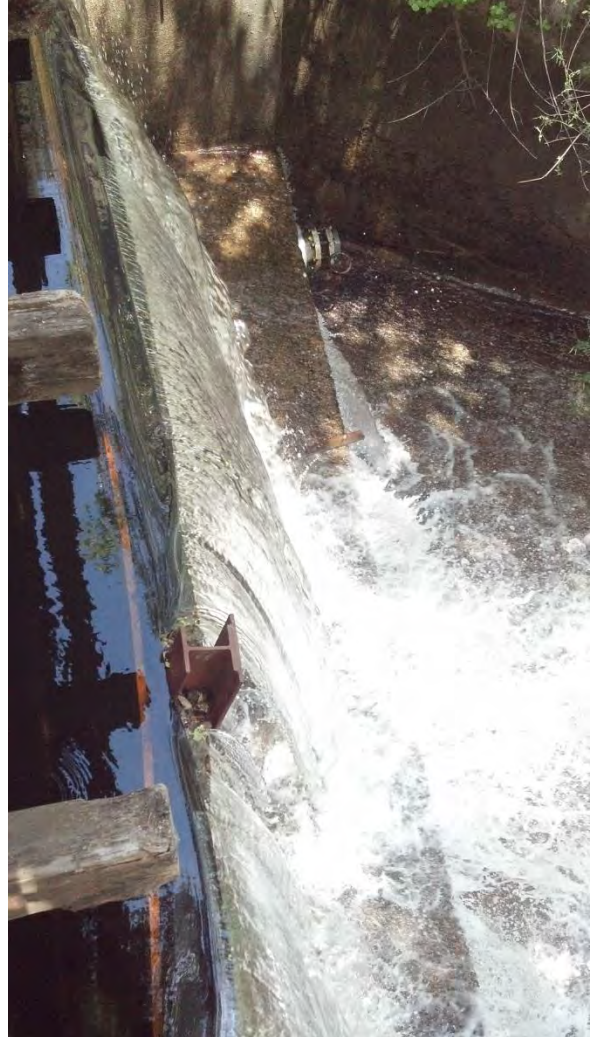
The dam is constructed with steel I-beams, braced with 3" metal pipes, supporting a 10' high 4x10' beam wall covered with black plastic on top of a concrete base structure. The dam face was bowing significantly so I did not feel safe working below it. MPWMD modified the outlet valve works in 2002 to improve the bypass of water in the spring as the reservoir fills. Dormody Road crosses above the spillway at the dam.

Trout Dam and Reservoir during construction - 1962.  
(photos from SCR Facebook page).
