**ASSESSMENT OF STEELHEAD PASSAGE BARRIERS IN  
PORTIONS OF FOUR TRIBUTARIES TO THE CARMEL RIVER**

**Monterey Peninsula Water Management District  
IRWM - PROJECT 3**

**Final Project Report - July 2014**

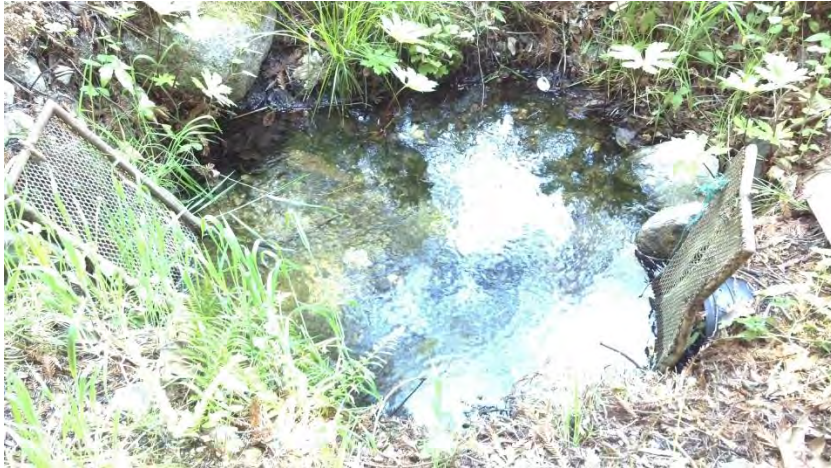
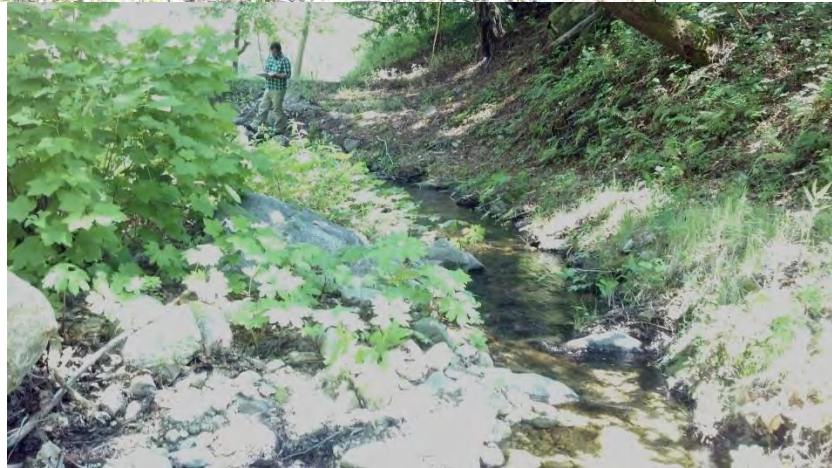
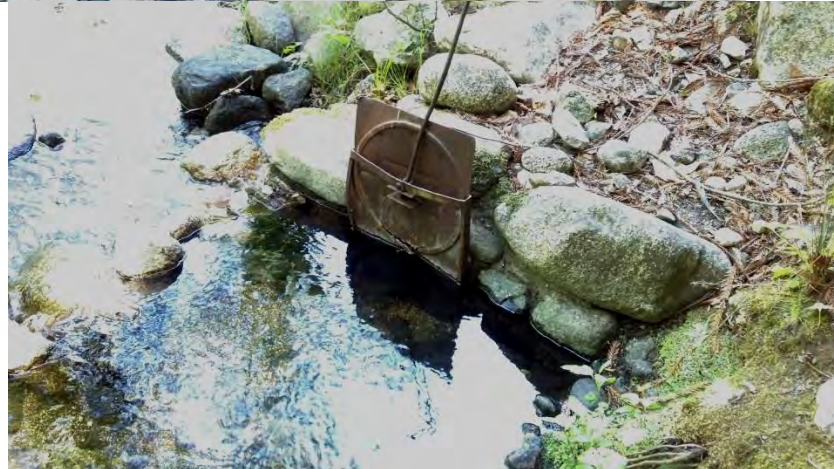
**SCC-3. San Clemente Rancho Trout Lake Inlet Culvert.**  
**GREEN** 36° 25' 30.4" / 121° 43' 45.7"  
5/21/2012, ~3 cfs.

The inlet diverts water from a San Clemente Creek side channel through a metal port (lower photo) into a screened pool then through a culvert into the stocked trout side of the pond. The screens are loosely placed and are in disrepair and would not keep fish from moving through the pipe in either direction.

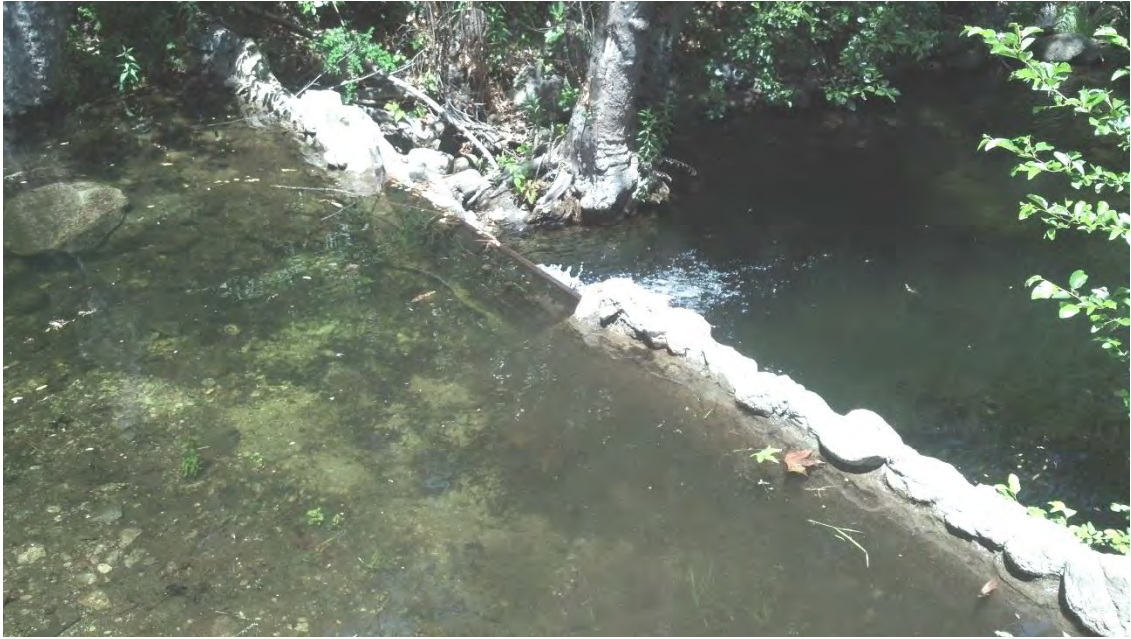
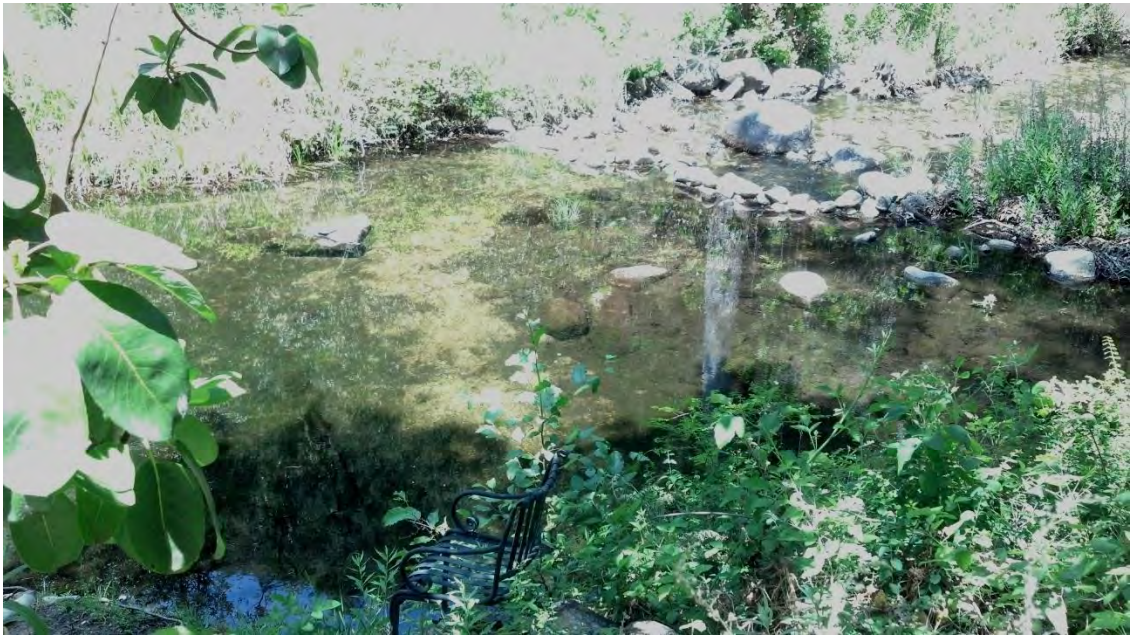
Located across from the clubhouse, this dam is constructed from cemented large cobbles and a 2.8' deep, flat-bottomed, concrete V-notch holding four planks. The substrate below the dam consists of large cobble/boulders while above the dam its primarily sand. The slack water pool extends 84 feet upstream. While the boards are in place this dam is a complete migration barrier. Without the boards, the wall may still be a velocity barrier and could easily trap LWD.

**SCC-4.** These two photos show the summer dam from upstream and the large amount of sand deposits behind the dam.

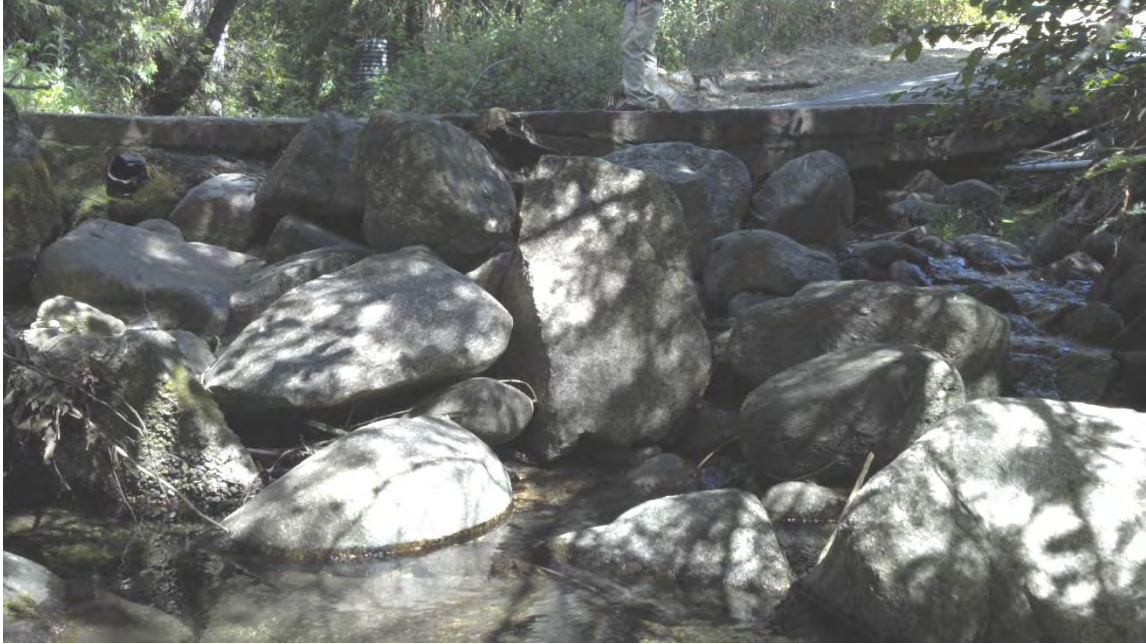
Located on San Clemente Creek, ~0.25 mile downstream from the entrance gate, this concrete ford is a major migration barrier that needs to be replaced with a small bridge. The old culvert is completely smashed and filled with debris. At this flow, 100% of the stream passes underneath the left bank side of the ford but no fish can pass due to failing concrete and a large amount of woody debris. At higher flows, water would go over the top of the ford but the downstream boulders are likely a barrier as well. Above the ford, the substrate is shallow sand.

Boulder substrate downstream of ford.

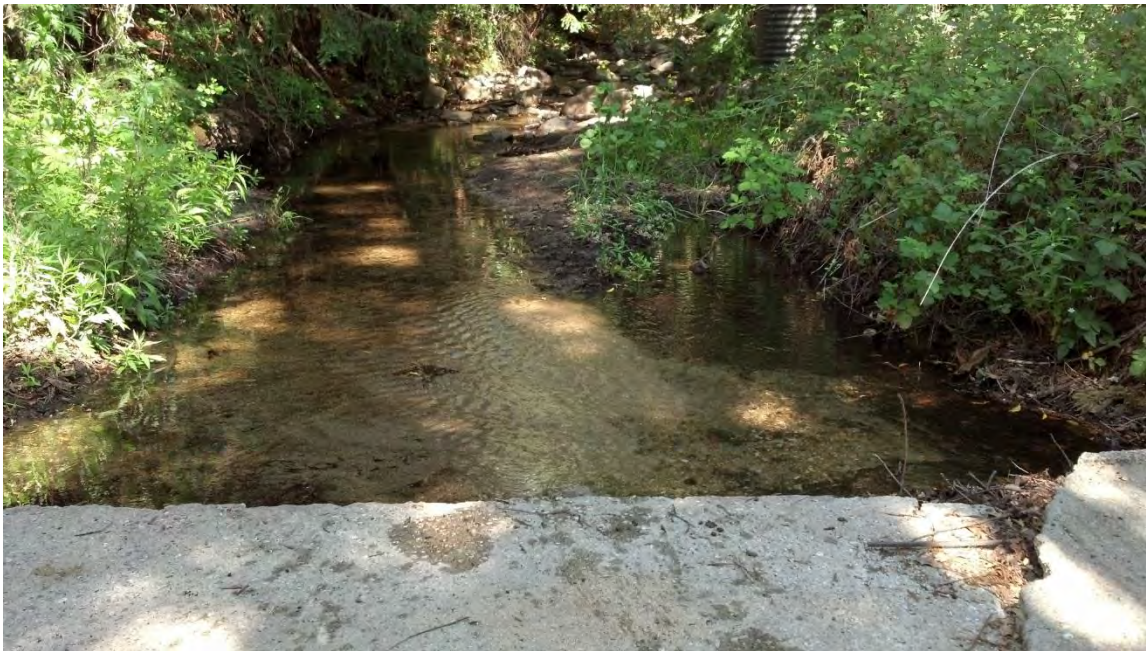
Sand substrate upstream of ford.

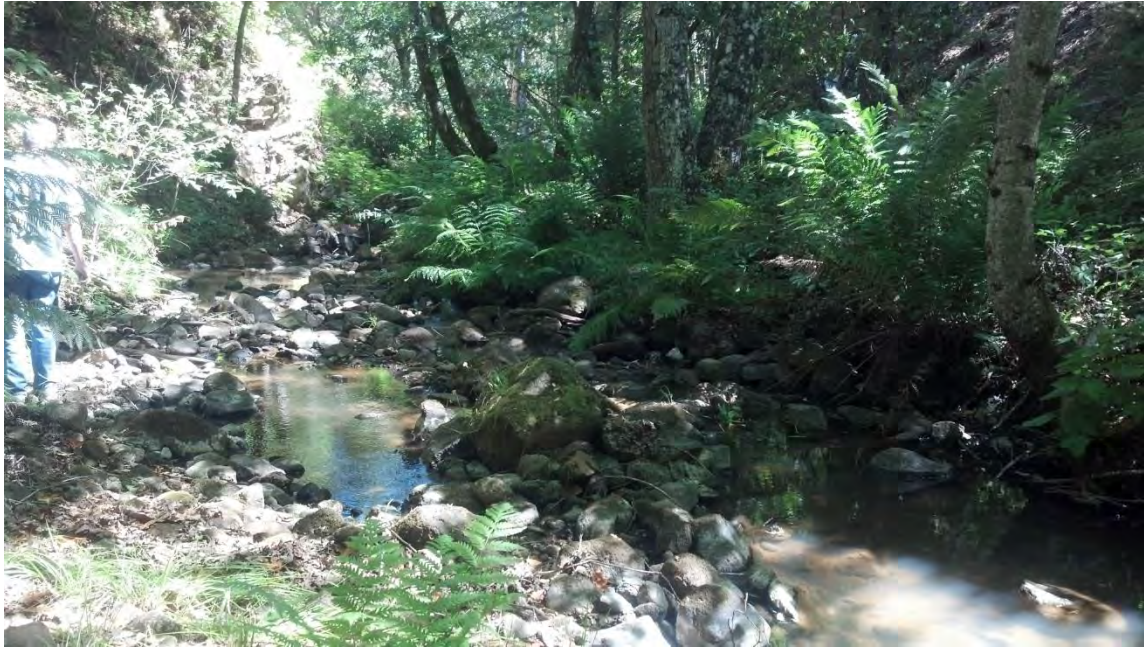
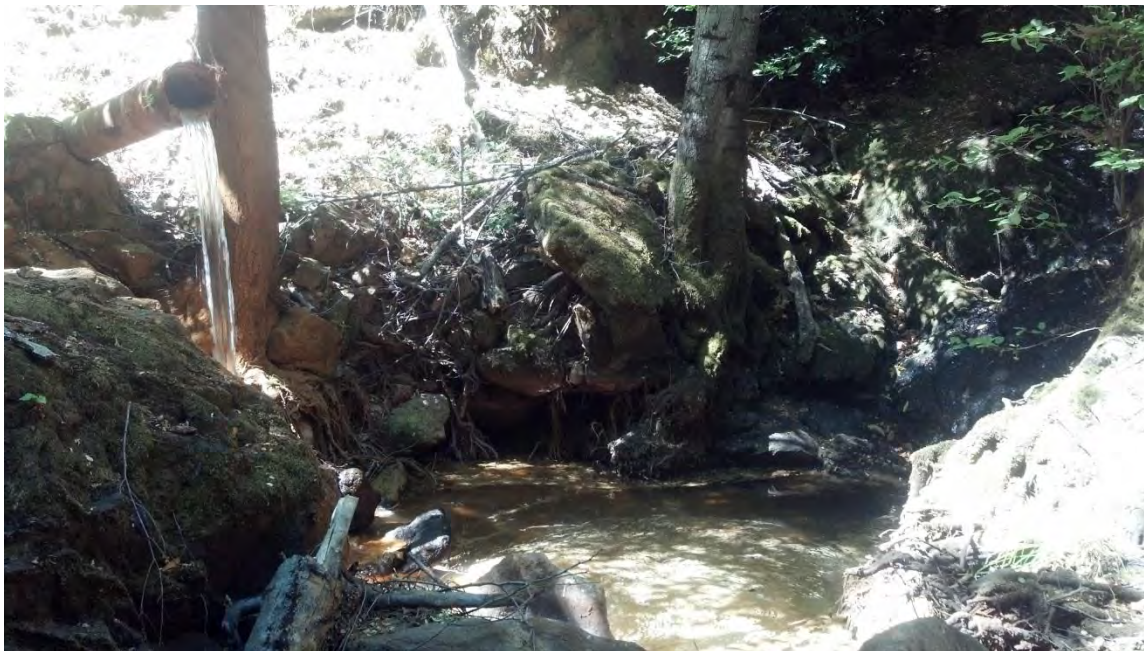
This ~70' high waterfall is a total/complete barrier for upstream fish migration. We observed one fish (~7") that looked sick in the outlet pool. The water quality appeared poor.

Photos below show: 1) the creek channel downstream of the dam; and 2) the dam's outlet pipe and plunge pool.

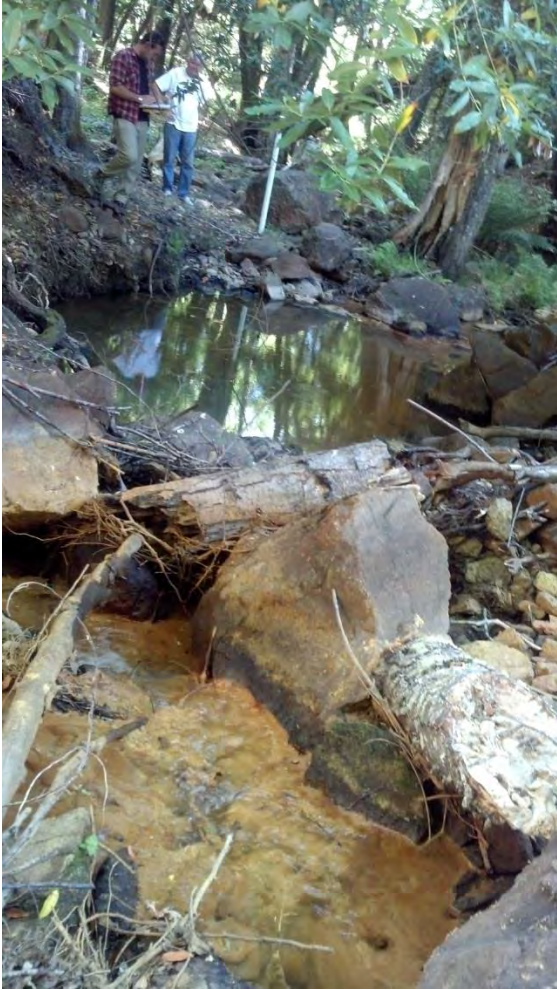
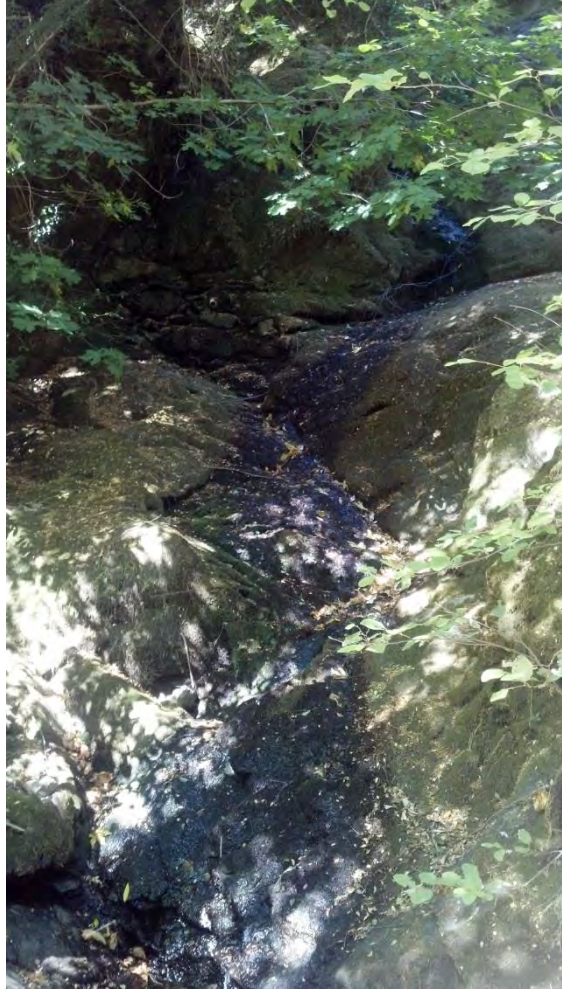
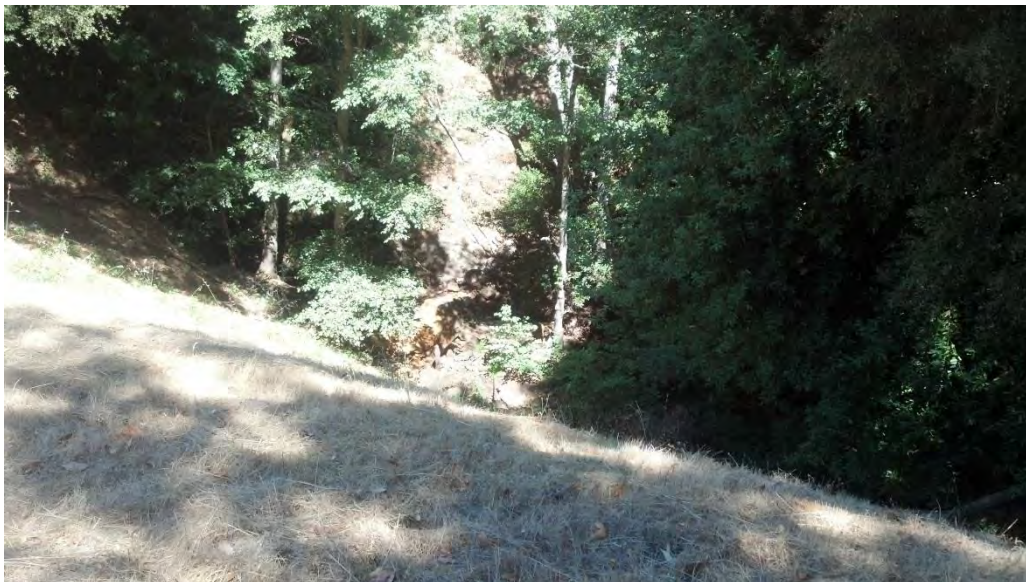
Photos below show: 1) poor WQ in the plunge pool; 2) looking up the waterfall/chute (dry); and 3) looking down the dam face towards the plunge pool.

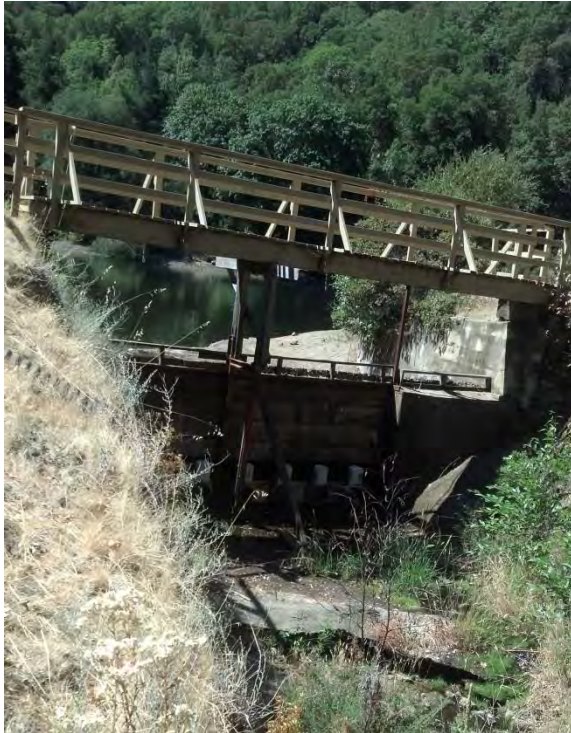
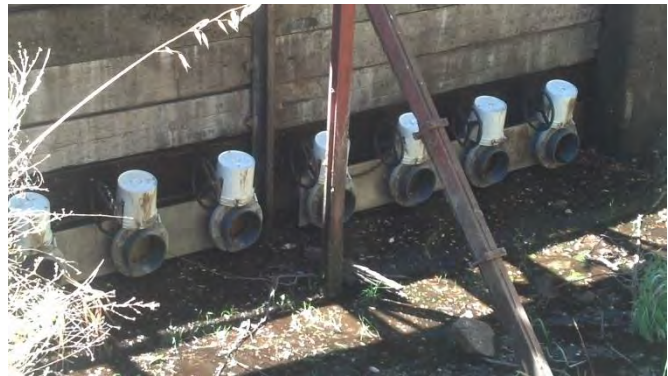
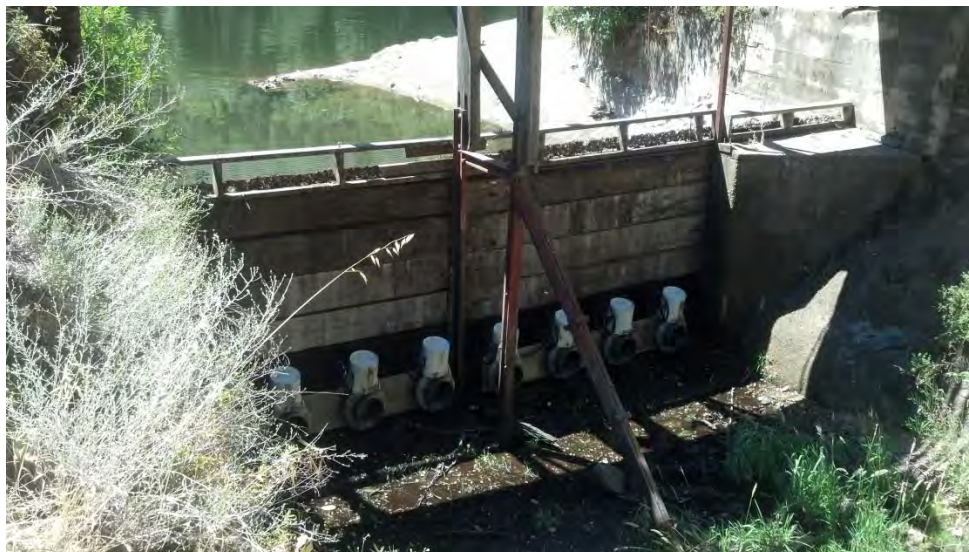
**SCC-13. White Rock Lake Dam, Black Creek**  
**See Notes** 36° 24' 43.1" / 121° 46' 21.2"  
8/6/2012

Built in 1926, this dam is located on White Rock Gun Club property and is stocked with catchable-sized trout. While it would be a complete barrier to steelhead migration, it is located upstream of two natural barriers (SCC-11 and SCC-12) so it should not be significantly impacting natural steelhead populations.

Photos below show: 1) the Black Rock Creek Dam and foot bridge; 2) and 3) close-up detail of the outlet works.

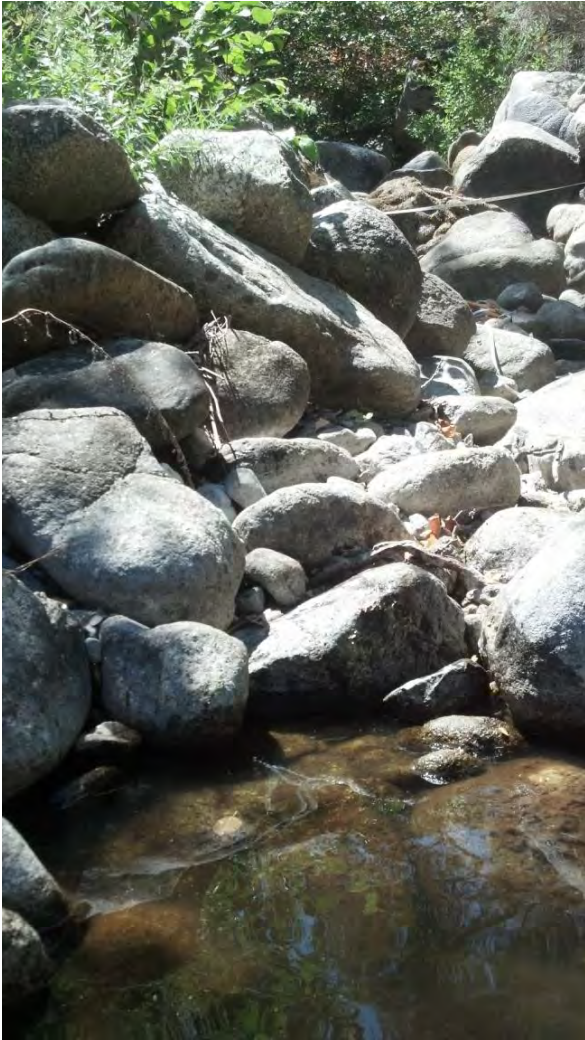
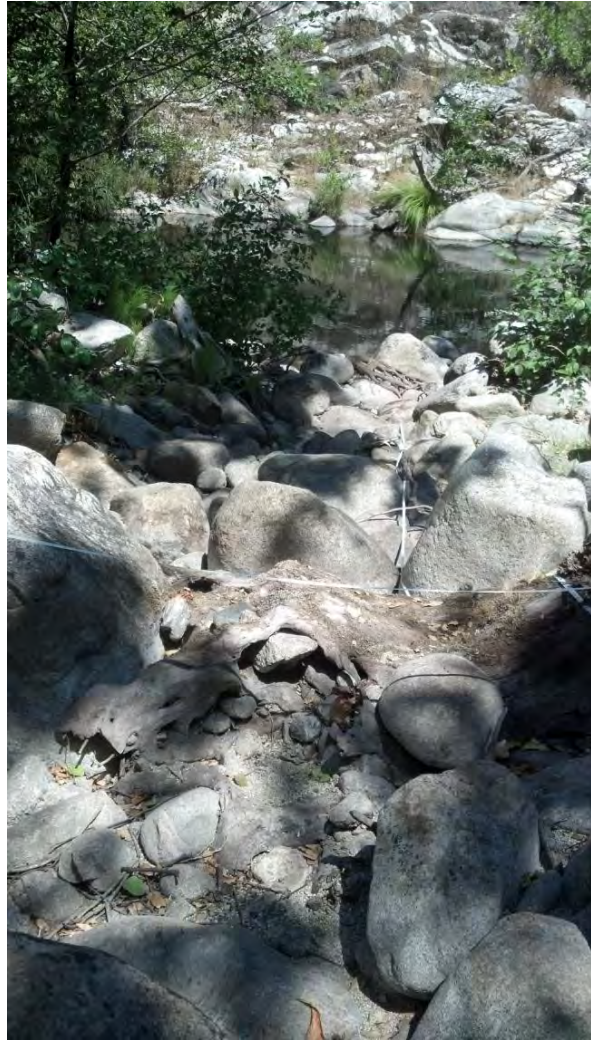
**Site PC-1. Pine Creek Confluence with Carmel River.**

Although not a total barrier to migrating steelhead, clearly this natural feature can block adult upstream migration to spawning glides during low flow years. The loss of juvenile fish in the spring is also possible if the tributary dries too early for fish to reach the main river. In addition, as the Carmel River channel continues to down cut from the lack of sediment recruitment, the lower Pine Creek cascade continues to steepen. Physically modifying this reach seems implausible due to the remote nature of the area and the naturally steep watershed of the creek. Additional sediment releases from upstream and good water management practices would seem to offer the best chance of maintaining adequate fish passage in this important tributary.

Photo 1 (left side): Looking up Pine Cr. cascade from Carmel River pool.

Photo 2 (right side): Looking down the cascade towards the Carmel River pool.

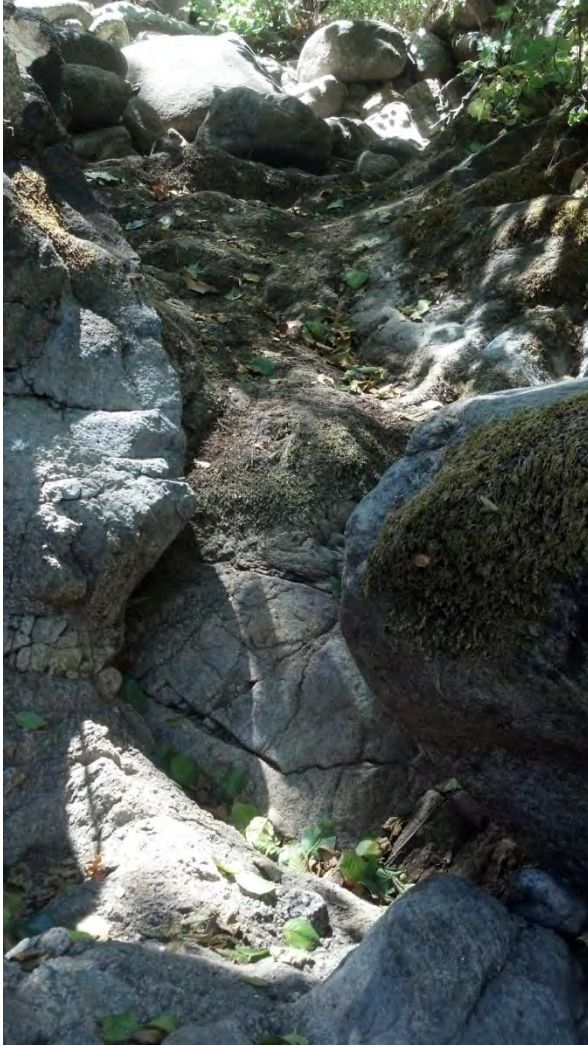
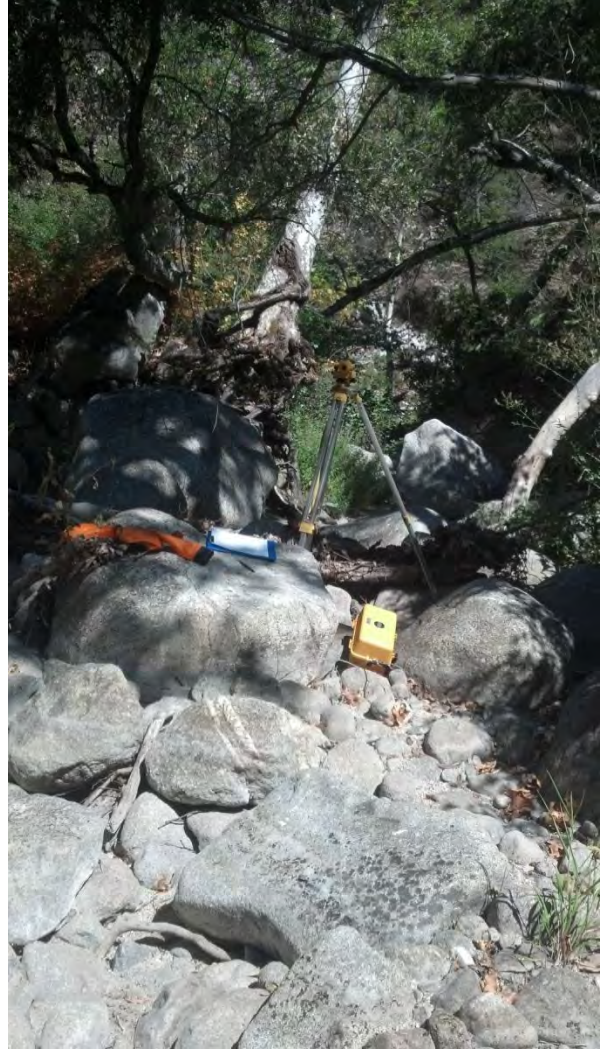
Photo 5) (left side): Bedrock chute ~60 feet upstream of the confluence.  
Photo 6) (right side): Steep boulders ~130 feet upstream of confluence.

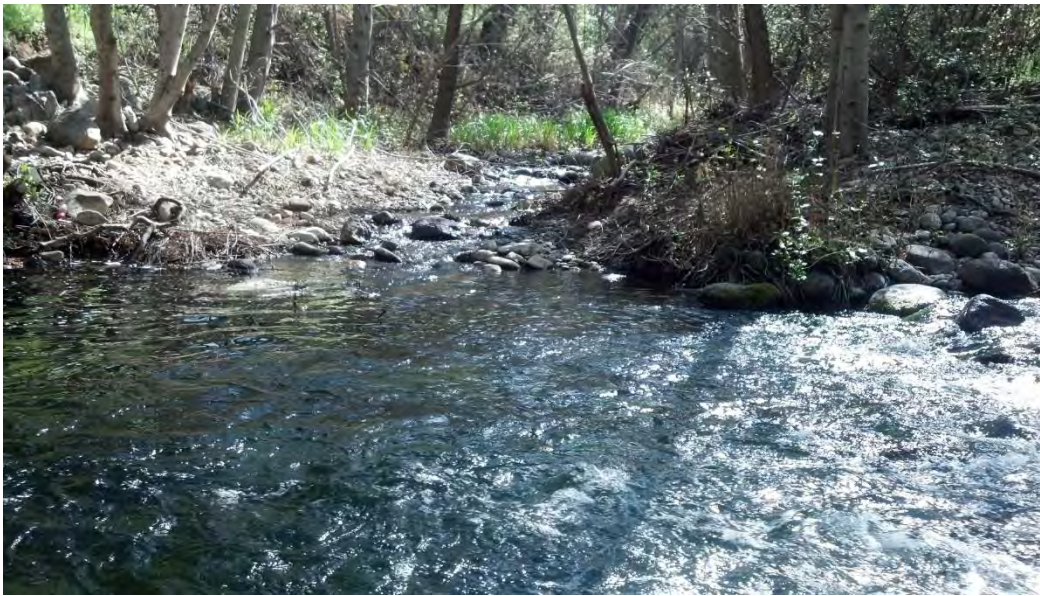
Site LCC-1. Cachagua Creek Confluence.

The confluence was observed during the redd survey on March 27, 2013. Carmel River flow was ~20 cfs and Cachagua Creek flow was ~1 cfs. There does not appear to be any barriers to steelhead migration.

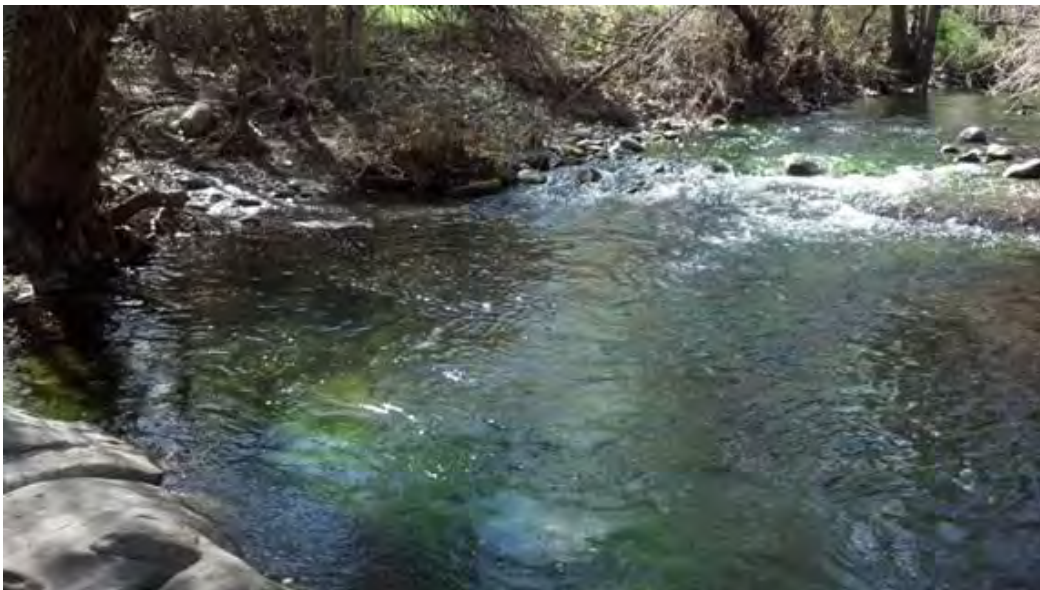
Site LCC-1. Cachagua Creek entering large CR pool from left side of photo.

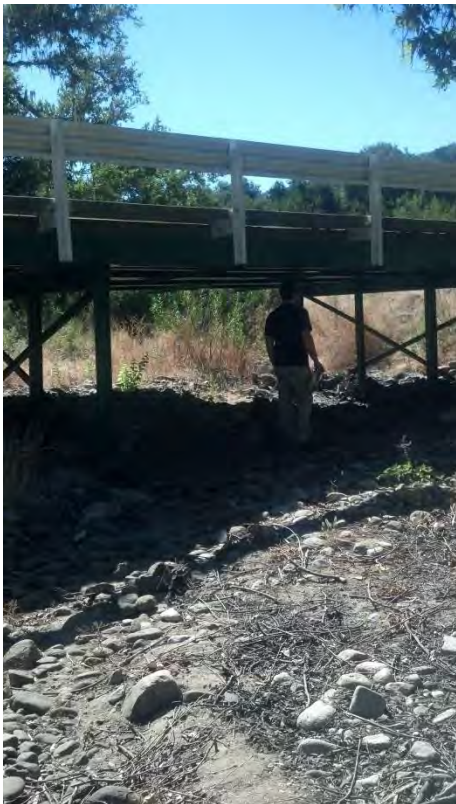
Although there are bridge supports in the center of the channel, they are unlikely to cause a migration barrier. Channel is wide and shallow. Substrate is a boulder/cobble/gravel mix and the riparian vegetation is sparse.

Site LCC-2. Nason Road Bridge. Looking u/s.

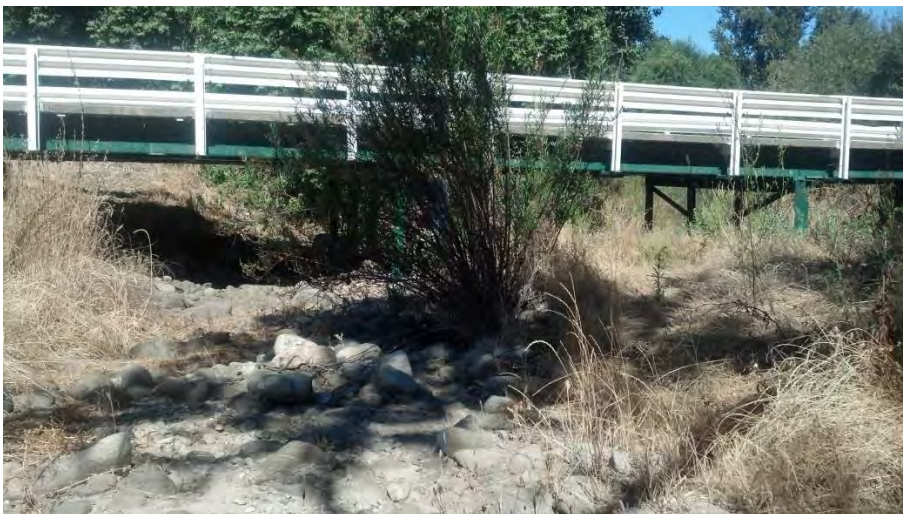
Site LCC-2. Nason Road Bridge. Looking d/s.

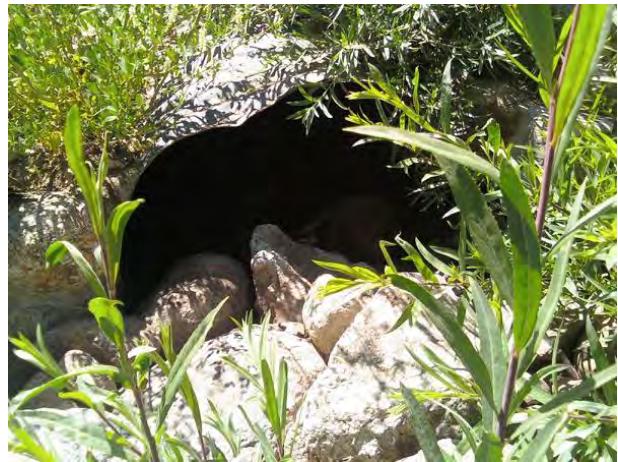
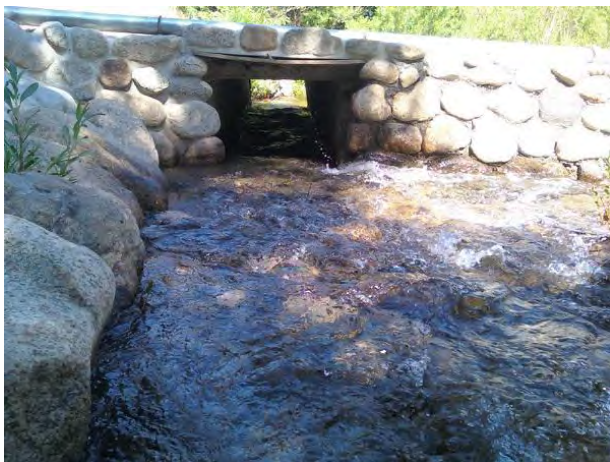
**Site LCC-3.** Outlets.

Entire roadway and culvert system look to be recently repaired. Four culverts (2 square concrete, 2 corrugated metal pipes). Water was flowing in the two square L/B culverts at this flow; both were clear and fully passable. The two R/B ones have some rocks and debris at outlet and sand bars/willows at inlets).

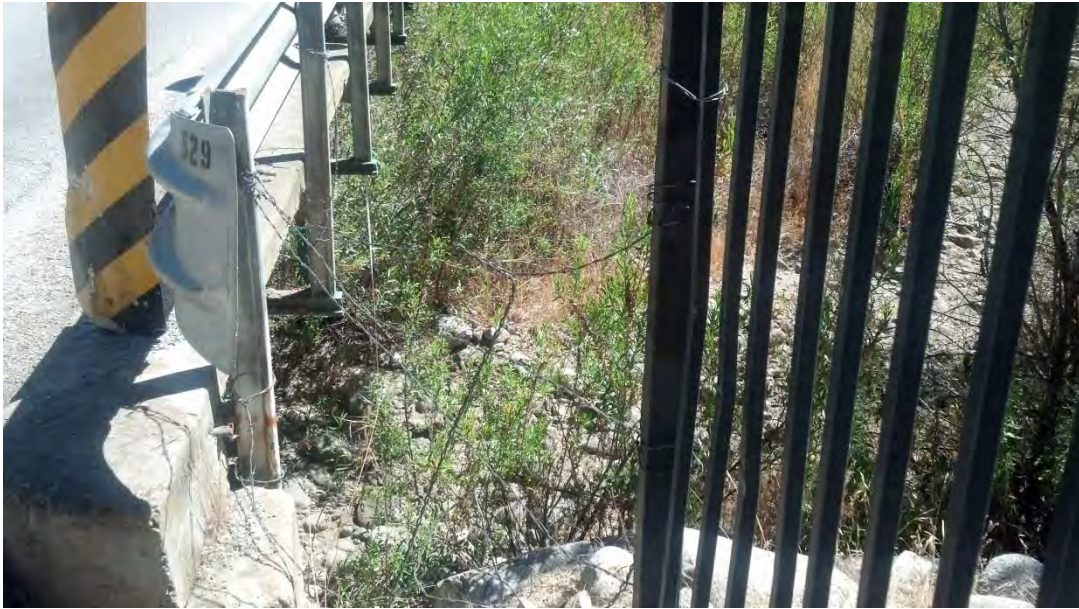
We could not access river channel due to barbwire fence but bridge clear-spans the creek and is not a passage barrier, but should be monitored on a regular basis.

**Site LCC-6.** Downstream channel. Cobble substrate, brushy vegetation. No barrier.

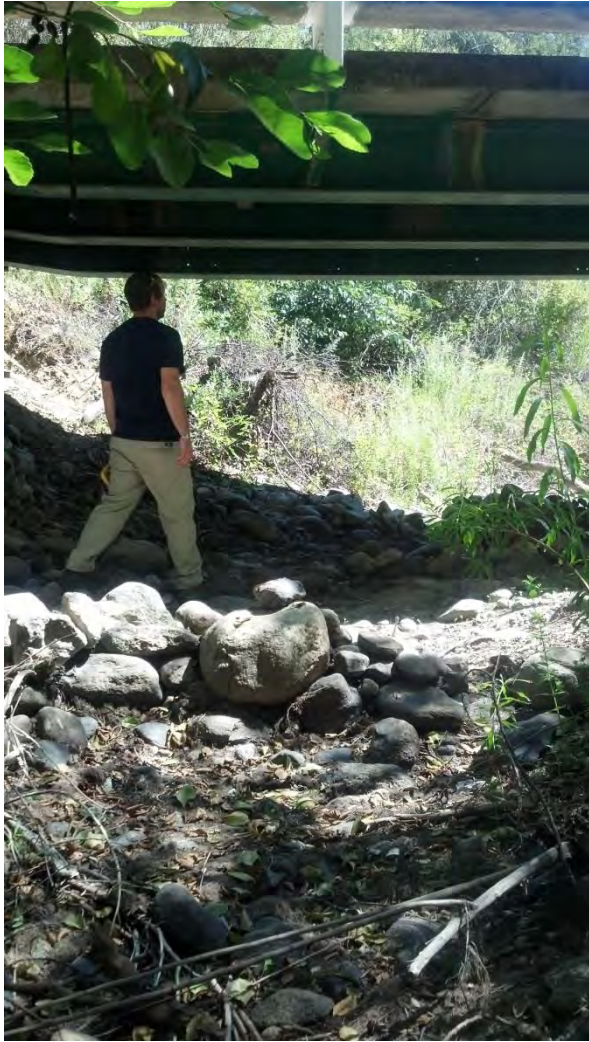
Bridge clear-spans creek and is not a passage barrier. Substrate is boulder/cobble with sand.

Site LCC-8. Photo #1. Looking upstream.

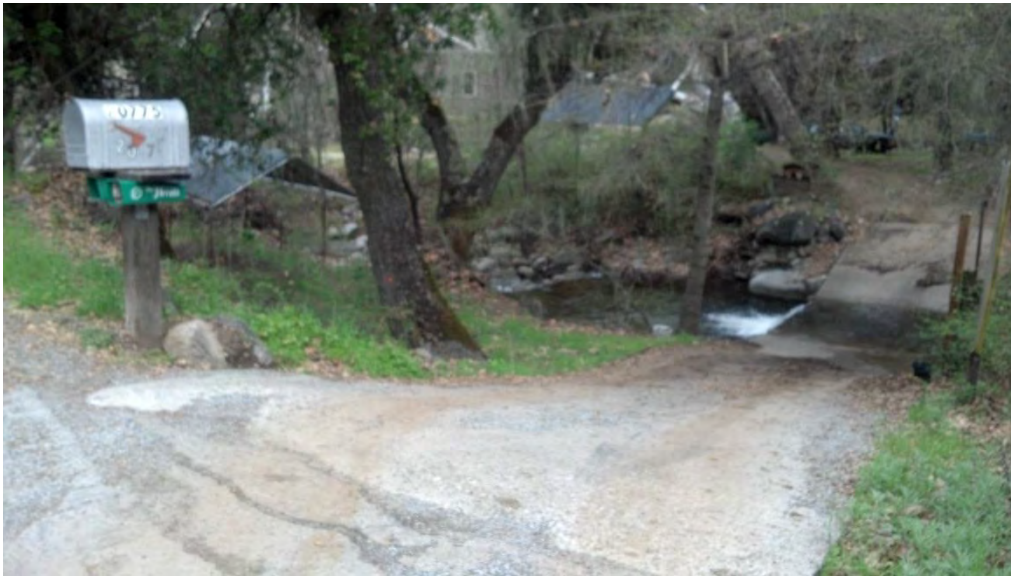
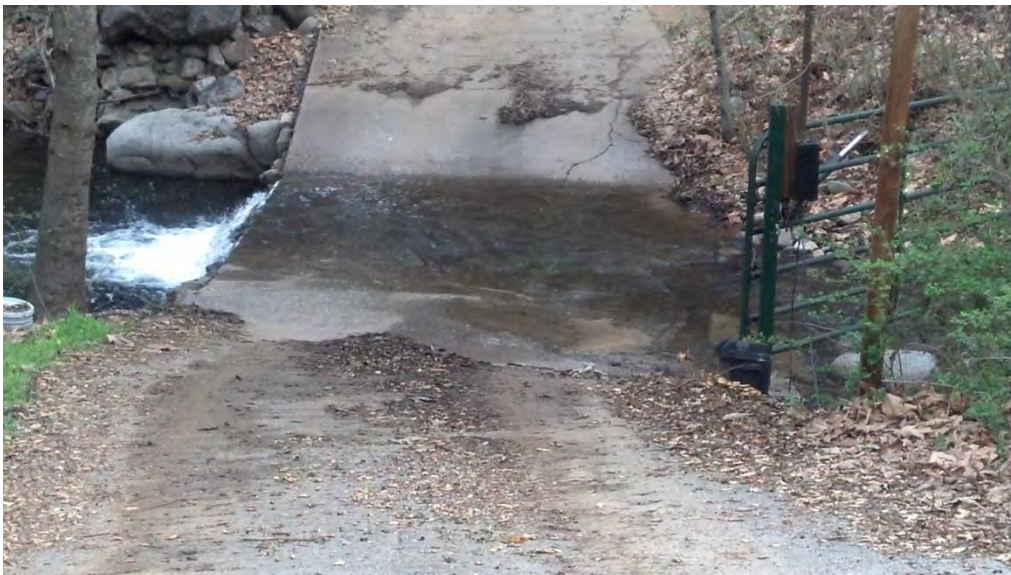
**Site LCC-10.**

Smooth concrete ford with no apparent culverts. Water drops ~3' into pool of unknown depth. Classify as a likely "Red" due to high jump and shallow crossing.

This would be a prime location for a small, clear-span bridge crossing.

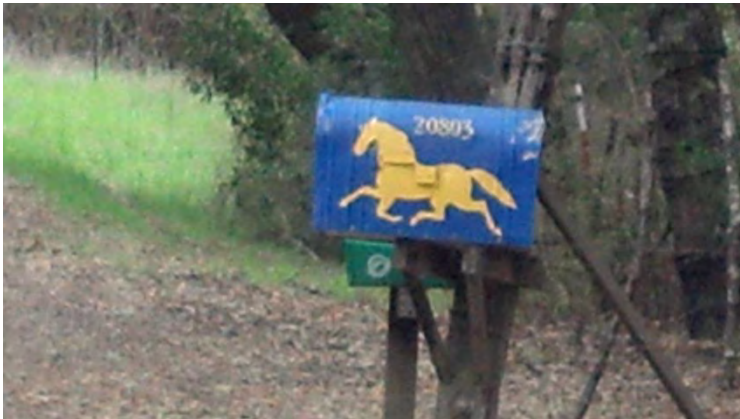
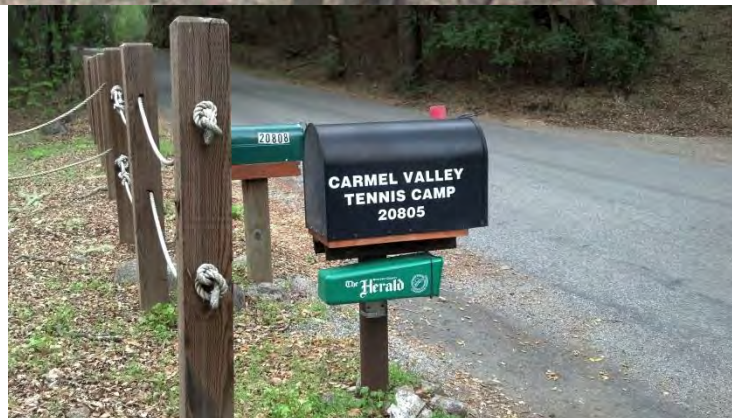
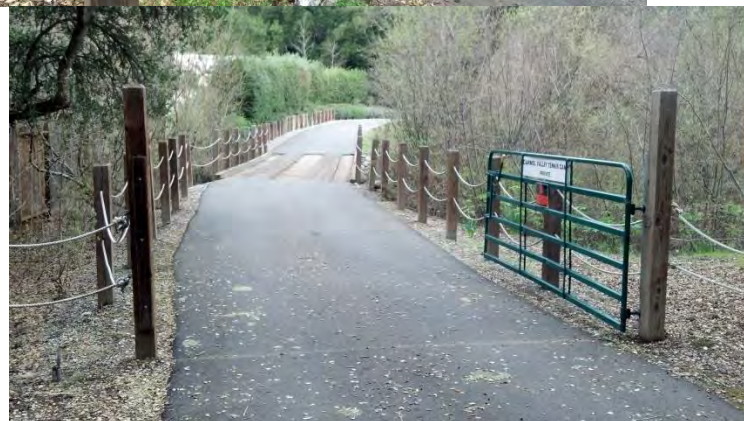
Both 20803 and 20805 have clear-span bridges over natural streambeds and no barrier issues.

The crossing at 20808 appears to be a natural-streambed road crossing - no structures were observed and there are no barrier issues.

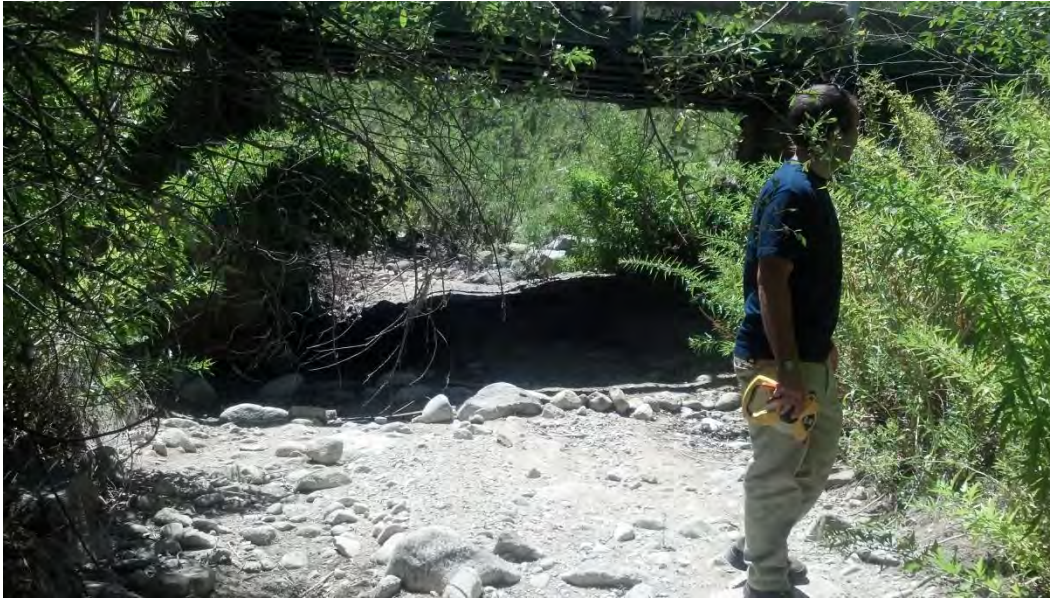
This clear-span bridge is located just downstream of the confluence of Cachagua, Finch, James Creeks and is not migration barrier. However, a large boulder dam has been constructed numerous times across creek on the upstream side of the bridge and it can be a migration barrier to both upstream and downstream migration. We removed it during this survey but this location should be monitored regularly.

**Site LCC-13.** Looking upstream under bridge towards rock dam.

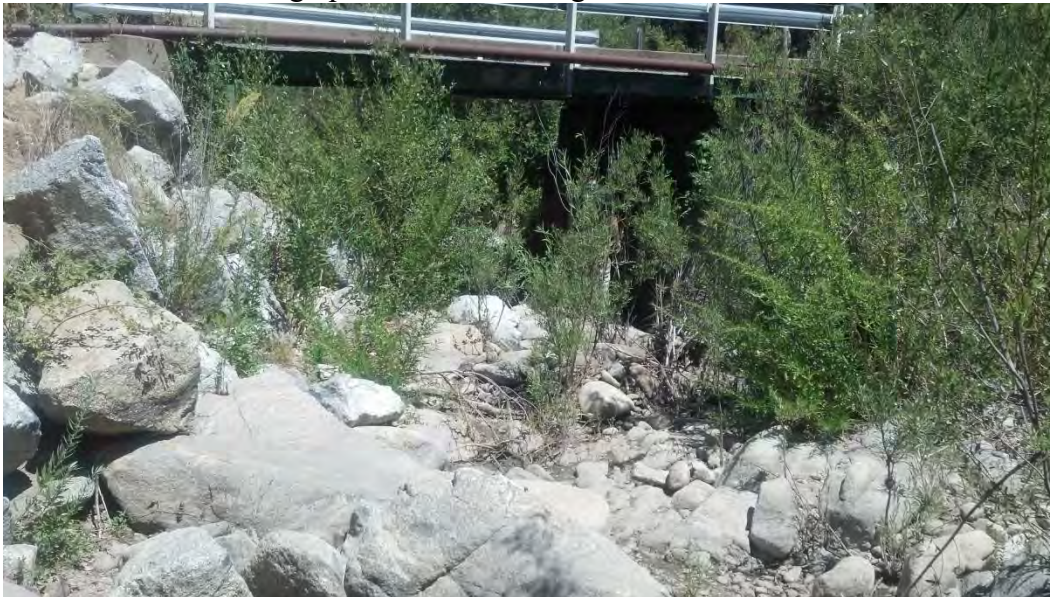
**Site LCC-13.** Looking downstream. Substrate is boulder/cobble, riparian vegetation is brushy.

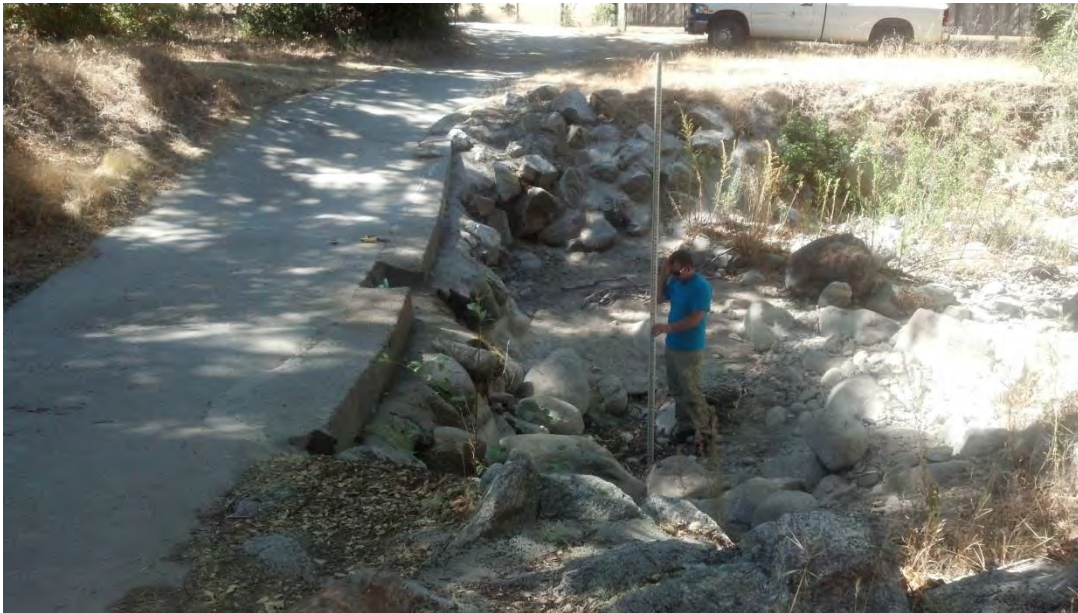
Site consists of a long concrete ford with four small culverts on the left bank side. Most of flow would pass over top of ford. Plunge pool has down cut ~6 feet below top of ford. The substrate upstream of the ford is primarily sand/small gravel, while downstream it is a boulder/cobble mix.

**Site UCC-3.** Looking across from r/b side. Note the 6' drop-off and very large boulders.

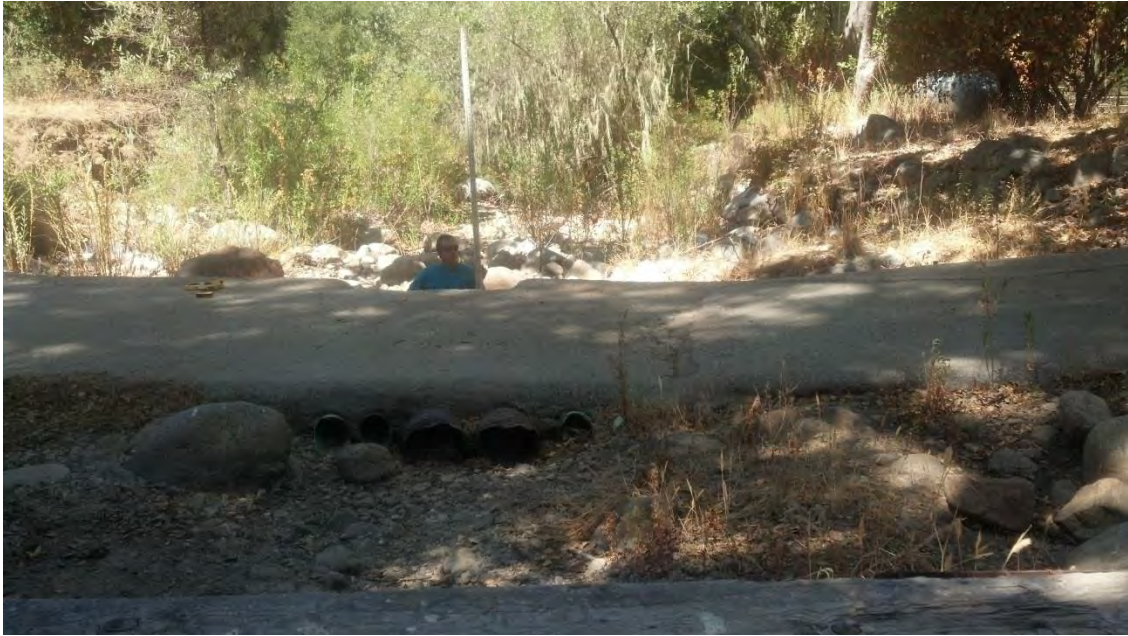
**Site UCC-3.** Looking downstream at the culverts and plunge pool drop-off.

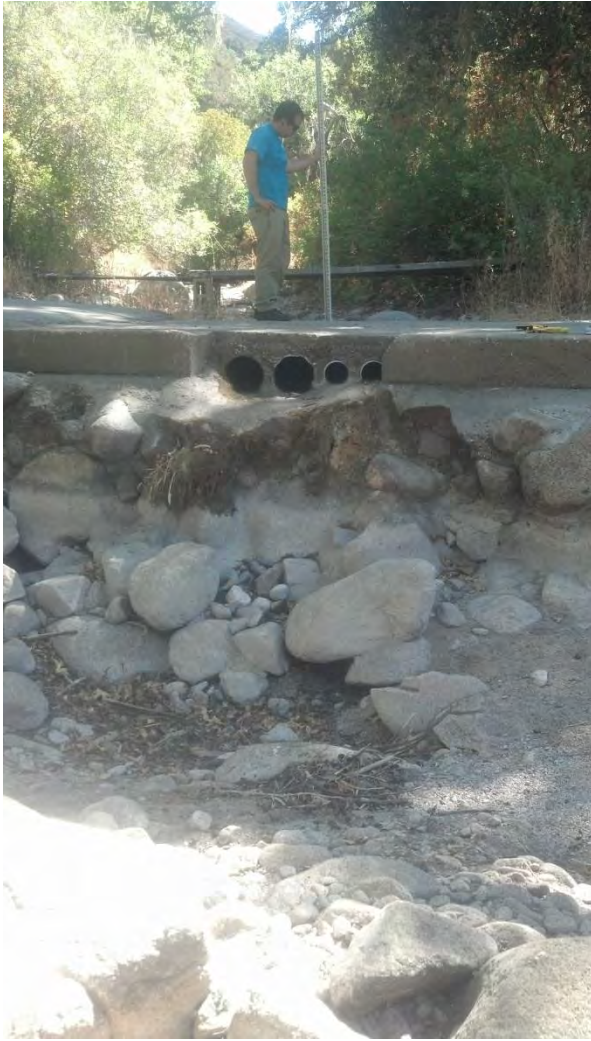
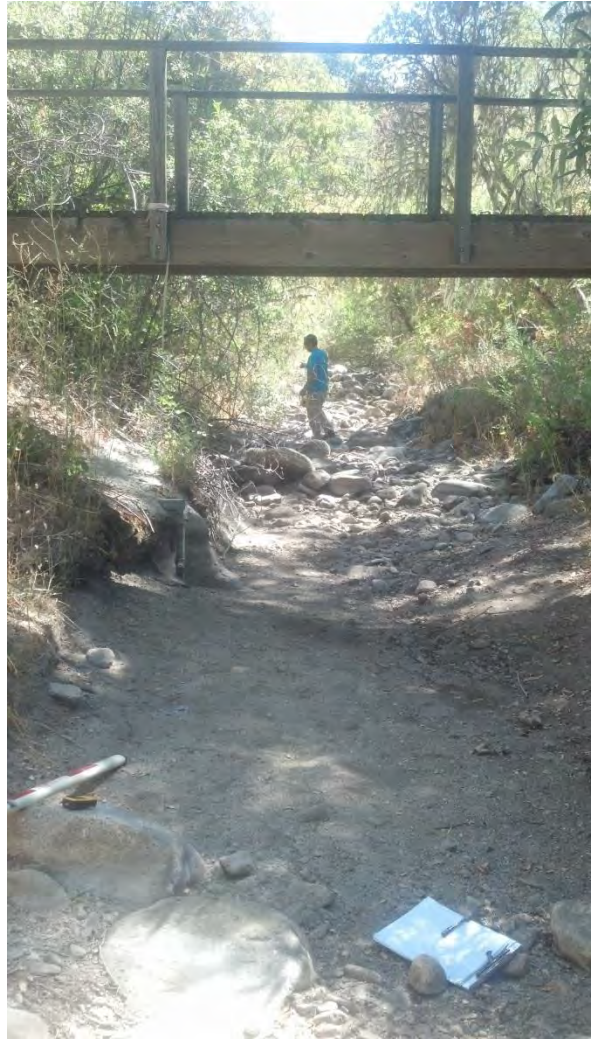
**Site UCC-3.** Left photo. Looking upstream at the culvert outlets and the ford drop-off. A seasonal plank walkway is shown in the background.
