**ASSESSMENT OF STEELHEAD PASSAGE BARRIERS IN  
PORTIONS OF FOUR TRIBUTARIES TO THE CARMEL RIVER**

**Monterey Peninsula Water Management District  
IRWM - PROJECT 3**

**Final Project Report - July 2014**

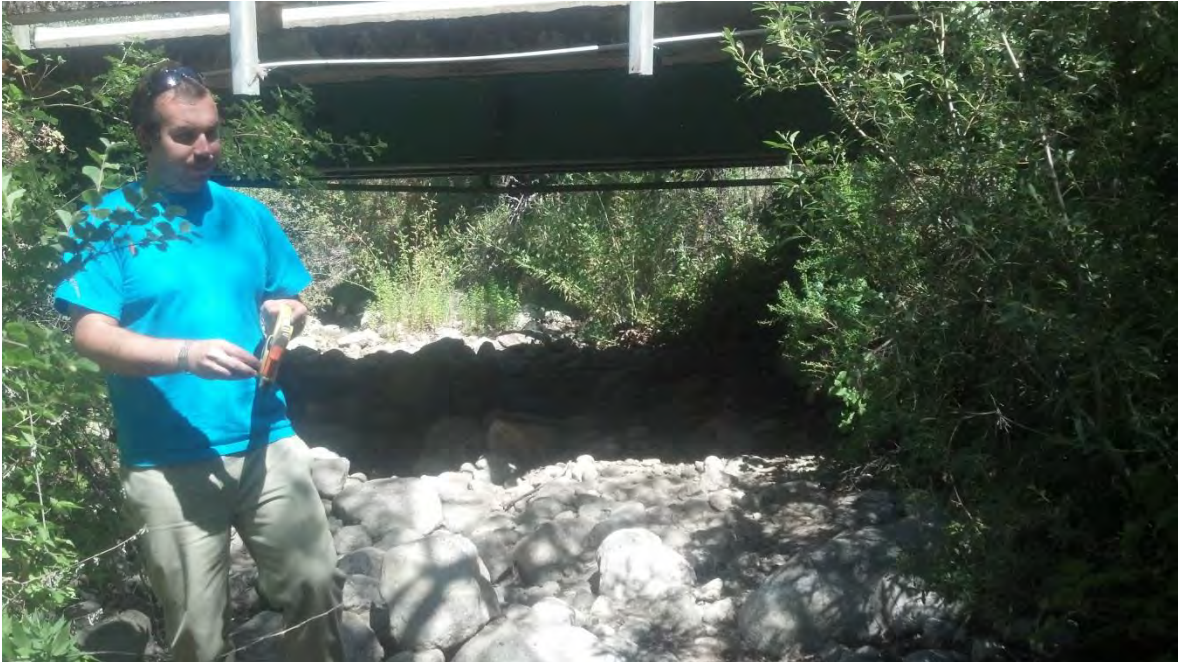
Site UCC-5. Looking upstream.

Clear-span bridge. Not a barrier. Boulder/cobble substrate and brushy vegetation.

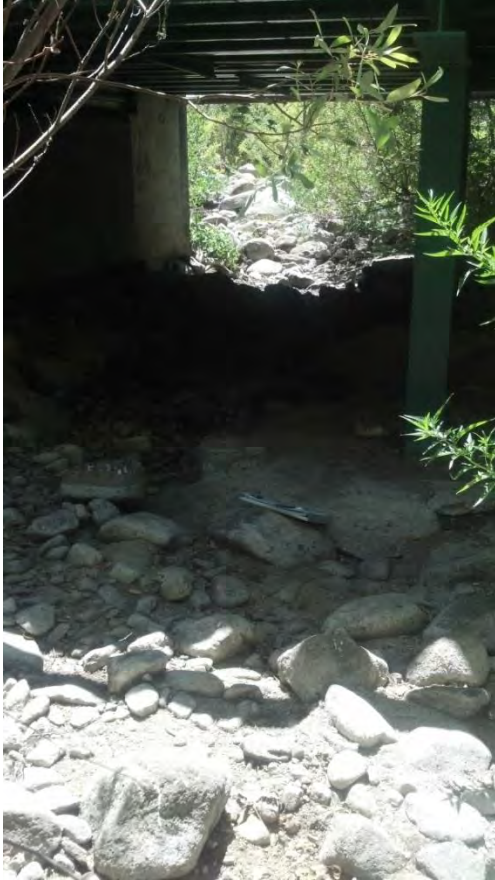
Site UCC-6. Looking upstream.

Clear-span bridge. Not a barrier. Boulder/cobble substrate and brushy vegetation.

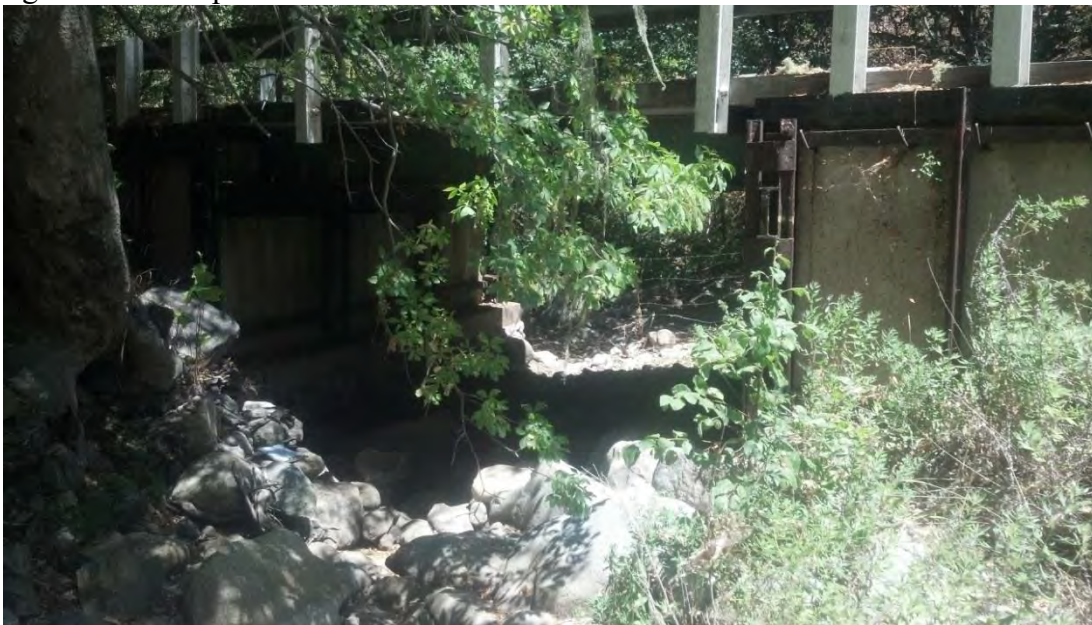
Clear-span bridge. The channel is constricted above the bridge by a large tree growing next the channel and a pile of large boulders, and below the bridge from a loose barbwire fence across the channel and the left bank bridge support. Boulder/cobble substrate. Vegetation is a mix of mature trees and shrubby plants. This site should be monitored regularly.

**Site UCC-7.** Looking downstream. Note the large sycamore tree on left side and boulder pile across the channel.

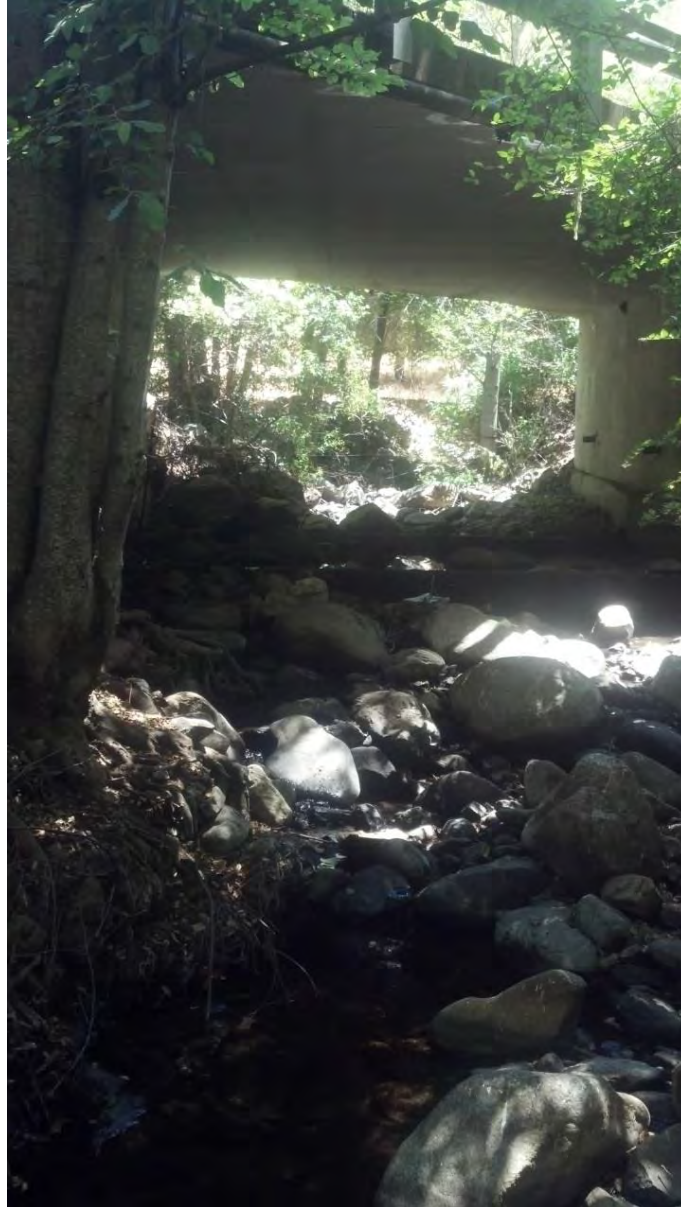
Site UCC-8. Looking upstream.

Clear-span bridge is narrower than the others but is not a barrier. Boulder/cobble substrate. Vegetation is a mix of mature trees and shrubby plants.

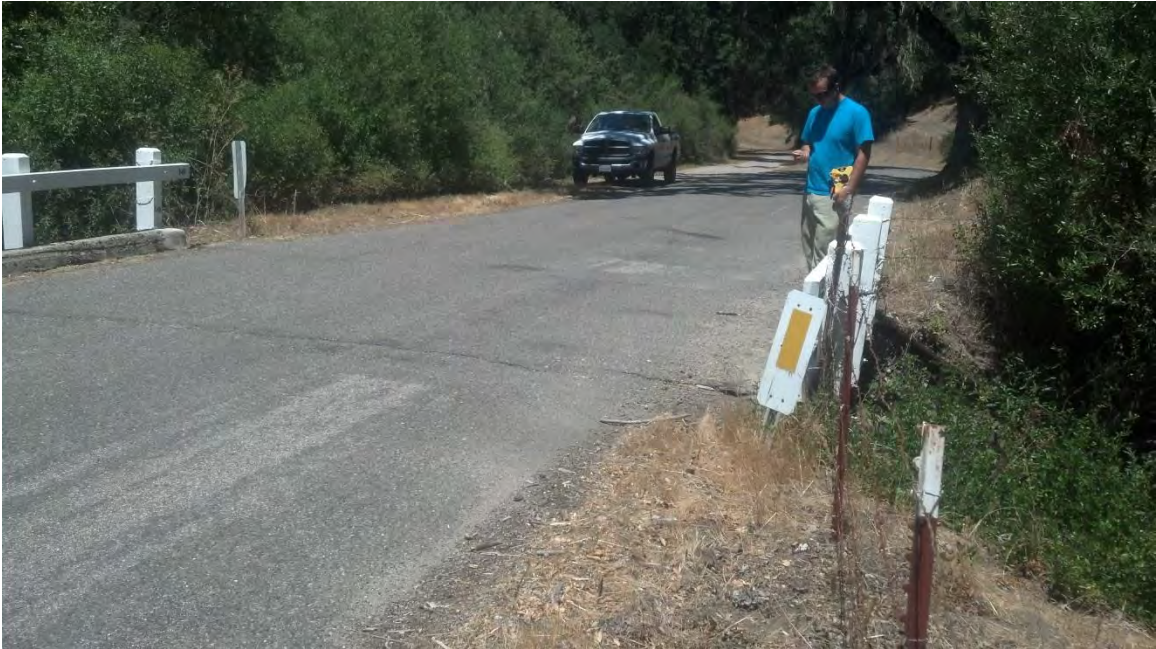
**Site UCC-11. Small MoCo. Bridge.**

Very small, narrow, clear-span bridge is not a barrier. Substrate is boulder/cobble. Vegetation is a mix of mature trees and shrubby plants. No access to channel.

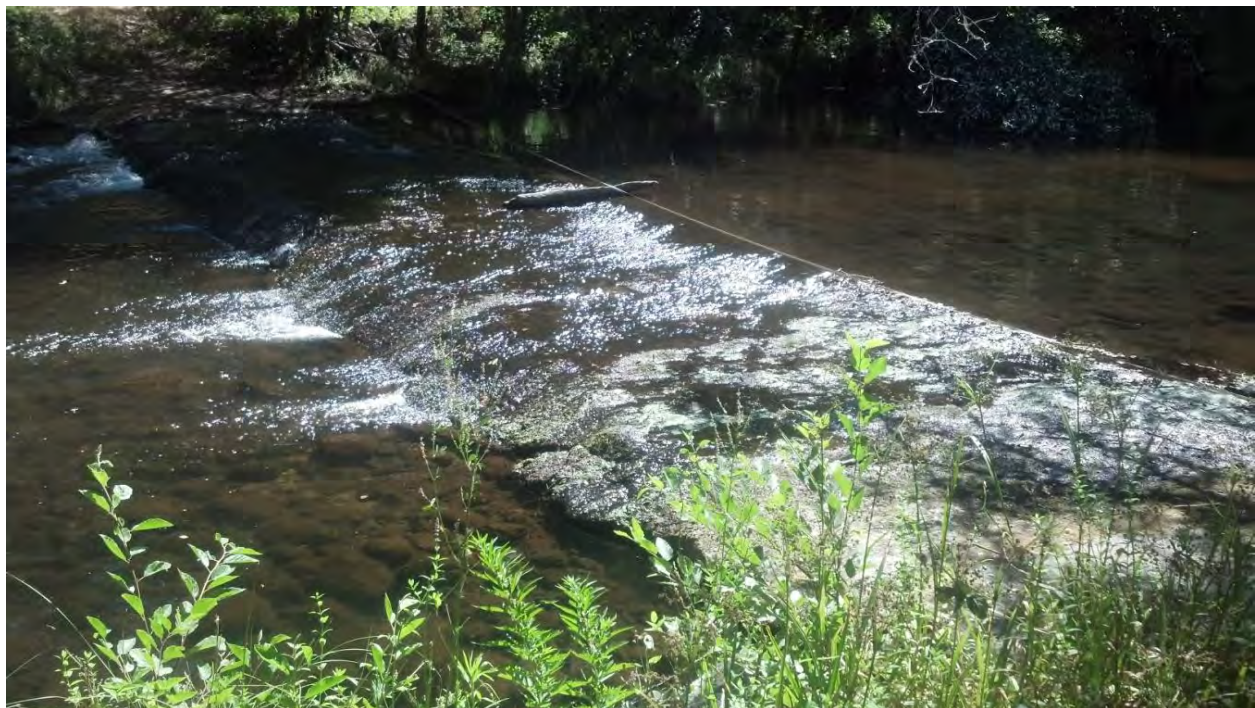
The ford acts like a low dam across the river and has caused both backwatering and down-cutting on its upstream and downstream sides. Upstream, there is a ~ 100 meters long, 1-2 meter deep, slack water pool with a fine silt and sand bottom. Downstream, the riverbed has down cut and steepened. The substrate is primarily boulders. The ford's plunge pool is ~2-4 feet deep depending on river flow.

Photo 2) Looking across the ford from downstream left bank.

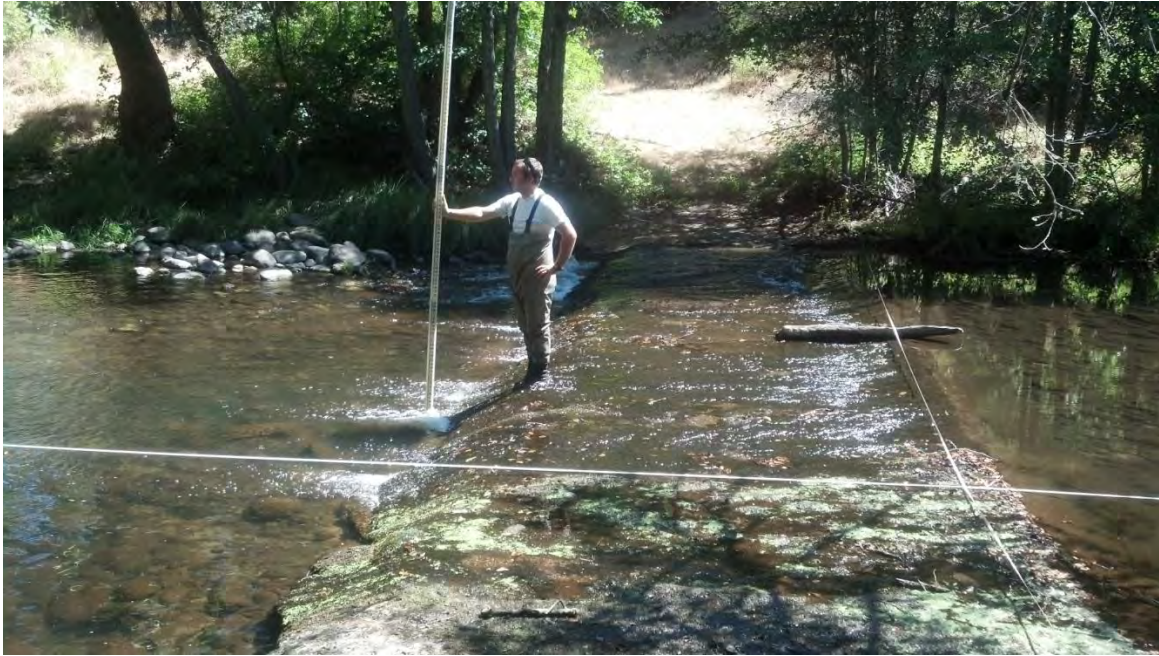
Photo 3) Looking across the ford from left bank. Note the shallow water depth across ford. Depth of plunge pool at this flow is ~1.5 feet.

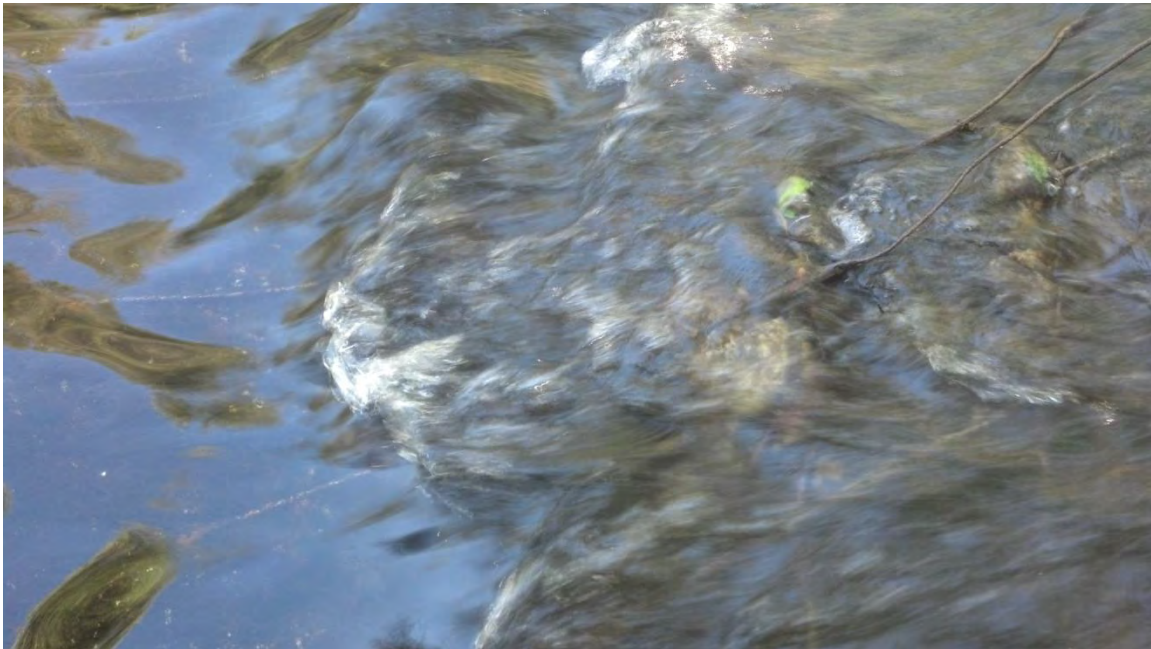
The ford was poured directly onto the riverbed substrate. There are no culverts (as far as I can tell). In some sections, the metal rebar has become badly exposed with long loose pieces of bars aiming downstream, potentially endangering upstream migrating steelhead, and other wildlife. During low flows, the water passing over the ford is very shallow, potentially restricting both upstream and downstream fish migration.

Photo 4) Exposed rebar extending up from surface of eroded concrete ford.

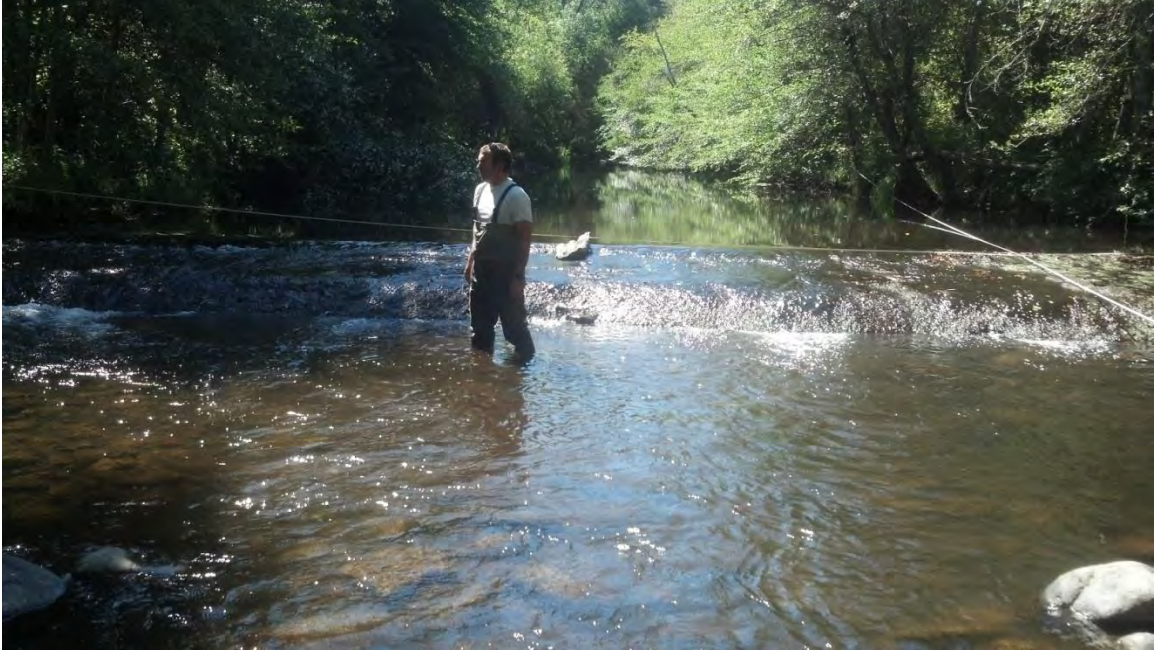
Photo 5) Looking upstream towards the long backwatered pool.

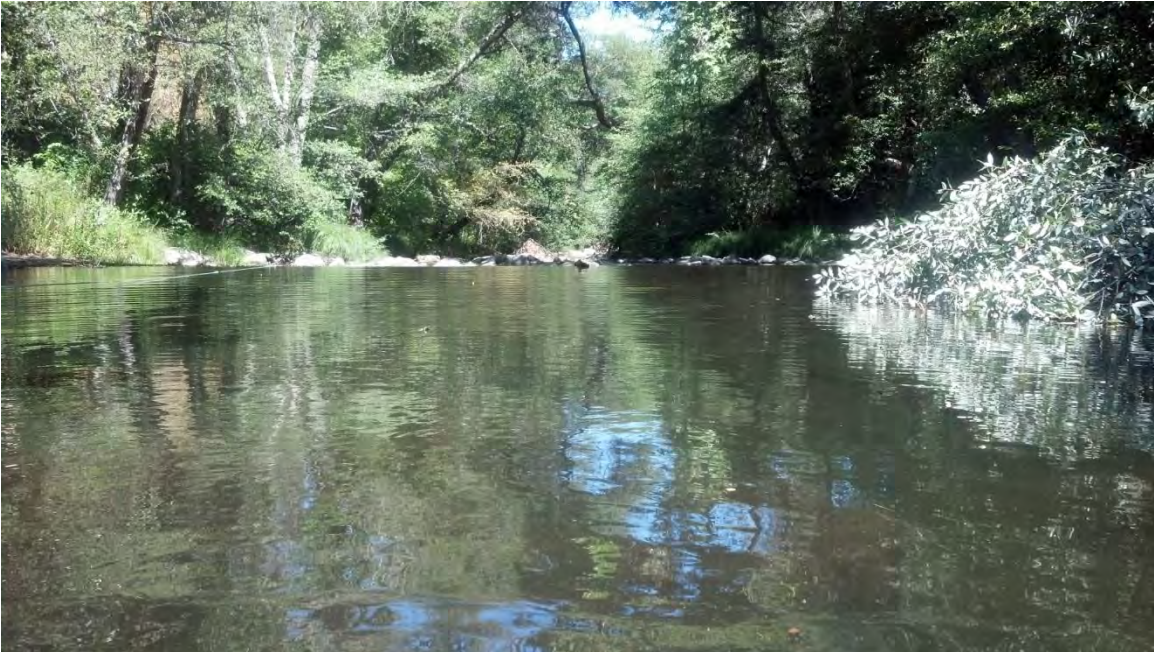
Photo 6) Large backwatered pool above the ford (~100 m long and 1 m deep). Pool substrate is ~3" of fine silt over sand.

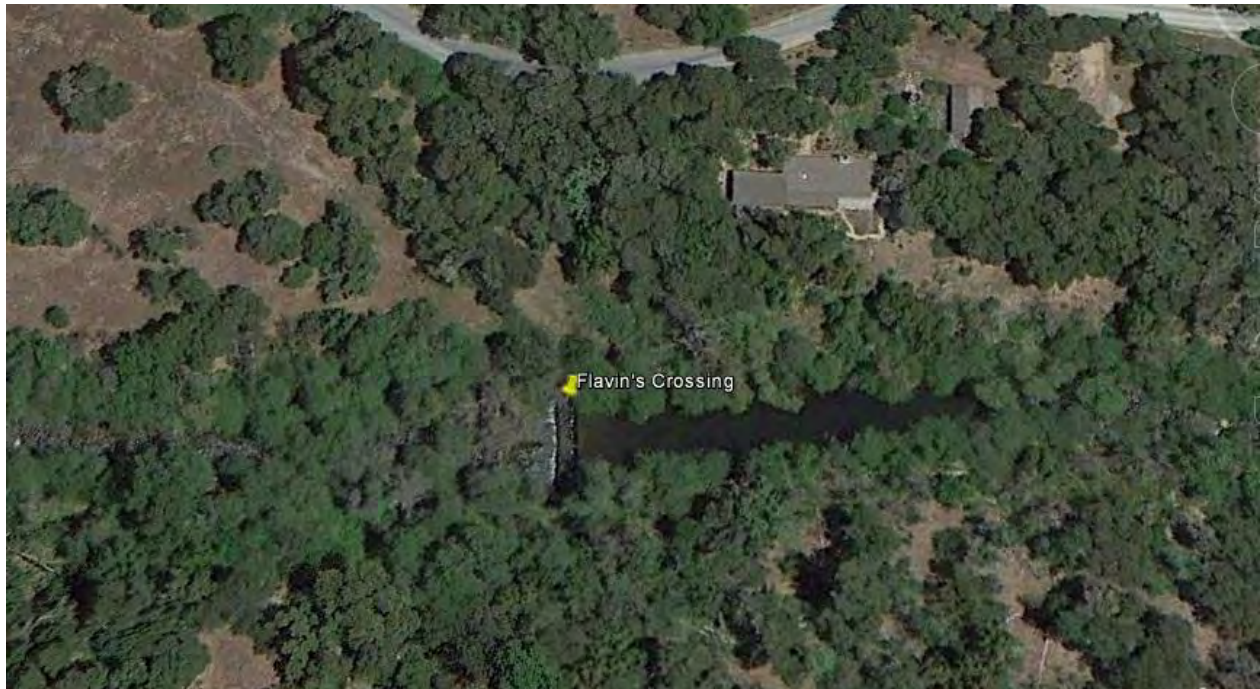
This manmade structure is both unsightly and a partial barrier to fish migration. In addition, it is causing the degradation of the streambed and changes to the flow regime.

Photo 8) 2012 Google Earth photo of Flavin's Crossing in Cachagua Valley, CA. Note the slack water pool upstream and narrow riffle section downstream of crossing. Cachagua Road is at the top of the photo.

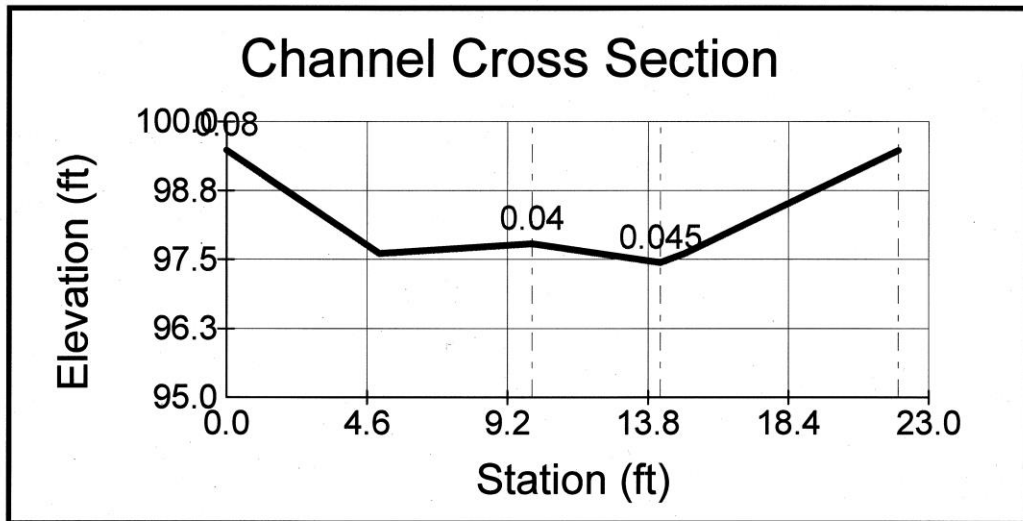
**Figure 1.** Channel Cross Section at Tailwater Crest.

**Table 2.** Tailwater Cross Section Data.

Station (ft)	Elevation (ft)	Roughness Coefficient
0.00	99.48	0.080
5.00	97.60	
10.00	97.78	0.040
14.20	97.44	0.045
15.00	97.60	
22.00	99.48	0.100

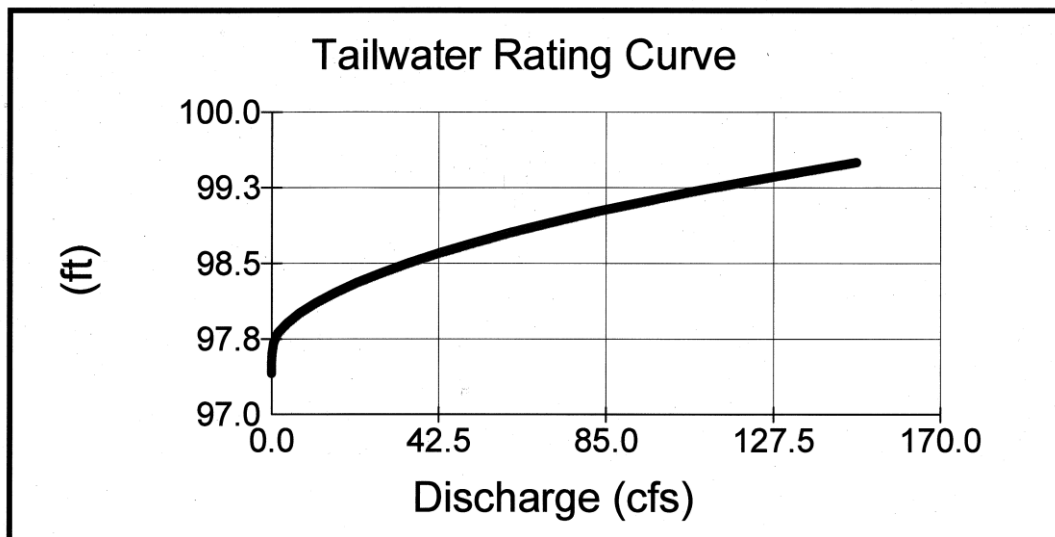
**Figure 2.** Tailwater Rating Curve

Discharge (cfs)	Tailwater Elevation (ft)	Wetted Perimeter (ft)	Cross-Sect. Area (sq. ft)	Composite Roughness Coefficient
0.0	97.4	0.00	0.00	0.000
0.0	97.5	0.70	0.01	0.041
0.2	97.6	2.45	0.17	0.041
0.5	97.7	6.55	0.59	0.057
1.6	97.8	11.24	1.48	0.062
4.0	97.9	11.91	2.62	0.062
7.2	98.0	12.58	3.83	0.062
11.3	98.1	13.25	5.11	0.062
16.1	98.2	13.92	6.45	0.062
21.7	98.3	14.59	7.85	0.062
28.0	98.4	15.26	9.31	0.062
35.0	98.5	15.93	10.84	0.062
42.9	98.6	16.60	12.44	0.062
51.5	98.7	17.27	14.09	0.062
60.8	98.8	17.94	15.82	0.062
70.9	98.9	18.60	17.60	0.062
81.8	99.0	19.27	19.45	0.062
93.6	99.1	19.94	21.36	0.062
106.1	99.2	20.61	23.34	0.062
119.5	99.3	21.28	25.38	0.061
133.7	99.4	21.95	27.48	0.061
148.7	99.5	22.62	29.65	0.061

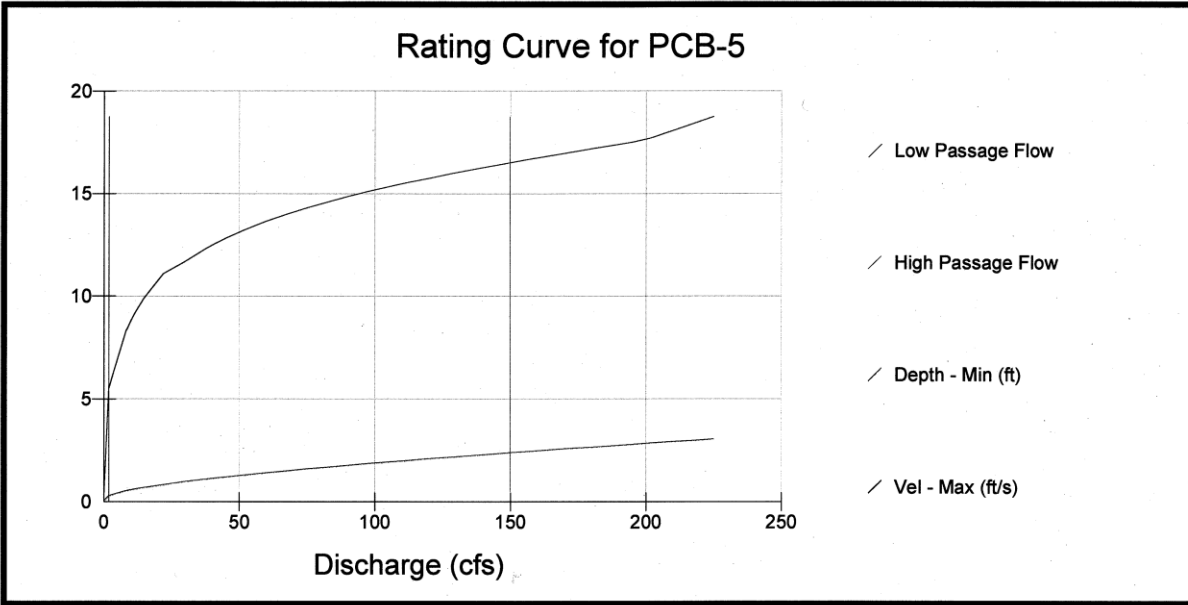
**Figure 3.** Culvert Rating Curve

Summary for Q = 10.00 cfs	
Normal Depth (ft)	0.54
Critical Depth (ft)	0.87
Headwater Depth (ft)	1.11
HW/D	0.22
Inlet Velocity (ft/s)	7.65
Tailwater Depth (ft)	0.84
Outlet Water Surface Drop ...	0.00
Prolonged Swim Time (min)	0.00
Burst Swim Time (s)	5.00
Barrier Code	EB

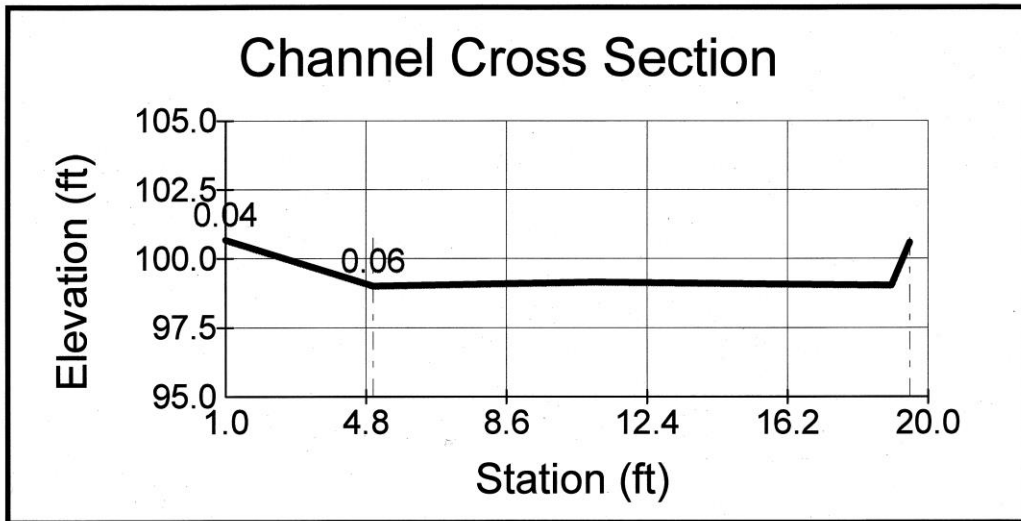
Figure 1. Channel Cross Section at Tailwater Crest.

Two identical culverts under the small bridge/access road at CVAC between the upper parking lot and the driveway to the yoga center.  
L/B culvert: sections of the bottom rusted out, substrate showing through.  
R/B culvert: large hole in center of pipe, wter drops down under concrete pipe.  
Has a concrete apron level with outlets but perched 2 feet above substrate (freefall). Tailwater control is a concrete rubble weir below apron.  
Ave channel width u/s is 9'.  
Both culverts need to be replaced asap with a small clear-span bridge and concrete rubble d/s removed.

Station (ft)	Elevation (ft)	Roughness Coefficient
1.00	100.66	0.040
5.00	98.99	0.060
11.00	99.13	
19.00	99.03	
19.50	100.59	0.040

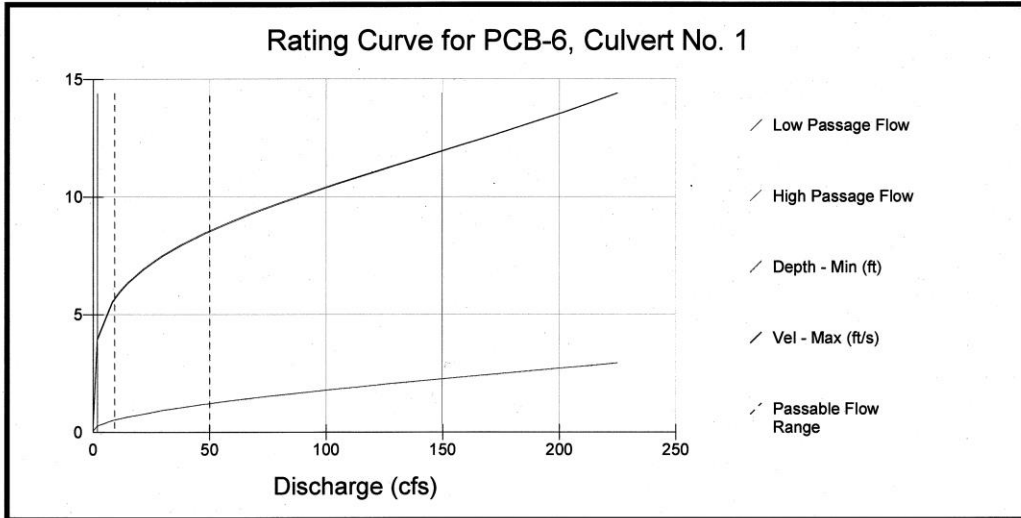
**Figure 3.** Culvert Rating Curve

Summary for Q = 10.00 cfs	
Normal Depth (ft)	0.51
Critical Depth (ft)	0.65
Headwater Depth (ft)	0.83
HW/D	0.22
Inlet Velocity (ft/s)	5.73
Tailwater Depth (ft)	0.01
Outlet Water Surface Drop ...	0.51
Prolonged Swim Time (min)	0.00
Burst Swim Time (s)	3.26
Barrier Code	NONE

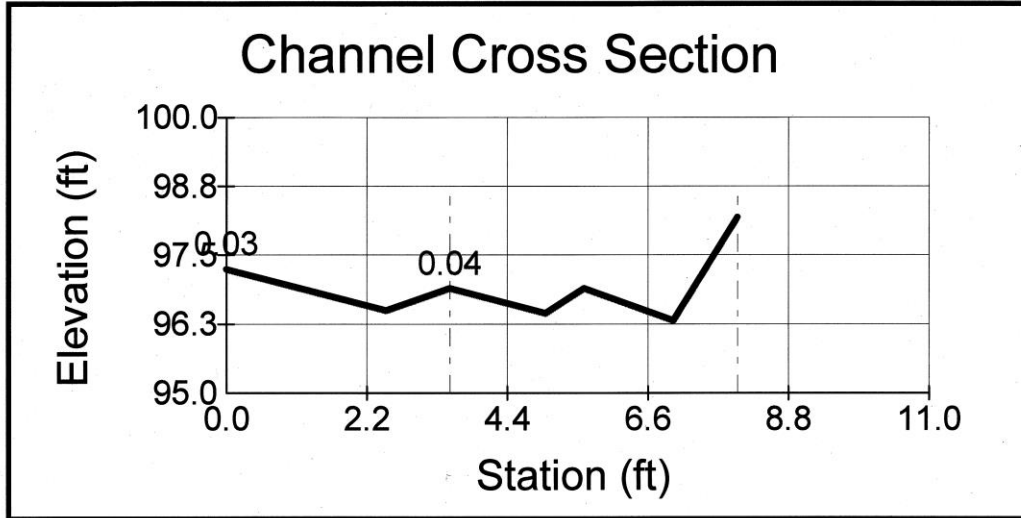
**Figure 1.** Channel Cross Section at Tailwater Crest.

Huge streamgrade culvert with 1+' rockweir apron dropoff . Lower end is corroding. Substrate is sand/sm gravel. ~0.5 cfs flowing through pipe at survey.

Station (ft)	Elevation (ft)	Roughness Coefficient
0.00	97.24	0.030
2.50	96.49	
3.50	96.89	0.040
5.00	96.44	
5.60	96.89	
7.00	96.30	
8.00	98.19	0.030

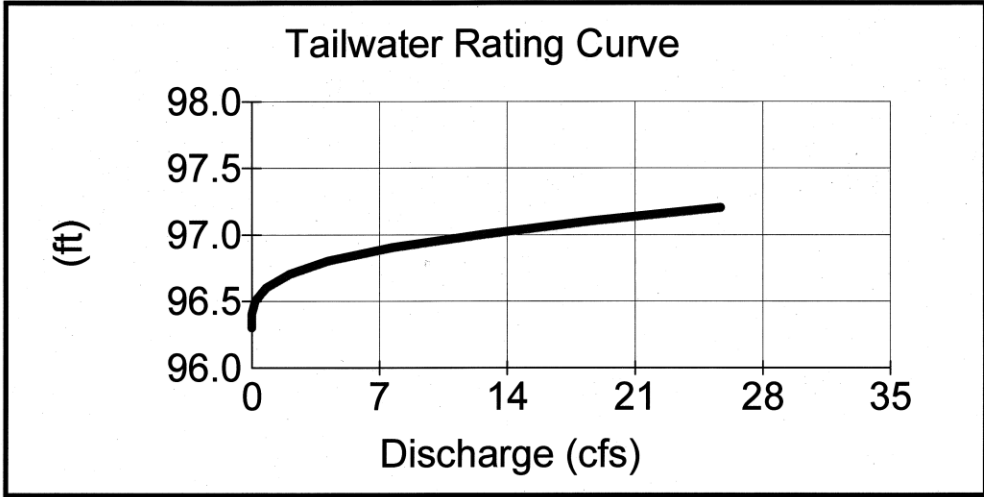
Figure 2. Tailwater Rating Curve

Discharge (cfs)	Tailwater Elevation (ft)	Wetted Perimeter (ft)	Cross-Sect. Area (sq. ft)	Composite Roughness Coefficient
0.0	96.3	0.00	0.00	0.045
0.0	96.3	0.15	0.00	0.040
0.0	96.4	0.52	0.03	0.040
0.2	96.5	1.71	0.11	0.038
0.8	96.6	3.22	0.33	0.037
2.1	96.7	4.72	0.67	0.037
4.2	96.8	6.22	1.15	0.037
7.7	96.9	7.20	1.76	0.036
12.7	97.0	7.66	2.41	0.036
18.7	97.1	8.12	3.10	0.036
25.7	97.2	8.59	3.83	0.036

Q total (cfs)	Depth Min (ft)	V(occ) Max (ft/s)	Depth TW (ft)	Outlet WS Drop (ft)	Depth Pool (ft)	Barrier Type
0	0.00	0.00	-96.36	96.36	-96.23	Depth
2.00	0.35	2.12	0.38	0.00	0.51	Depth
15	0.72	5.30	0.72	0.00	0.85	NONE
22	0.83	6.49	0.83	0.00	0.96	NONE
30	0.94	7.50	0.94	0.00	1.07	NONE
38	1.06	8.17	1.05	0.00	1.18	NONE
45	1.16	8.56	1.15	0.01	1.28	NONE
52	1.26	8.91	1.25	0.00	1.38	NONE
60	1.37	9.22	1.37	0.00	1.50	EB
68	1.48	9.41	1.48	0.00	1.61	EB
75	1.58	9.53	1.58	0.00	1.71	EB
82	1.68	9.62	1.68	0.00	1.81	EB
90	1.79	9.69	1.79	0.00	1.92	EB
98	1.90	9.74	1.90	0.00	2.03	EB
105	2.00	9.76	2.00	0.00	2.13	EB
112	2.10	9.77	2.10	0.00	2.23	EB
120	2.22	9.78	2.22	0.00	2.35	EB
128	2.33	9.77	2.33	0.00	2.46	EB
135	2.43	9.77	2.43	0.00	2.56	EB
142	2.53	9.75	2.53	0.00	2.66	EB

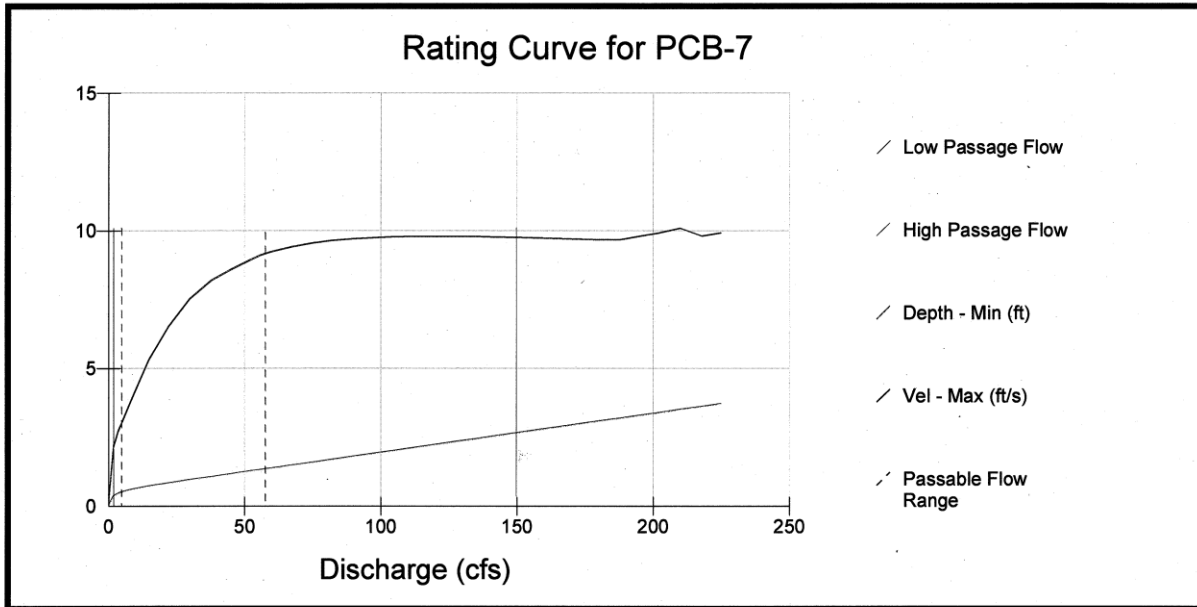
**Figure 3.** Culvert Rating Curve

150.00	2.64	9.74	2.64	0.00	2.77	EB
158	2.75	9.72	2.75	0.00	2.88	EB
165	2.85	9.70	2.85	0.00	2.98	EB
172	2.95	9.68	2.95	0.00	3.08	V
180	3.07	9.66	3.07	0.00	3.20	V
188	3.18	9.66	3.18	0.00	3.31	V
195	3.28	9.78	3.28	0.00	3.41	V
202	3.38	9.90	3.38	0.00	3.51	V
210	3.49	10.07	3.49	0.00	3.62	V
218	3.60	9.80	3.60	0.00	3.73	EB
225	3.70	9.91	3.70	0.00	3.83	EB
