SCHULTE RESTORATION PROJECT

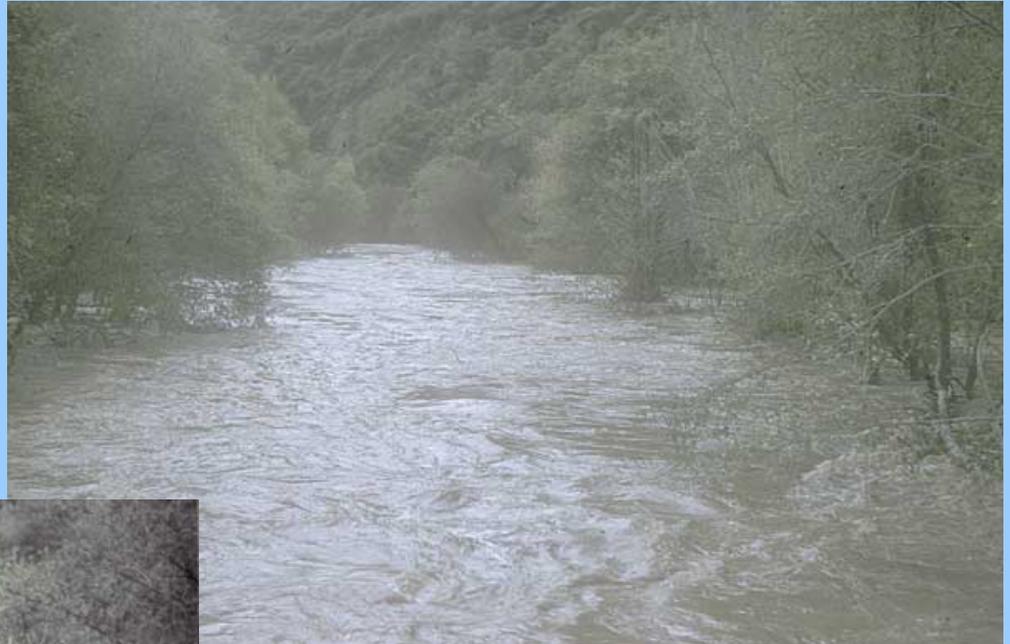
Above – this photo, taken in 1958 by Charles R. Walker in slide form, is simply labeled “Carmel River.” It was probably shot on April 2, the day a major flood event occurred. Note the abundance of streamside vegetation.

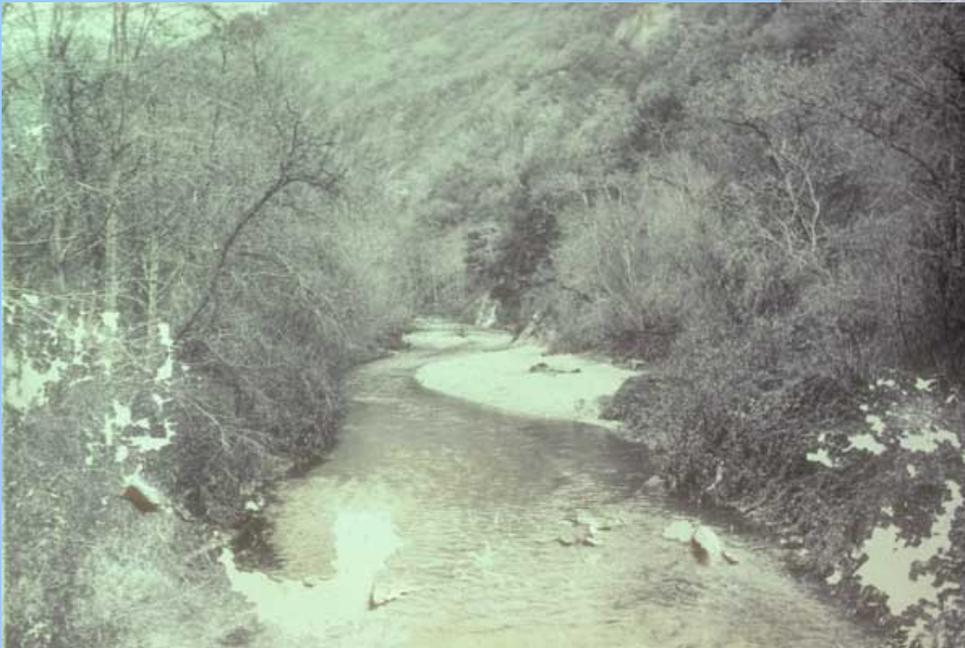
Left – this view is ca. 1971, during a short, but severe drought. It was probably taken in late fall or early winter, before trees began leafing out. But streamside vegetation appears to be fairly dense.
