# The Carmel River 30 Years of Restoration

A presentation to the

San Jose Branch of the  
American Society of Civil Engineers

Larry Hampson, District Engineer

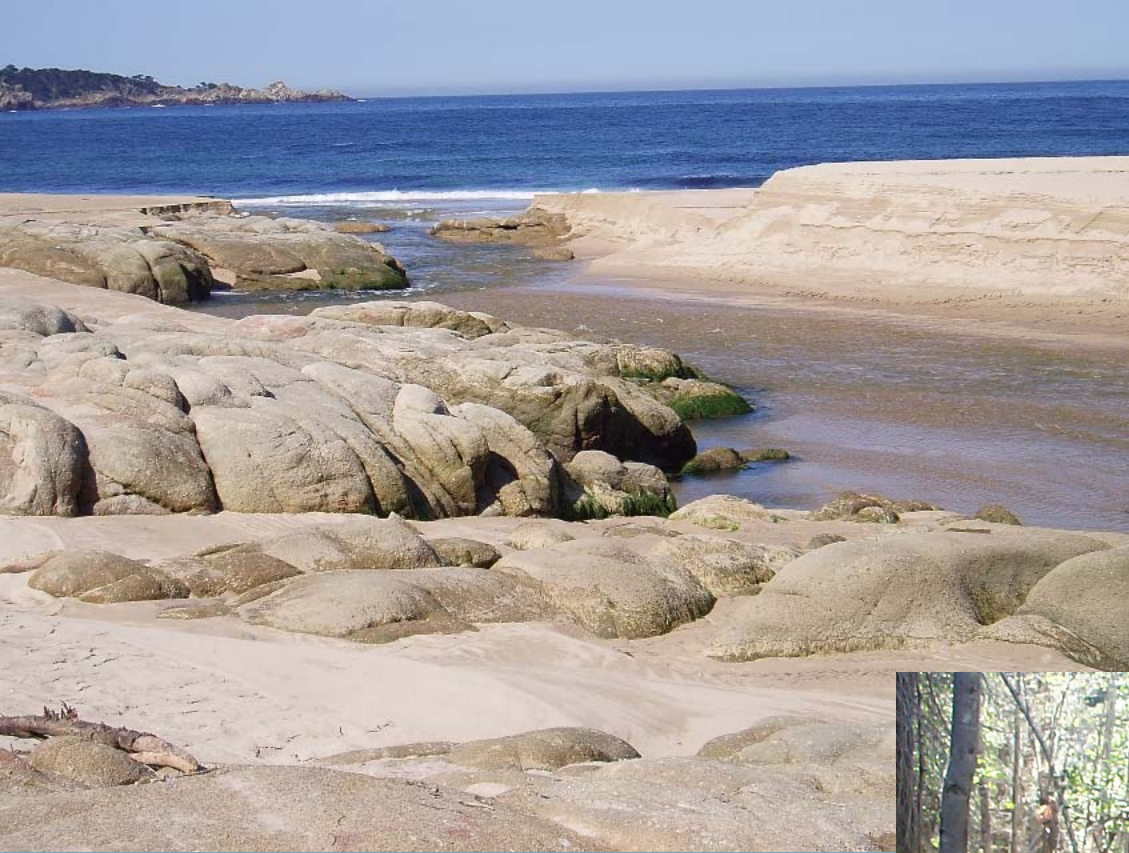
Above - river flow  
through the "slot"  
in bedrock outcrop at the  
Carmel River mouth,  
April 25, 2008

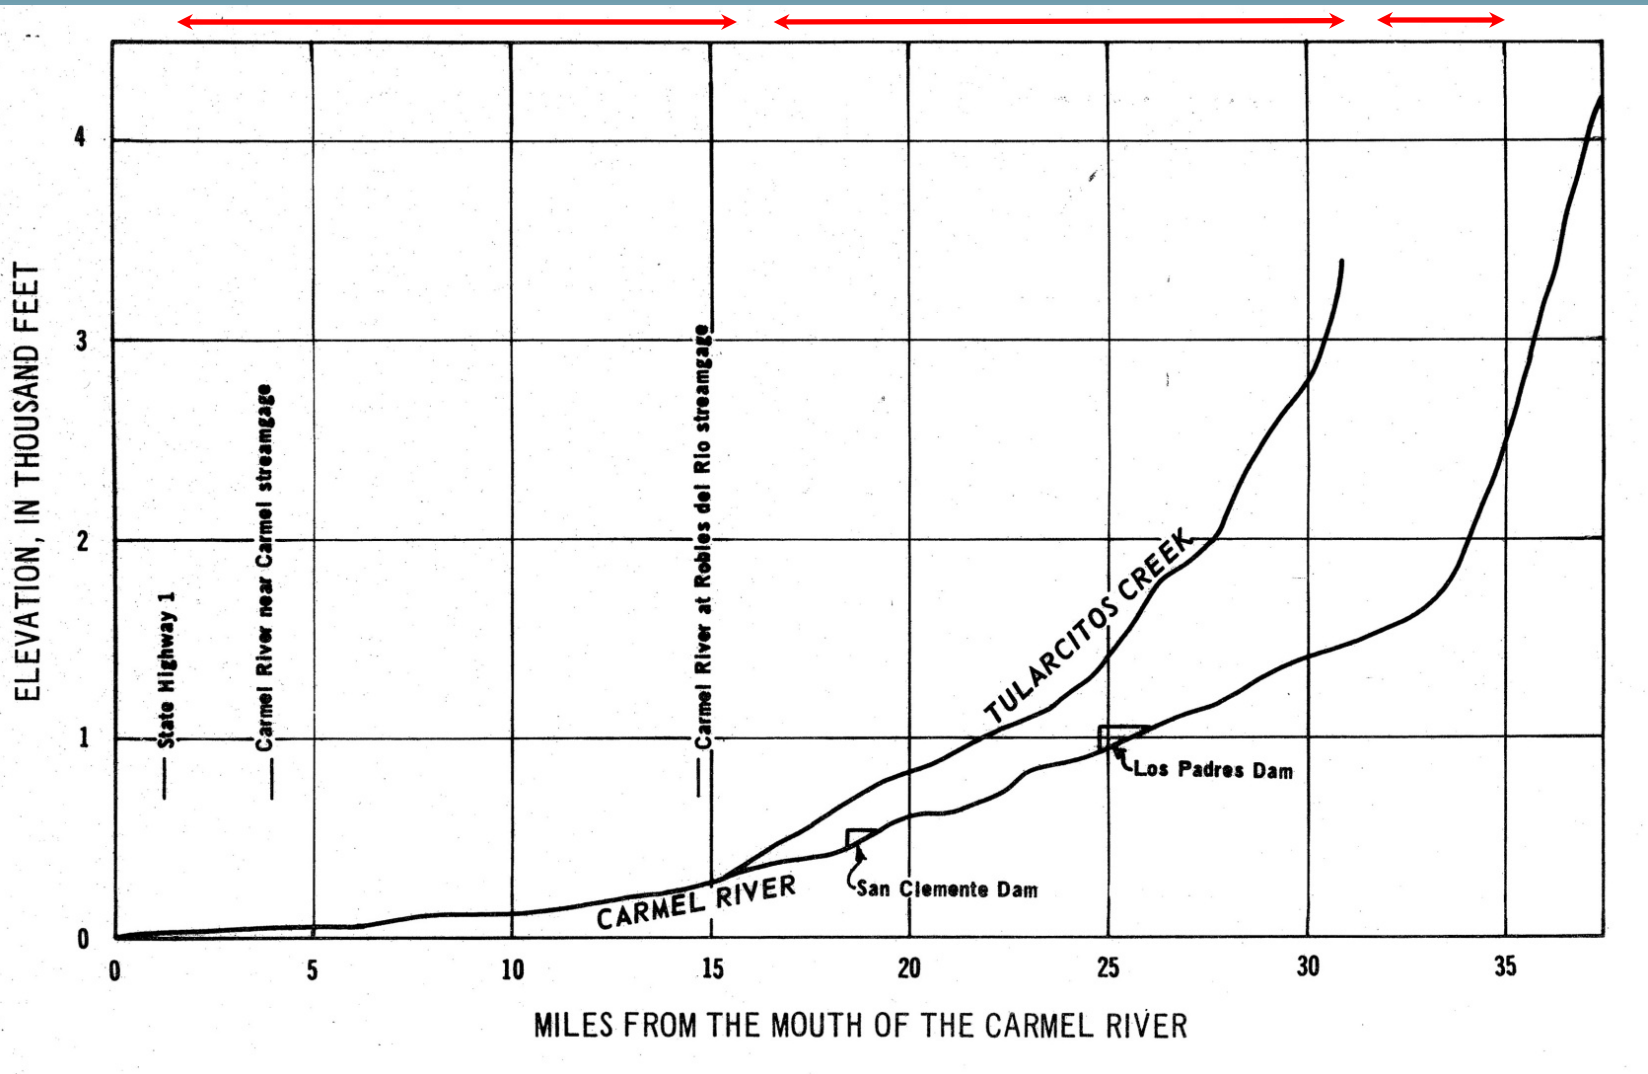
# Carmel River Profile

Lower 16 miles  
0.3% to 0.8%

Middle 16 miles  
1.5% to 2%

Upper 5 miles:  
5% to 12%

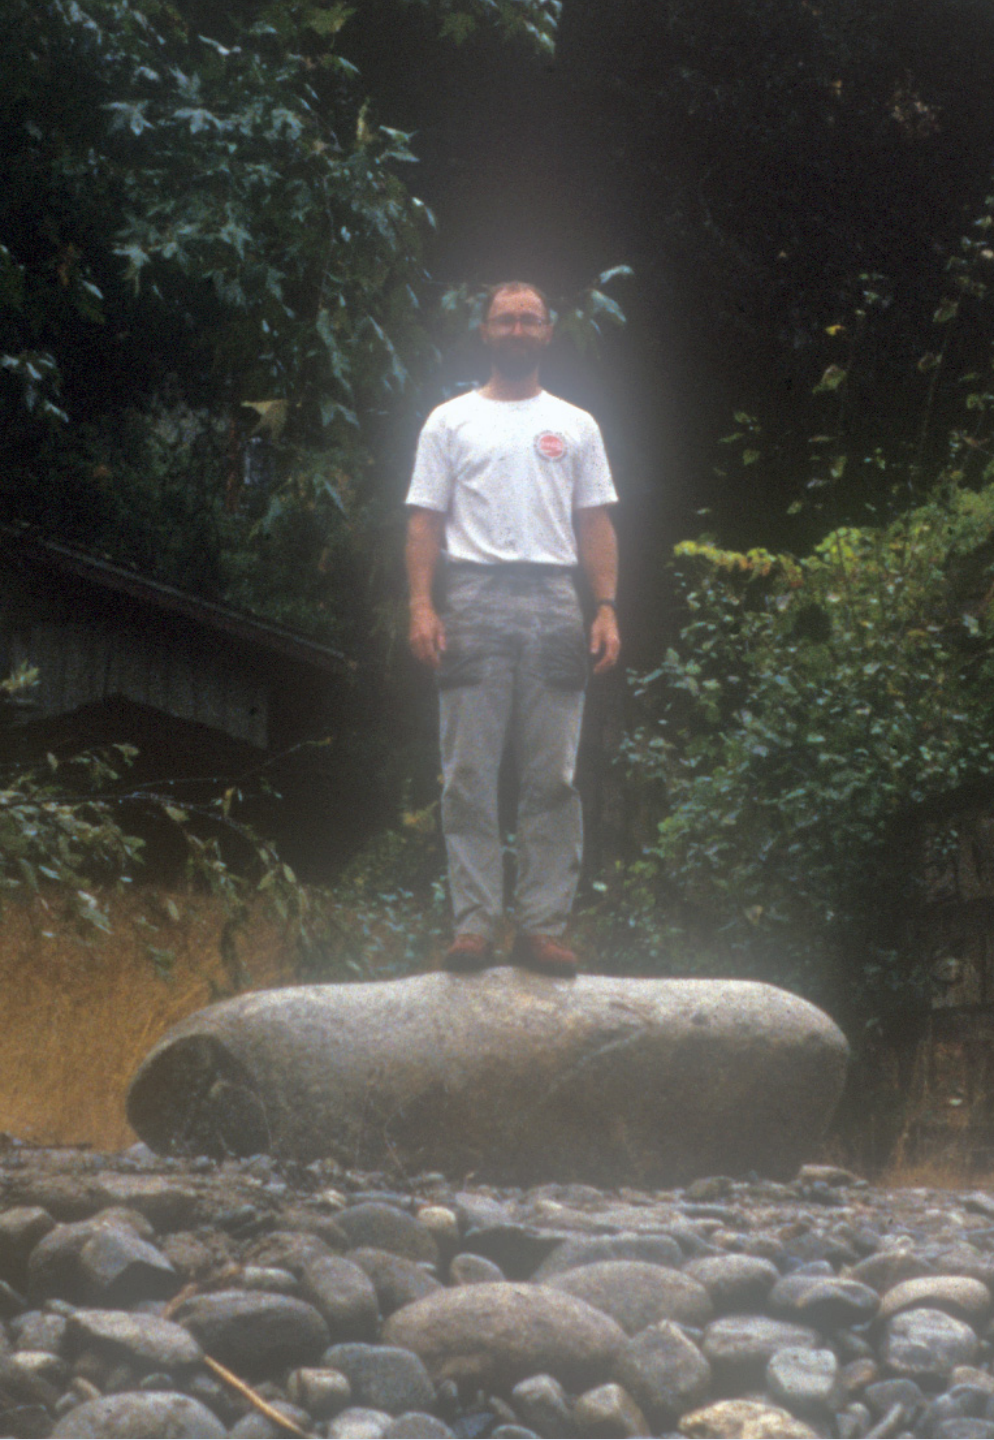
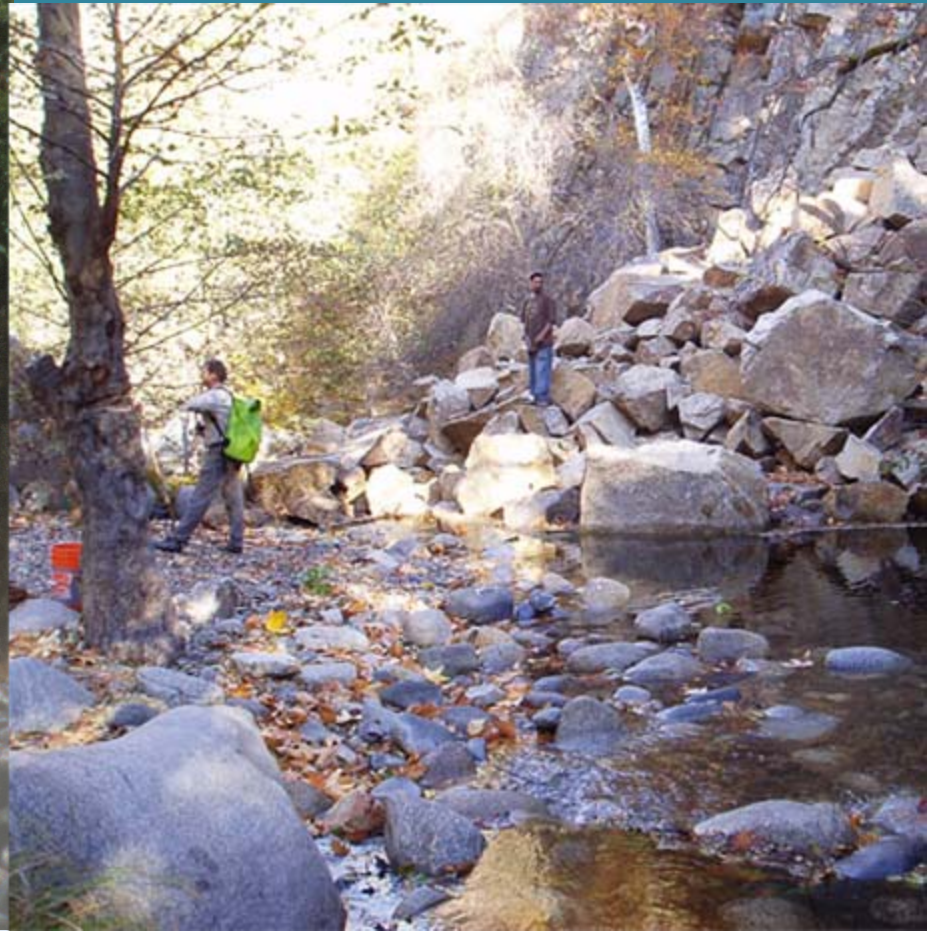
# Largest particles

Left – RM 12 in alluvium  
Below – RM 28 in canyon

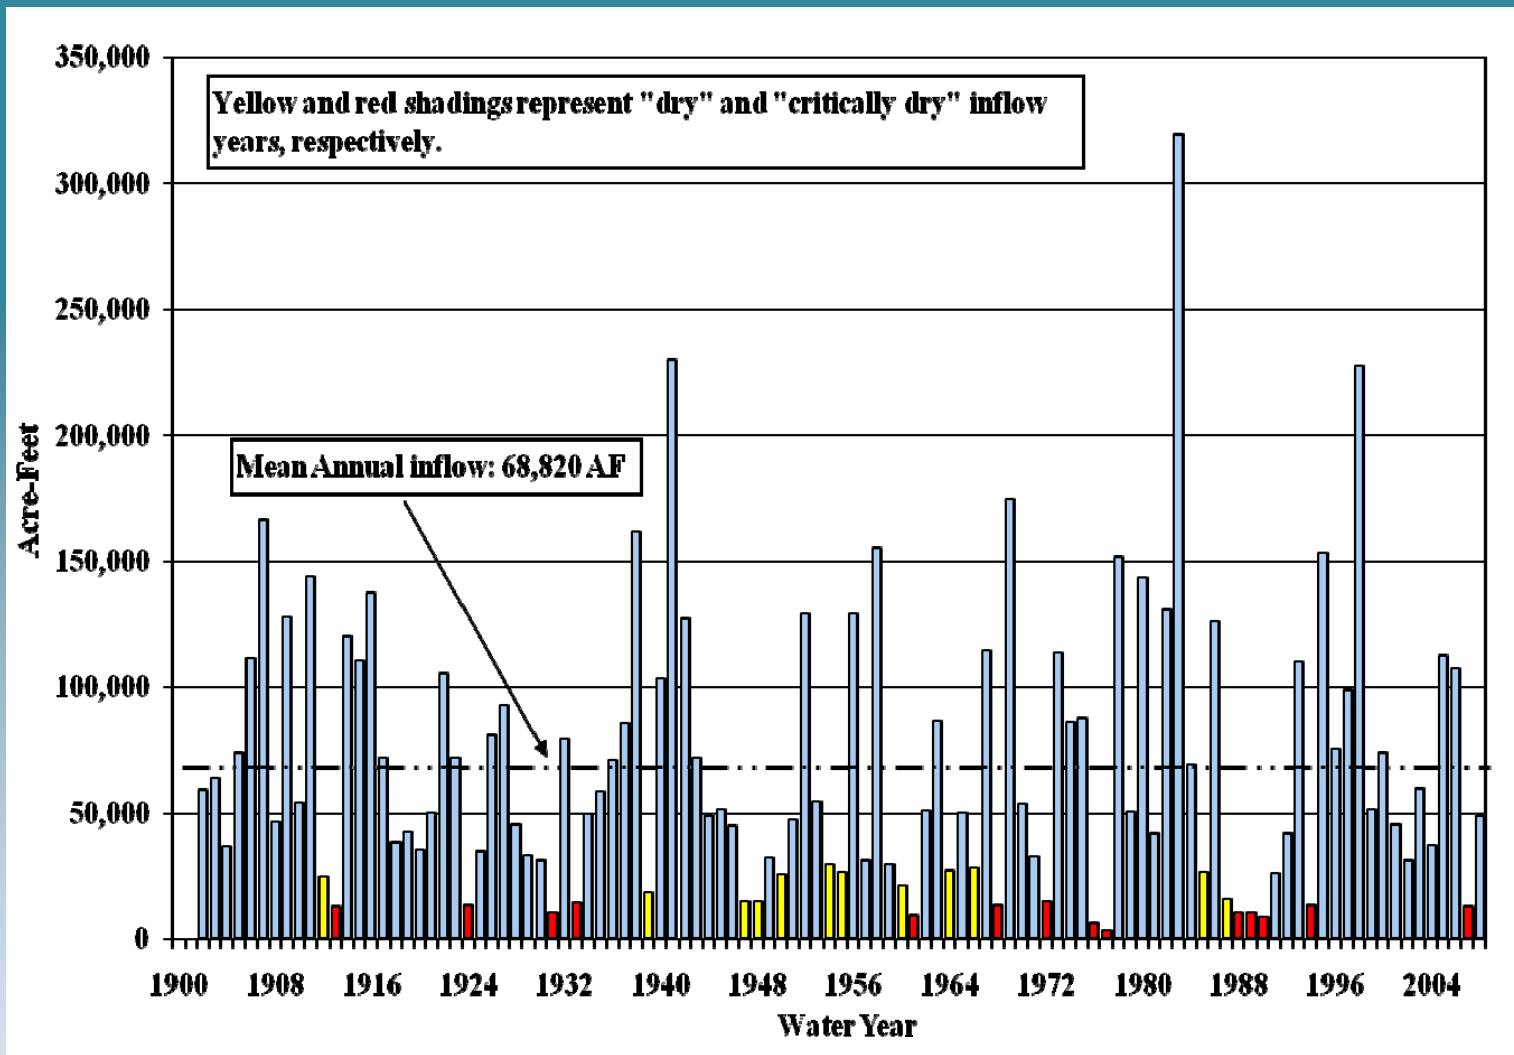
# Unimpaired Carmel River Flow at San Clemente Dam Site: Water Years 1902- 2008

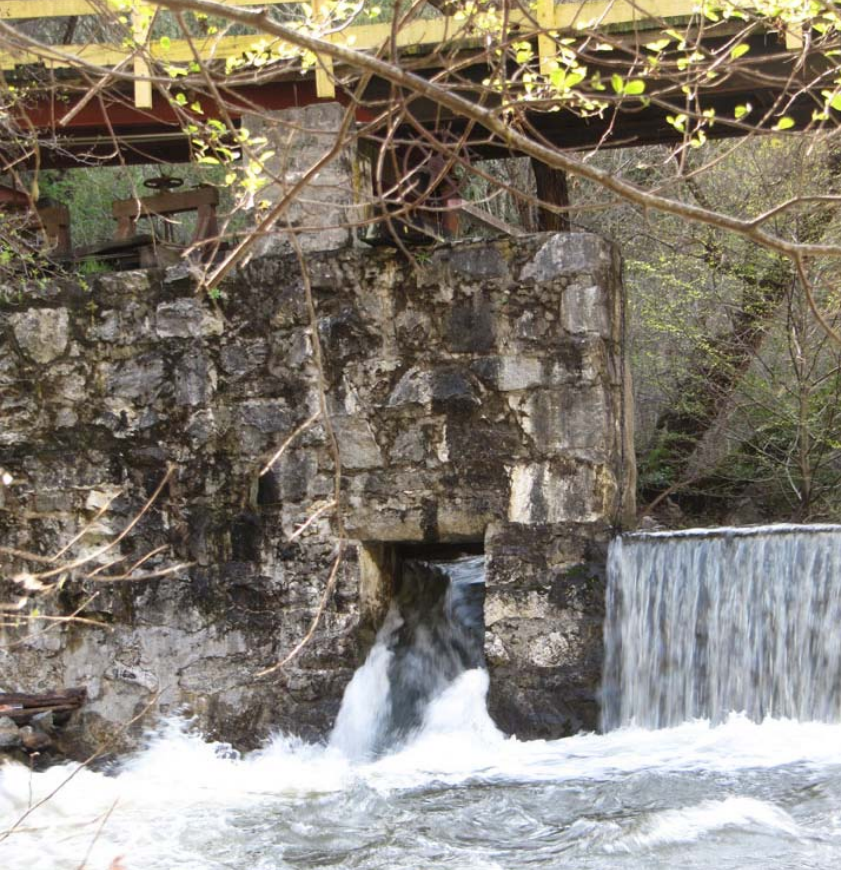
# Old Carmel Dam built at RM 18 to serve Hotel Del Monte

- constructed ca 1880
- 700 Chinese laborers
- 25 miles of 12-inch iron pipe
- crossed river in five places
- first Monterey Peninsula water supply
- included five-foot trestle at Robinson Canyon (RM 8.1)

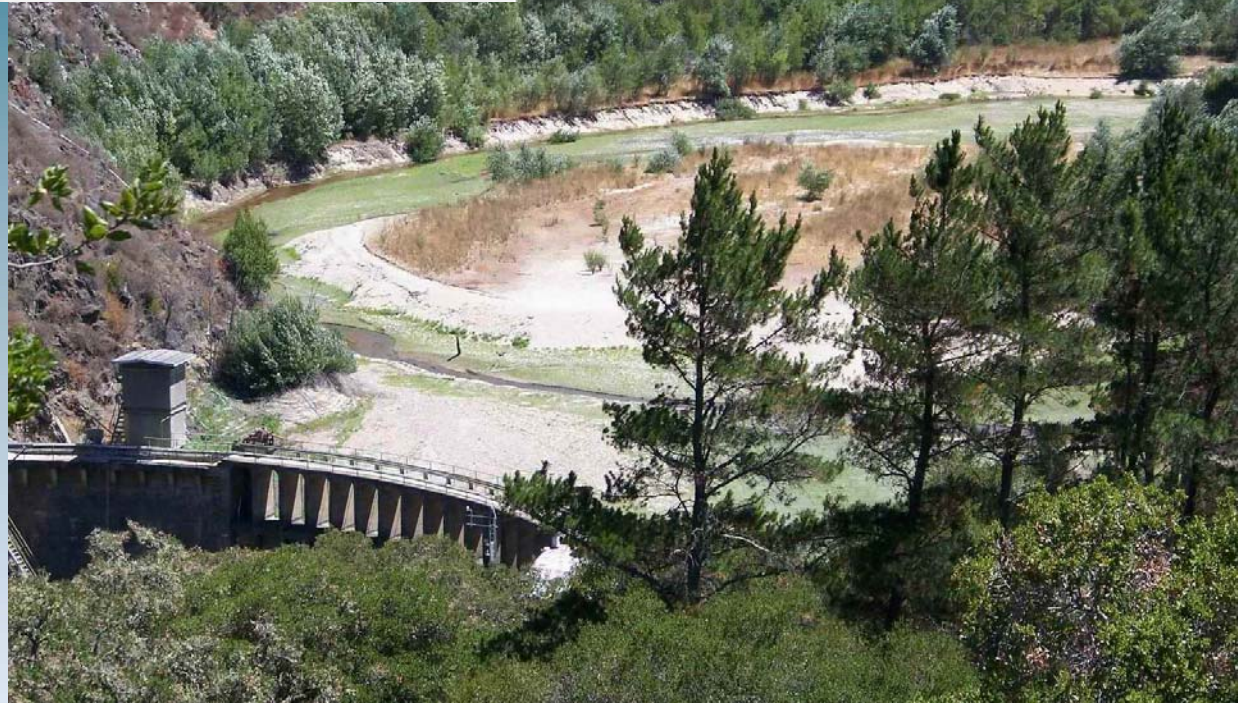
**San Clemente  
Dam at RM 18.6  
1921 cost to  
build:  
\$1-2 million**

**2007 estimate  
to remove:  
\$83 million**

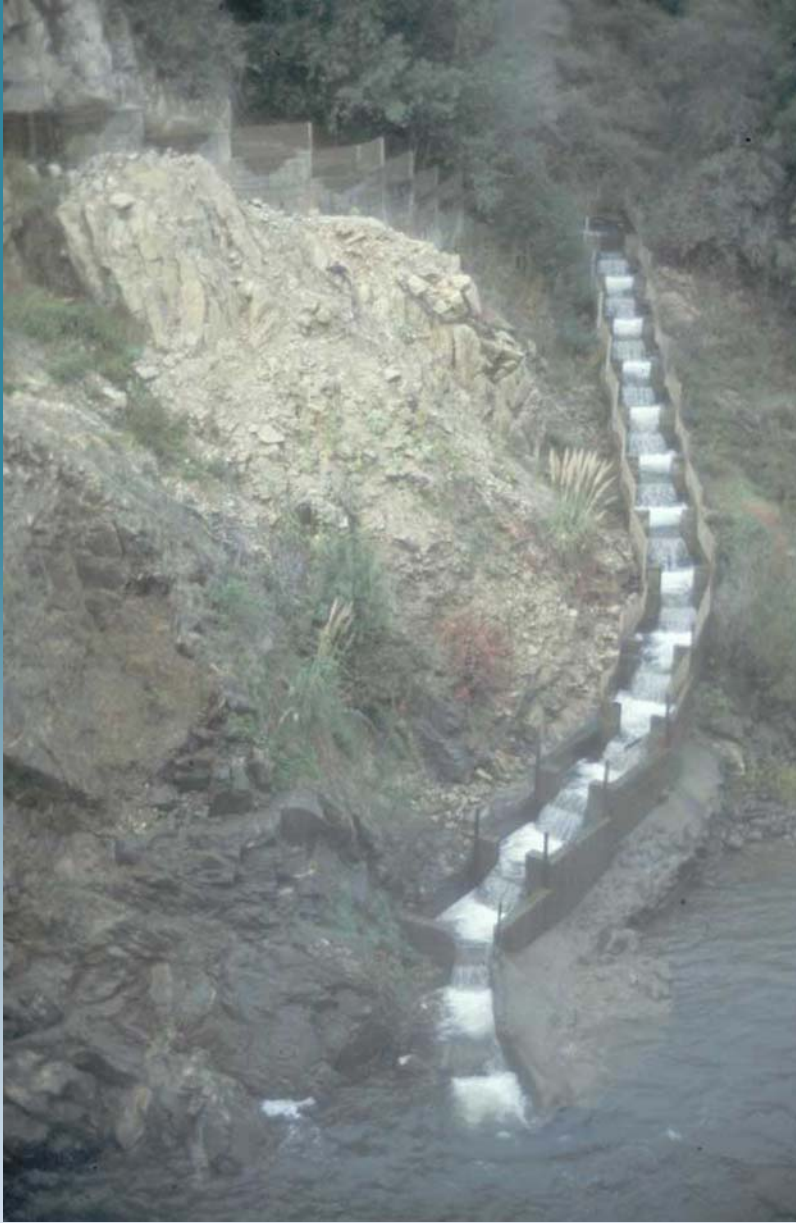
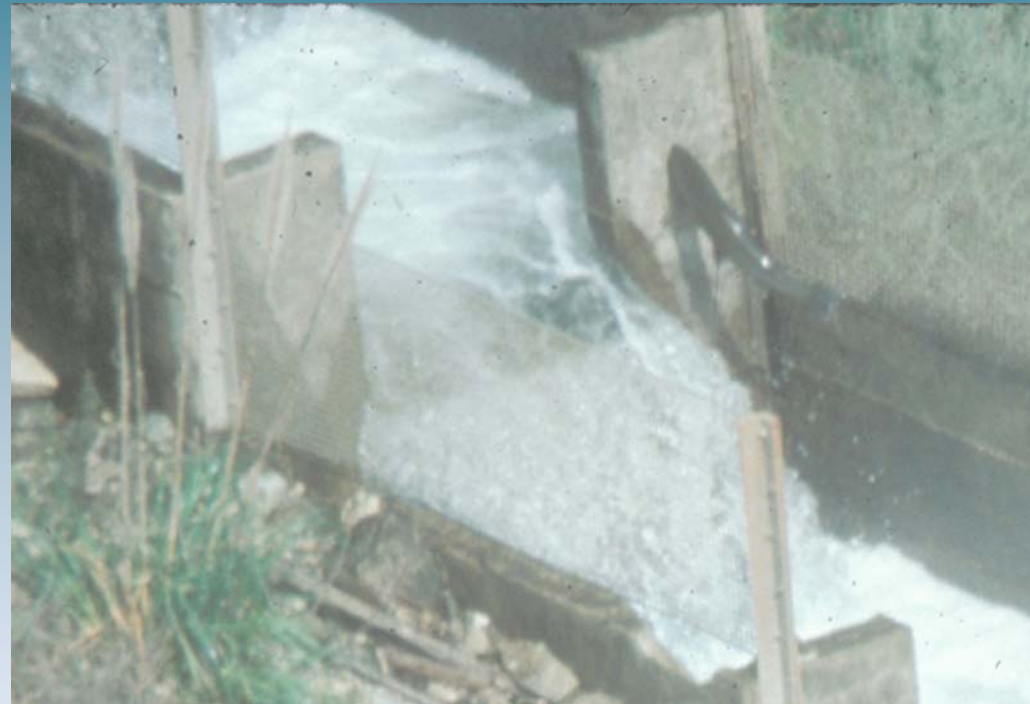
**San Clemente Dam Fish  
Ladder 70 feet – reported  
to be highest working  
ladder in California**

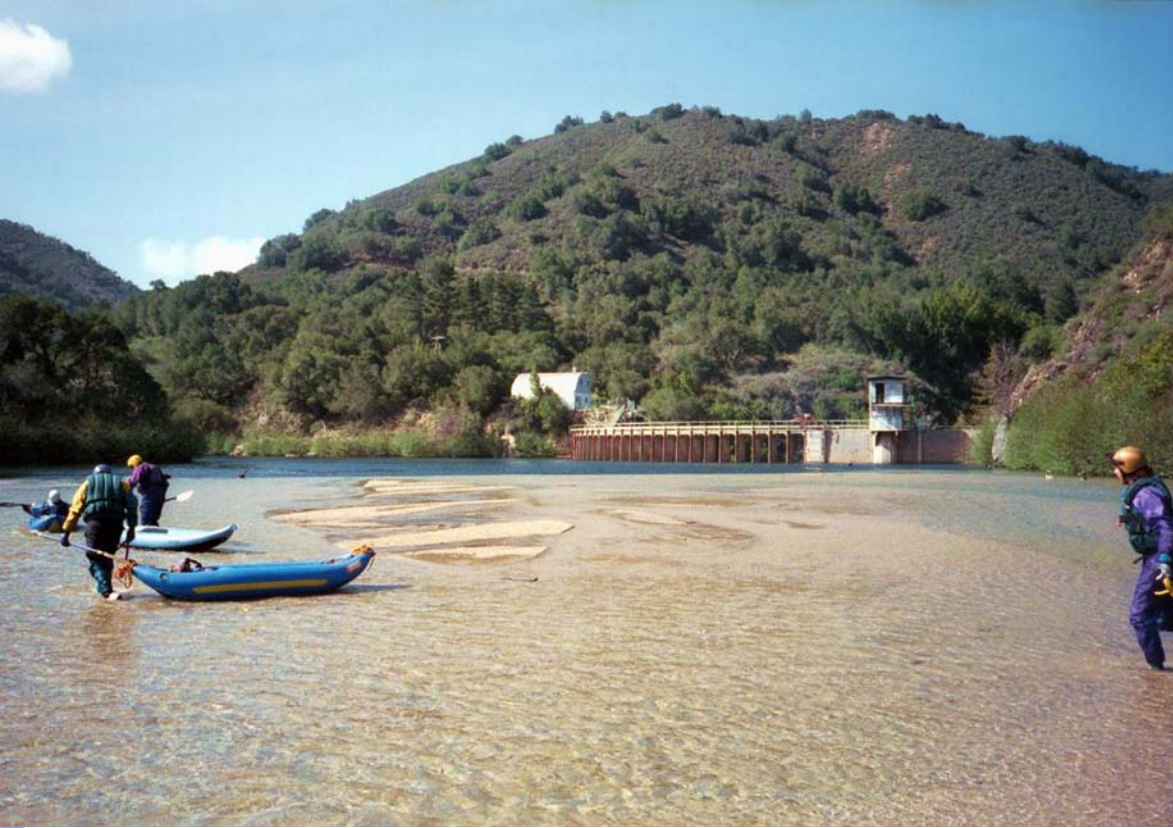
**Usable surface  
storage in San  
Clemente  
Reservoir  
reduced to ~  
60 AF**

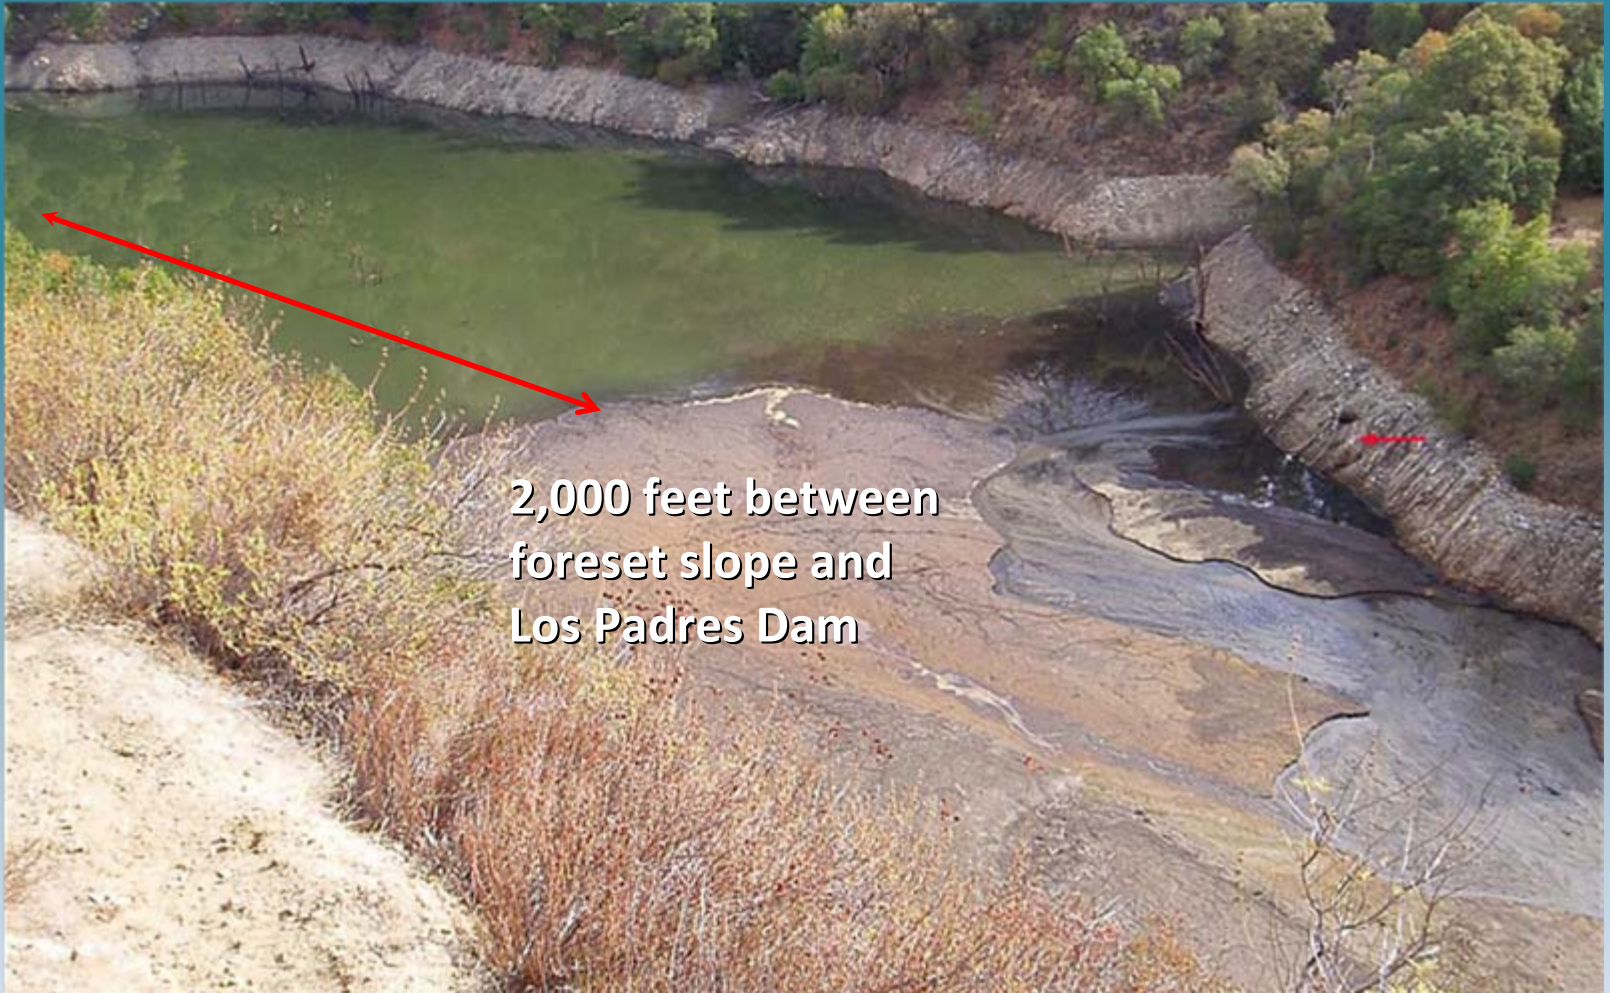
# 40% of Los Padres Reservoir has silted in over 60 years

2,000 feet between  
foreset slope and  
Los Padres Dam

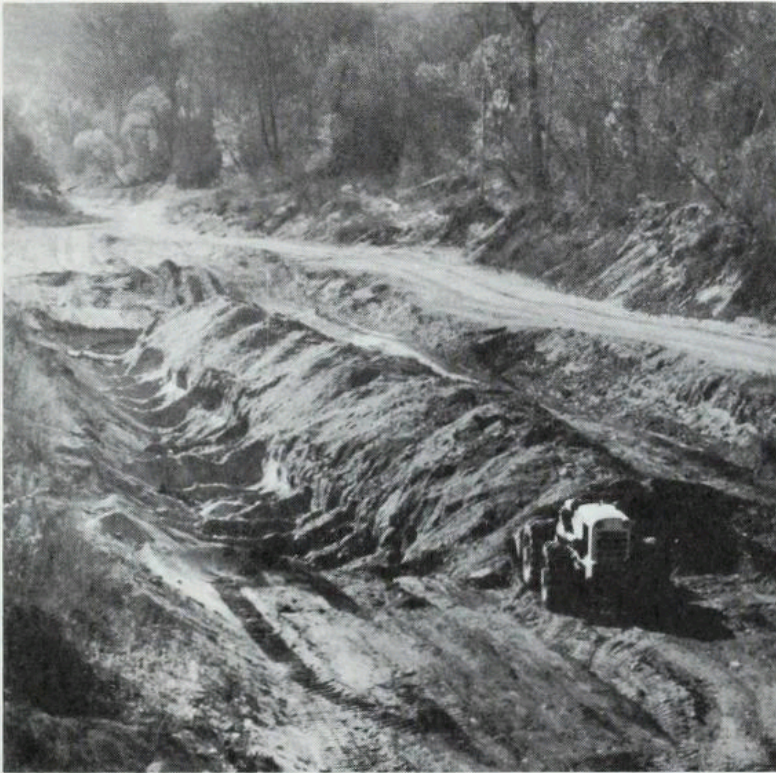
Photo 41. Valley Rock and Adobe Company's sand and gravel pit. This Carmel River stream channel deposit is narrow, being confined by levees over a distance of 15 miles upstream from the mouth. The stream normally flows most of the year, but after three successive "dry" winters the channel was completely dry in October 1961.

Notes about the Carmel River in 1966:

- "Constant exploitation since 1920."
- "...rate of replenishment during flood is small compared to mining."

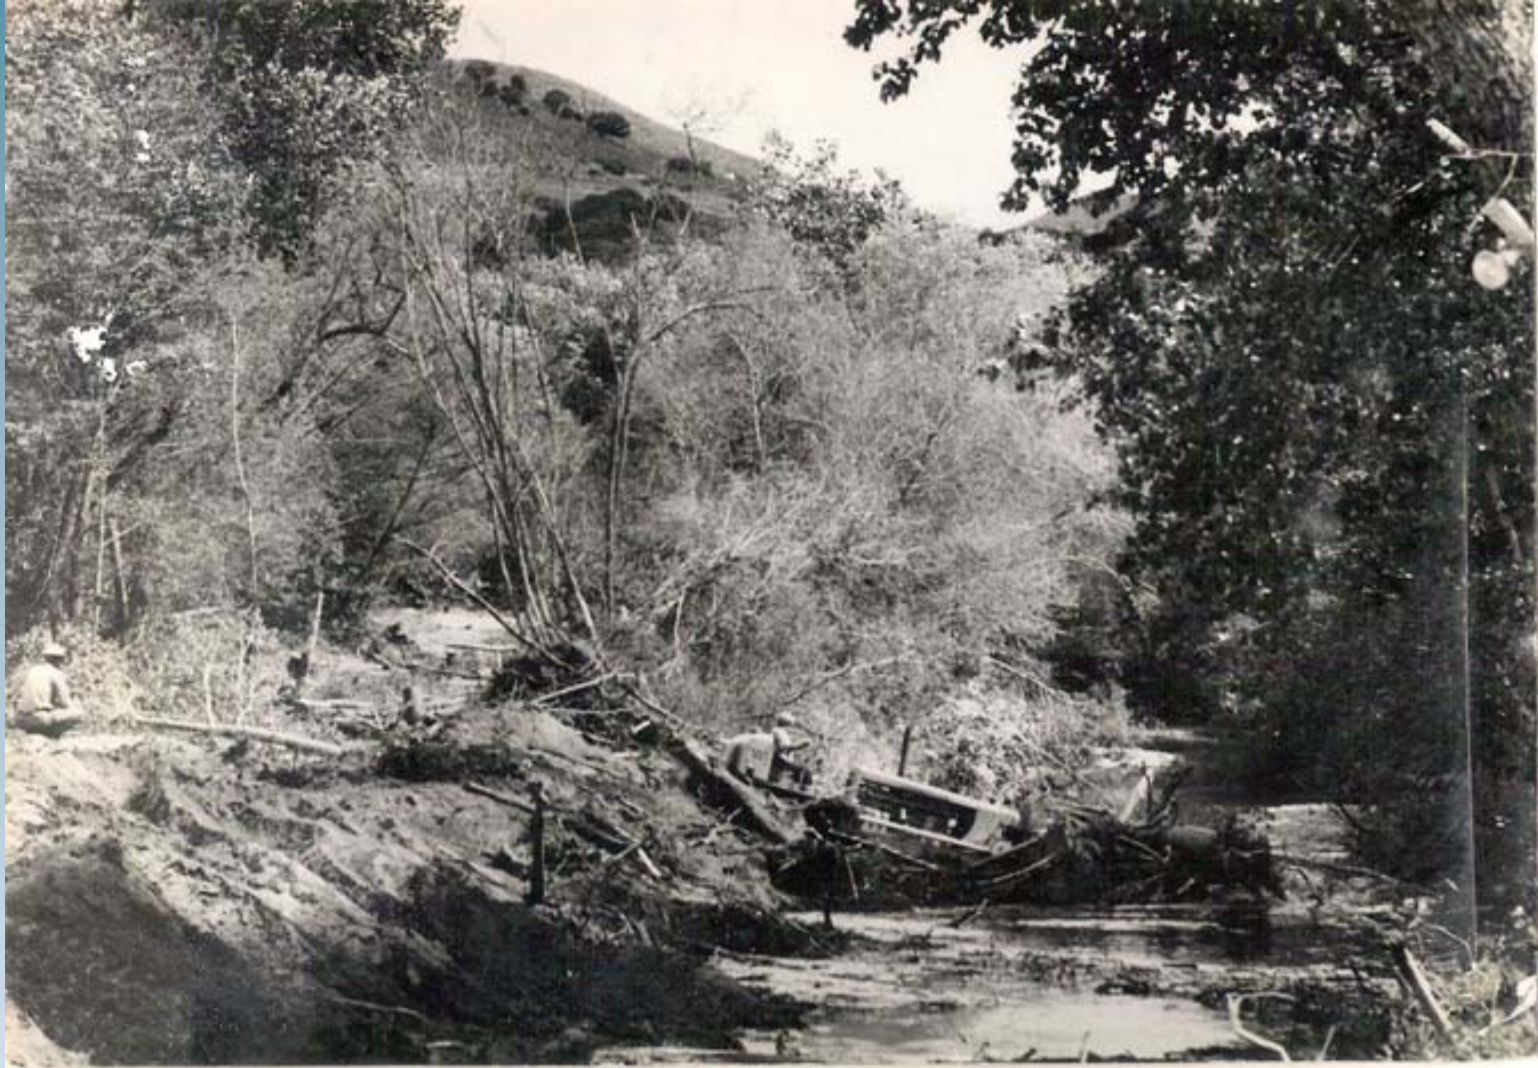
Carmel Valley Road at RM 8

# Channel Maintenance – 1940's

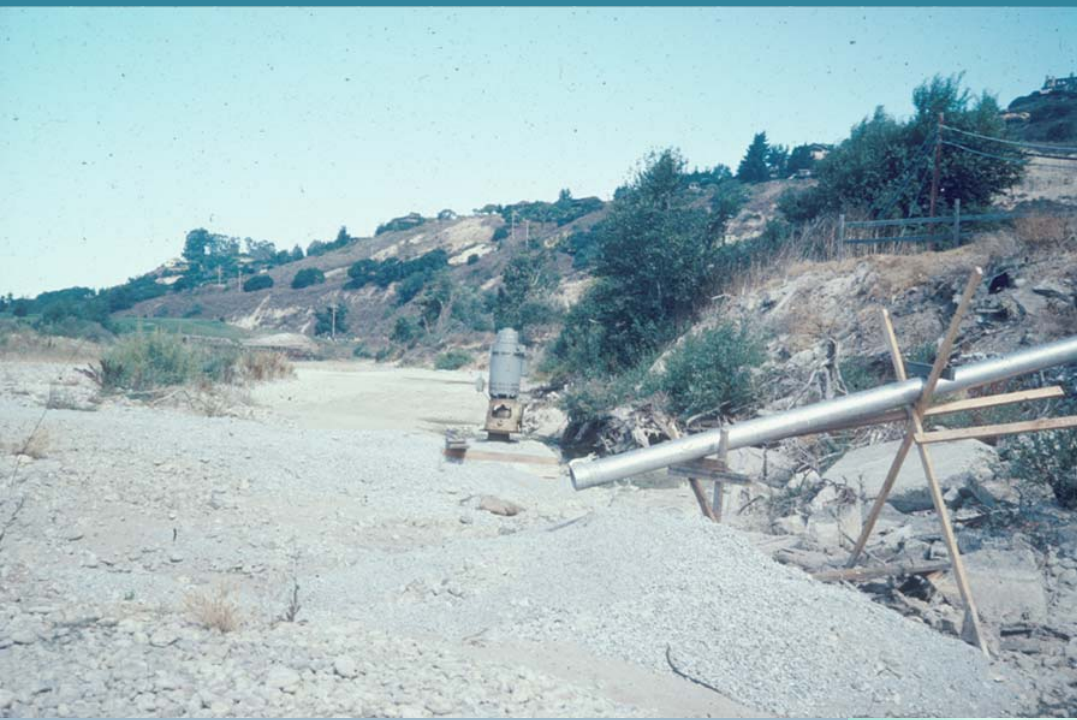
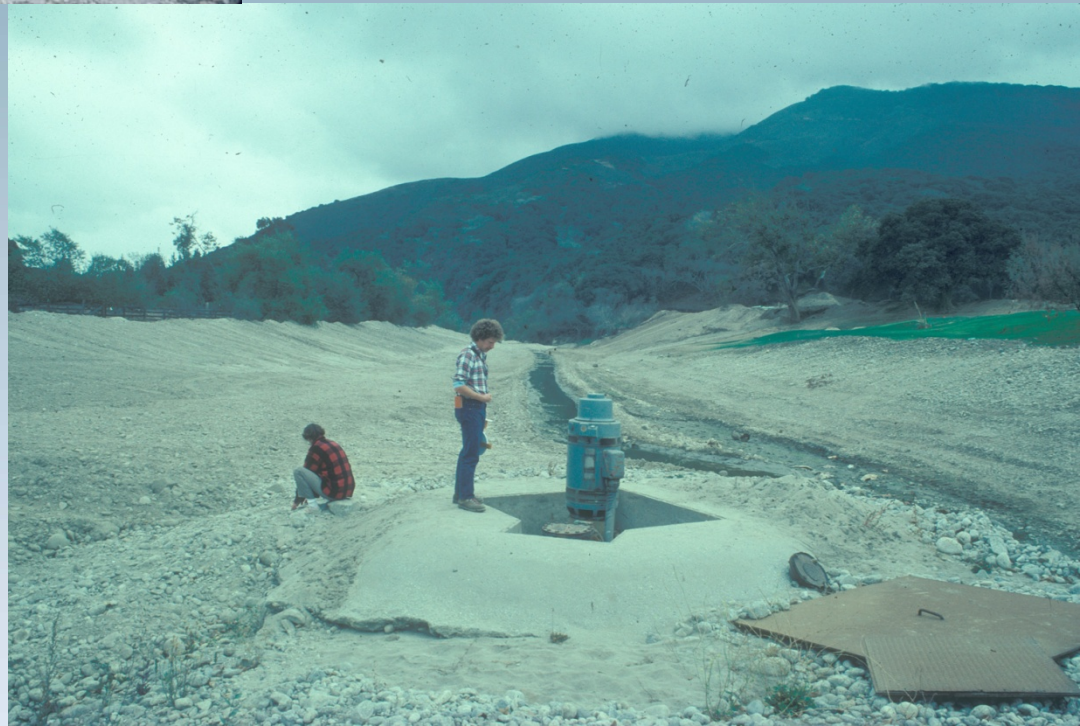
# Diversions dewater the river annually

Carmel River at  
RM 9 in 1984  
(above) and  
1980 (right),  
next to Carmel  
Valley Ranch

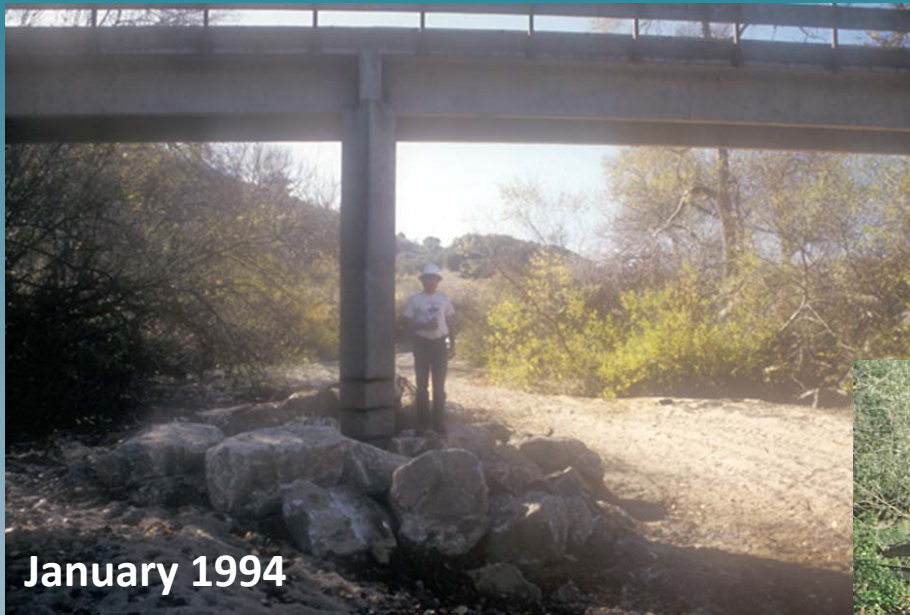
January 1994

# Bridges in the Carmel River

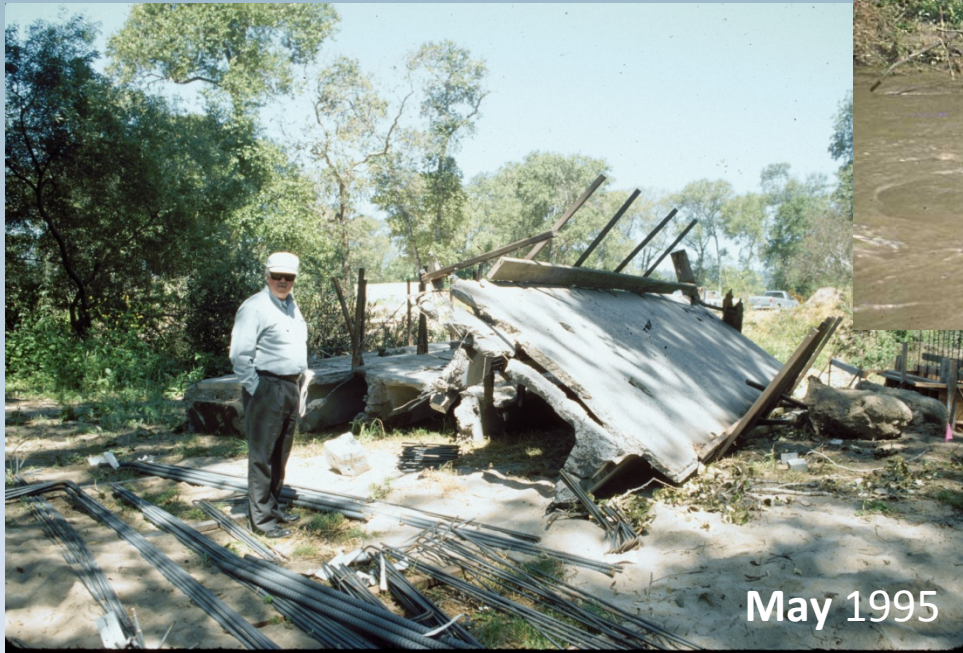
May 1995

## Rancho Cañada golf course

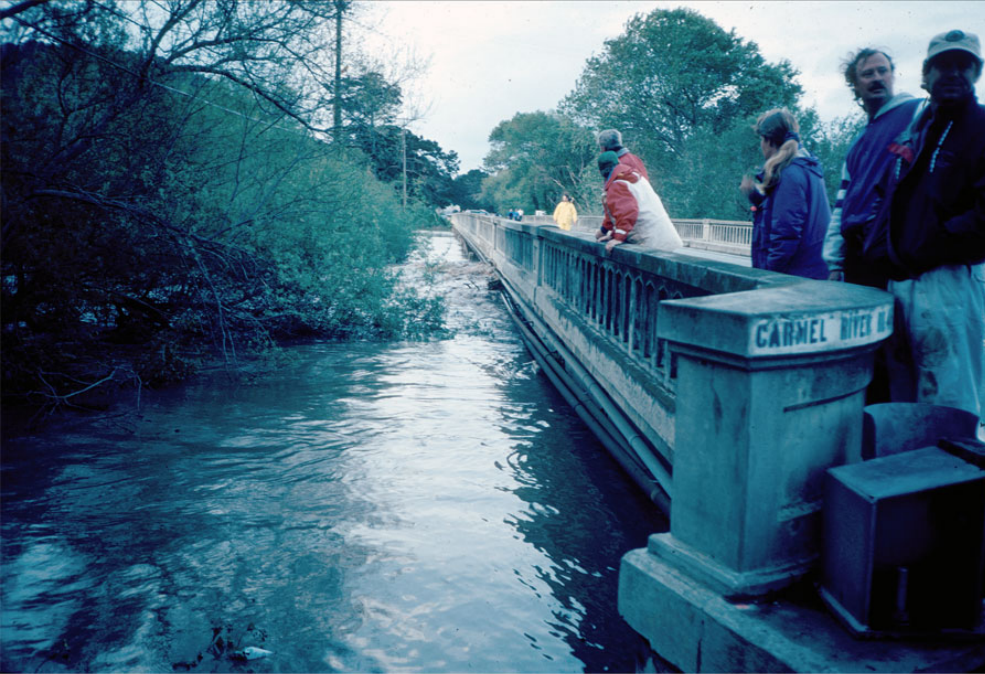
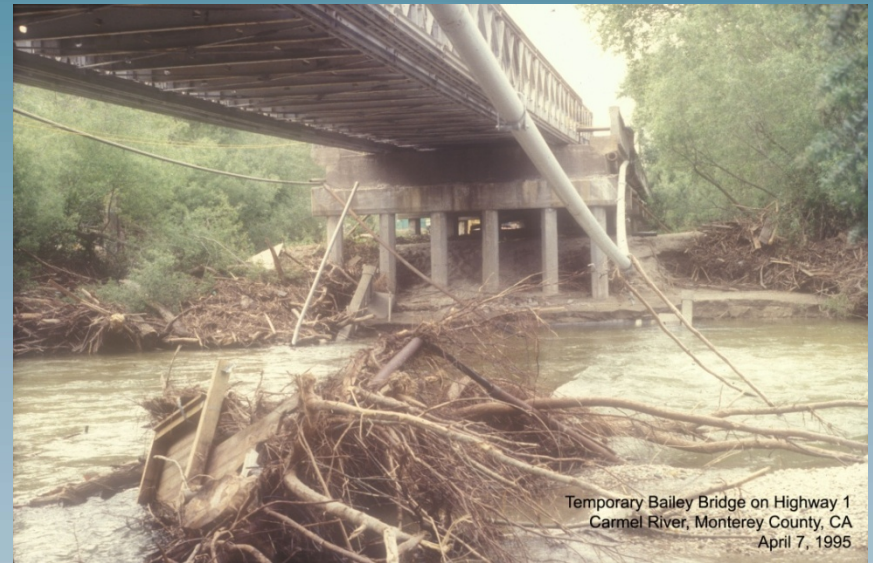
Highway 1 Bridge over the Carmel River  
Above - March 10, 1995  
Below - March 12, 1995

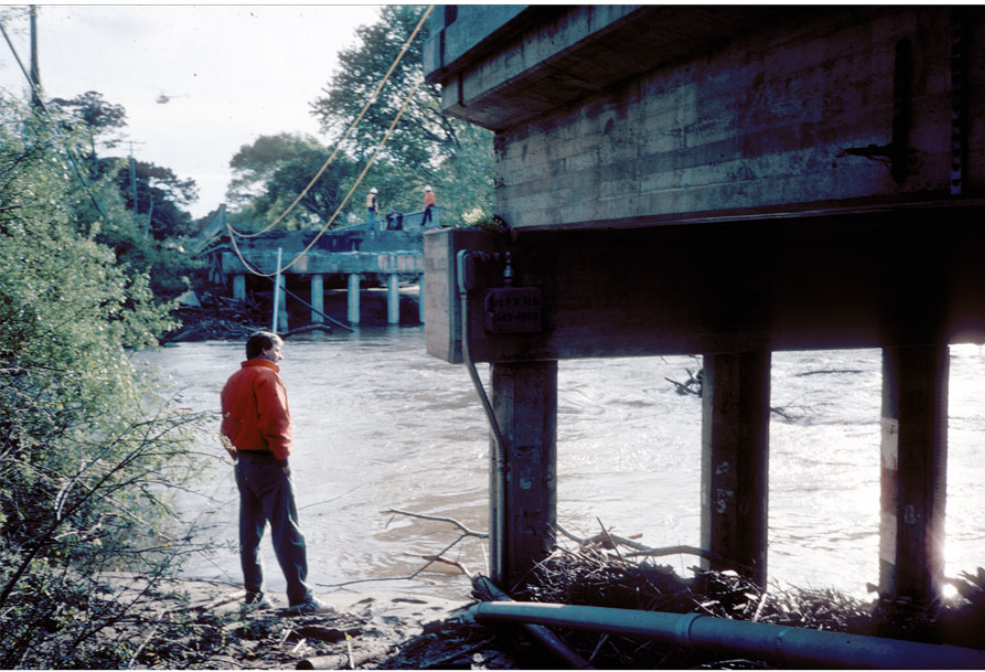
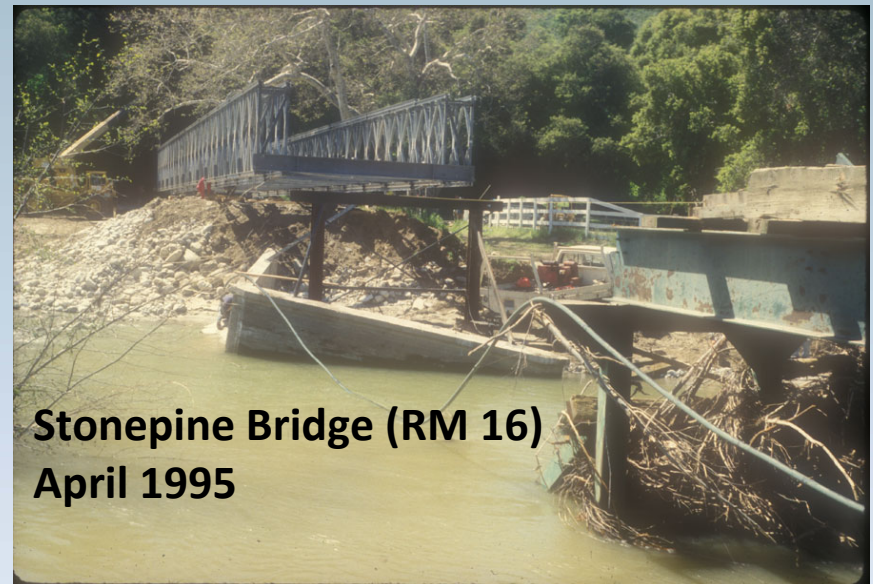
Stonepine Bridge (RM 16)  
April 1995

Temporary Bailey Bridge on Highway 1  
Carmel River, Monterey County, CA  
April 7, 1995

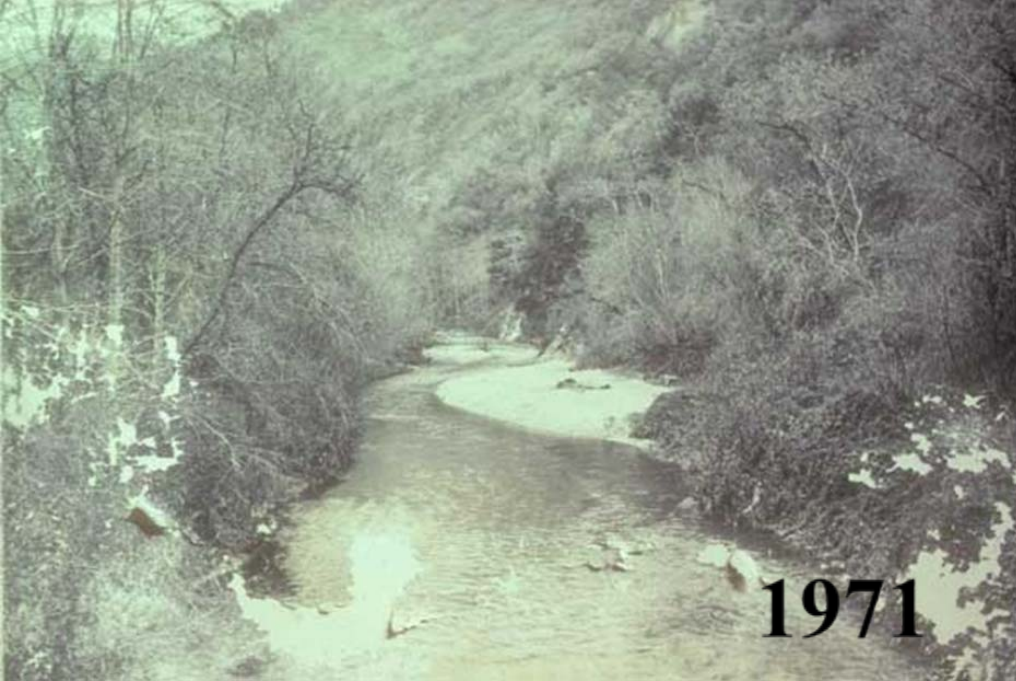
1971

# Lateral migration after 1976-77 drought upstream of Schulte Road Bridge at RM 7

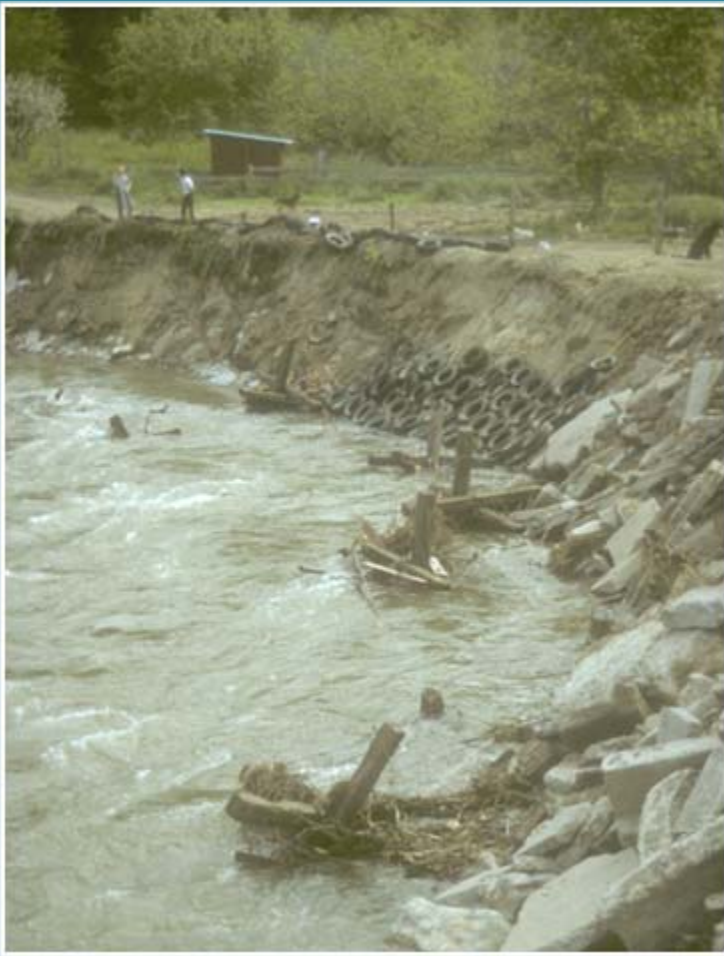
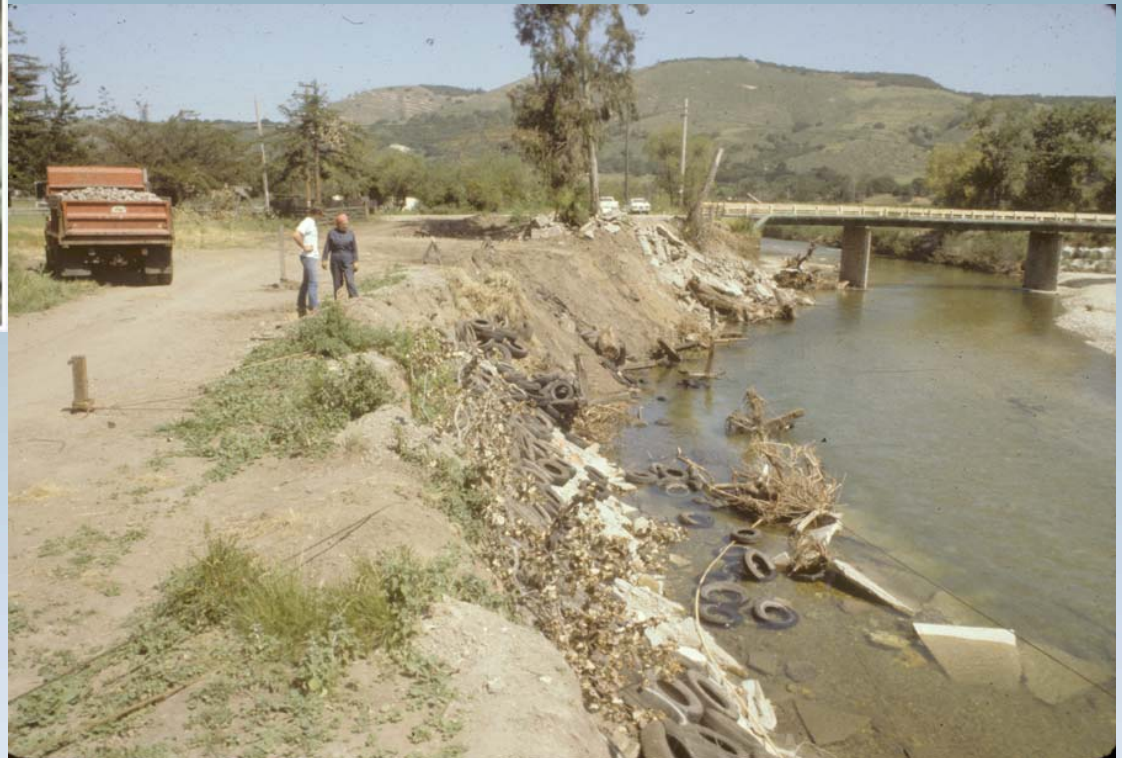
# Property owners act unilaterally at Schulte Road Bridge, RM 7

Above – April 1982  
Right – May 1982
