# The Carmel River 30 Years of Restoration

A presentation to the

San Jose Branch of the  
American Society of Civil Engineers

Larry Hampson, District Engineer

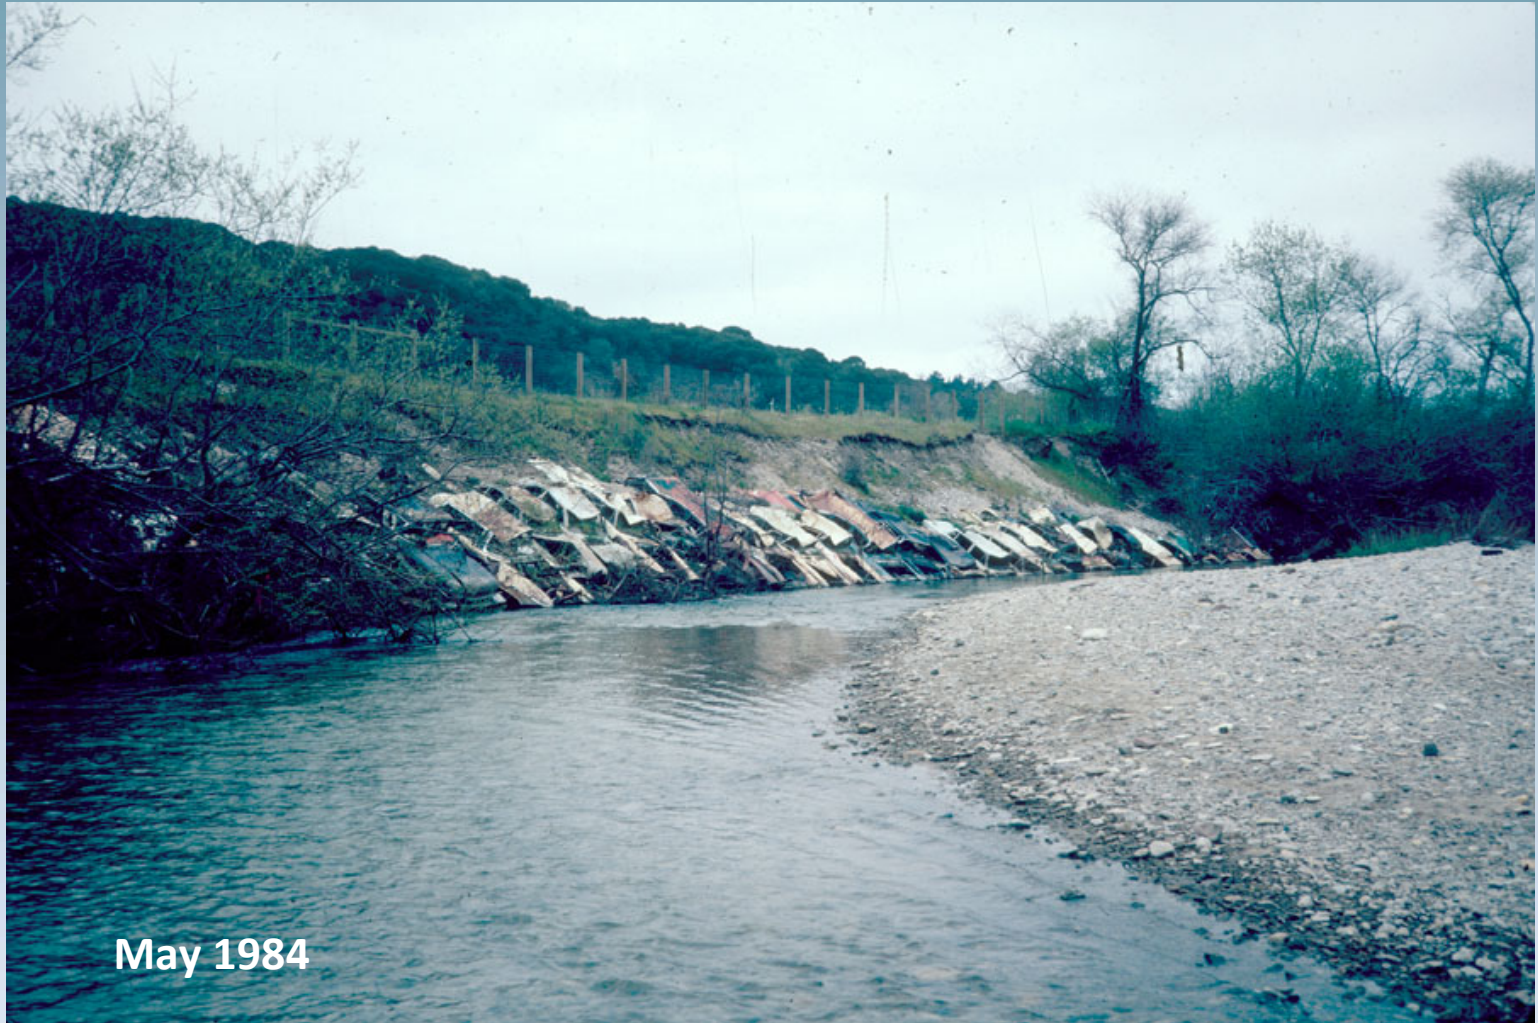
May 1984

# Locally available, relatively inexpensive erosion protection materials were used (Valley Hills Project, RM 5)

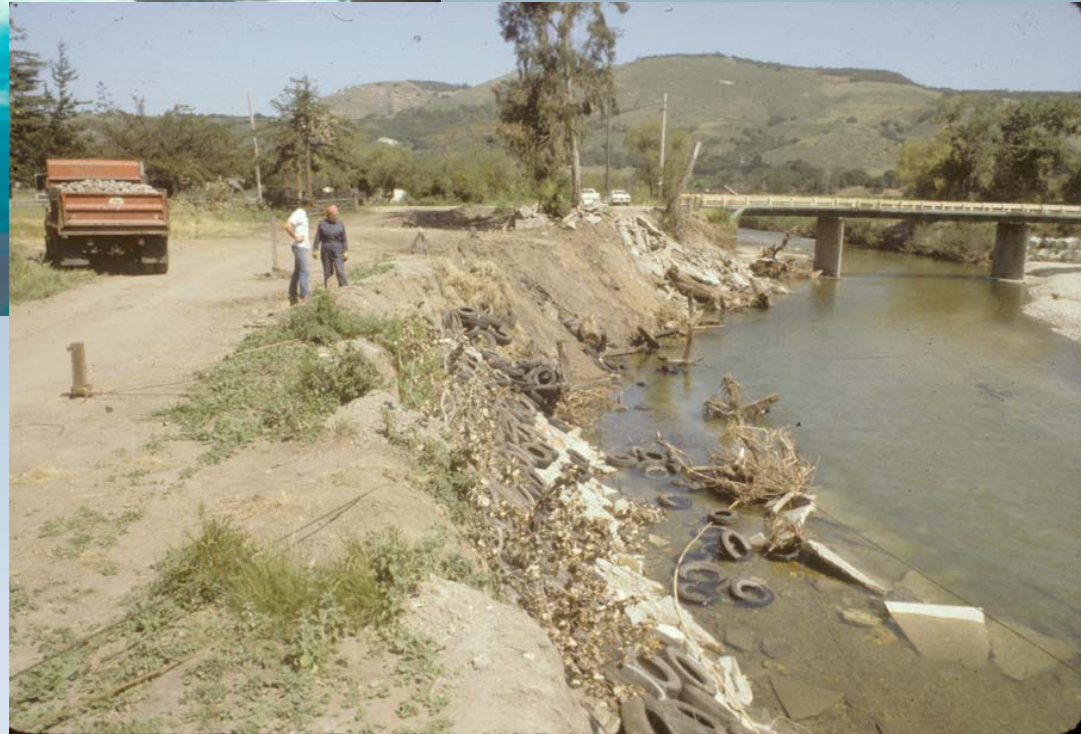
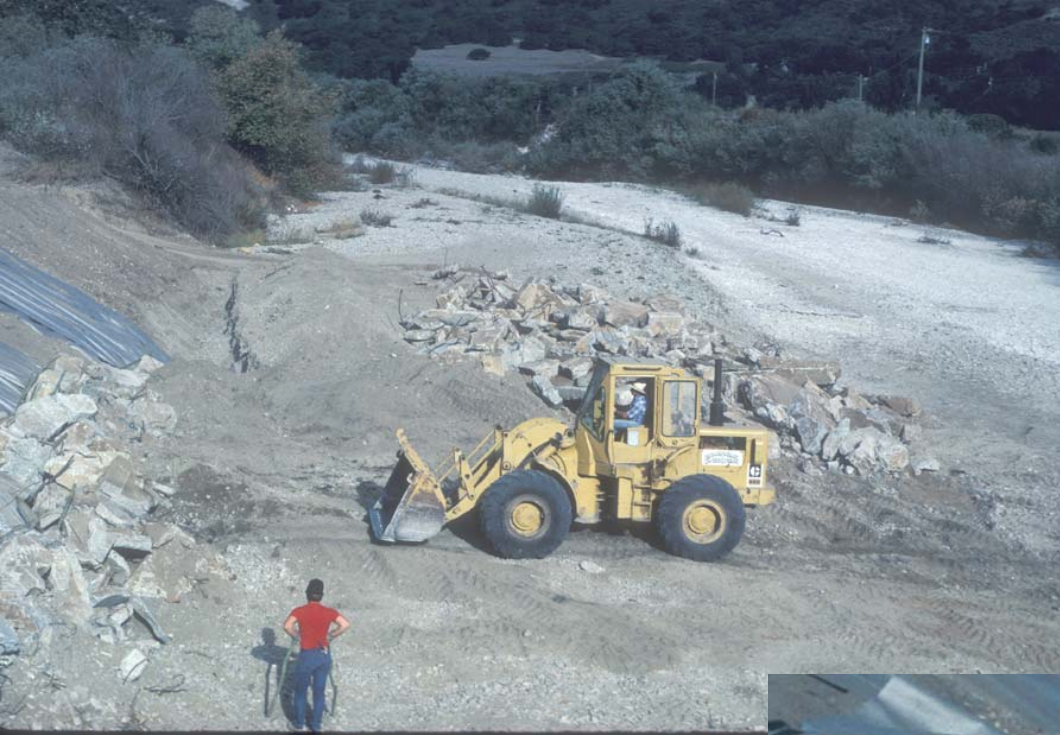
**Structural  
protection on  
outside meander  
bends integrated  
with vegetative  
solution**

**Note: concrete  
rubble, filter  
fabric no longer  
allowed**

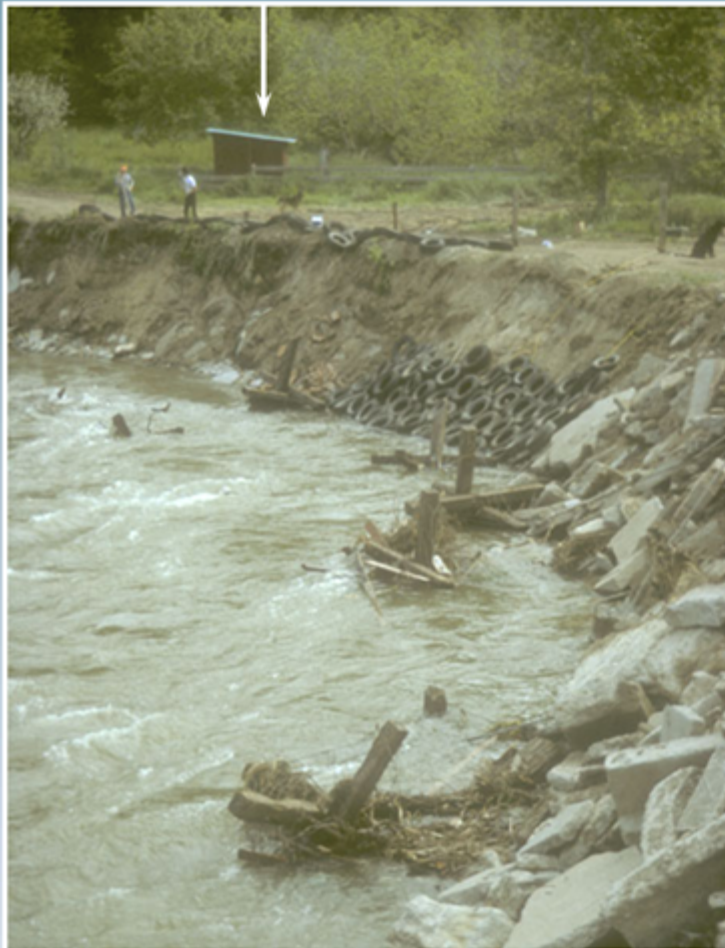
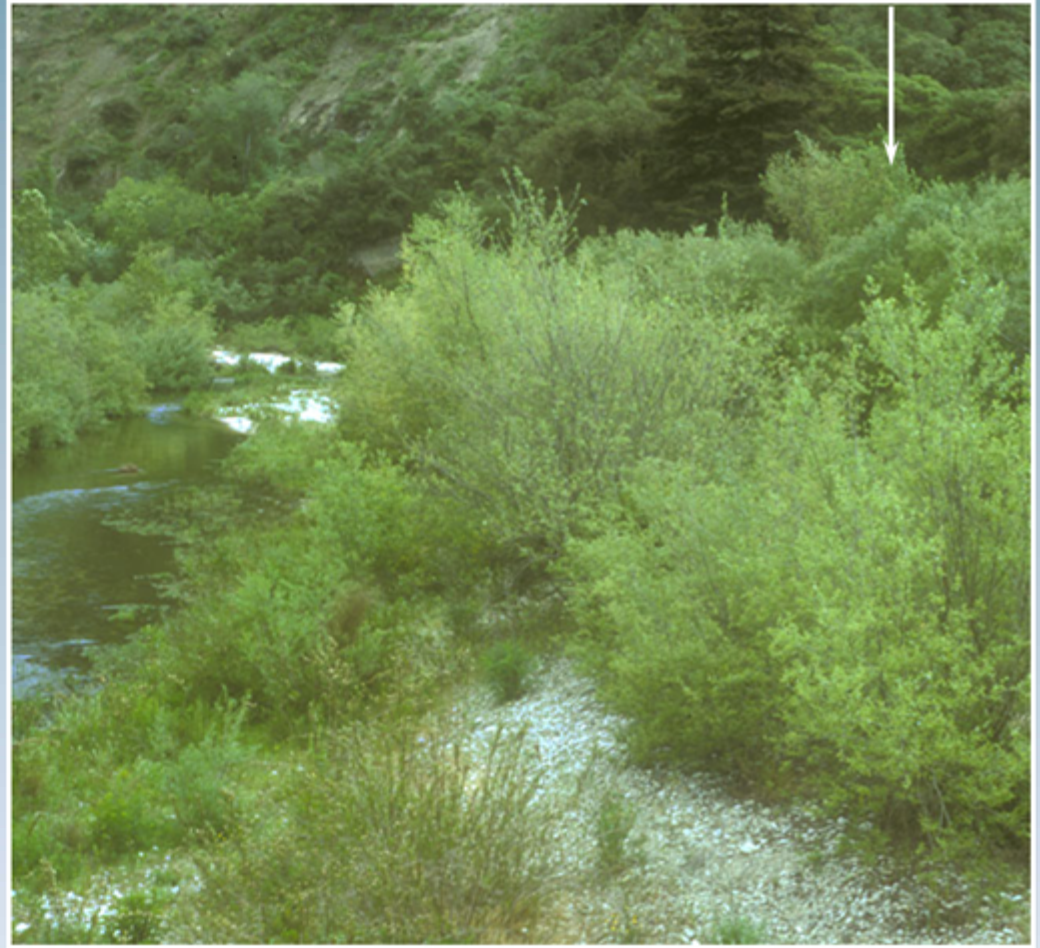
# Schulte Project – 1982 and 2003

Left - Looking upstream from Schulte Bridge, April 1982. Note tires, wooden jacks, and concrete rubble dumped by the owner on the stream bank to slow erosion.

Right - May 2003 - after MPWMD-sponsored restoration work. The arrow shows where the brown well pump building was at the upper left of the 1982 photo. MPWMD continues to maintain and monitor this project area.

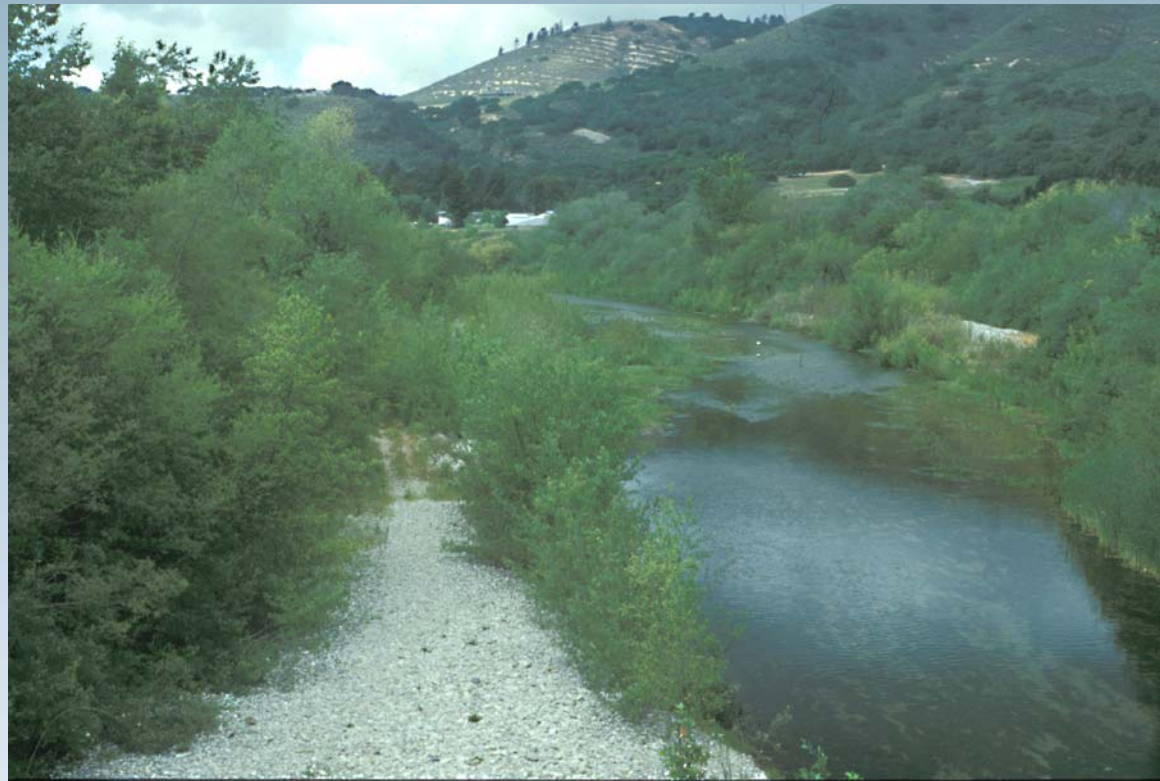
**Schulte Road  
Bridge at  
RM 6.7**

**Above – after  
completion in  
December 1986**

**Right – May 2002**

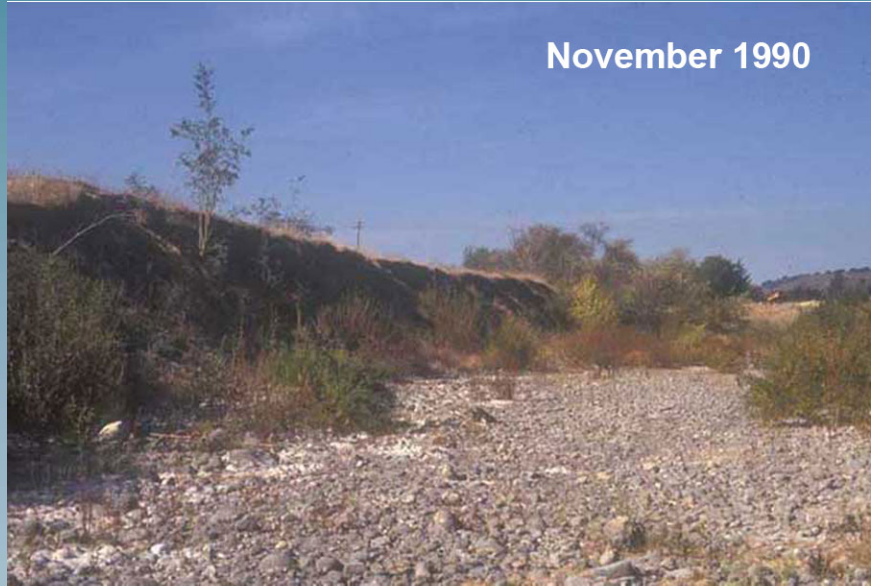
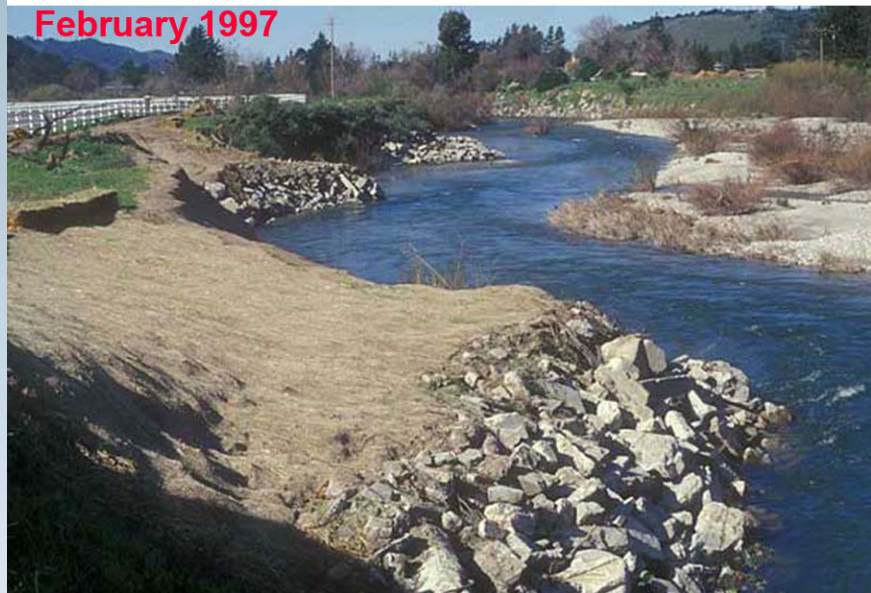
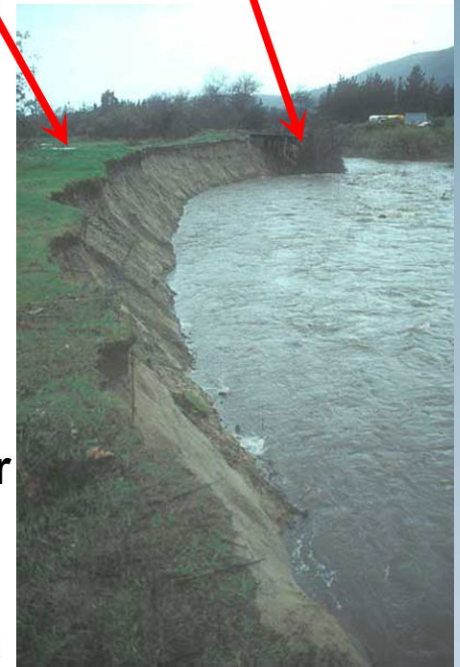
## Red Rock Area Restoration Project

# Chronic dewatering = chronic erosion

100-year  
floodplain

Remnants of  
old wooden  
bridge

Left - during  
drought

Right - during  
high flow (1993)

Below Left - after  
property owner  
performed  
emergency work

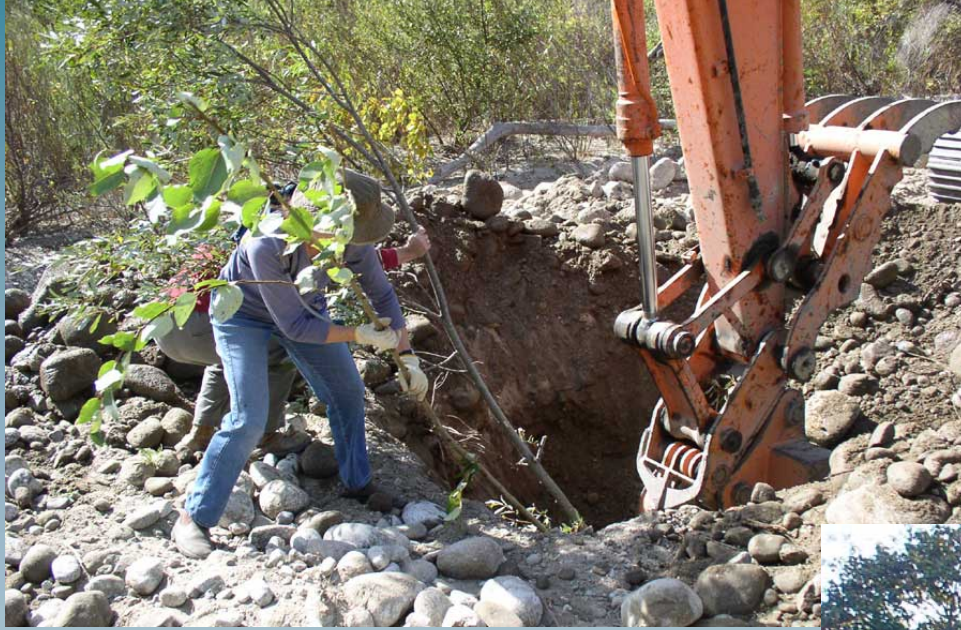
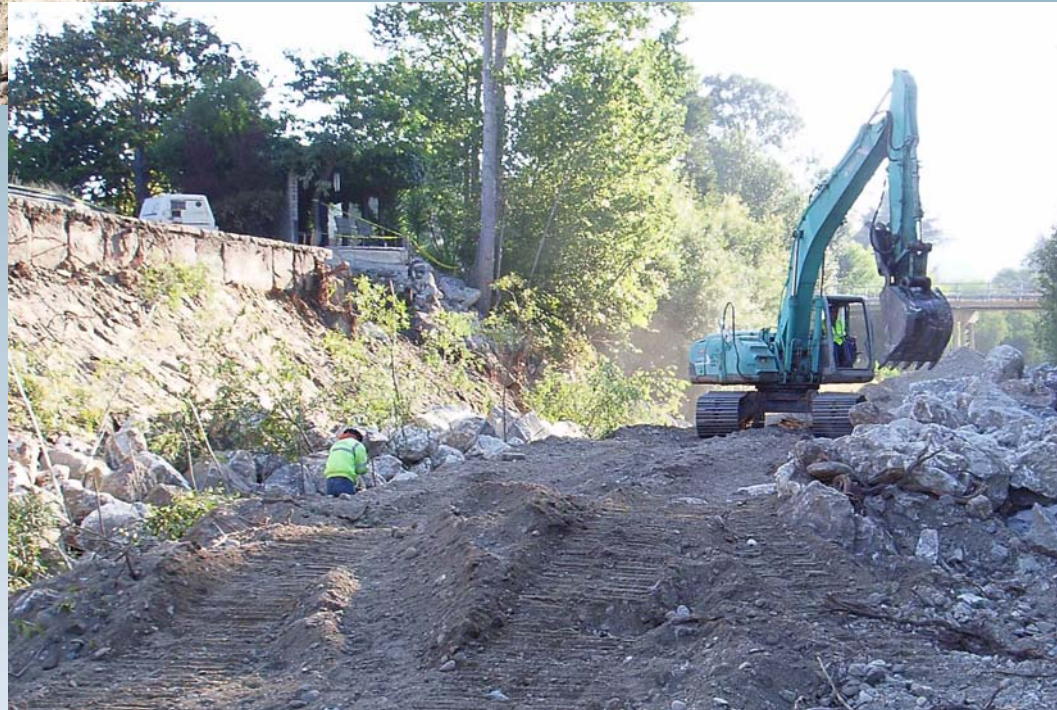
# Range of Methods used in 1990s

## Hardscape (e.g., RSP, rock groins)

- At bridges
- Within 25 ft. of structures
- Constrained channel ( < 200 feet)
- Outside of meander bends

## Bioengineering

- Channel width > 400 feet
- Inside of meander bends
- No structures of concern
- Bank deformation not a concern

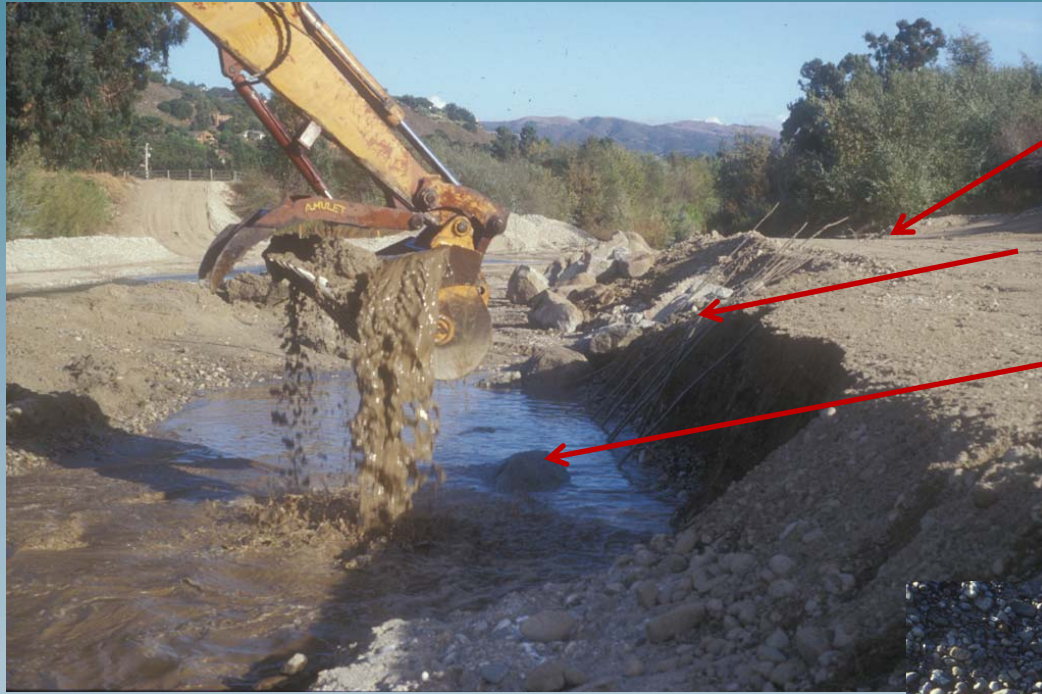
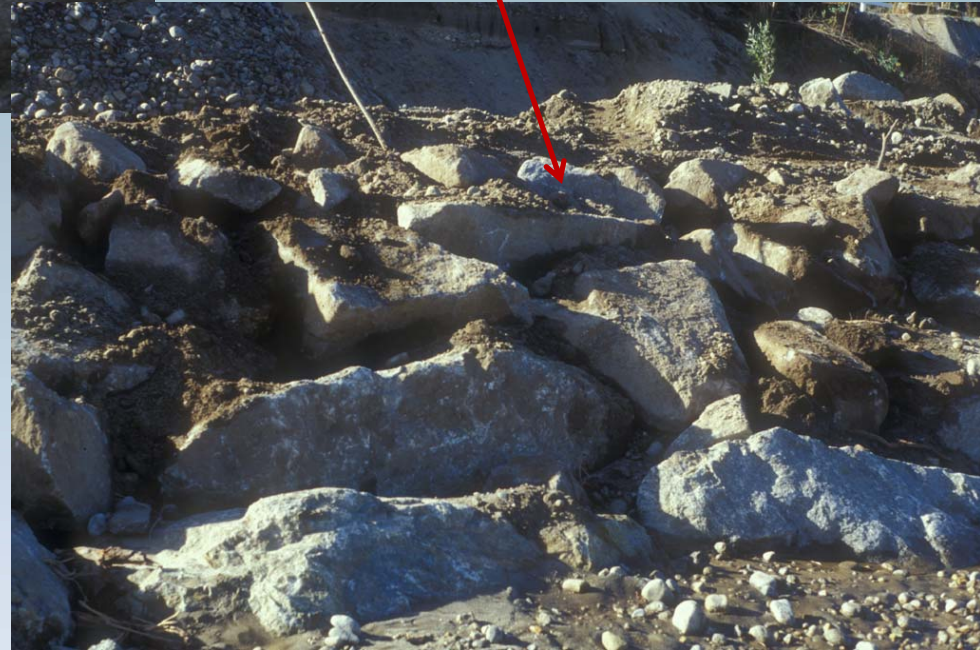
# Active Channel Reconstruction

- reconstructed two-year floodplain
- willows stakes in toe trench
- rip-rap in toe and on streambank (no filter cloth)

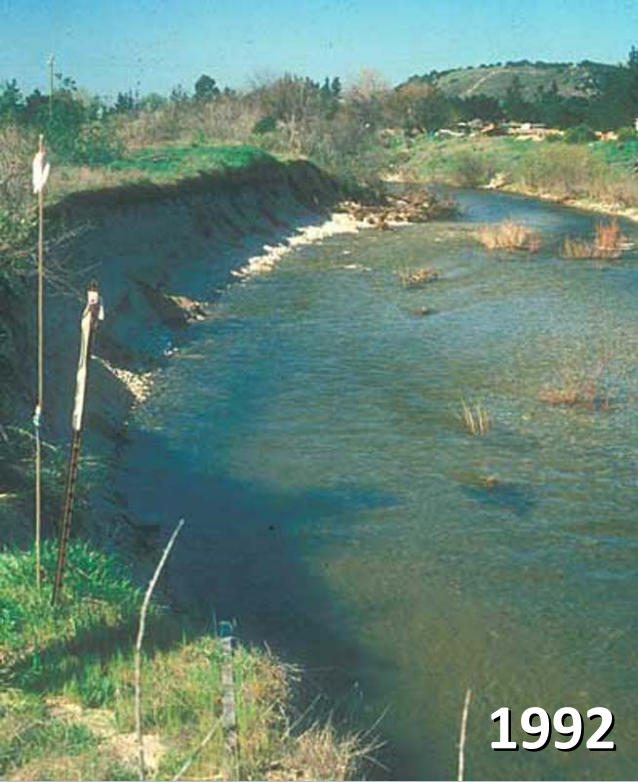
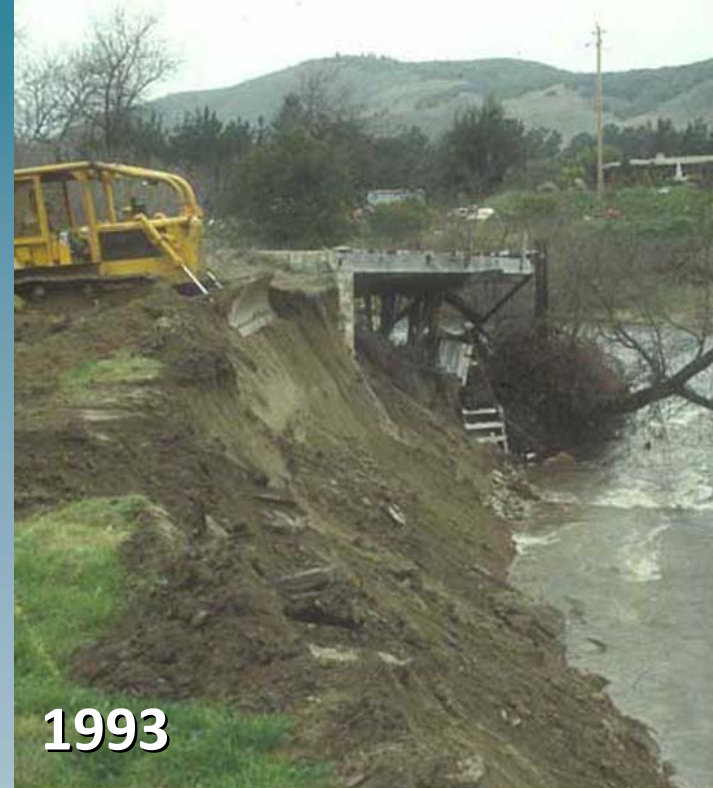
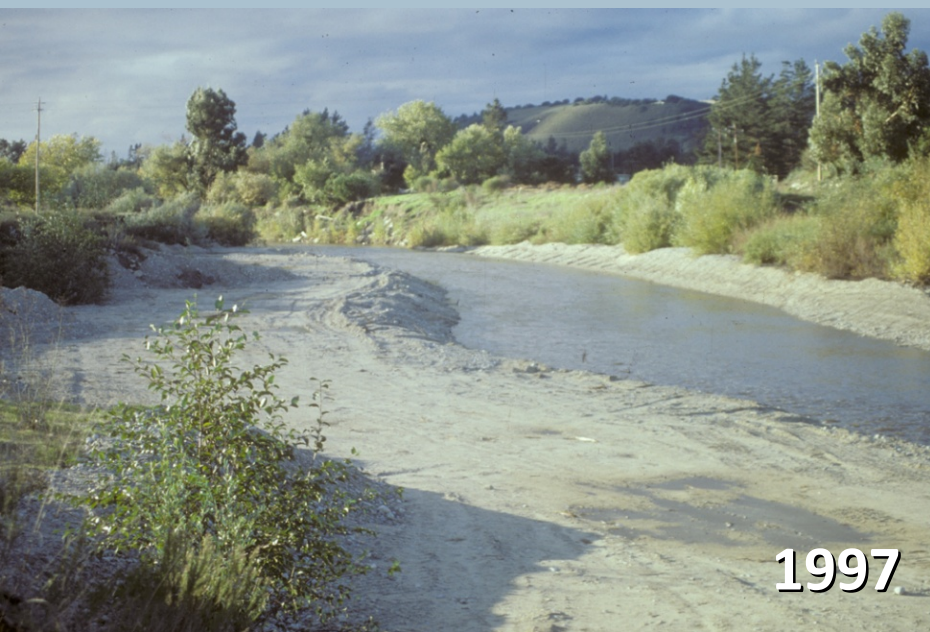
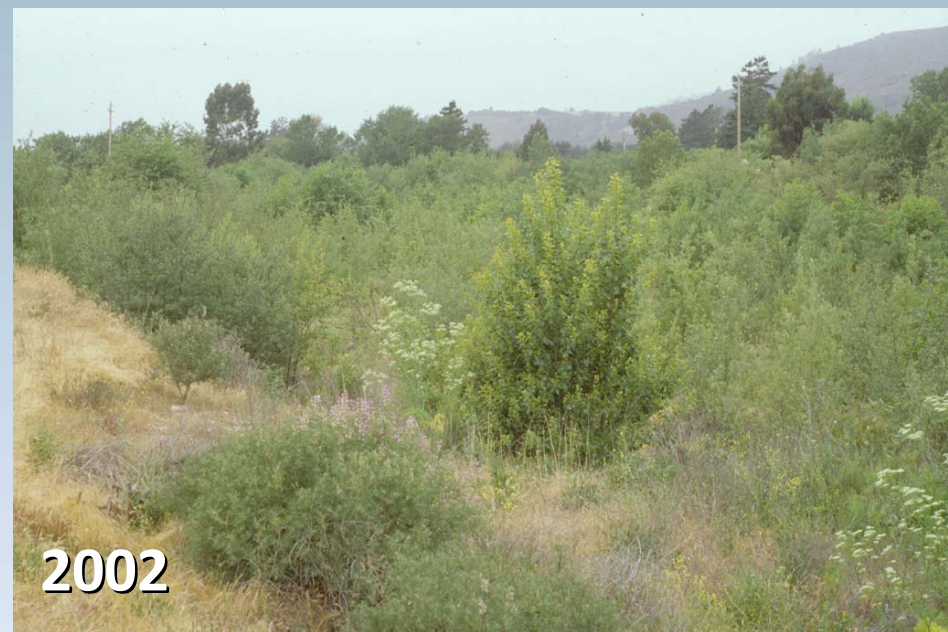
# Typical project evolution

1992

1993

1997

2002

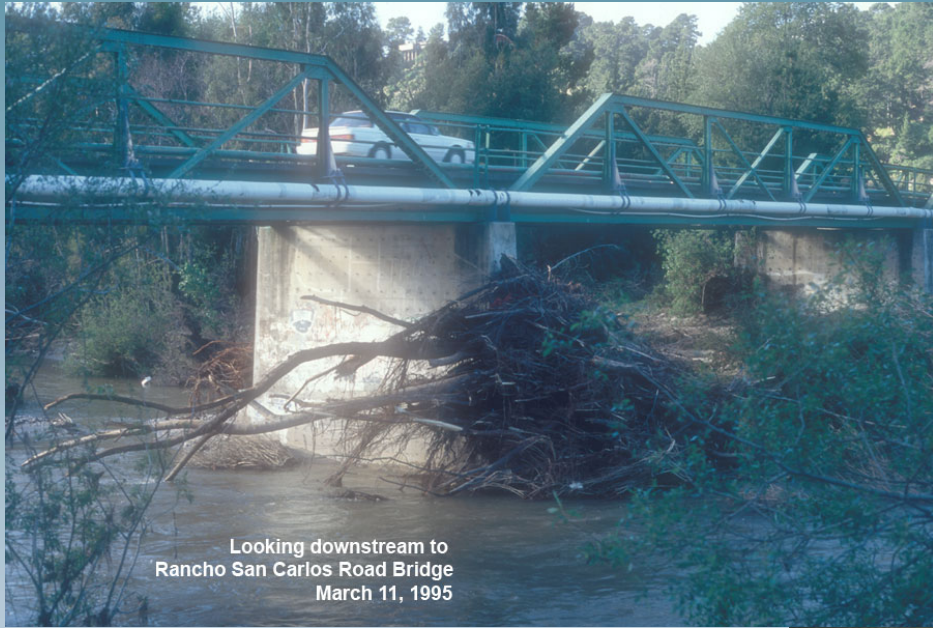
Looking downstream to  
Rancho San Carlos Road Bridge  
March 11, 1995

Left – debris racking during high flows is predictable at some locations

Right – tree fall is random and difficult to manage during high flow events

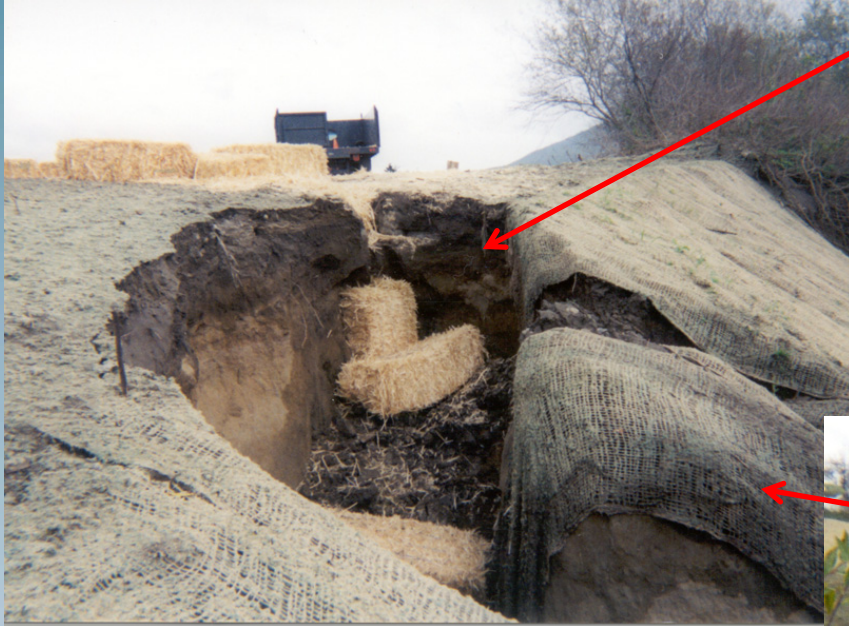
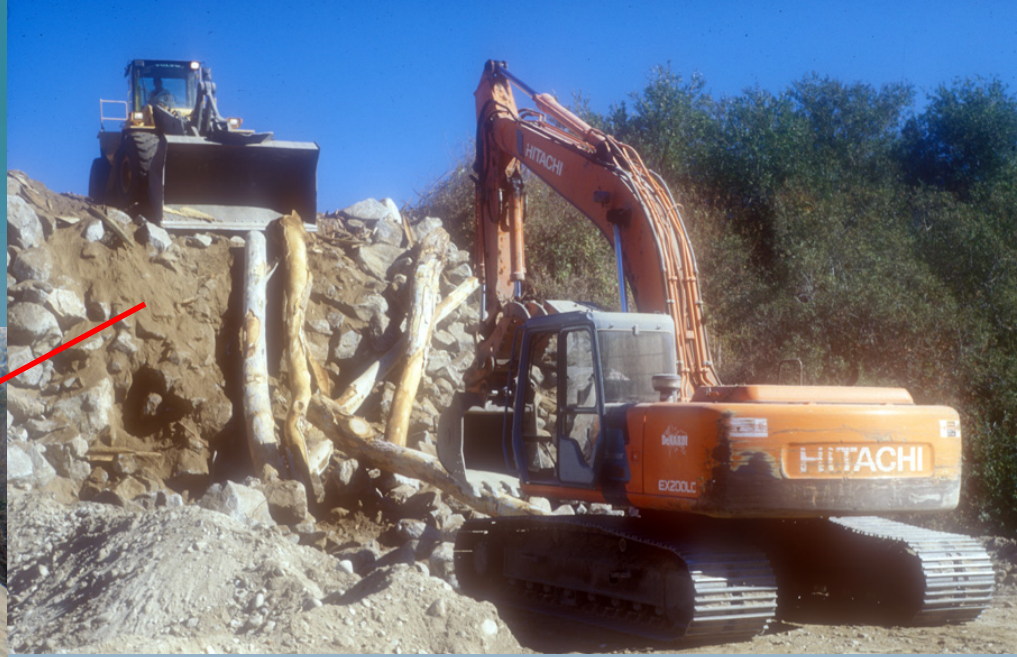
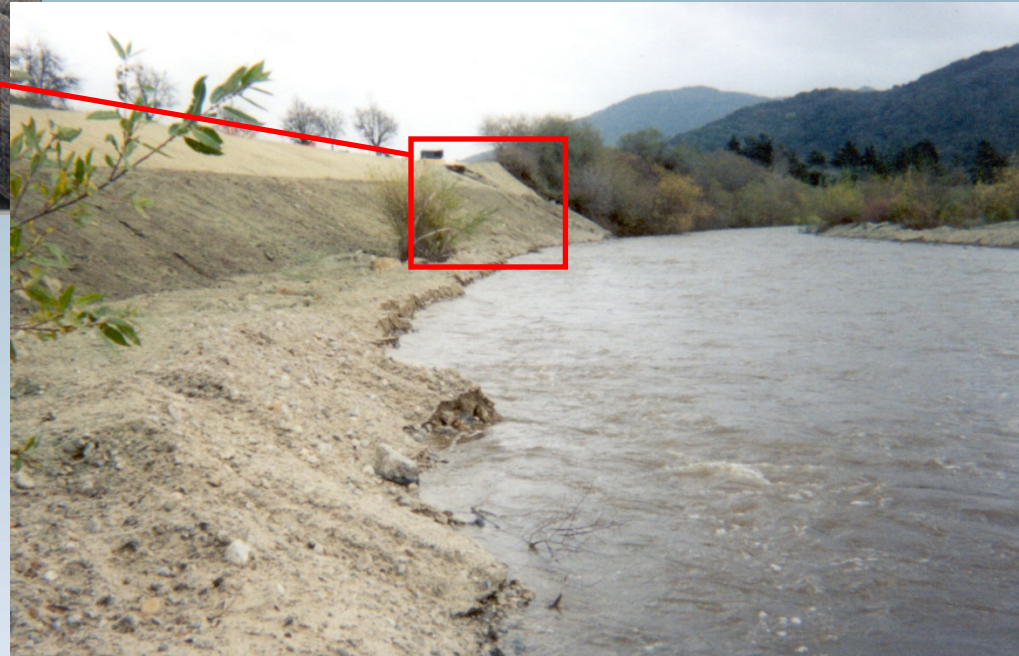
# Unintended consequences

A knick in the streambank may be a catalyst for much larger erosional events along the river at high flows

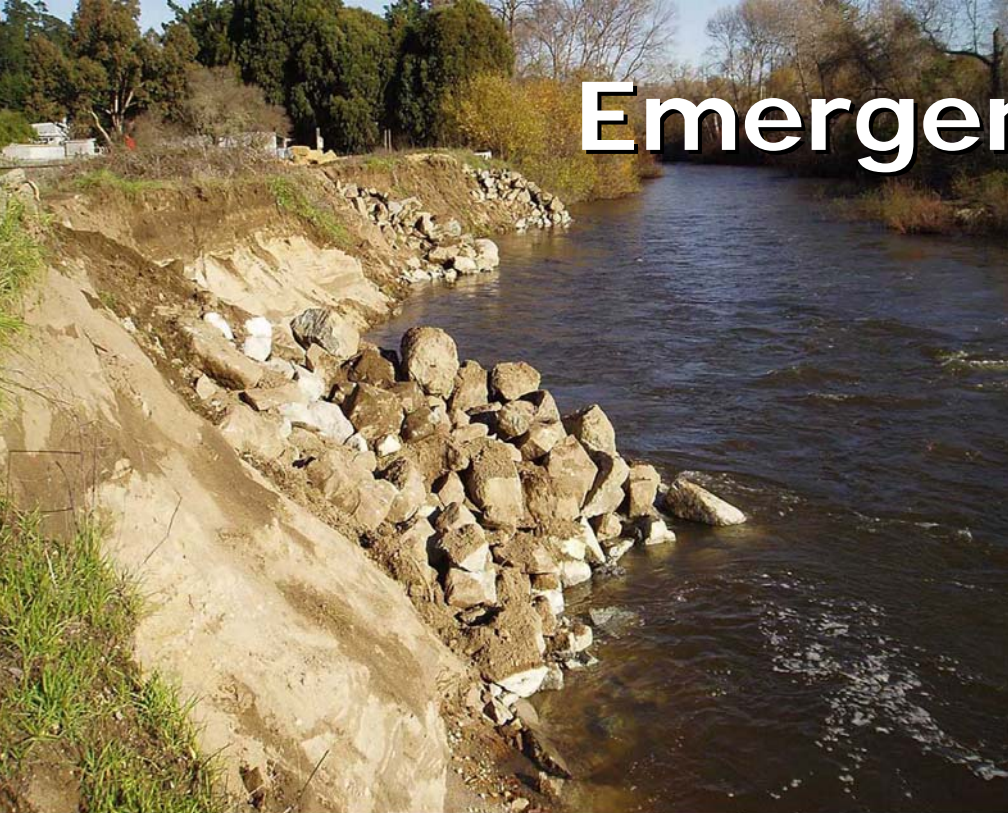
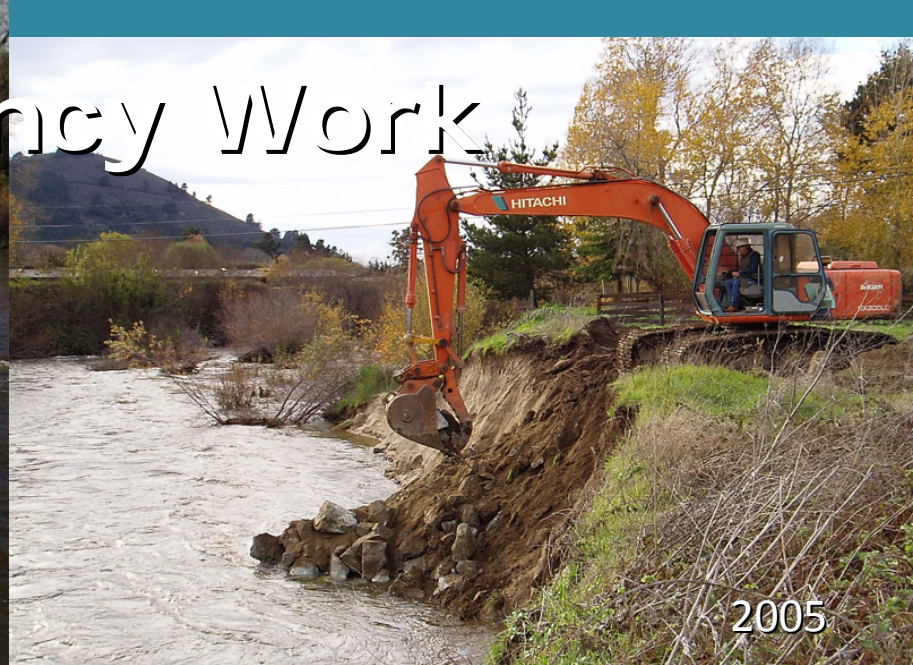
Above - after rock placmeent on January 13, 2005. Below - during erosion on January 9, 2005

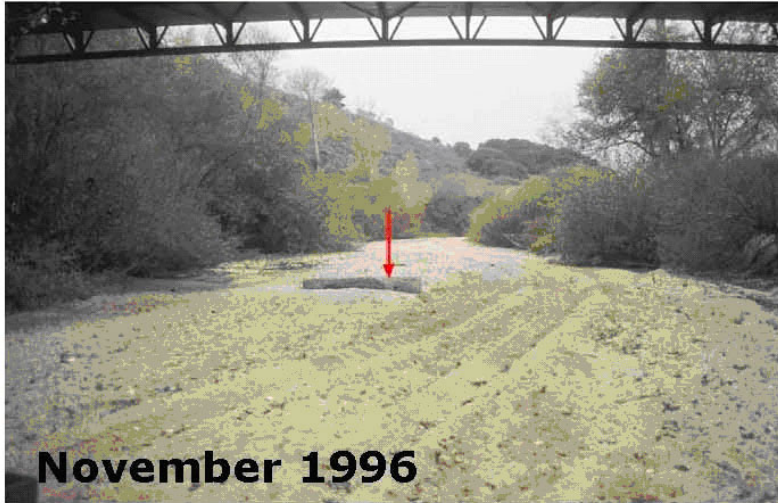
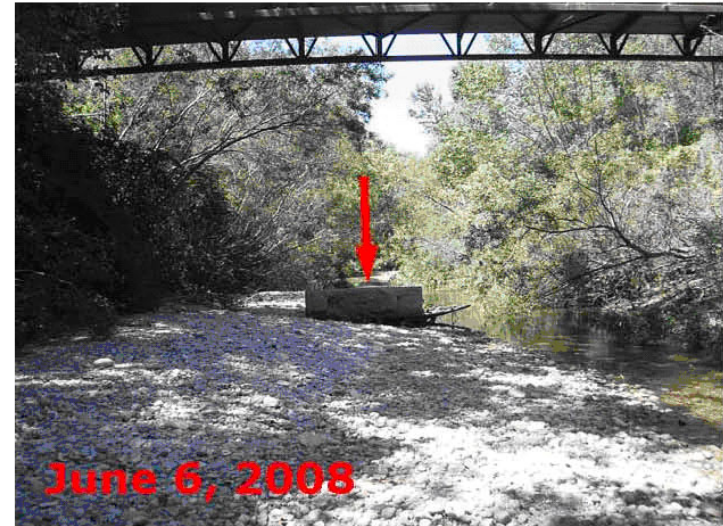
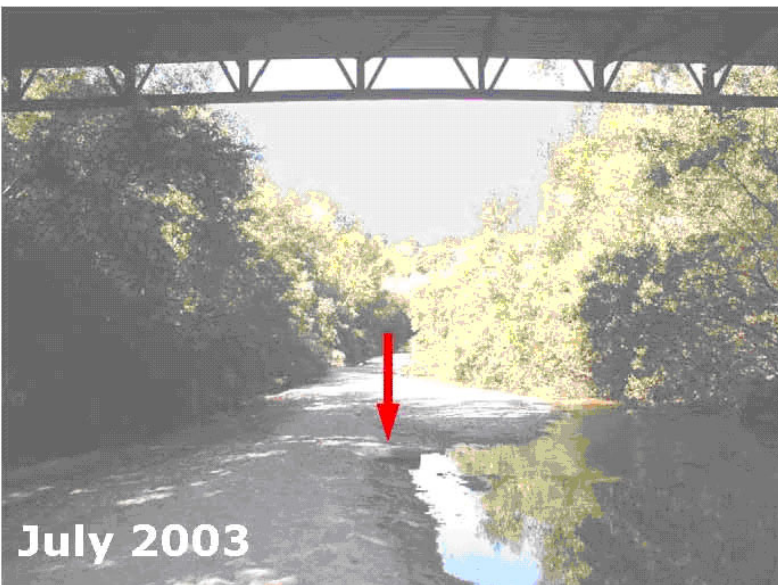
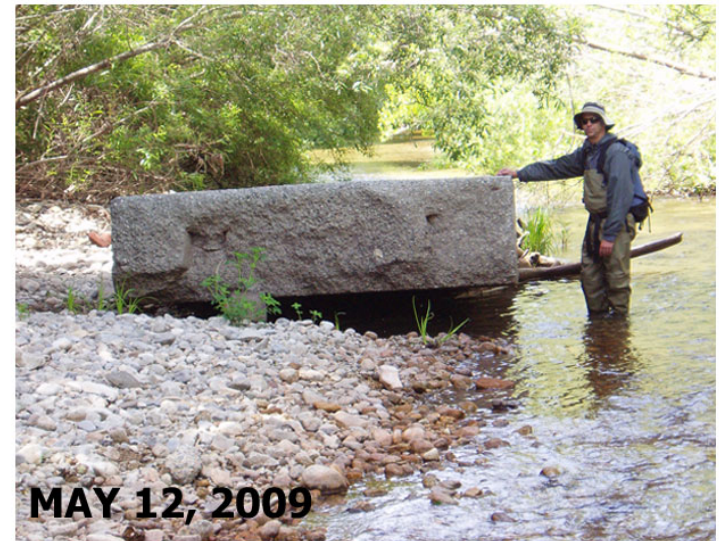
## *Rancho Cañada Bridge No. 5*

# Channel Degradation

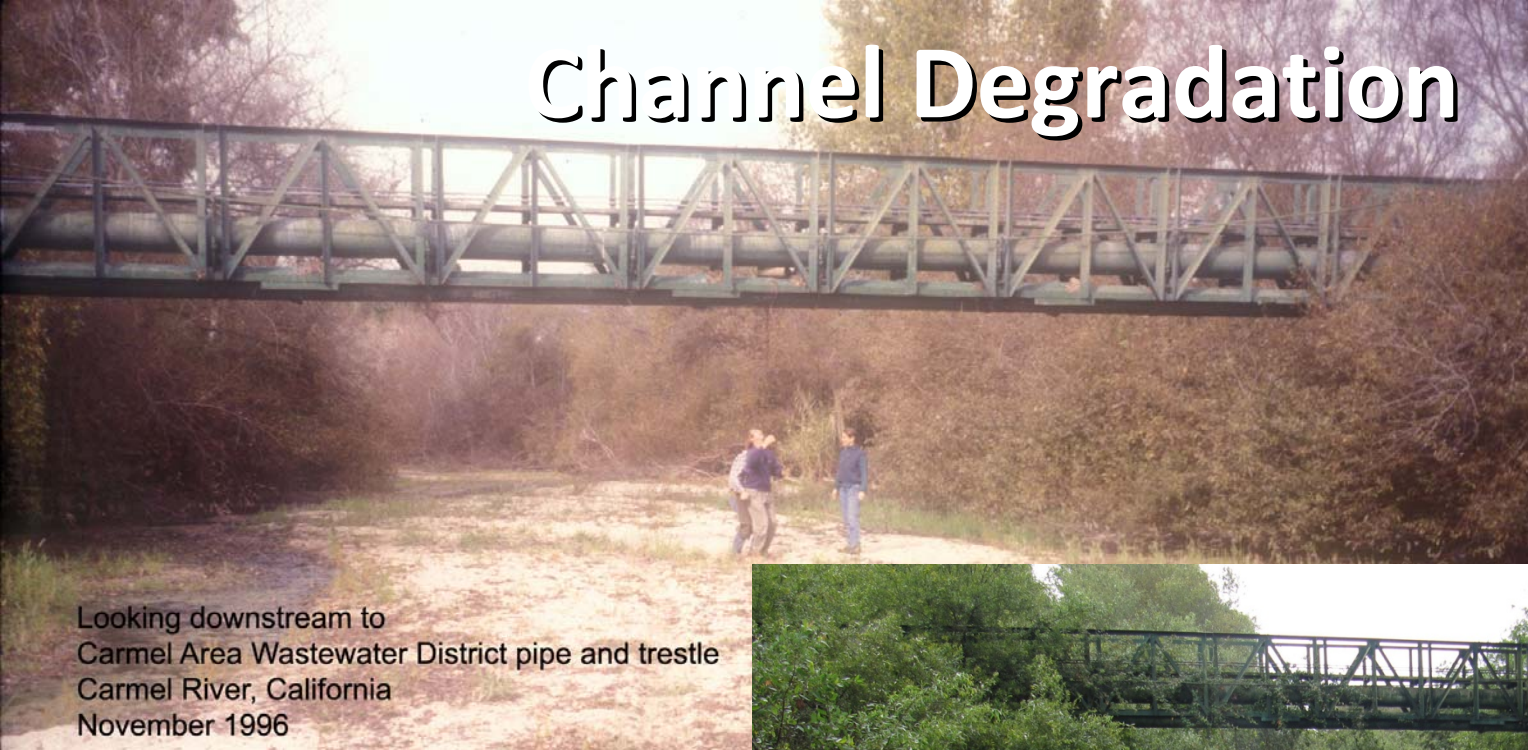
Looking downstream to Carmel Area Wastewater District pipe and trestle Carmel River, California November 1996

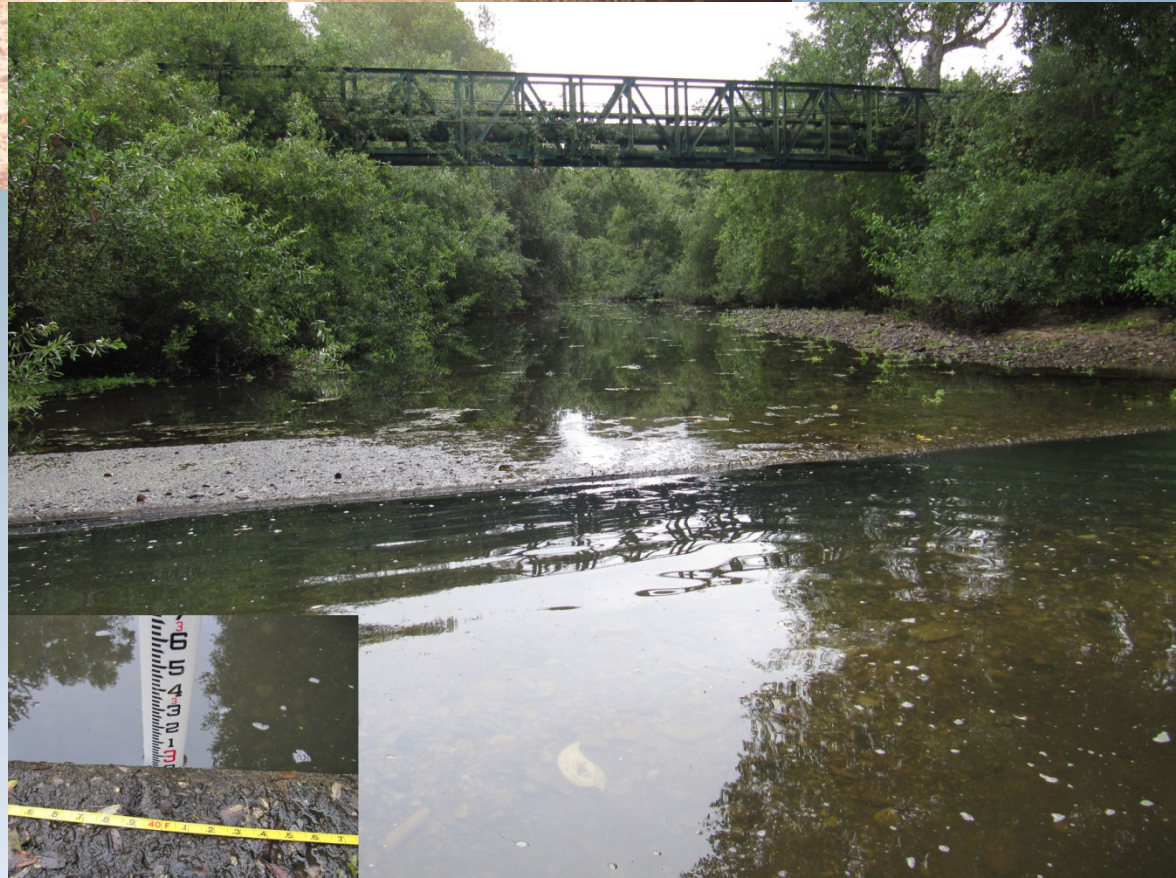
Carmel Area  
Wastewater District  
pipeline located  
3,000 feet upstream  
of Carmel Bay
