Los Padres Dam Alternatives: fire-related references

Soberanes Fire
Watershed Emergency Response
Team Report

CA-BEU-003422

September 29, 2016

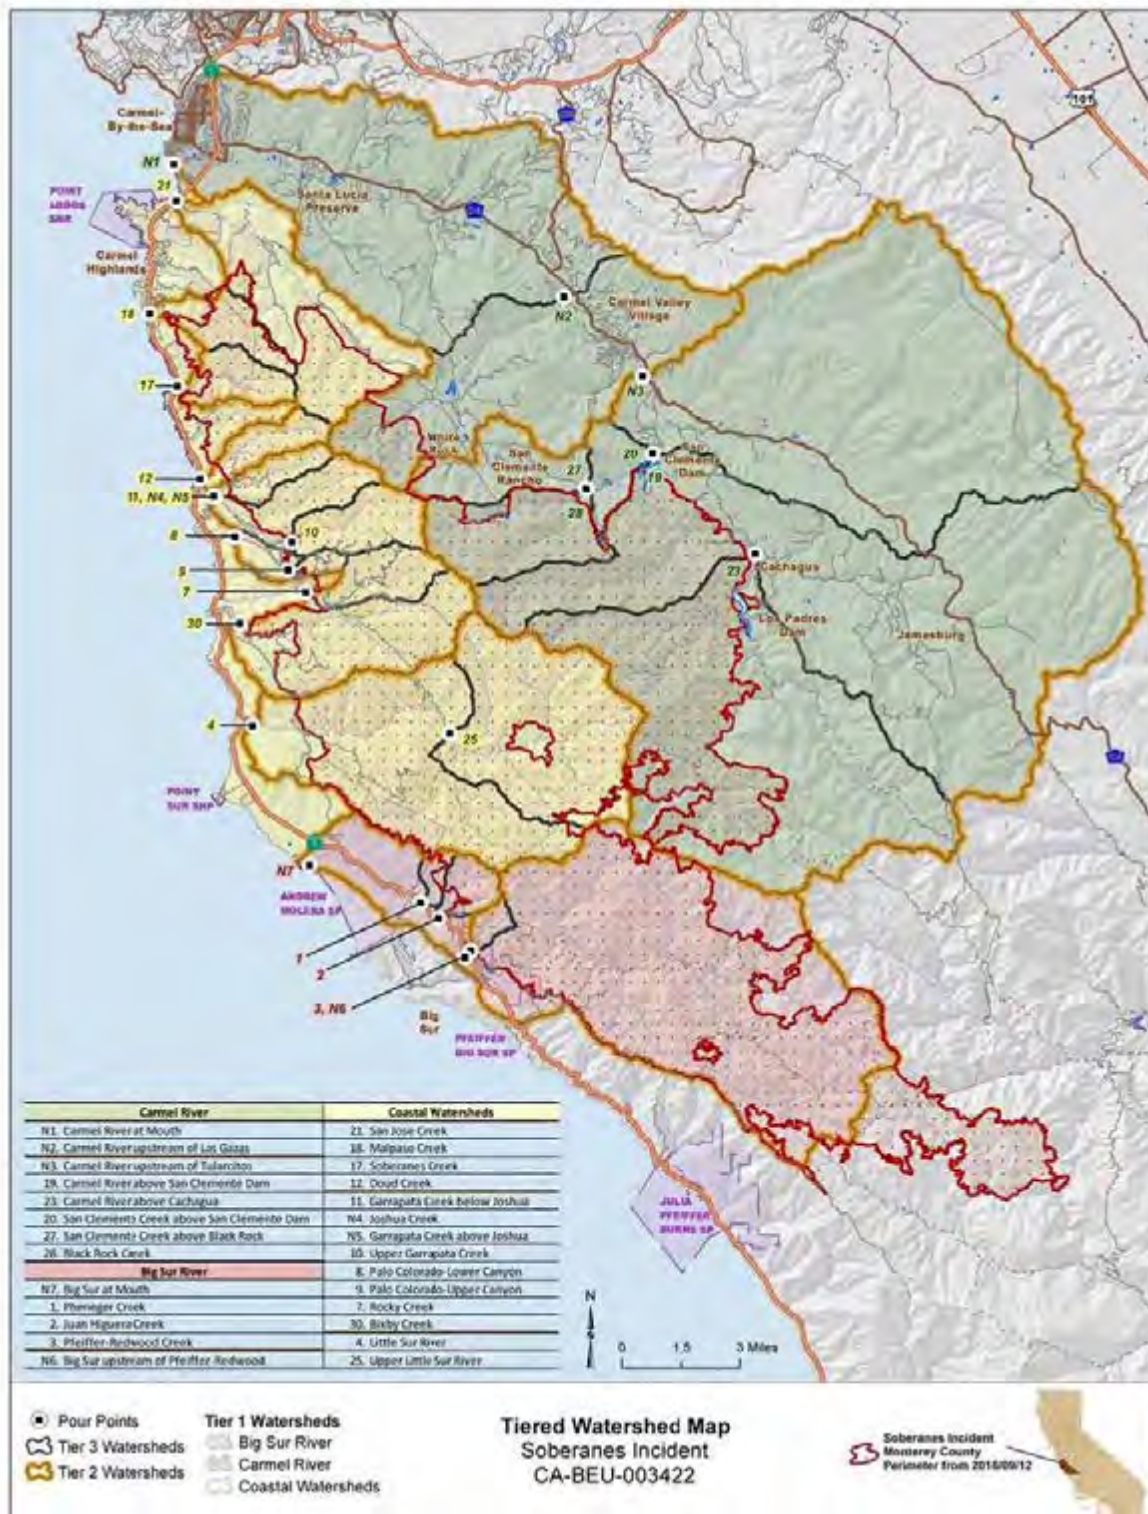
Figure 5. Tiered watershed map for the Soberanes Fire showing how the assessment area is broken into 1) large watersheds, 2) sub-watersheds, and 3) “pour point” watersheds.

Communities and specific Values at Risk were assessed hierarchically using a nested watershed approach. The following figures (Figure 4 and Figure 5) describe how the various watersheds were nested.

Refer to Appendix C for specific “pour point” discussion and Figure 5 (or Appendix B) for location of “pour point” watersheds.

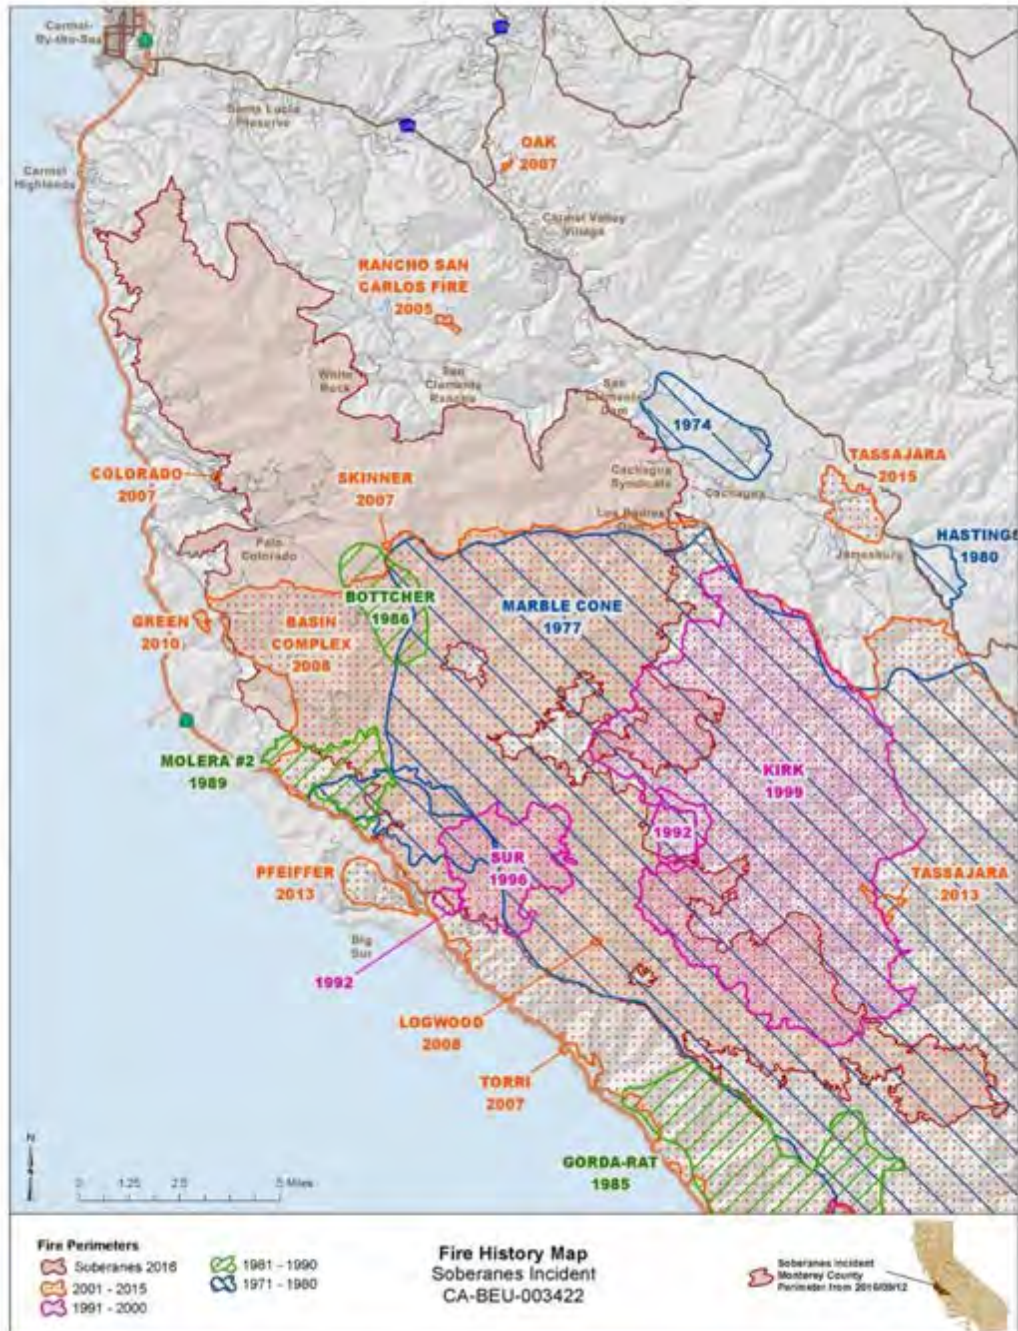
Figure 7. Fire history map for the Soberanes Fire

The northern third of the burn area has little to no recently recorded fire history, and this largely corresponds with the highest proportions of moderate and high soil burn severity. The southern two-thirds of the burn area have had multiple fires, and the recurrence interval of fire in this area is approximately 10-15 years (Figure 7).

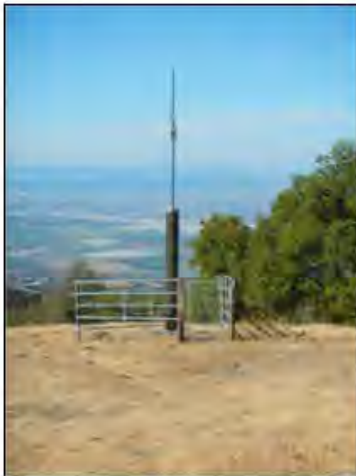
ALERT Flood Warning System

Following the Marble Cone fire of 1977, Monterey County began the installation of one the first ALERT flood warning networks anywhere. ALERT (Automated Local Evaluation in Real Time) is a communications protocol that was developed by the National Weather Service in the 1970's. ALERT is a reliable, low cost method of transmitting environmental data from remote sites to a central database in real time. ALERT compatible hardware and software has continued to improve and is currently being used for environmental monitoring and flood warning systems throughout the world.

The current Monterey County ALERT flood warning system is operated and maintained by the Monterey County Water Resources Agency. The system consists of approximately 50 remote sites located throughout the major watersheds of Monterey County. These remote sites measure a variety of environmental factors including rainfall, water level, and air temperature that are used to forecast flooding and monitor storm events..

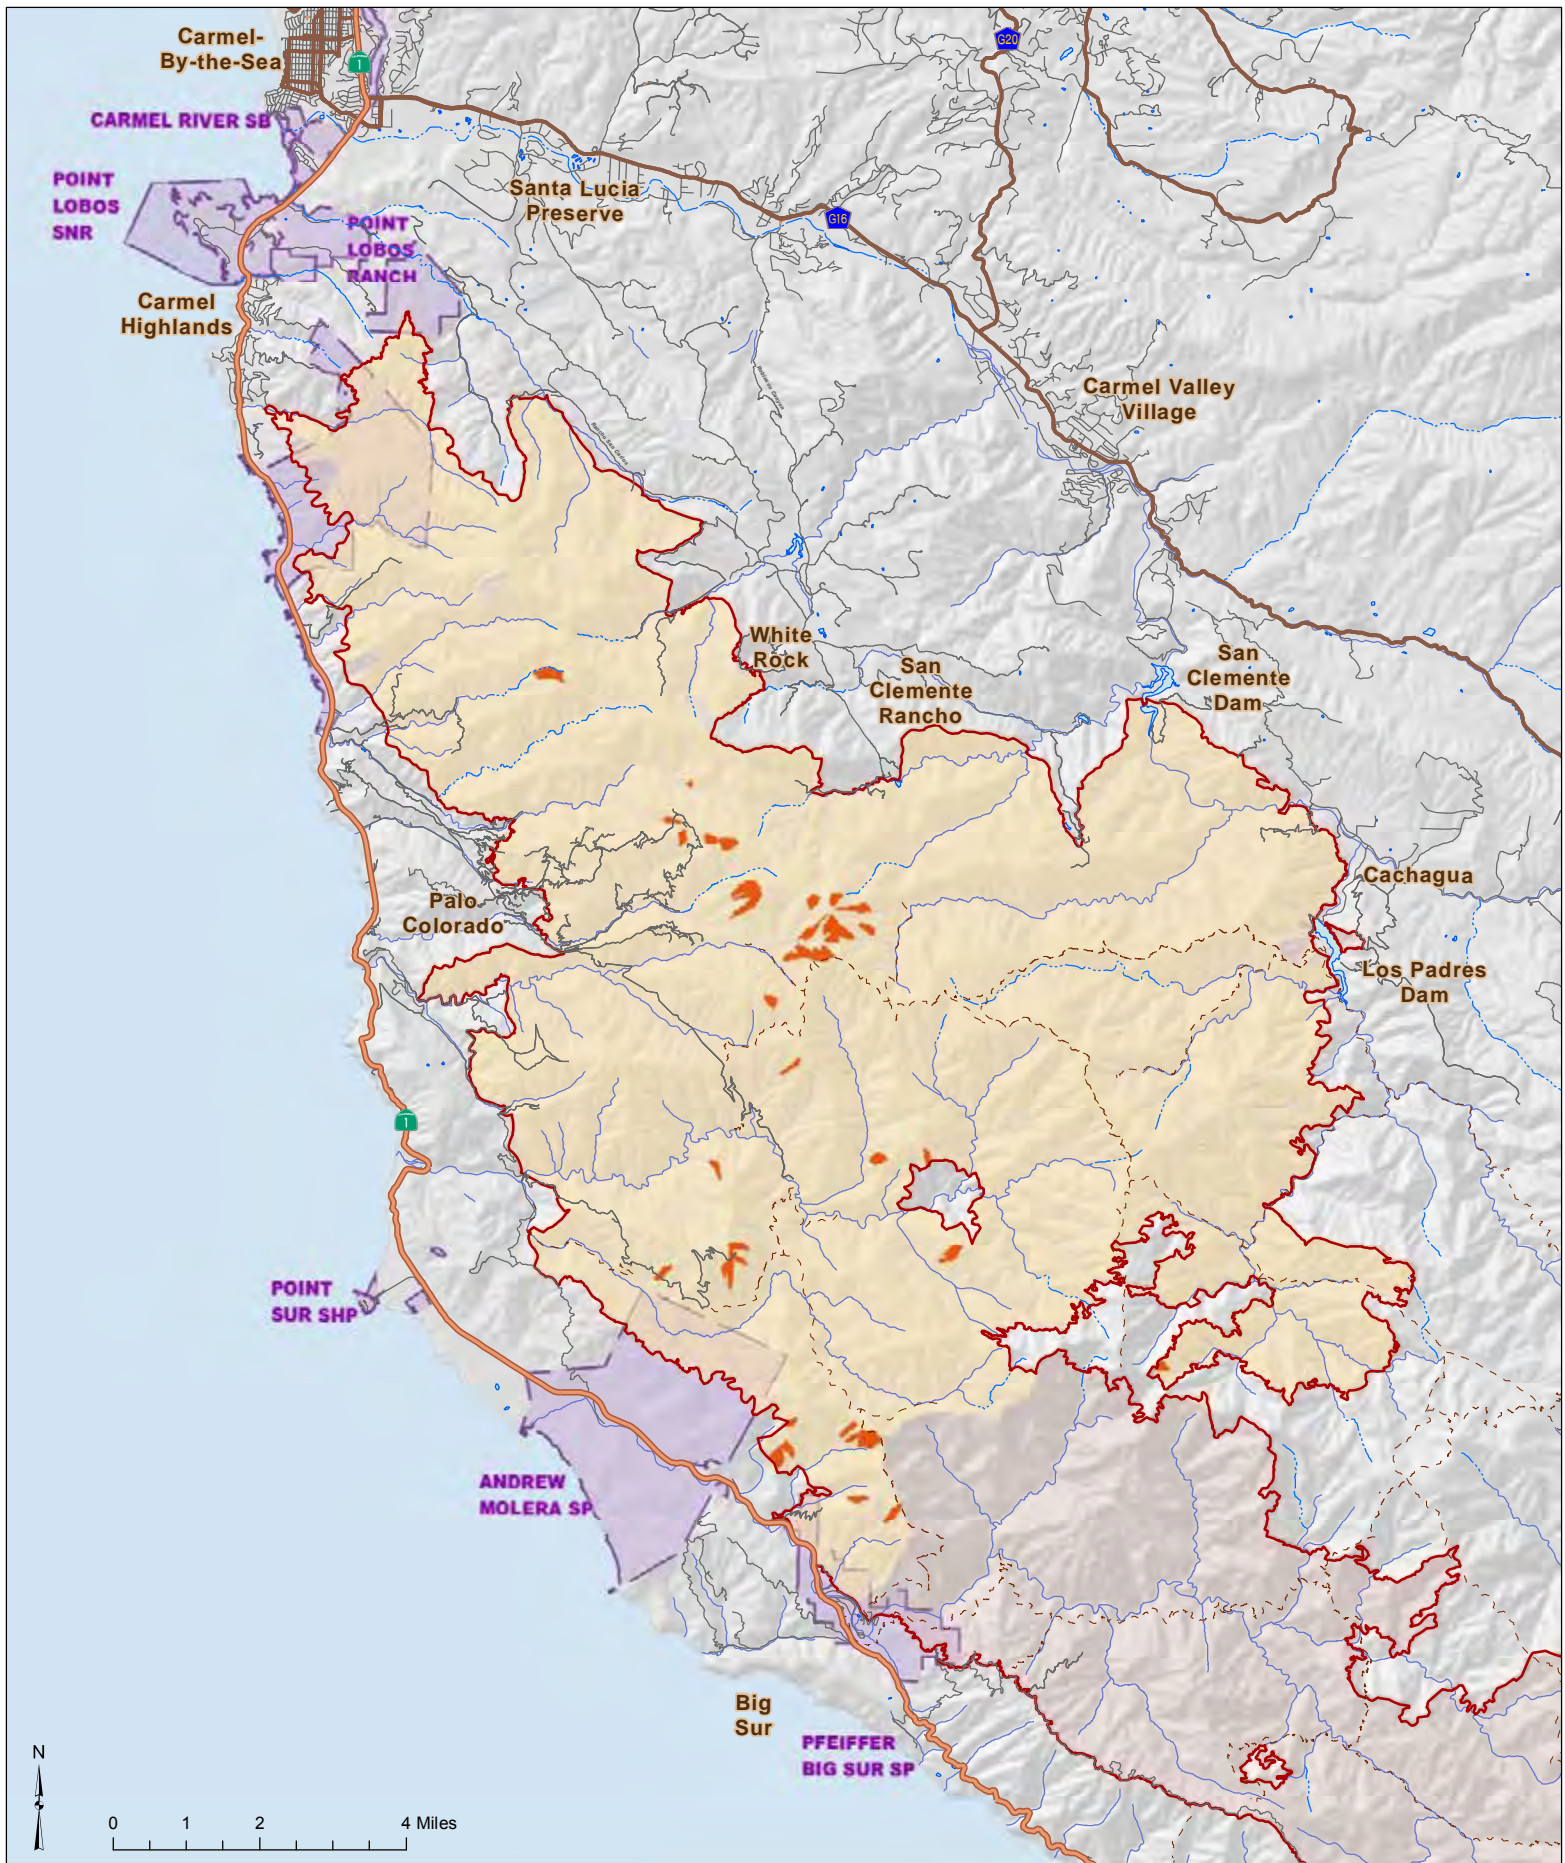
Sediment Production (tons/acre)

10-year storm event

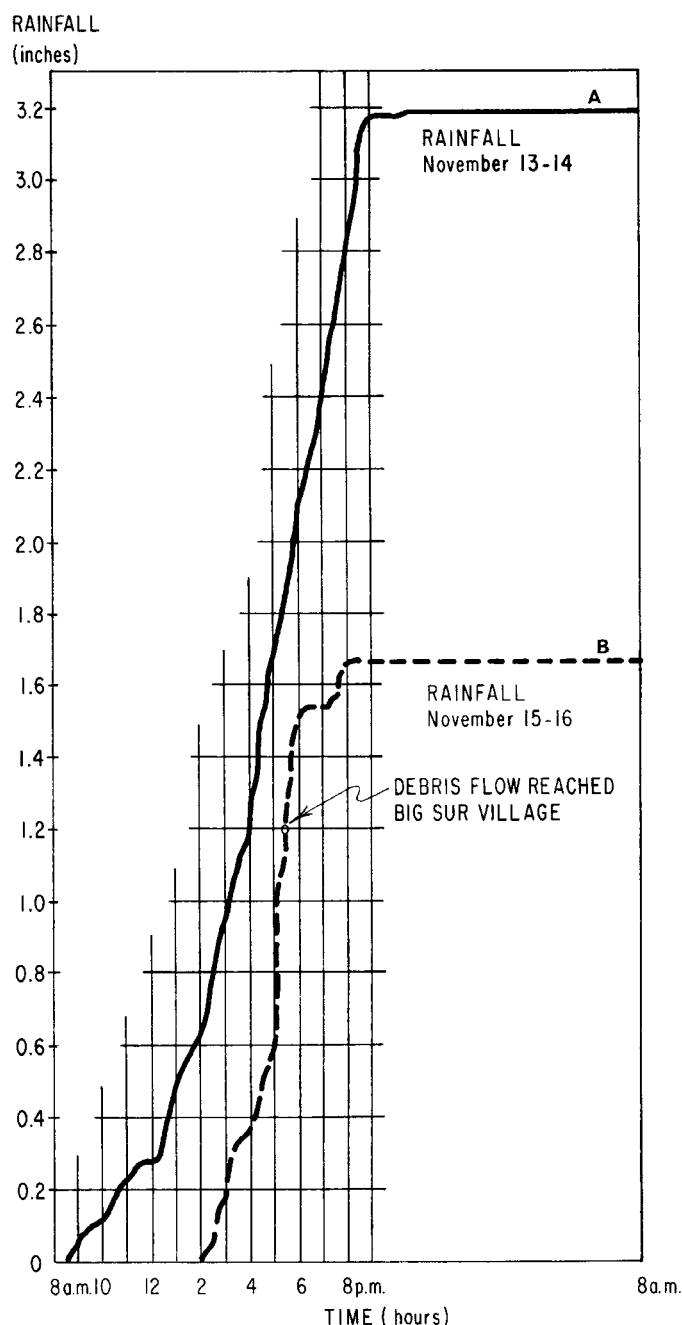
Figure 3. Graph showing the cumulative rainfall for 13-14; 15-16 November at Big Sur, California, as measured by a recording rain gauge. The total rain fall shown does not represent the total amount of rain for the 24 hour period. See Table 2 for correct totals. Differences are caused by the inaccuracies introduced by the recording rain gauge apparatus. The accuracy of this apparatus decreases with increased rainfall. Courtesy of U.S. Forest Service weather station, Big Sur.

The first storm yielded 5.07 inches of rain from 10 October through 17 October. The major drainages were flooded during this period, but mudflows occurred only on 12 and 15 October, during intense, short duration rainfall. The mudflow on 12 October followed 0.82 inches of rain, most of which fell within an hour; that on 15 October followed rainfall of 0.73 inches, which was recorded between 0800 and 0900 of that day.

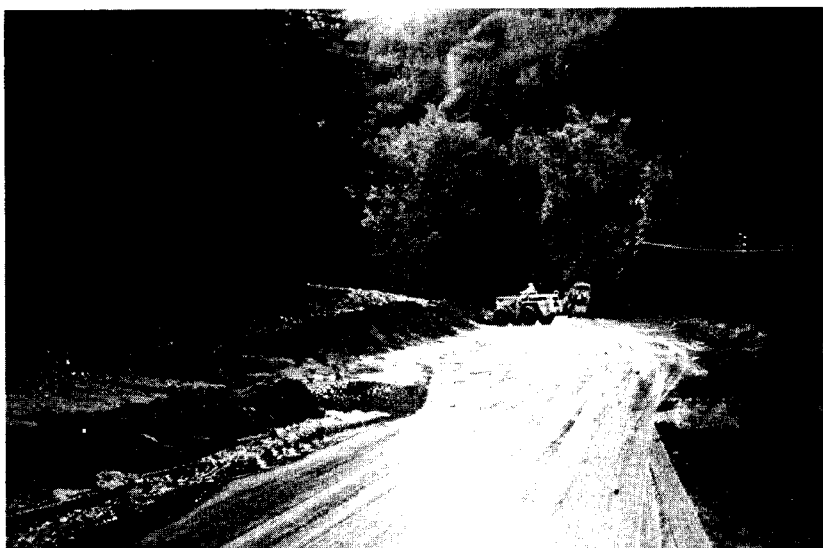
Figure 4. Mudflows repeatedly closed Highway 1 at Pfeiffer-Big Sur State Park during storms of October and November 1972. Mudflows jumped the bed of Pfeiffer-Redwood Creek and crossed the highway to the Big Sur River (out of sight to the right). View southeast.

The notable difference in grain size between the flows that originated on Pfeiffer-Redwood Creek and those farther north is difficult to explain; compare figures 4 and 5. The available source materials for all the flows is debris that accumulates near the mouths of the tributaries to the Big Sur River and the blanket of soil that mantles the hillslopes. These materials are derived from the face of the massif behind Big Sur which is mainly crystalline rocks and younger sedimentary rocks. The sedimentary rocks are of the Great Valley Sequence north of the cross fault near Pheneger Creek, and "Big Sur Sandstone", to the south. Although both units are mainly sandstones, some shale occurs with sand in the section to the south. This difference in lithology, the erosion of soil left unprotected after the fire, or the possibility that Pfeiffer-Redwood Creek failed to develop enough energy to move larger clasts, may account for the finer grained flows along this creek.

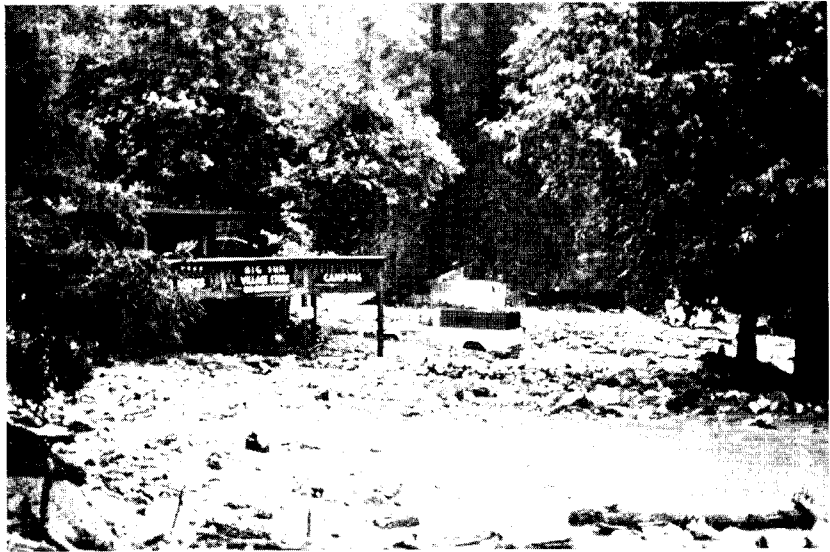
Figure 6. Debris flow of 15 November 1972 inundated the Big Sur Village, damaged buildings, and swept vehicles ahead of it toward the Big Sur River, beyond the trees.

On 15 November a debris flow was crowded out of the channel of Pheneger Creek at Big Sur Village and flowed toward the north and west cutting across the business area to the Big Sur River. It blocked the highway with a train of debris 6 feet thick, plowed through a cement block building, climbed up and around the lower story of the two story building that houses the post office, and farther beyond dropped a tow truck onto a house trailer. In all it smashed a dozen cars or more into trees and rocks and into each other, then rafted four of them to the river where one of them was washed downstream 2 miles from the village (figures 6 and 7).

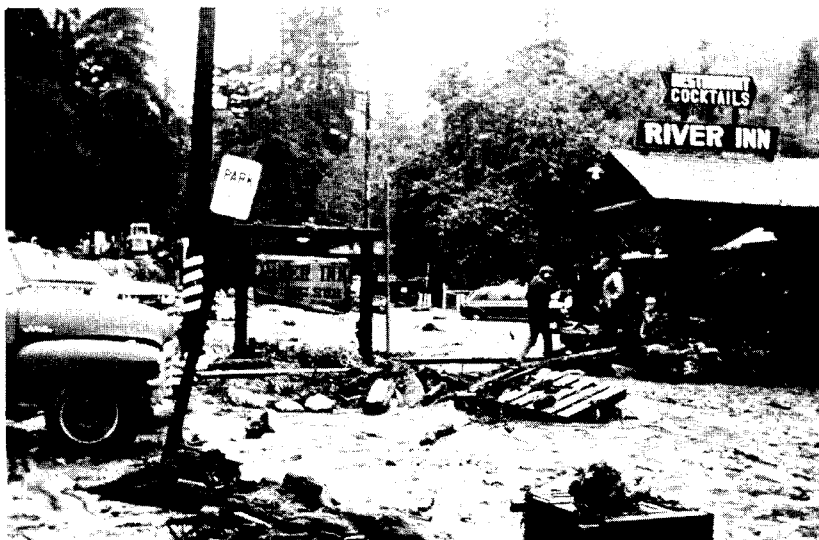
Figure 7. Ironically, this establishment at Big Sur Village lived up to its name when some of the flow from Pheneger Creek chose to cut through a parking lot on its way to the Big Sur River.

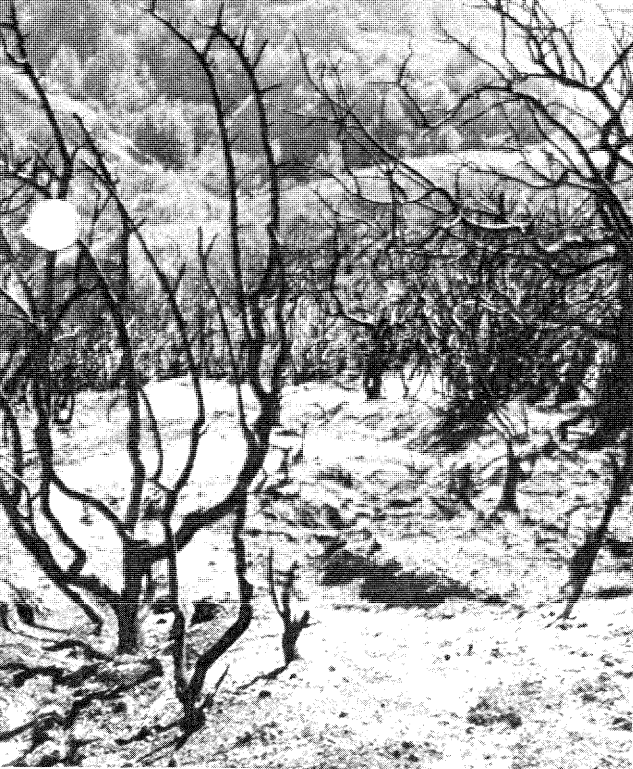
↑ Foot-trail showing burned chaparral and erosion along the trail just north of Pfeiffer-Big Sur Park in the Pfeiffer-Redwood Creek watershed, Monterey County, California. The vegetation which normally insulated the steep slopes from effects of winter rainfall was almost completely destroyed when a wildfire developed in August 1972 on Highway 1 north of Big Sur Village and swept northeastward to the main ridge above Big Sur and southward along the east side of Big Sur Canyon.

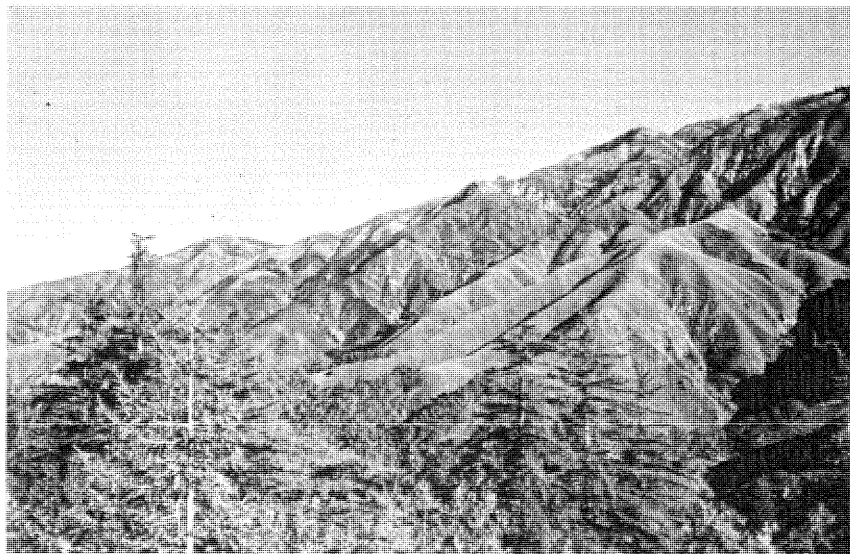
Figure 2. Molera fire which occurred in early August 1972 left baked slopes above Big Sur. View north.

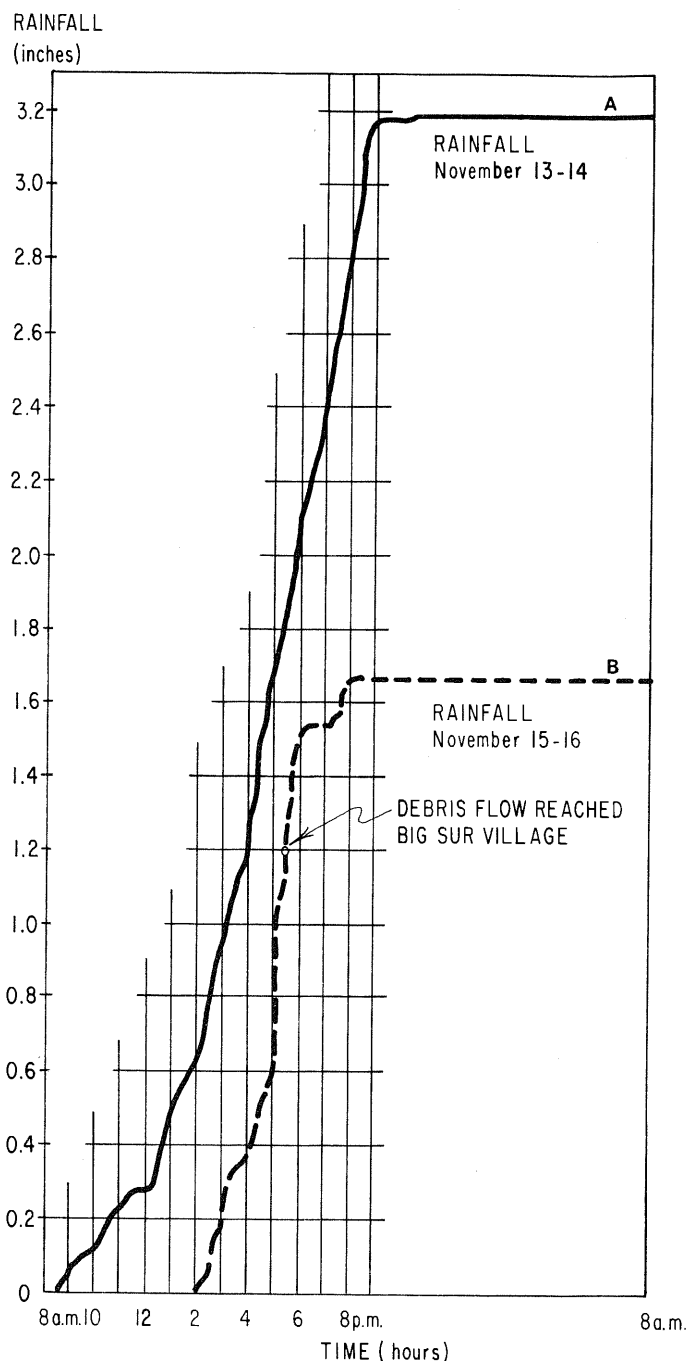
Figure 3. Graph showing the cumulative rainfall for 13-14; 15-16 November at Big Sur, California, as measured by a recording rain gauge. The total rain fall shown does not represent the total amount of rain for the 24 hour period. See Table 2 for correct totals. Differences are caused by the inaccuracies introduced by the recording rain gauge apparatus. The accuracy of this apparatus decreases with increased rainfall. Courtesy of U.S. Forest Service weather station, Big Sur.

The first storm yielded 5.07 inches of rain from 10 October through 17 October. The major drainages were flooded during this period, but mudflows occurred only on 12 and 15 October, during intense, short duration rainfall. The mudflow on 12 October followed 0.82 inches of rain, most of which fell within an hour; that on 15 October followed rainfall of 0.73 inches, which was recorded between 0800 and 0900 of that day.

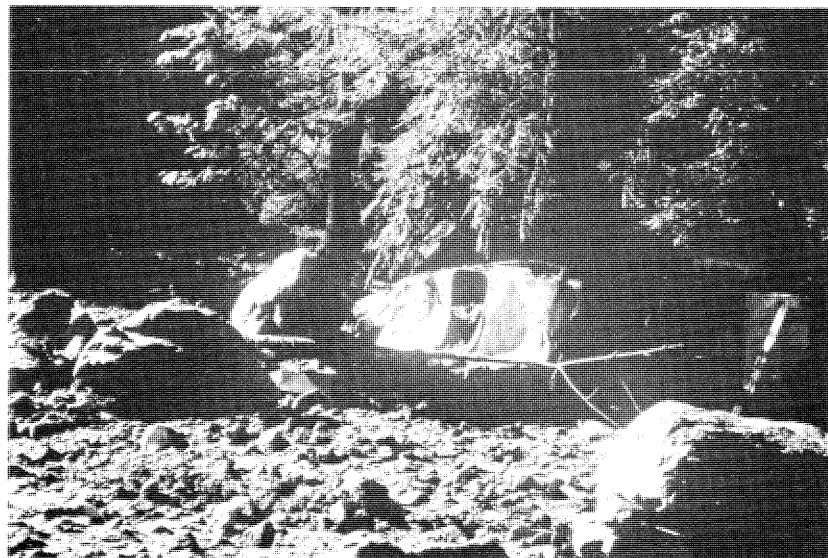
Figure 5. Large boulders, some 8 feet in greatest dimension, rode atop the debris flow that struck Big Sur Village on 15 November, 1972. Debris shown here came to rest in the Post Office parking lot. An automobile was crushed between a large boulder and a tree. Fifteen other vehicles met a similar fate and four were known to have been washed into the Big Sur River.

During the storm periods of late 1972 three of the four creeks draining into the Big Sur River at Big Sur would at one time yield relatively clear water and at another time a mudflow or debris flow. Generally, Pfeiffer-Redwood Creek carried fine grained materials and only mudflows occurred along this drainage course (figure 4). The size of the debris fragments was greater on the creeks to the north and at Pheneger Creek, blocks of rock 8 feet in greatest dimension and trees 4 feet in diameter were carried along, within, or riding atop the flows (figure

The notable difference in grain size between the flows that originated on Pfeiffer-Redwood Creek and those farther north is difficult to explain; compare figures 4 and 5. The available source materials for all the flows is debris that accumulates near the mouths of the tributaries to the Big Sur River and the blanket of soil that mantles the hillslopes. These materials are derived from the face of the massif behind Big Sur which is mainly crystalline rocks and younger sedimentary rocks. The sedimentary rocks are of the Great Valley Sequence north of the cross fault near Pheneger Creek, and "Big Sur Sandstone", to the south. Although both units are mainly sandstones, some shale occurs with sand in the section to the south. This difference in lithology, the erosion of soil left unprotected after the fire, or the possibility that Pfeiffer-Redwood Creek failed to develop enough energy to move larger clasts, may account for the finer grained flows along this creek.

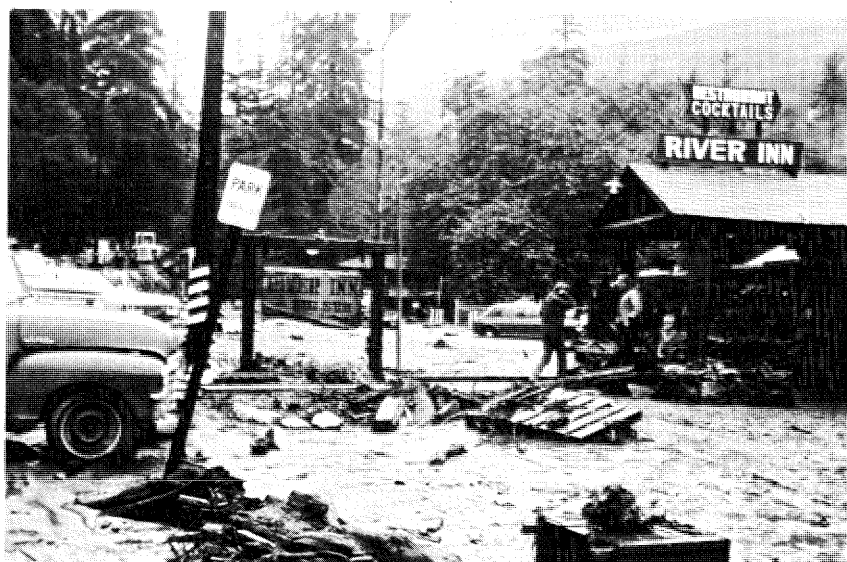
Figure 7. Ironically, this establishment at Big Sur Village lived up to its name when some of the flow from Pheneger Creek chose to cut through a parking lot on its way to the Big Sur River.

On 15 November a debris flow was crowded out of the channel of Pheneger Creek at Big Sur Village and flowed toward the north and west cutting across the business area to the Big Sur River. It blocked the highway with a train of debris 6 feet thick, plowed through a cement block building, climbed up and around the lower story of the two story building that houses the post office, and farther beyond dropped a tow truck onto a house trailer. In all it smashed a dozen cars or more into trees and rocks and into each other, then rafted four of them to the river where one of them was washed downstream 2 miles from the village (figures 6 and 7).

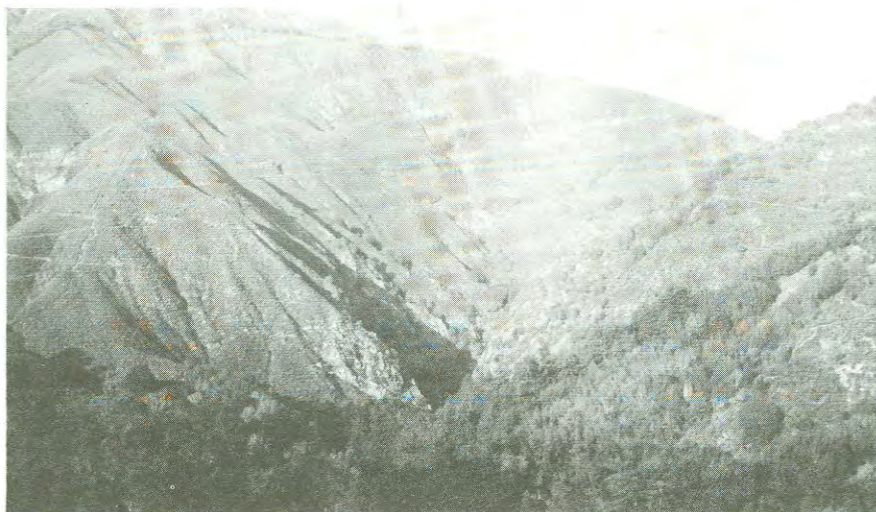
Photo 1. Big Sur River Gorge. Runoff and debris from about 28,000 acres in the upper Big Sur drainage basin, burned over during the Marble Cone fire, must pass through this narrow defile.

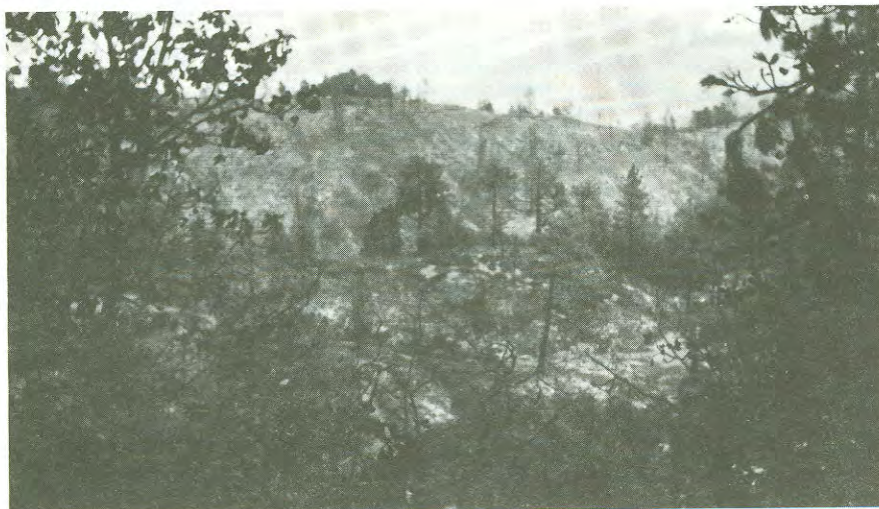
Photo 2. Burned over area along Logwood Creek in upper Big Sur drainage basin; view east from Coast Ridge Road.

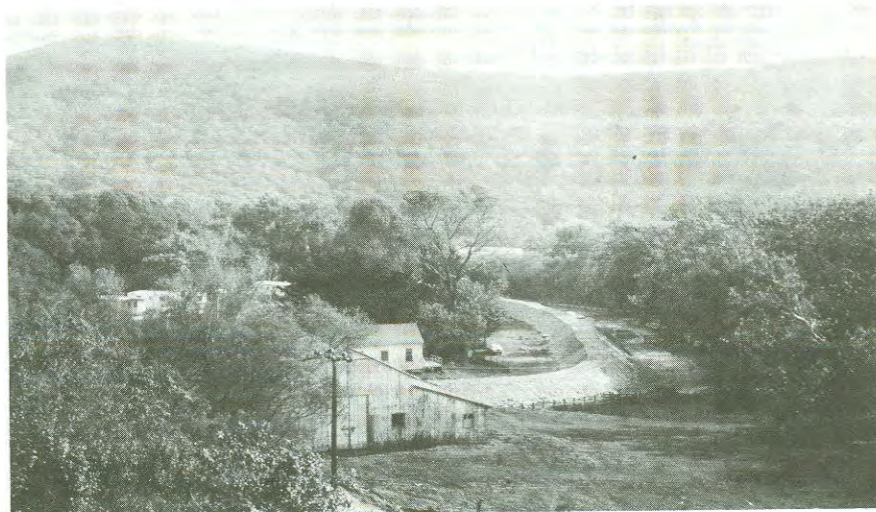
Photo 3. Dikes around structures near mouth of lower Big Sur River. Dikes were constructed to provide protection from floodwaters.
