**MONTEREY PENINSULA WATER SUPPLY PROJECT
NEW LOS PADRES DAM
GEOTECHNICAL STUDIES**

**PREPARED FOR
THE MONTEREY PENINSULA
WATER MANAGEMENT DISTRICT
MONTEREY, CALIFORNIA**

**BY
BECHTEL CORPORATION
JUNE 1992**

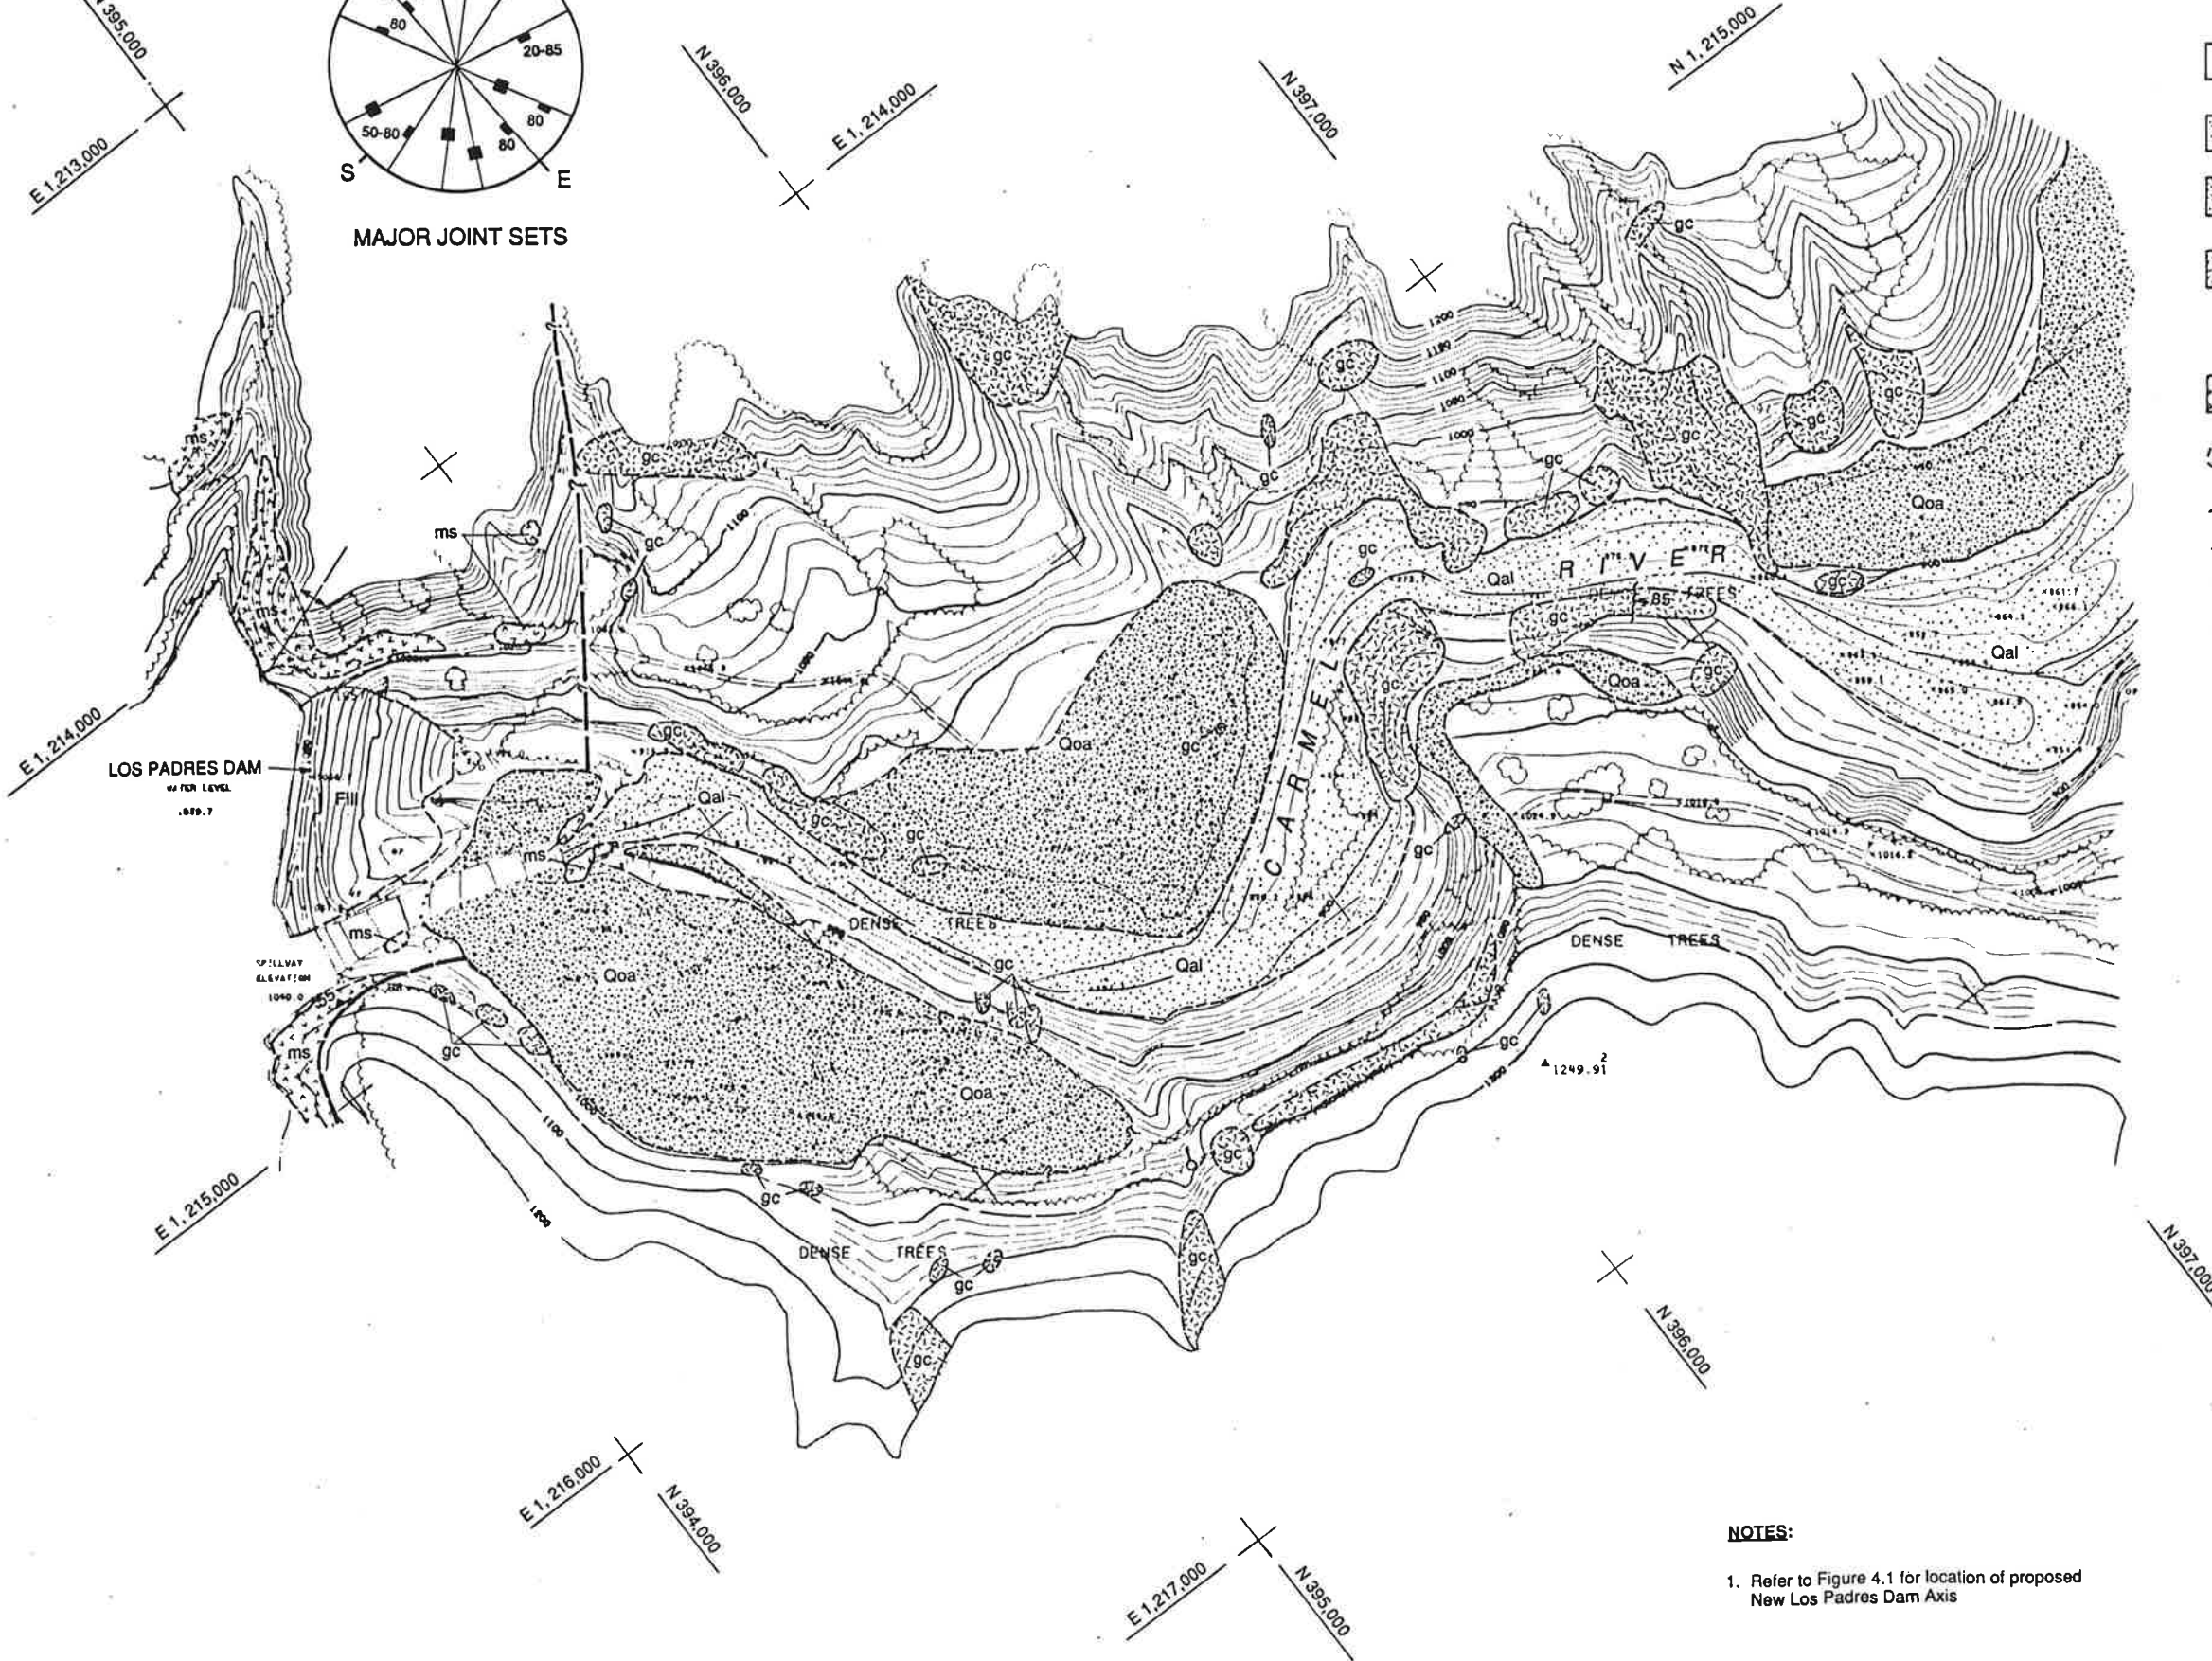
JOB No. 21675	DRAWING No. FIGURE 5.1	REV.
--	------------------	---------------------------	------

- RESIDUAL SOIL AND COLLUVIUM: overlies bedrock, unconsolidated; includes slopewash, talus and rock-soil debris; usually supports a vegetative cover. Holocene in age.

The reservoir area is underlain by the granitic complex and the older, complexly folded meta-sediments of the Sur series. A geologic contact between the granitic and metamorphic rocks has been mapped just downstream of the Los Padres Dam (Figure 5.1). It is uncertain if this is an intrusive contact or an ancient fault contact. Reservoir leakage does not seem to be a problem. A few shallow landslides, mostly in the colluvium and older alluvium, were noted in the reservoir area. There is a potential for siltation especially under conditions where the vegetative cover is removed by forest fires followed by high intensity storms.

Quarry Site A is located just upstream of the proposed New Los Padres damsite on the left bank of the Carmel River (Figures 5.3 and 5.5). An exposure of slightly weathered and jointed granitic rock about 200 feet long lies between elevations 900 and 1,000 feet (Figure 5.1). The rock is similar to that described at the damsite, ranging from quartz monzonite to diorite in composition. The prominent minerals are feldspar, quartz, mica, augite and hornblende. The crystalline rock texture varies from fine to coarse grained. The rock is altered, in-part, with the formation of chlorite. The most prominent joint sets have the following attitudes: N80°E, 90; N30°E, 85°E; N55°W, 55°N; and sub-horizontal. The fracture interval is variable, ranging from less than one foot to three feet.

This alternate quarry site is located immediately upstream of the damsite on the east side of the Carmel River as shown on Figures 5.3 and 5.5. Highly weathered and jointed exposures of granitic rock occur along the road and on the steep road cut (Figure 5.1). A slightly weathered and jointed outcrop of granitic rock exposed in the gully on the south border of the site has these joint set attitudes: $N70^{\circ}W, 75^{\circ}N$ and $80^{\circ}S; N5^{\circ}W, 55^{\circ}E$; and sub-horizontal. Rectangular blocks of rock are formed by joints spaced less than one foot to three feet apart.

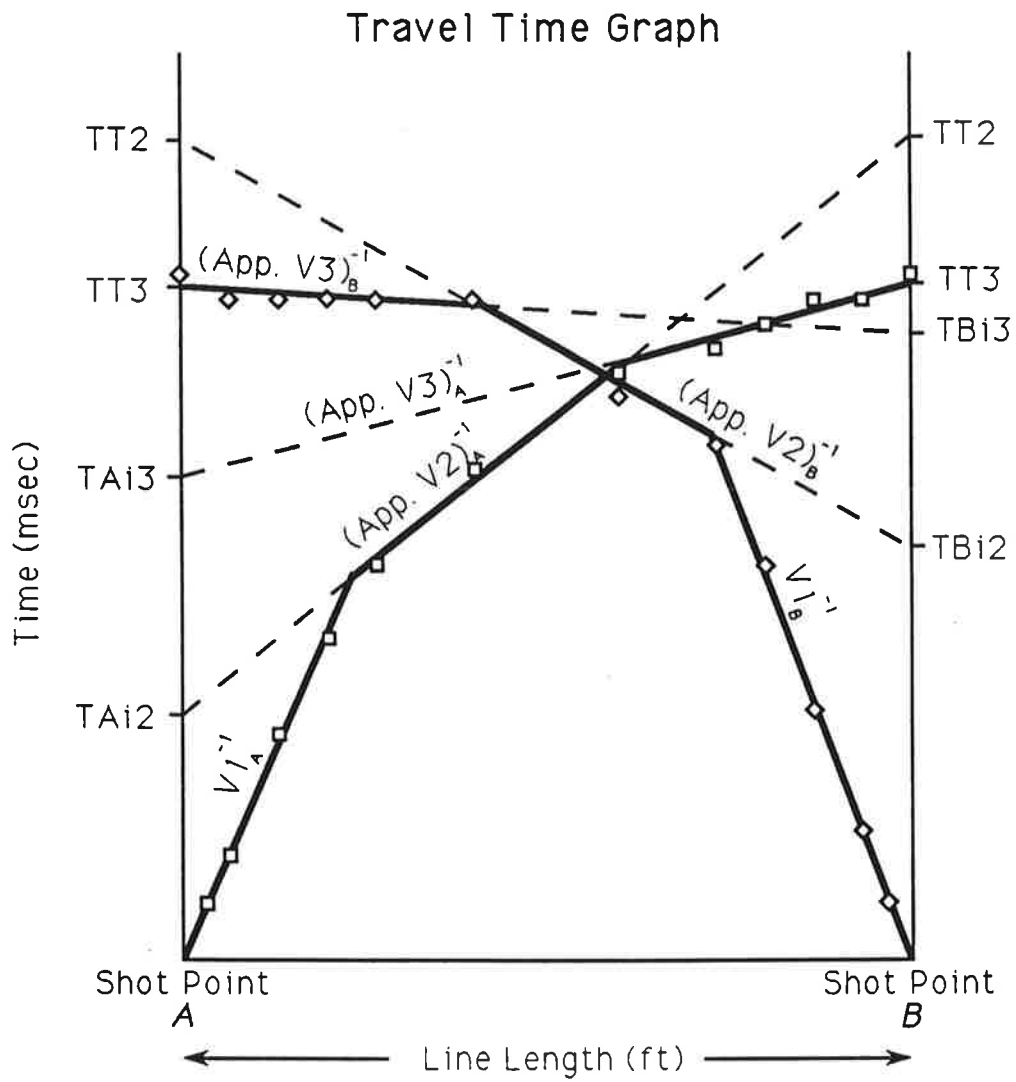
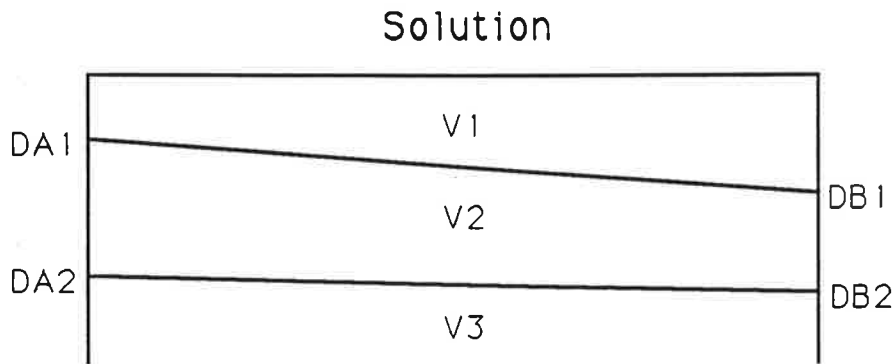
Figure B.1-3. Idealized travel-time curves and the corresponding solution for a reversed seismic refraction line. Line segments are drawn through first-arrival picks read from the data. Apparent velocities, intercept times (eg. TAI_2), and total travel times (eg. TT_2) are used to develop velocity profile solution. See text and appendix for details.

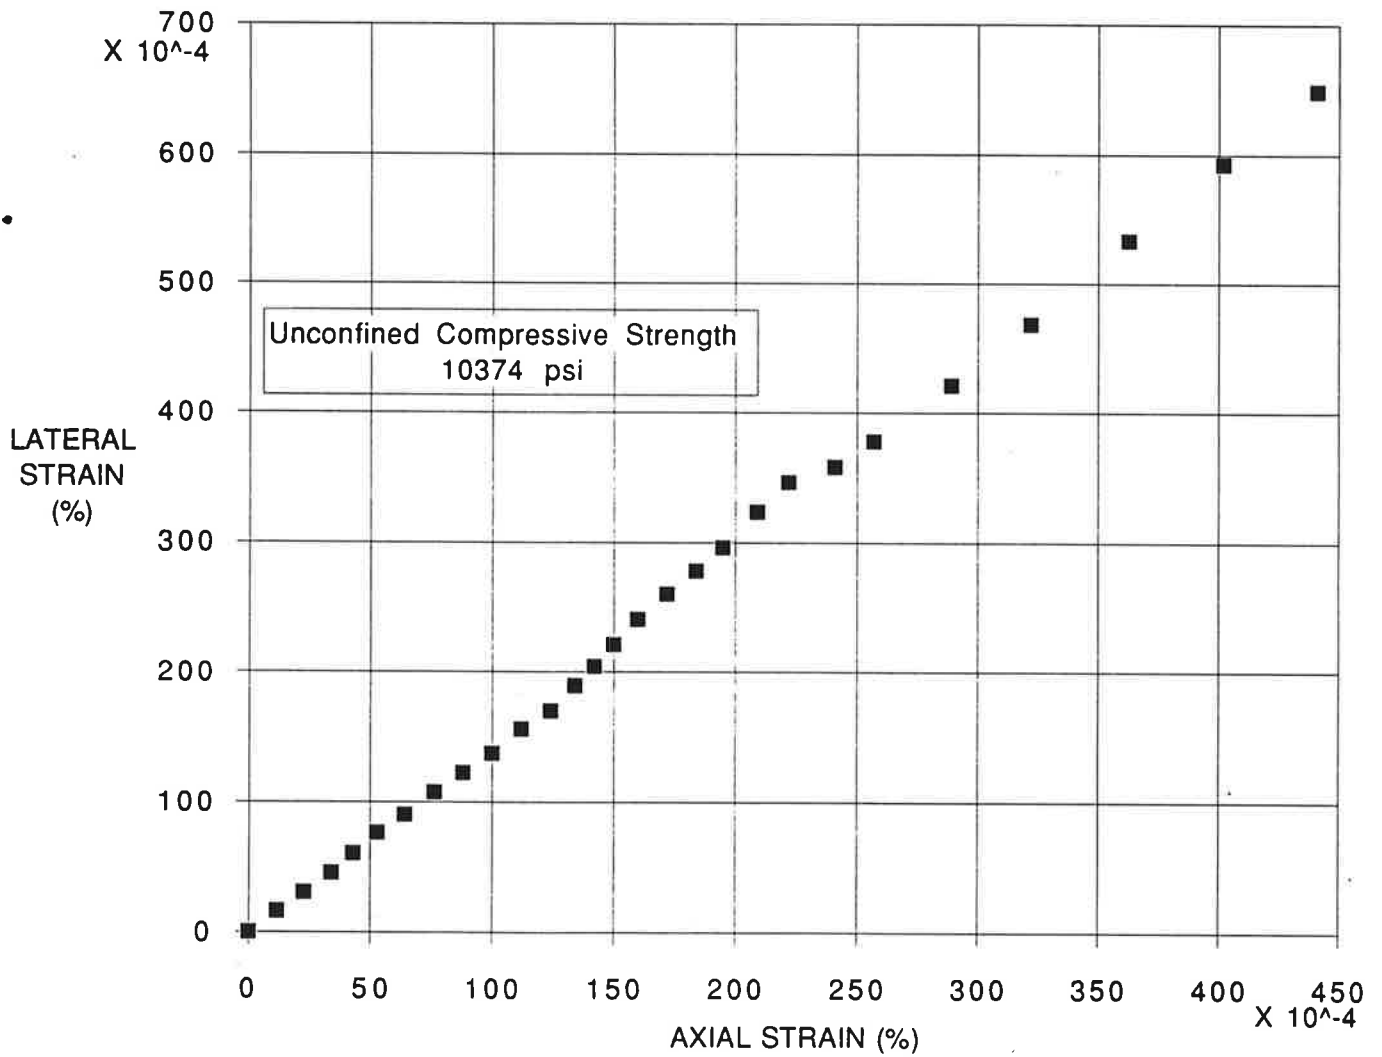
NEW LOS PADRES DAM
21675-000
RA-1 (59.7-60.2 ft.)
LATERAL STRAIN - AXIAL STRAIN

DEFORMATION DATA ARE UNRELIABLE SINCE STRAIN GAGES MALFUNCTIONED

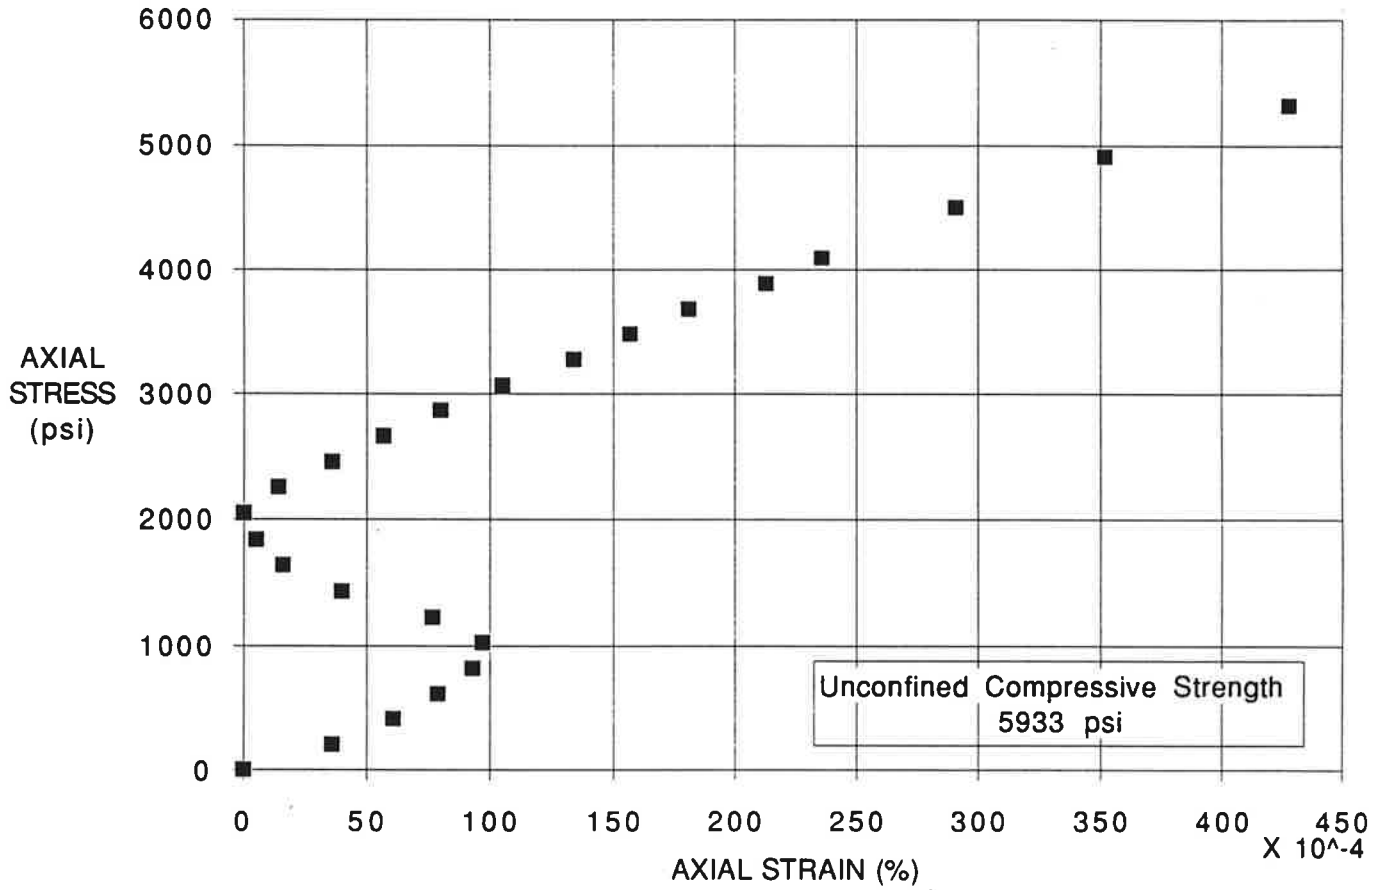
**NEW LOS PADRES DAM
21675-000
RA-1 (74.6-75.1 ft.)
AXIAL STRESS - AXIAL STRAIN**
