FINAL REPORT  
GEOTECHNICAL AND ENGINEERING  
STUDIES FOR THE  
NEW LOS PADRES WATER SUPPLY  
PROJECT  
MONTEREY PENINSULA WATER  
MANAGEMENT DISTRICT

Subject: REPORT - Geotechnical and Engineering Studies  
New Los Padres Water Supply Project  
Monterey County, California

The New Los Padres Dam will be located on the Carmel River approximately 19 miles southeast of the City of Monterey as shown on Figure ES-1. The project includes a 24,000 acre-foot reservoir, a 282 foot high roller compacted concrete (RCC) gravity dam, access roads, and fish passage facilities. Investigations were performed to evaluate borrow area material, the potential for faulting of the Cachagua fault, geotechnical conditions at the dam site, and seismic design parameters. A review also was made of the preliminary design from previous studies for the dam and fish collection and screening facilities. The preliminary design of the dam was modified and cost estimates were prepared for the RCC dam and fish facilities.

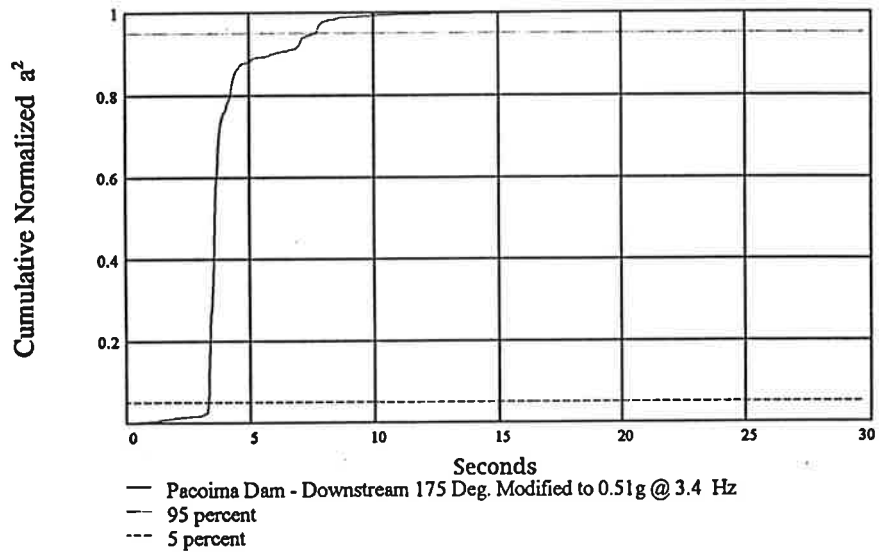
Normalized Cumulative Acceleration - Husid Plot

Northridge Earthquake : Pacoima Dam - Downstream  
 19 km Epicentral Distance - Diorite Gneiss

Modified Pacoima Dam Downstream - 175 Degrees Time History

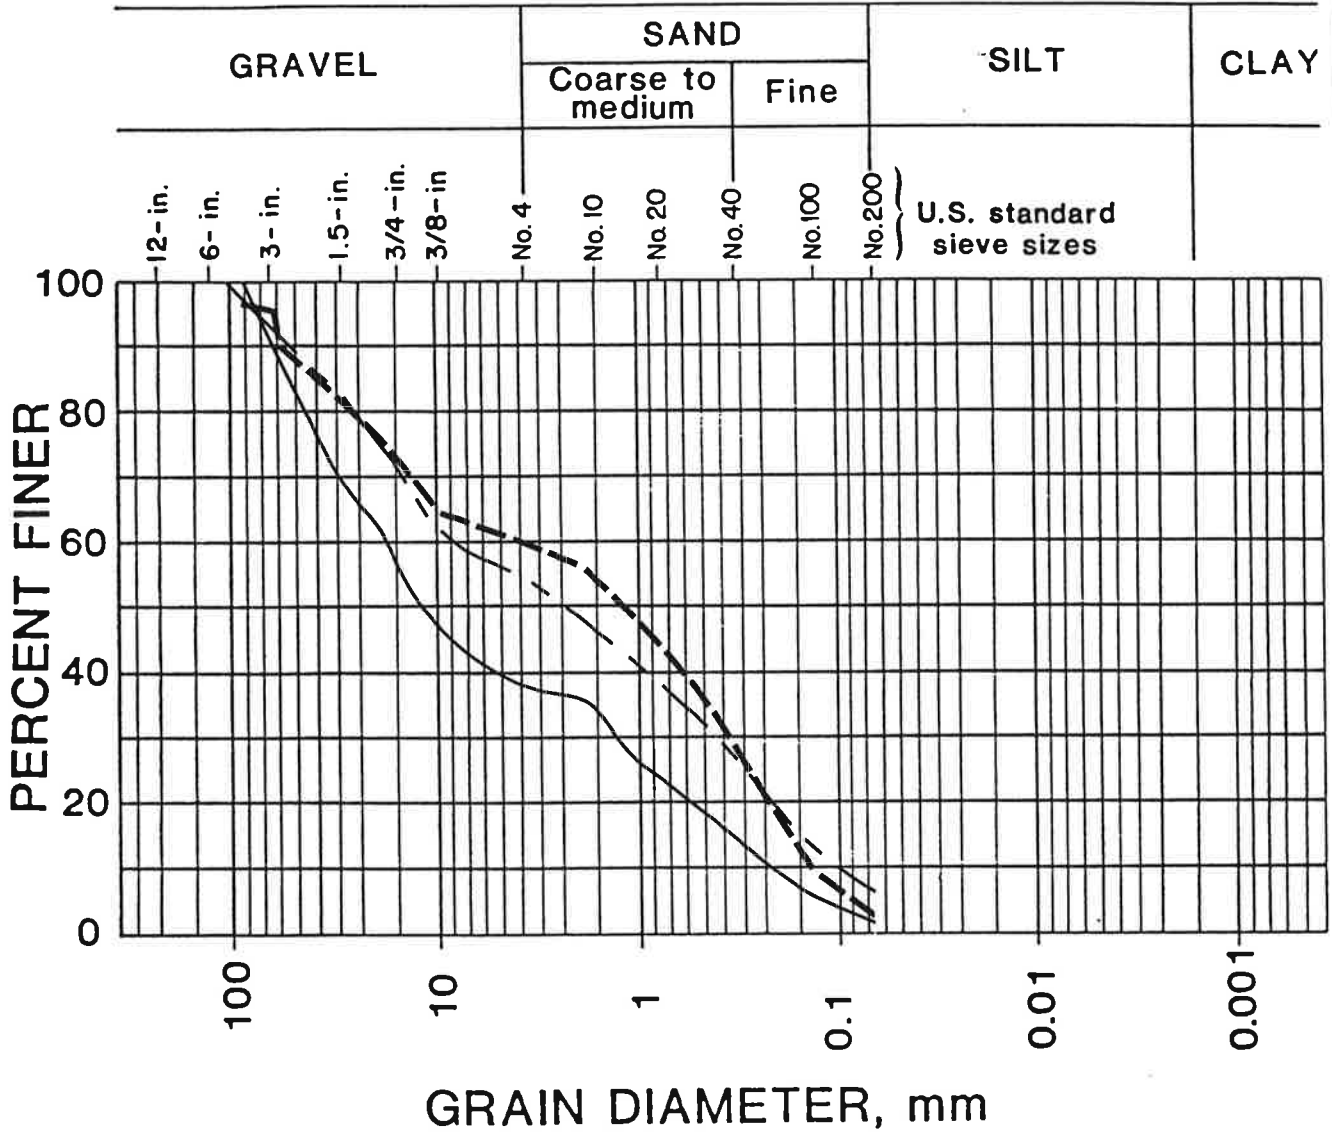
- Distribution for Borrow Area A (Based on 1 Sieve Analysis)
- - - Average Distribution for Borrow Area B (Based on 4 Sieve Analyses)
- - - Average Distribution for Borrow Area C (Based on 2 Sieve Analyses)

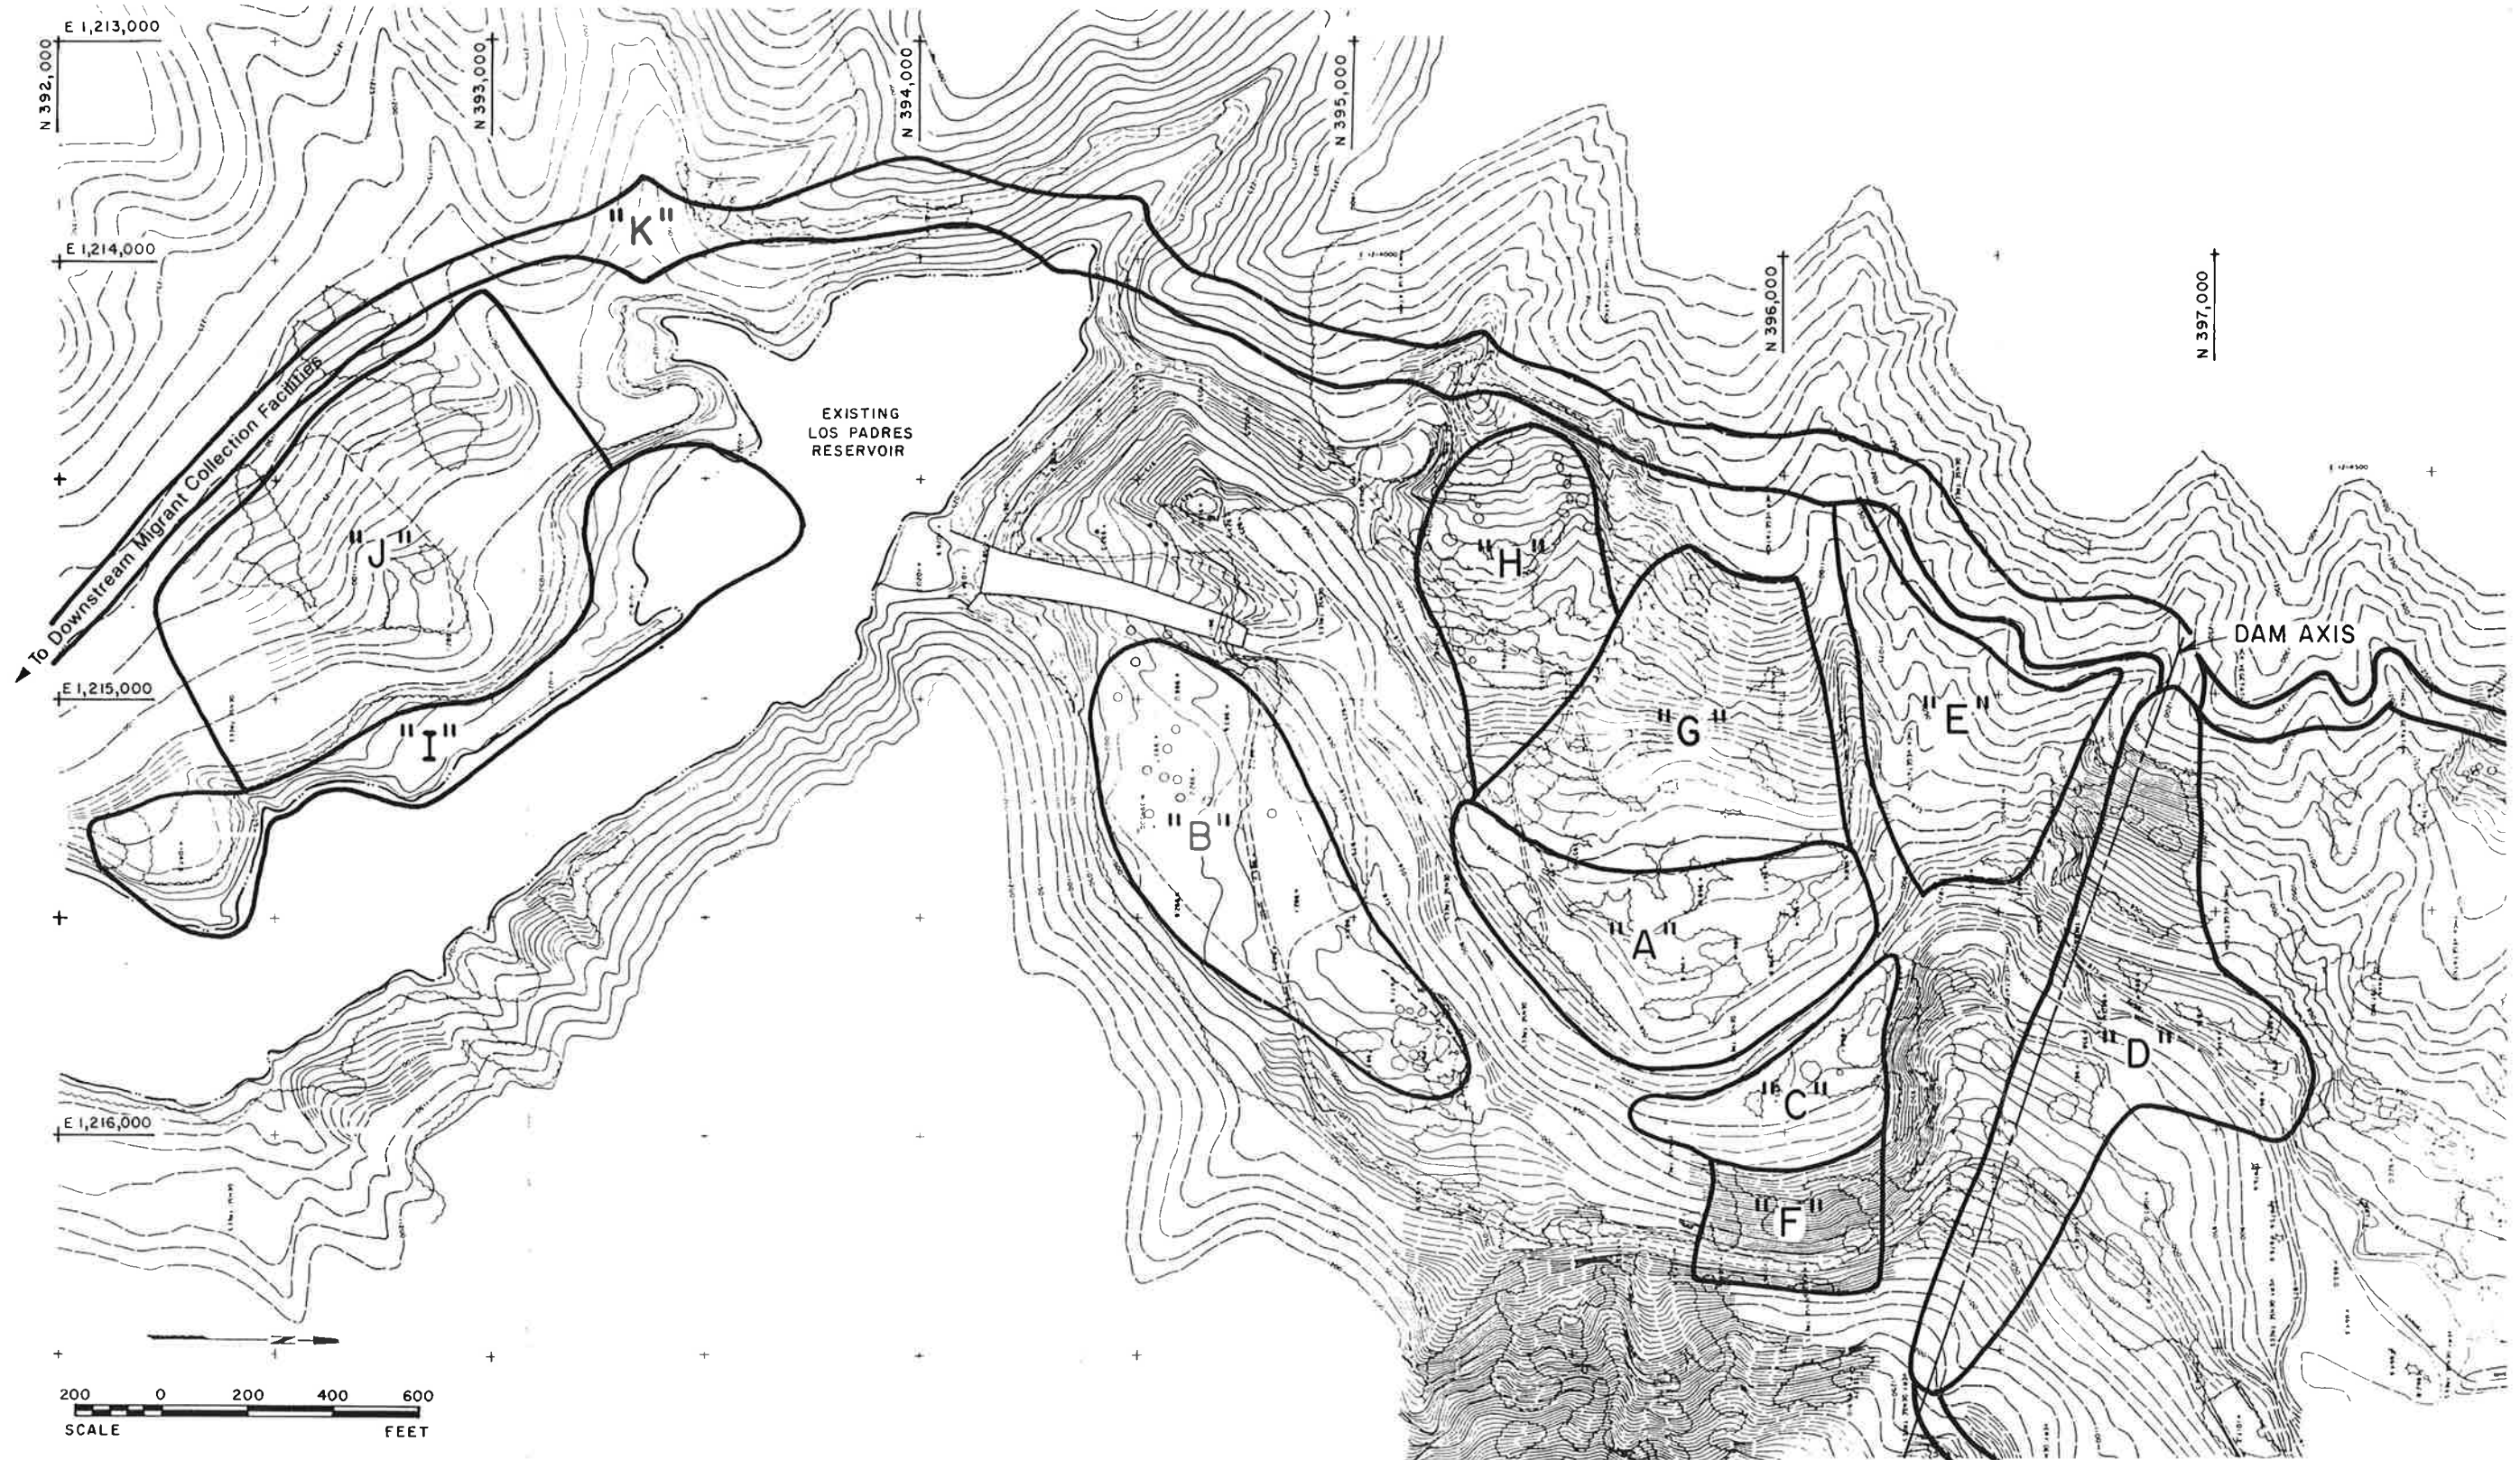
DRAWING NO  
 3-1

**BORROW AREA LOCATIONS**

EXPLANATION	
	Approximate Limits of Borrow Areas

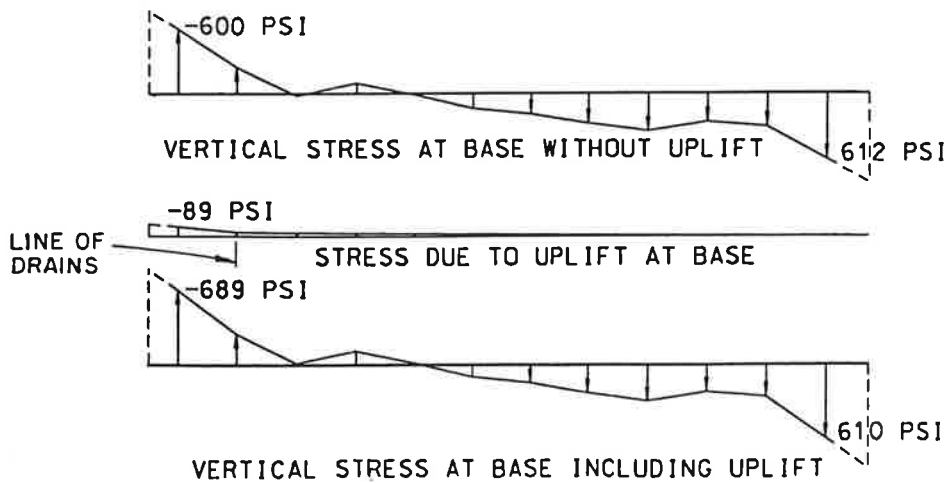
**VERTICAL STRESSES AT T=11.30 SECONDS**

NOTE: CONTOURS SHOW VERTICAL COMBINED  
STATIC AND DYNAMIC STRESSES OCCURRING  
AT THE 11.30 SECOND TIME INTERVAL  
COMPUTED WITH UPLIFT.

STRESSES IN PSI

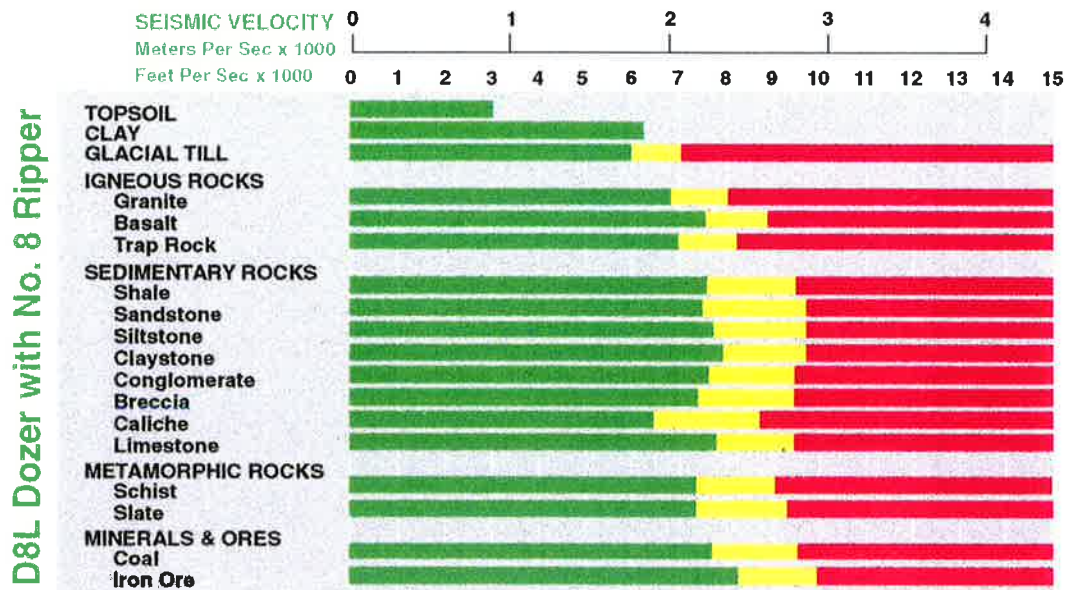
# RIPPER PERFORMANCE

Multi or Single Shank Rippers  
Estimated by Seismic Wave Velocities

Rippable █ Marginal █ Non-Rippable █

Source: Caterpillar™, 1990

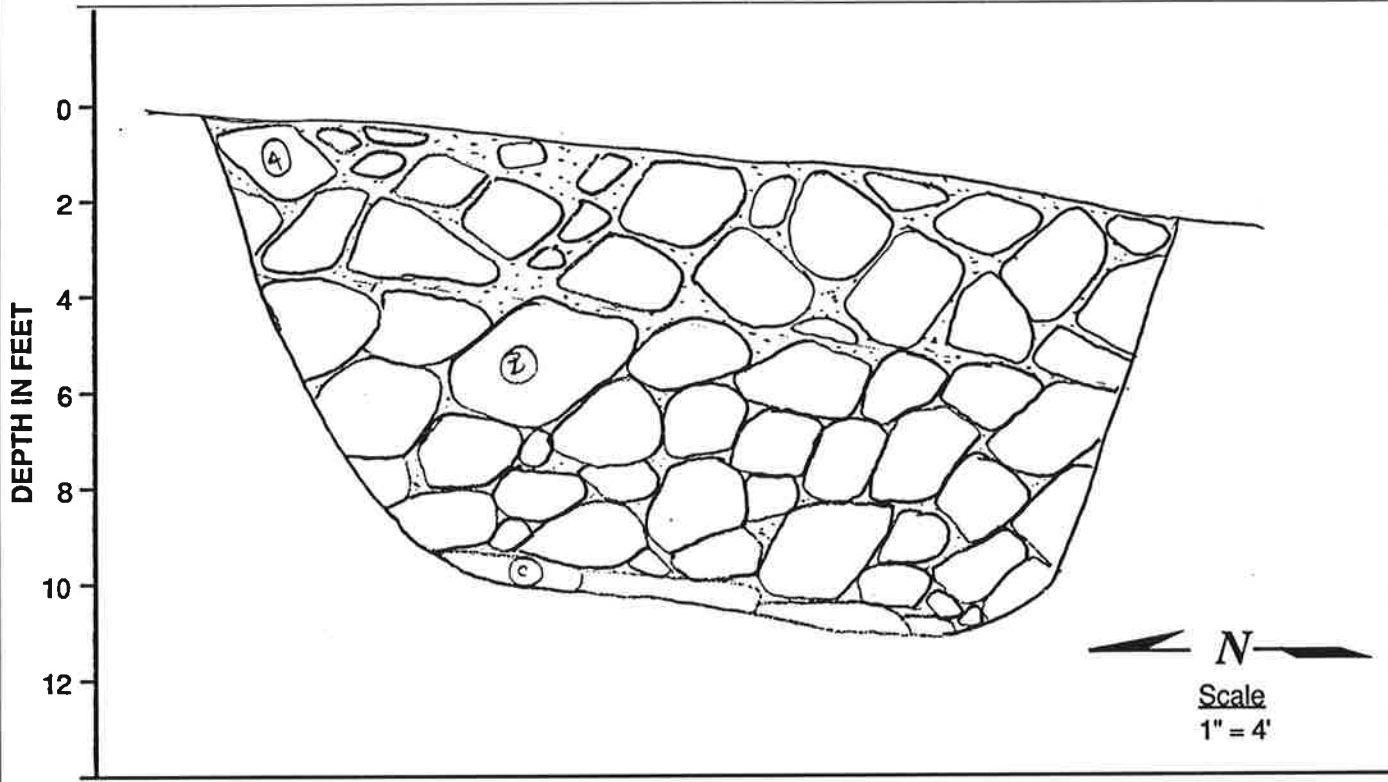
SAMPLE NO.	TYPE	DEPTH (feet)	TESTS	DESCRIPTION
		0-3.5		<b>Fan Deposits</b> (A) Sandy GRAVEL (GP) - dry, pale yellowish brown (10YR 6/2), cobbles to boulders, angular to subangular, silty fine sand matrix, abundant roots to 3" diameter, clasts slightly to moderately weathered
		3.5-9		(B) As in (A) but much less matrix
		9-9.5		(C) Large boulders, highly weathered rind, moderately weathered cores  Refusal at 9.5 feet, no water

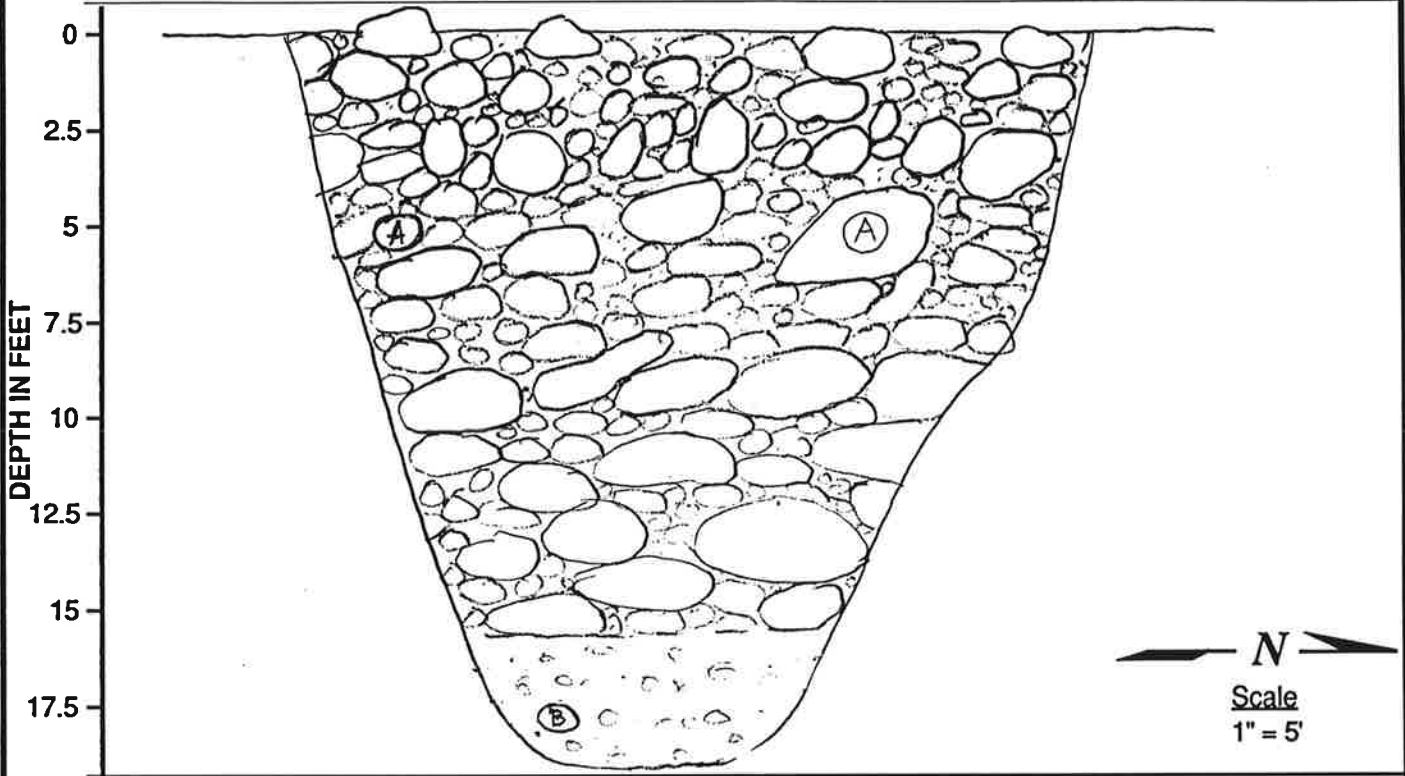
SAMPLE NO.	TYPE	DEPTH (feet)	TESTS	DESCRIPTION
4	Sacks	0-14		<p><b>Terrace Deposits</b></p> <p>(A) Sandy GRAVEL (GP) - moist, pale yellowish brown (10YR 6/2), fine to medium sand, trace gravel, some cobbles, abundant boulders, subround to round, clast supported</p> <p>-3" = 10%</p> <p>+3" = 20%</p> <p>+12" = 70%      Maximum clast diameter = 3'</p>
		14-18		<p>(B) Gravelly SAND /Sandy GRAVEL (SW/GW) - very moist, moderate yellowish brown (10YR 5/4), trace boulders</p> <p>-3" = 50%</p> <p>+3" = 45%</p> <p>+12" = 5%      Maximum clast diameter = 12"</p> <p>Bedrock not encountered</p> <p>TD @ 18 feet, water at 18 feet</p>
