**MONTEREY PENINSULA WATER MANAGEMENT DISTRICT
PROJECT DESCRIPTION FOR**

**SELECTIVE VEGETATION MANAGEMENT
VIA MALLORCA BRIDGE MAINTENANCE
BANK PROTECTION (RANCHO SAN CARLOS AREA)**

IN THE CARMEL RIVER CHANNEL, SUMMER AND FALL 2013

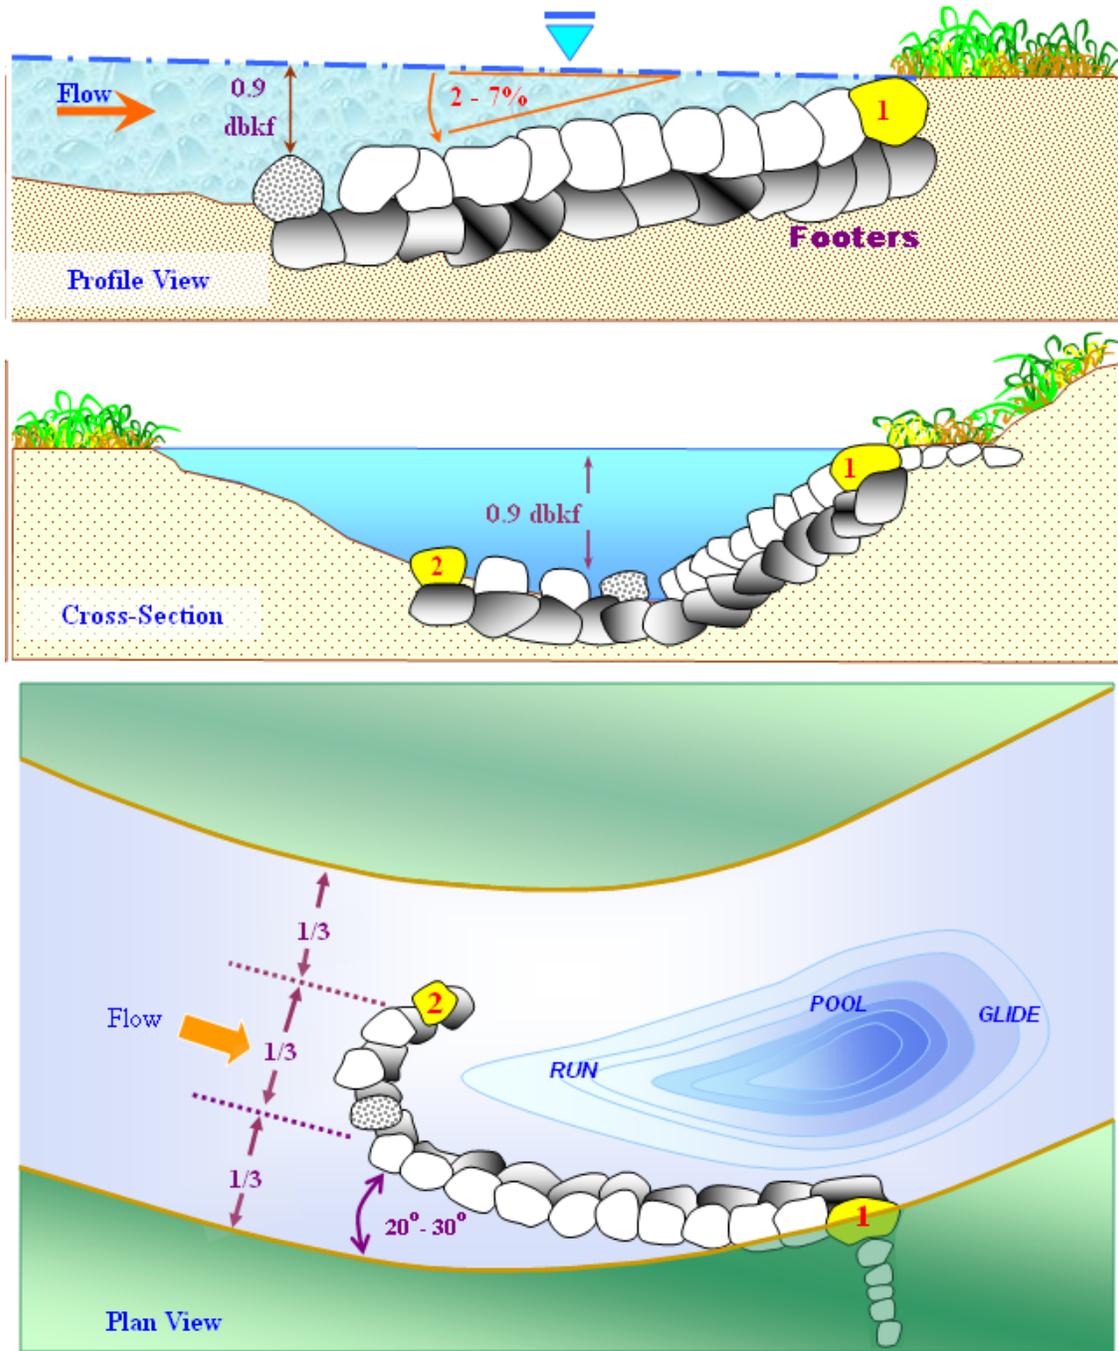
Plan, profile, and section views of the J-hook vane structure, Part 654 Stream Restoration Design, National Engineering Handbook, United States Department of Agriculture Natural Resources Conservation Service

Streambank erosion occurred along approximately 75 feet of the right streambank just downstream of the Rancho San Carlos Road bridge at RM 3.8 in the spring of 2011. The bank continued to erode in the winter of 2012-13. Temporary measures to stabilize the bank including jute net, sand bags, large wood, and willow cuttings do not appear to be adequate to protect the bank from additional erosion. A rock vane (without the J-hook extending into the middle of the channel) consisting of ¼ to two ton rip rap is proposed to be installed. Filtering to prevent piping would be accomplished with an appropriately sized gravel filter. Approximately 30-40 cubic yards of rock (about 60 to 80 tons) would be imported to the site and placed along the streambank to form a vane. Work would be carried out when the river dries up in this reach. Access into the river bottom would be through the Lake/Asselborn property and onto an existing gravel bar shown in the foreground of the photo below. Limited vegetation removal would be required for construction equipment access. Willow cuttings would be placed into the streambank and channel bottom along the rock vane as part of the installation.
