**MONTEREY PENINSULA WATER MANAGEMENT DISTRICT
PROJECT DESCRIPTION FOR**

**SELECTIVE VEGETATION MANAGEMENT
AND
BANK RESTORATION (RANCHO SAN CARLOS AREA)**

IN THE CARMEL RIVER CHANNEL, SUMMER AND FALL 2014

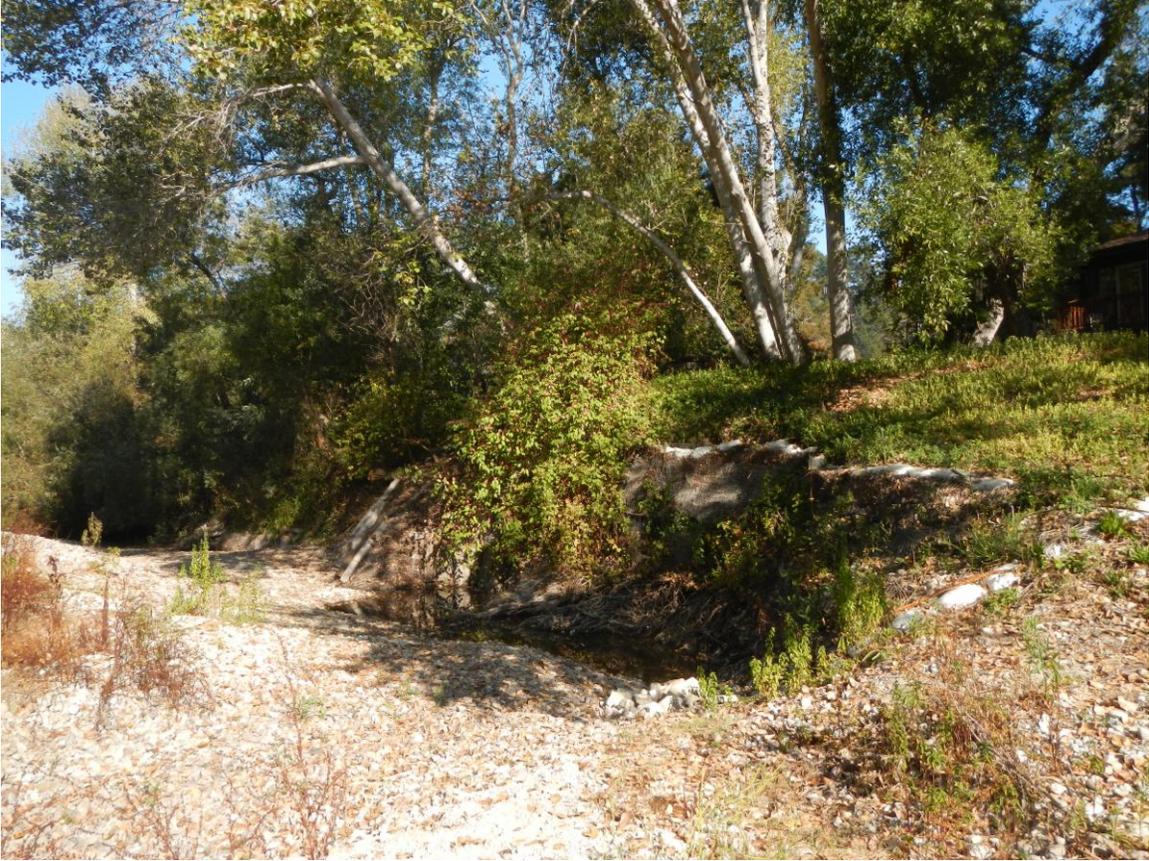
Photo looking downstream at erosion along Big Sur Land Trust/ Lake and Asselborn properties, Carmel River, Monterey County, California, November 7, 2011.

Streambank erosion occurred along approximately 75 feet of the right streambank just downstream of the Rancho San Carlos Road Bridge at RM 3.8 in the spring of 2011. The bank continued to show minor adjustments in the winter of 2013-14. However, no high flows have occurred because of ongoing drought conditions. Temporary measures to stabilize the bank including installation of jute net, sand bags, large wood, and willow cuttings do not appear to be adequate to protect the bank from a large flow event. A rock vane (without the J-hook extending into the middle of the channel) consisting of ¼ to two ton rip rap is proposed to be installed. Filtering to prevent piping would be accomplished with an appropriately sized gravel filter. Approximately 30-40 cubic yards of rock (about 60 to 80 tons) would be imported to the site and placed along the streambank to form a vane. Work would be carried out when the river dries up in this reach. Access into the river bottom would be through an existing ramp into the river located about 200 feet downstream of the bank erosion (the San Carlos well ramp) or through the Lake/Asselborn property and onto an existing gravel bar shown in the foreground of the photo below. Limited vegetation removal would be required for construction equipment access. Willow cuttings would be placed into the streambank and channel bottom along the rock vane as part of the installation.
