Project Name: Sleepy Hollow Steelhead Rearing Facility Raw Water Intake and Water Supply System

Lead Agency: Monterey Peninsula Water Management District

INITIAL STUDY/MITIGATED NEGATIVE DECLARATION SLEEPY HOLLOW STEELHEAD REARING FACILITY RAW WATER INTAKE AND WATER SUPPLY SYSTEM UPGRADE

September 2016

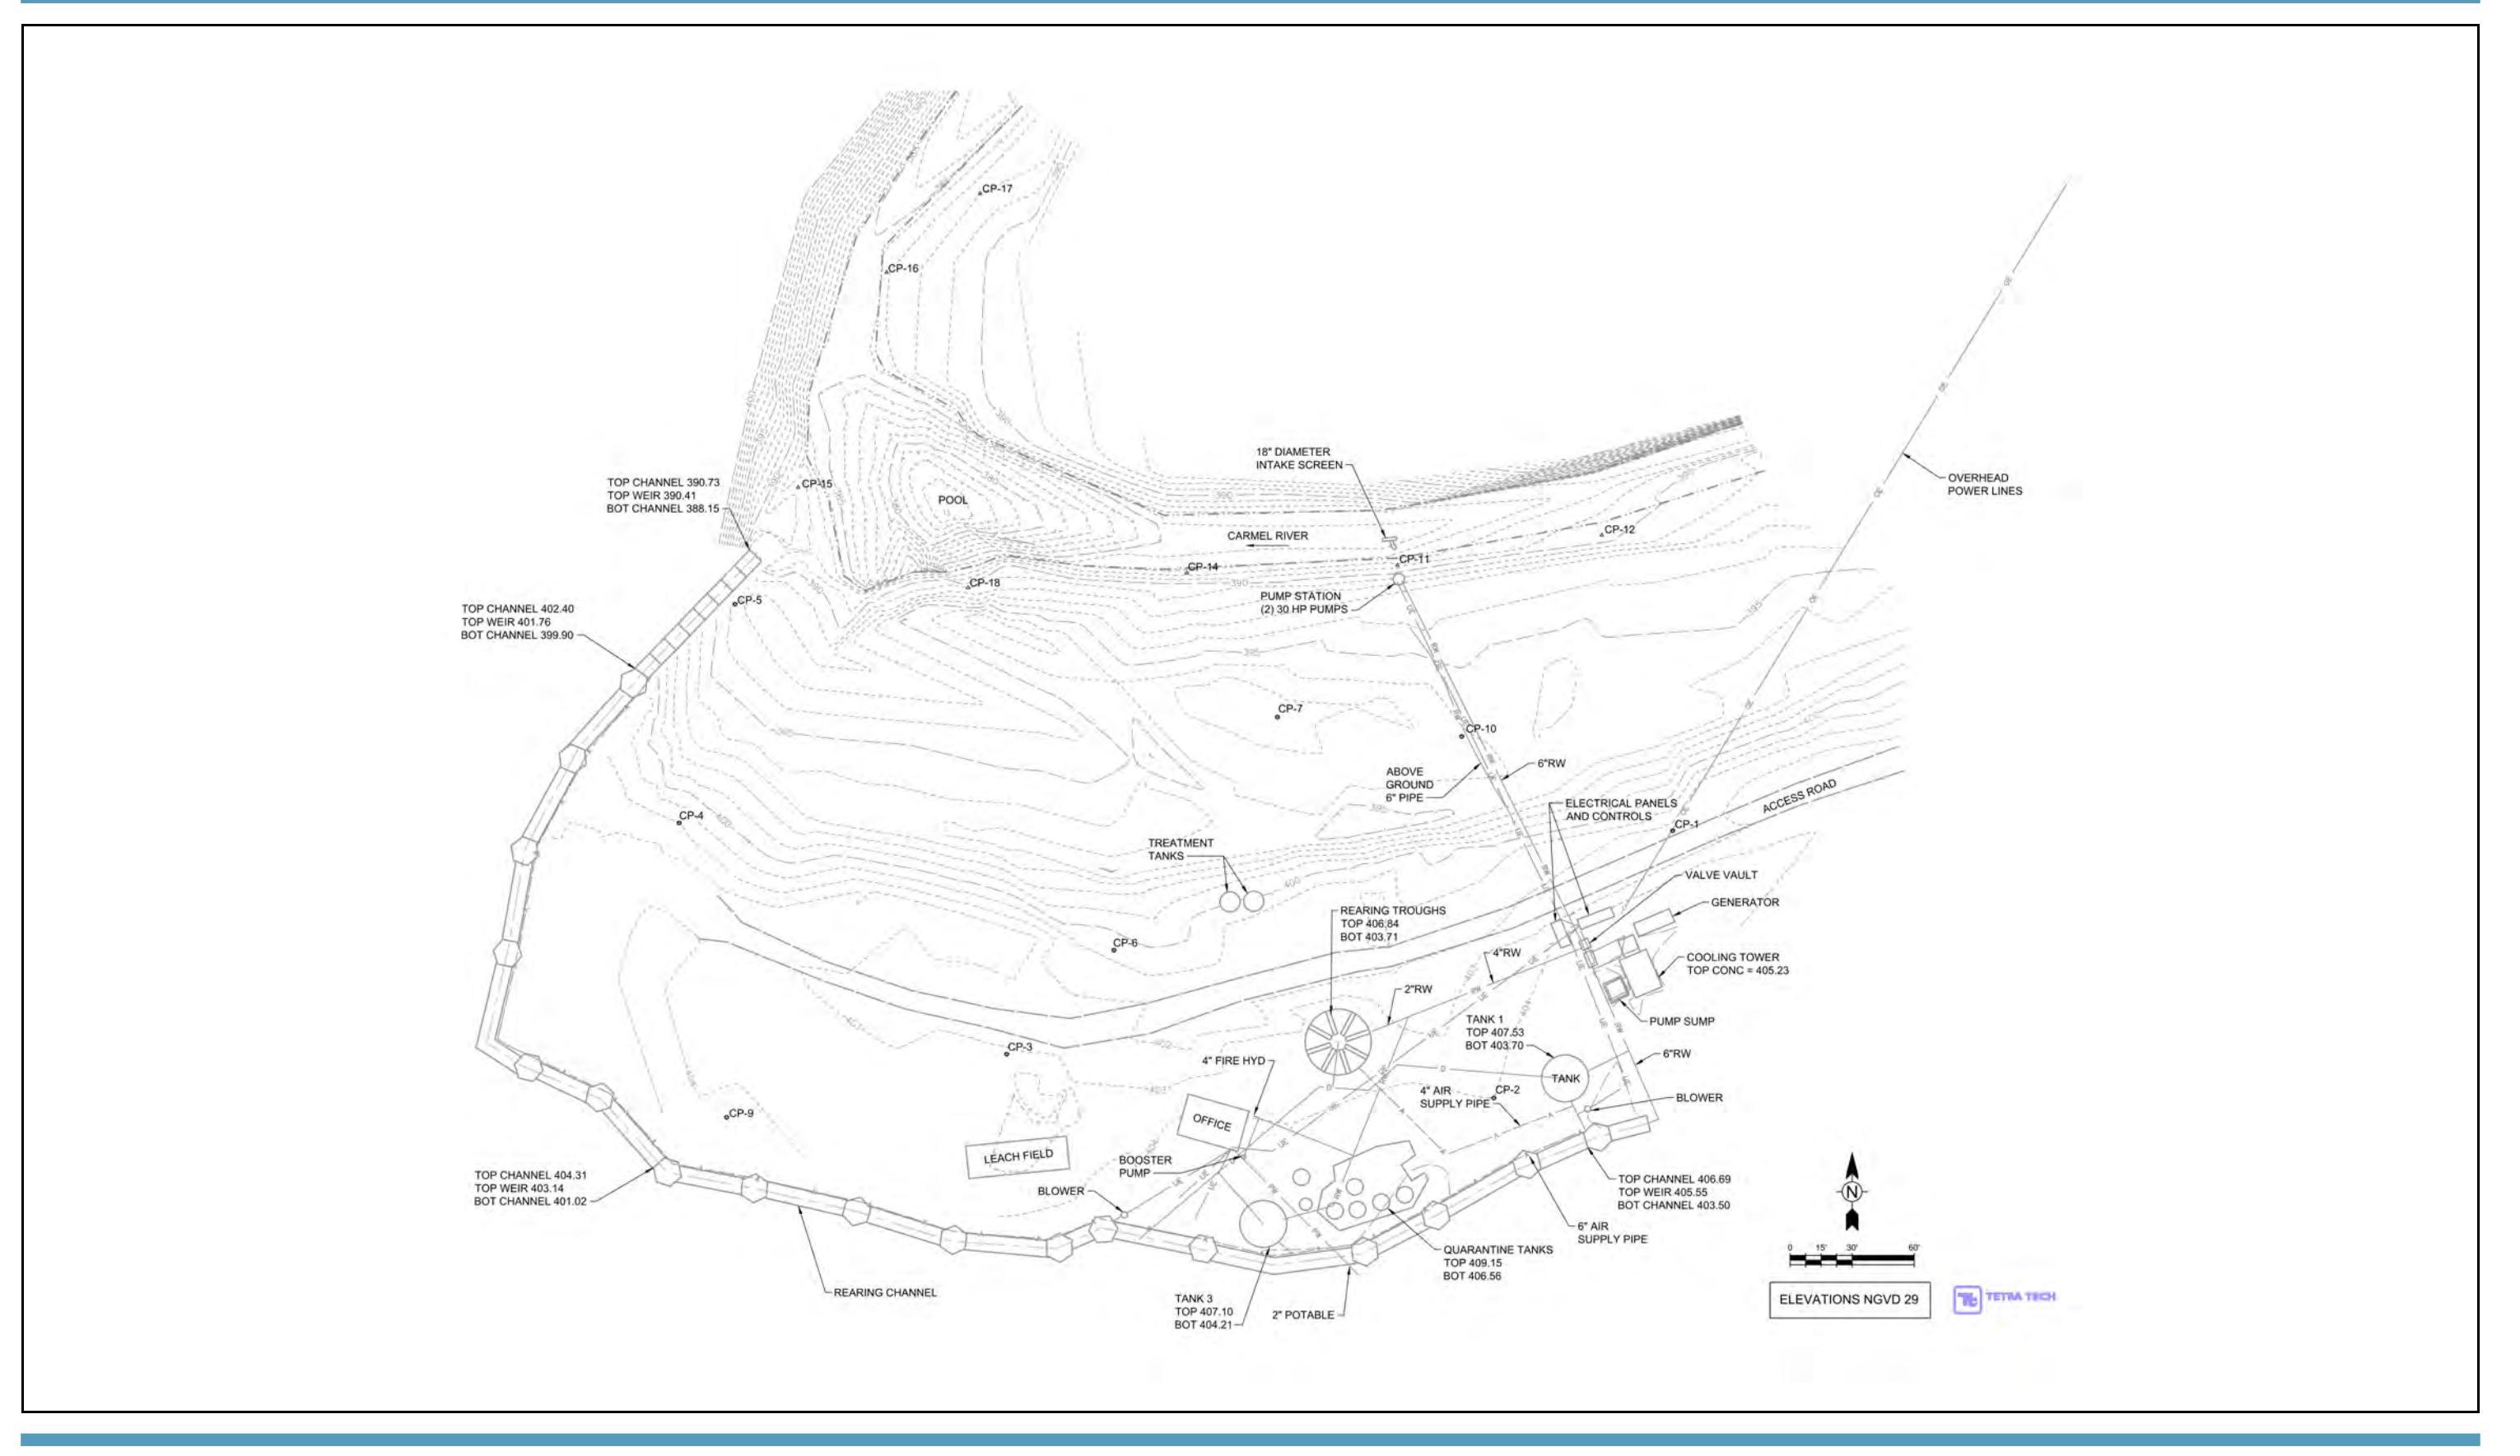
Figure 2 Existing Conditions Sleepy Hollow Steelhead Rearing Facility

The primary fish rearing capacity of the SHSRF is provided by its 800-foot long natural rearing channel (Figure 2). The channel has 17 pairings of 6-foot-wide riffle (rocky or shallow areas) and 9-foot diameter pool sections (Photograph 1). The approximate gross volume of the channel is 14,900 ft³; however, the channel is filled with cobble in almost all riffle sections, significantly reducing the volume of water available for fish rearing. It is estimated that the volume of water available for fish rearing is approximately 4,000 cubic feet (30,000 gallons). The SHSRF also includes two large holding tanks (22- and 30-foot diameter), eight insulated fiberglass rearing troughs, and six 8-foot-diameter quarantine/holding tanks (Photographs 2 and 3). These tanks are used for initial quarantine and sorting larger-sized fish for stocking into the mixed-sized population in the natural rearing channel, while smaller fish are held in the troughs and tanks.

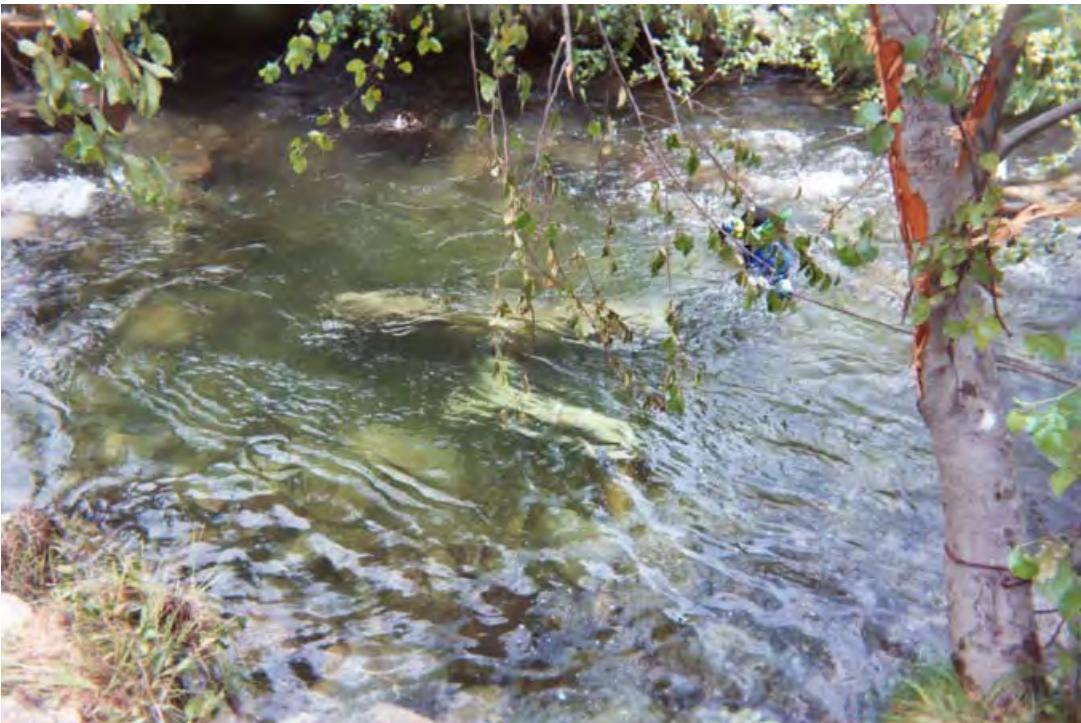
Photograph 4 Intake Screen

Water for the SHSRF is supplied from a screened freshwater intake located in the Carmel River approximately 250 feet from the facility (Photograph 4). An existing wet well and intake pumps deliver up to 900 gallons per minute (gpm) of water to the facility via a 6-inch-diameter buried PVC pipe. A portable irrigation pump provides an auxiliary backup water supply of 500 gpm for use in emergency situations. The intake pumps deliver water to the top of a cooling tower before water is distributed to the rearing channel and tanks.

The existing intake screen is a non-active horizontal Tee screen made of 3/32-inch wedge wire. Because the screen is not self-cleaning, buildup of silt, leaf debris, and algae on the screen has resulted in significant maintenance requirements. The screen is located at an elevation that is not submerged under river water when flows are less than 4 cubic feet per second (cfs). Due to a lack of adequate upstream surface storage at Los Padres Reservoir, evapotranspiration, and surface water diversions between Los Padres Dam and the SHSRF,

there can be reduced surface flow at the intake screen to less than 1 cfs in critically dry periods. Additionally, the existing intake screen becomes inaccessible for maintenance needs as flows increase in early winter.

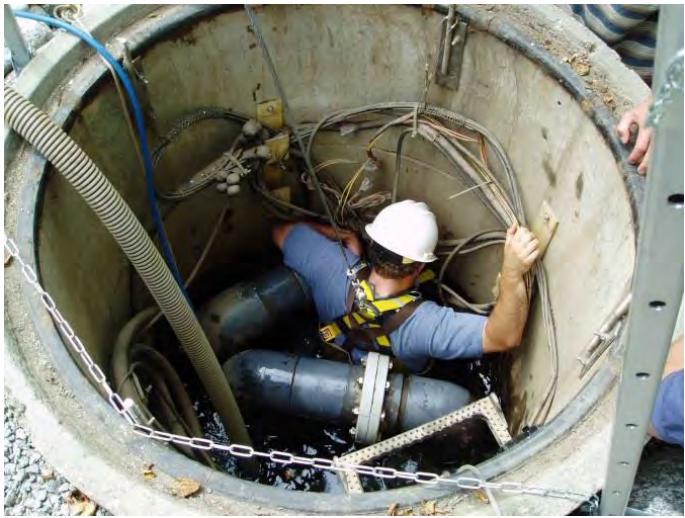
Photograph 5 Intake Pump Housing during Servicing

The facility currently has two 30 horsepower (hp) river intake pumps, each sized to deliver 900 gpm at 85 feet total dynamic head. In the past, problems have occurred when river sediment fouled the mechanical seals in the river pumps. The existing river pump station housing structure is also undersized for two large pumps, and it is in a flood prone area (Photograph 5). The structure is inundated at a flow of about 1,000 cfs, which is a magnitude slightly lower than that of the ordinary high water (Photograph 6). At flow levels of about 1,000 cfs, the river pump housing is underwater and, while it can still operate, maintenance cannot be performed if it is needed. Furthermore, the back-up river pump cannot operate while the other river pump is being serviced.

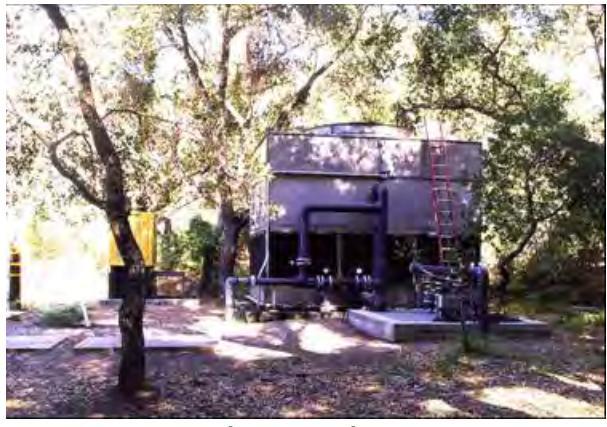
Photograph 7 Cooling Tower

Water is cooled in a cooling tower prior to use within the SHSRF (Photograph 7). The design goals are to keep maximum daily water temperature below 65°F and maintain mean daily water temperatures below 60°F. Within the tower, warm river water sprays over and drips through a stack of plastic media trays as a large fan pulls dry air from the bottom of the tower up through the dripping water. As the dry air passes through the dripping water, a small portion of the water evaporates, saturating the incoming air and cooling the remaining water in the process. About 50% of the time (primarily from early June through October), when the river water is warmer than 58°F, incoming water passes through the tower and the 30 hp fan is turned on to cool the water. At other times when the water is cooler than 58°F the incoming river water bypasses the cooling tower.

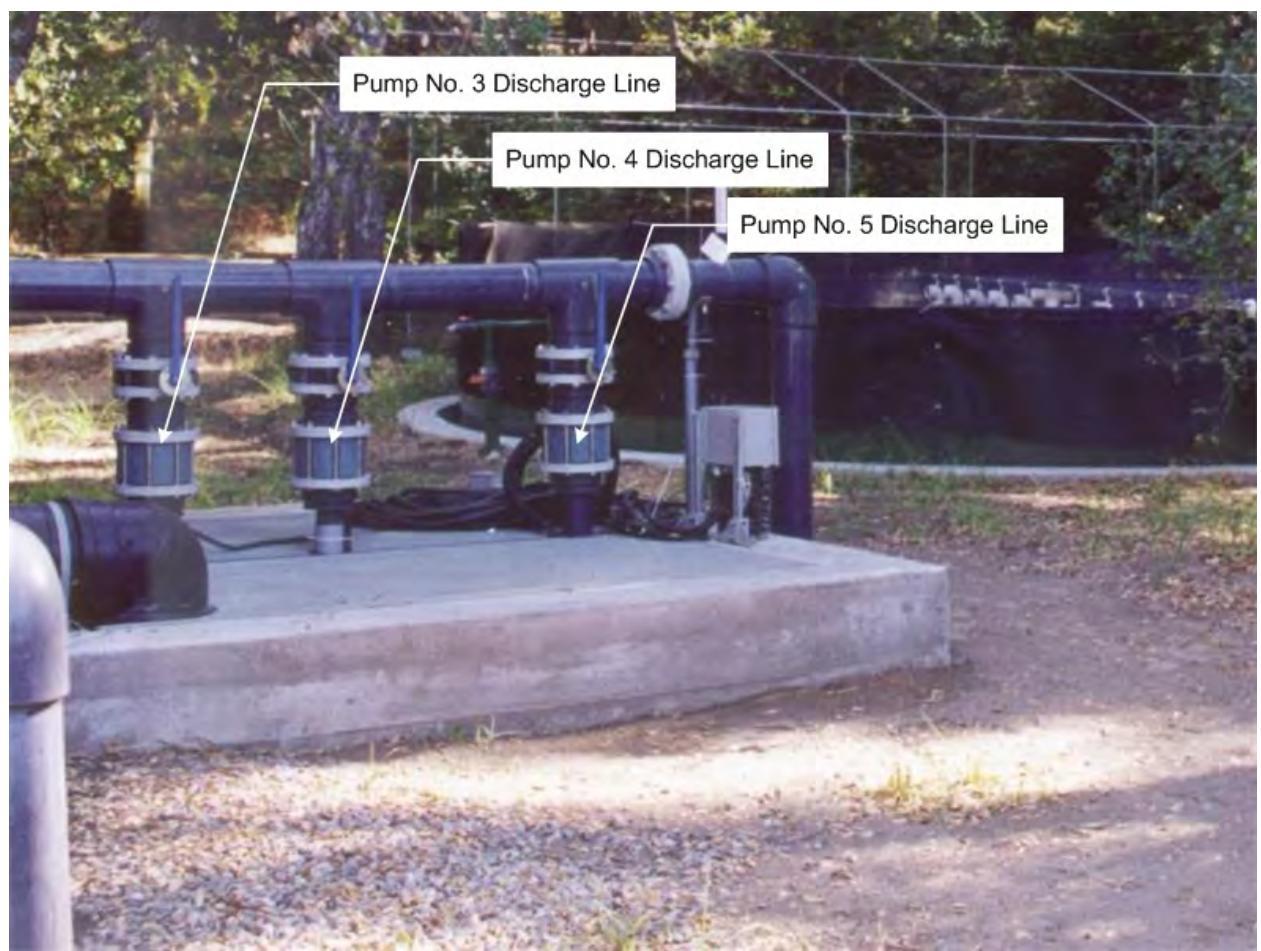
Photograph 8 Cold Well and Pumps

The cooling tower discharges water to a cold well which is then pumped for use by the facility (Photograph 8). Supply water is distributed between the tank systems and rearing channel by manually adjustable valves. Flow is distributed to the rearing channel and tank

system using three pumps located in the cold well sump; one pump is 10 hp and the other two are 7.5 hp. One of the 7.5 hp pumps runs constantly, and the second is a redundant backup that alternates operation with the first pump. The newer 10 hp pump runs at variable speeds to maintain a constant level in the cold well. Flow to the rearing channels can be measured with an existing flow meter on the influent pipe just upstream of the rearing channels.

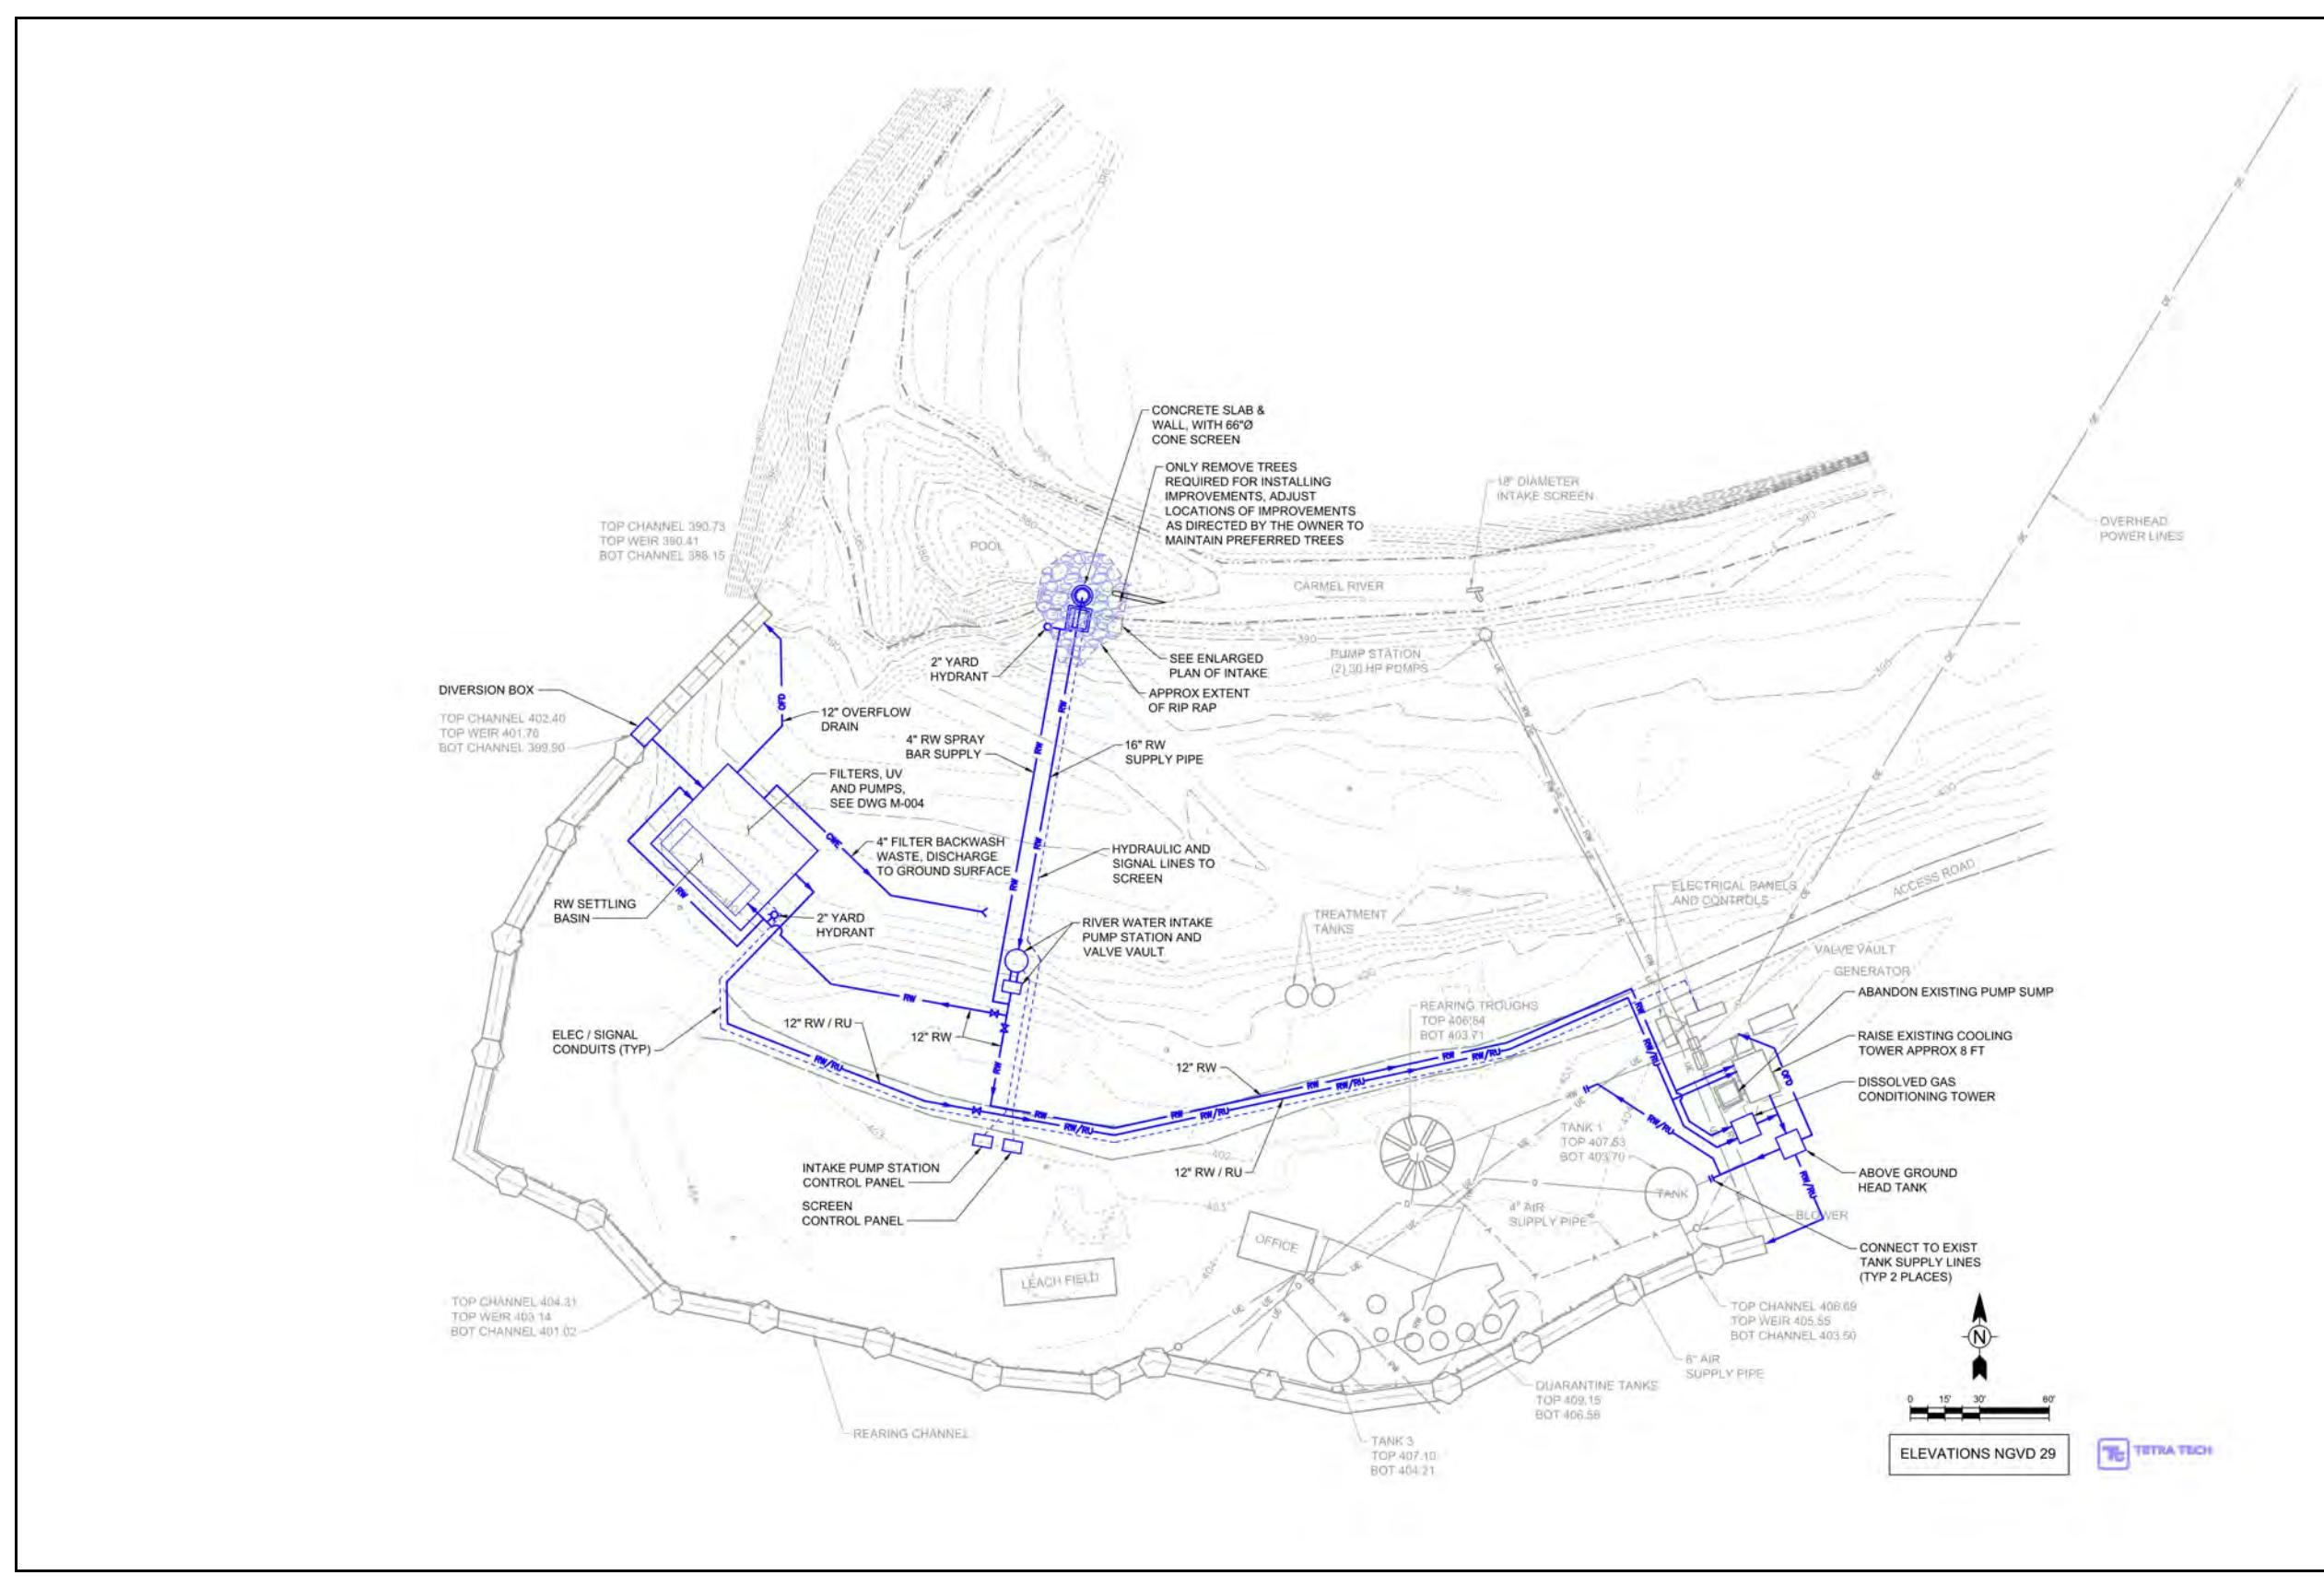
Figure 3 Proposed Site Plan Sleepy Hollow Steelhead Rearing Facility

The proposed project involves improving the facility's water supply intake and cooling tower as well as installing a water recirculation (or reuse) system to meet the identified water requirements and the objectives of the proposed project (Figure 3). Improvements to the water supply intake are needed to address existing maintenance issues, operational constraints, and increases in sandy bed load in the Carmel River due to removal of the San Clemente Dam; to allow for easier water supply intake pump access; and to provide greater in-stream intake screen reliability and ease of maintenance. The addition of an intake water reuse system would allow for the facility's operation when river flows fall below 3 cfs and when sediment load is extraordinarily high during storm events. The proposed project would also improve the facility's efficiency by removing the need for re-pumping from the cooling tower. This section provides more information on these project elements and associated construction methods.

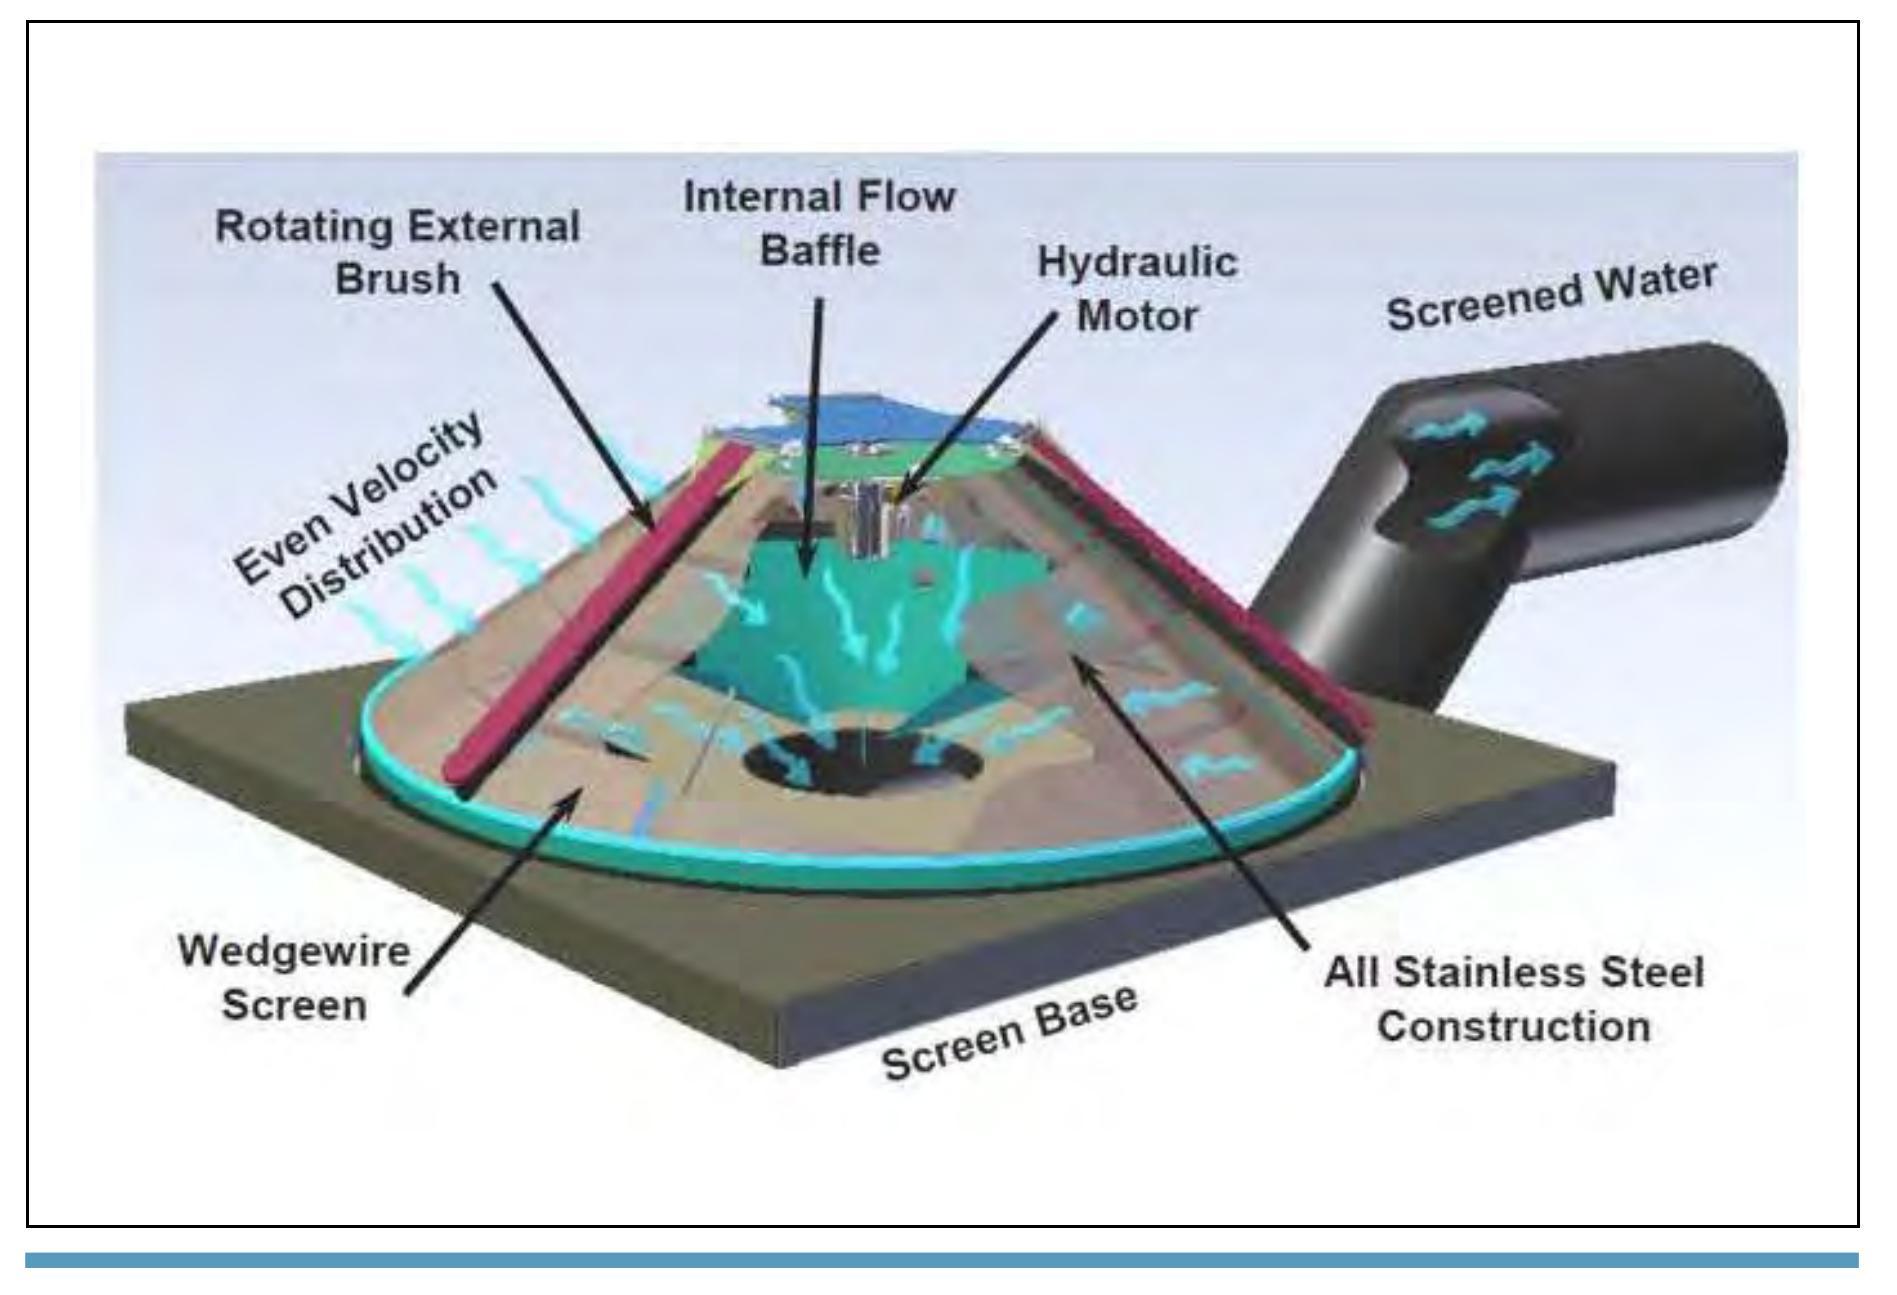
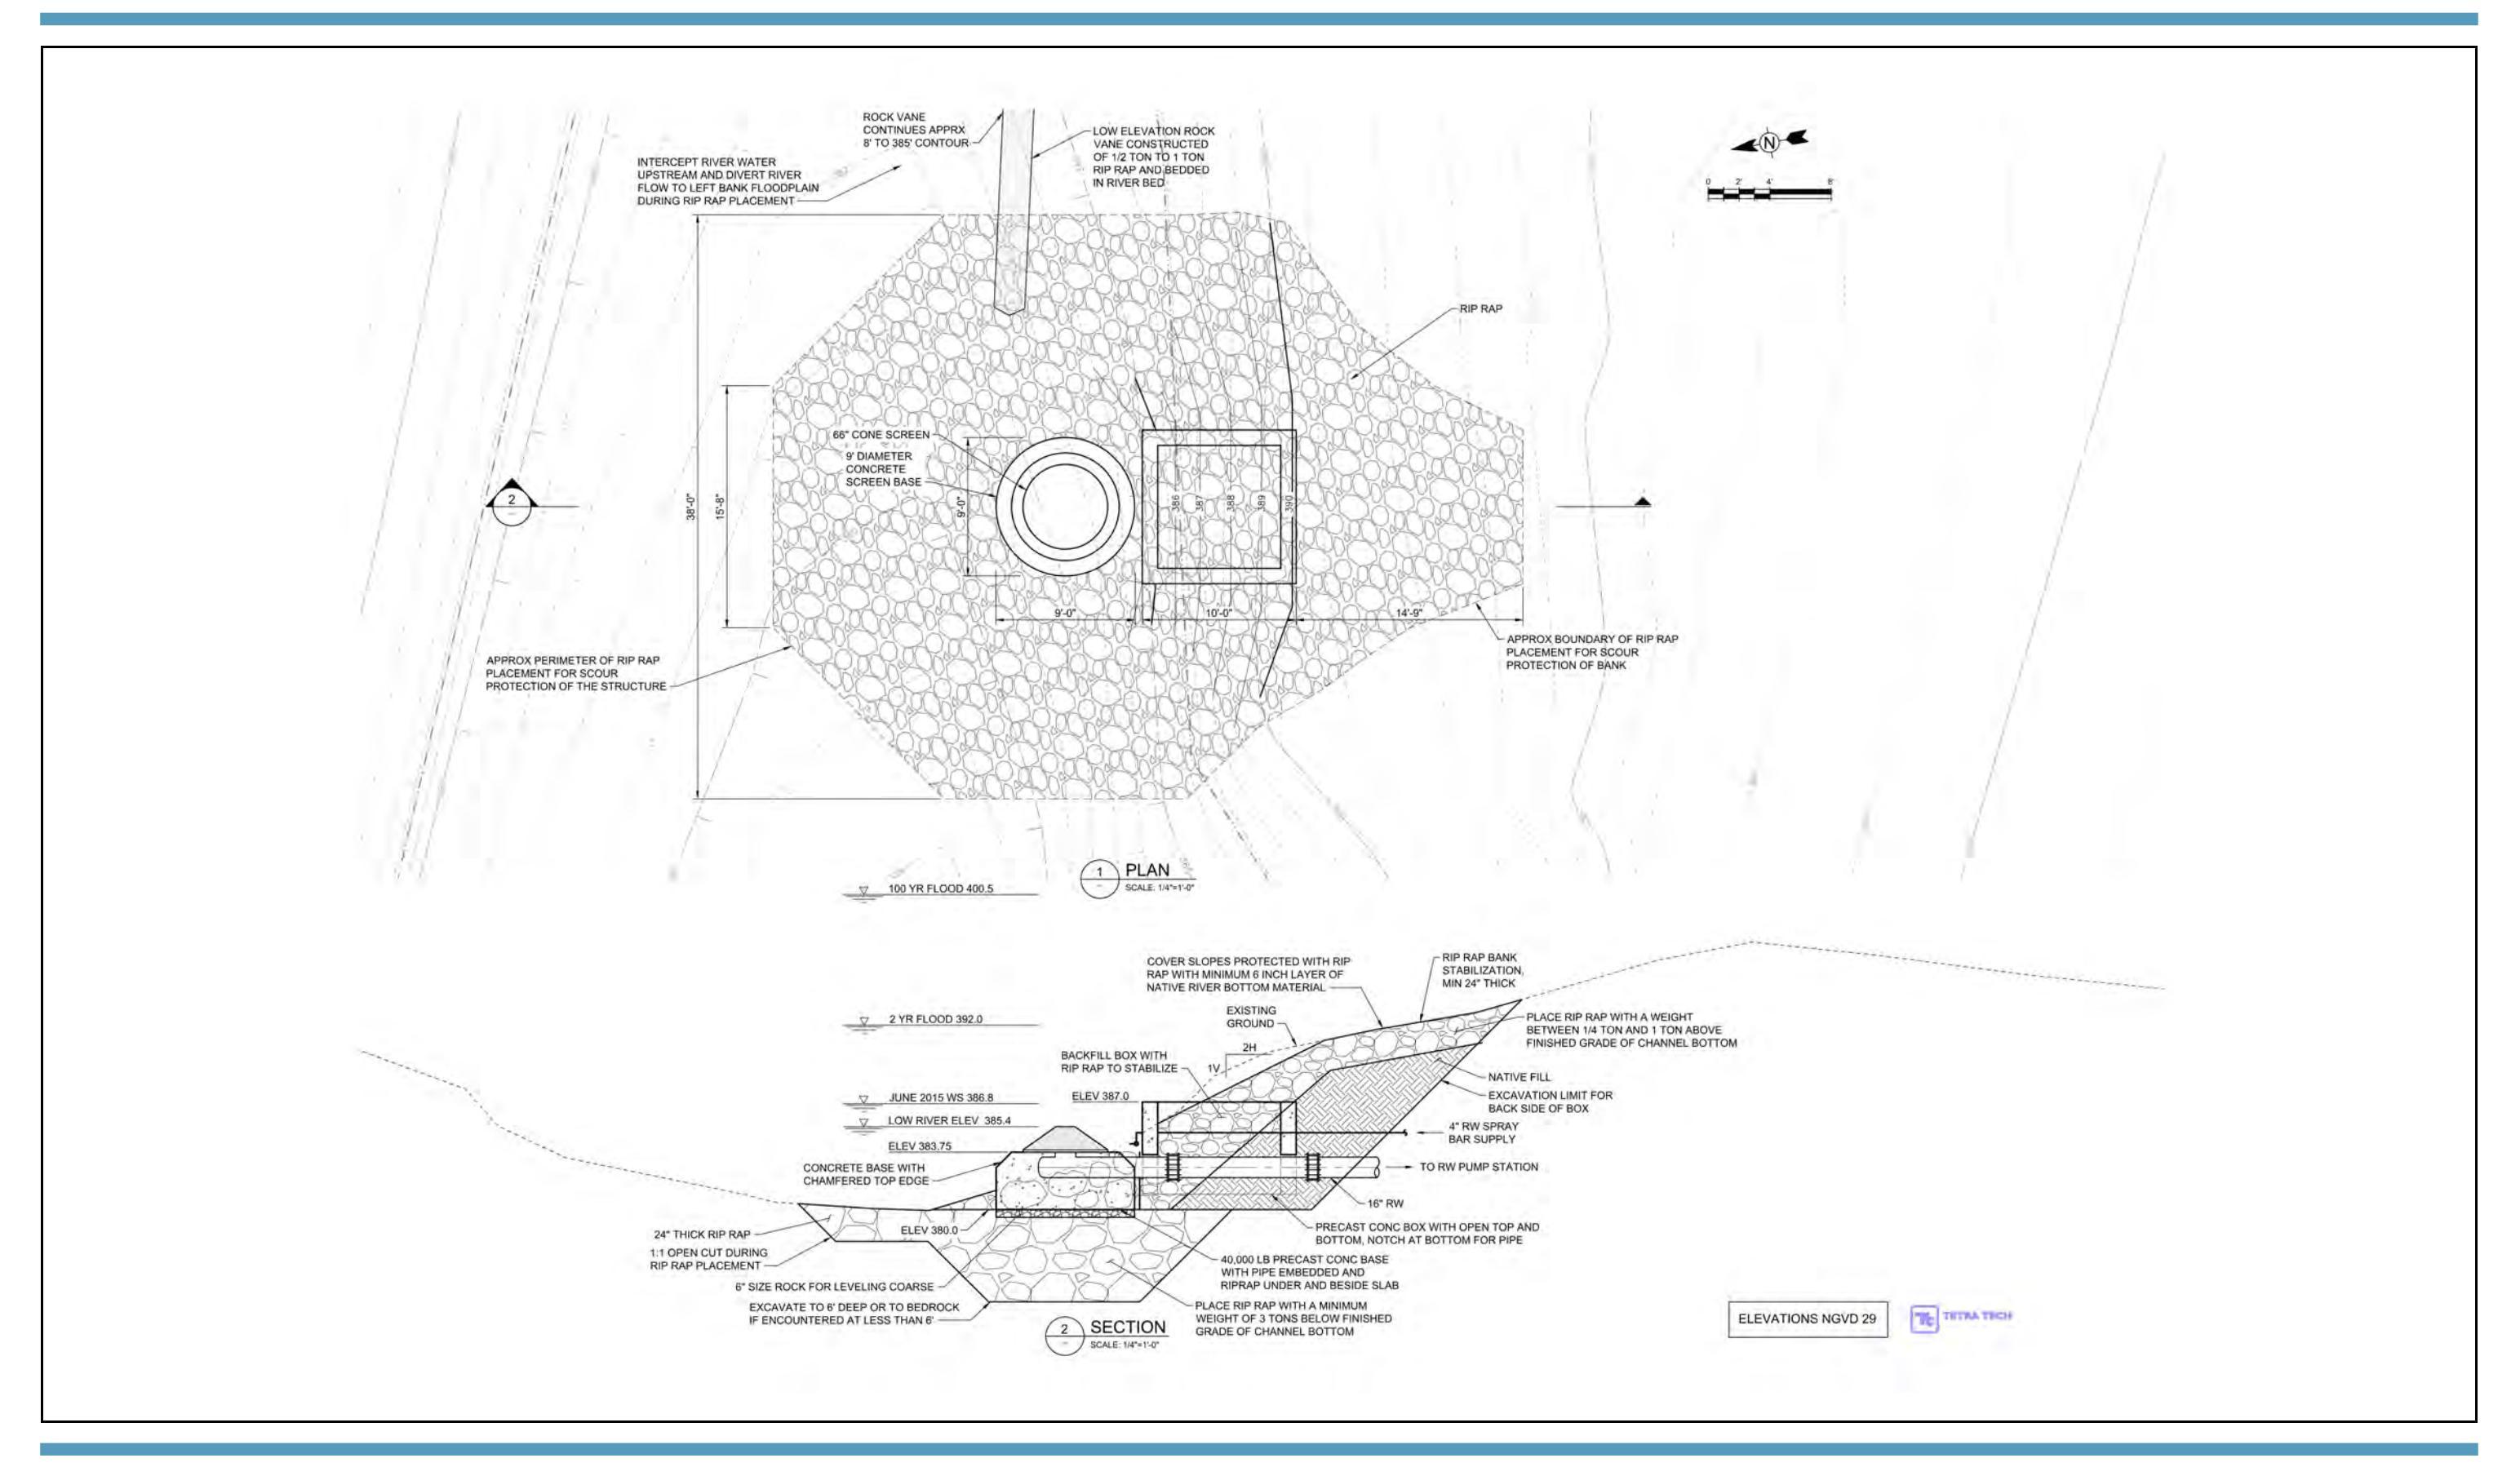
The new cone screen would be bolted to the top of a precast concrete base installed at the proposed intake location. The concrete base would weigh up to about 37,000 pounds and would measure 9 feet in diameter by 3.75 feet thick. The top of the base would be an average of 1 foot higher than the river bottom. At this location, the river's low water level would be at an elevation of 385.4 feet, which would be the approximate elevation for the top of the screen. The bottom of the screen would be located at an elevation of 383.75 feet, and the bottom of the concrete base would be installed at an elevation of 380 feet.

The concrete base would be underlain, supported, and surrounded with rock riprap at grade. A scour analysis was performed to identify required foundation improvements; in order to protect the new intake and concrete base from scour, the river bed would need to be excavated to a maximum depth of 6-feet or until bedrock is encountered (estimated maximum 175 cubic yards of excavation required). The excavated area would be backfilled with angular rock riprap with a minimum weight of 3 tons and size of 42 inches in diameter. Smaller riprap would be placed directly under the screen base location and leveled with an excavator bucket prior to placement of the precast concrete base. The maximum total riprap volume is 160 cubic yards. Native river rock removed during excavation would be stockpiled for reuse, and spread over the riprap at a 6-inch thickness to fill voids in the riprap surface. These improvements are shown in Figure 5.

Figure 5 Intake Screen Plan and Cross Section Sleepy Hollow Steelhead Rearing Facility An upstream rock vane may be needed to deflect bedload away from the intake screen. During final design, additional sediment transport modeling will be performed to make an accurate estimate of sediment impacts in the vicinity of the intake structure over the full range of river and intake flow conditions. This modeling will indicate if the design should incorporate a low-elevation rock vane, likely consisting of 4 cubic yards of 12- to 24-inch diameter boulder material buried in the river bed upstream from the intake. It is anticipated that the single vane (if needed) would be linear when viewed from an overhead perspective. The upstream end of the vane would be located against the river bank about 30 feet upstream of the new intake and would gradually angle away from the river bank to align with the front of the new intake screen (Figures 3 and 5). The purpose of the vane would be to minimize regular maintenance, including reducing the need for staff to enter the river and remove sediment from the intake screen. The total area of the proposed in-channel improvements is estimated to be 1,030 sf (below toe of bank), including a 1,000 sf area for placement of the intake screen, concrete base, and riprap, as well as a 30 sf area from removal of the existing pump station (pump station removal discussed in Section 2.4.1.3).

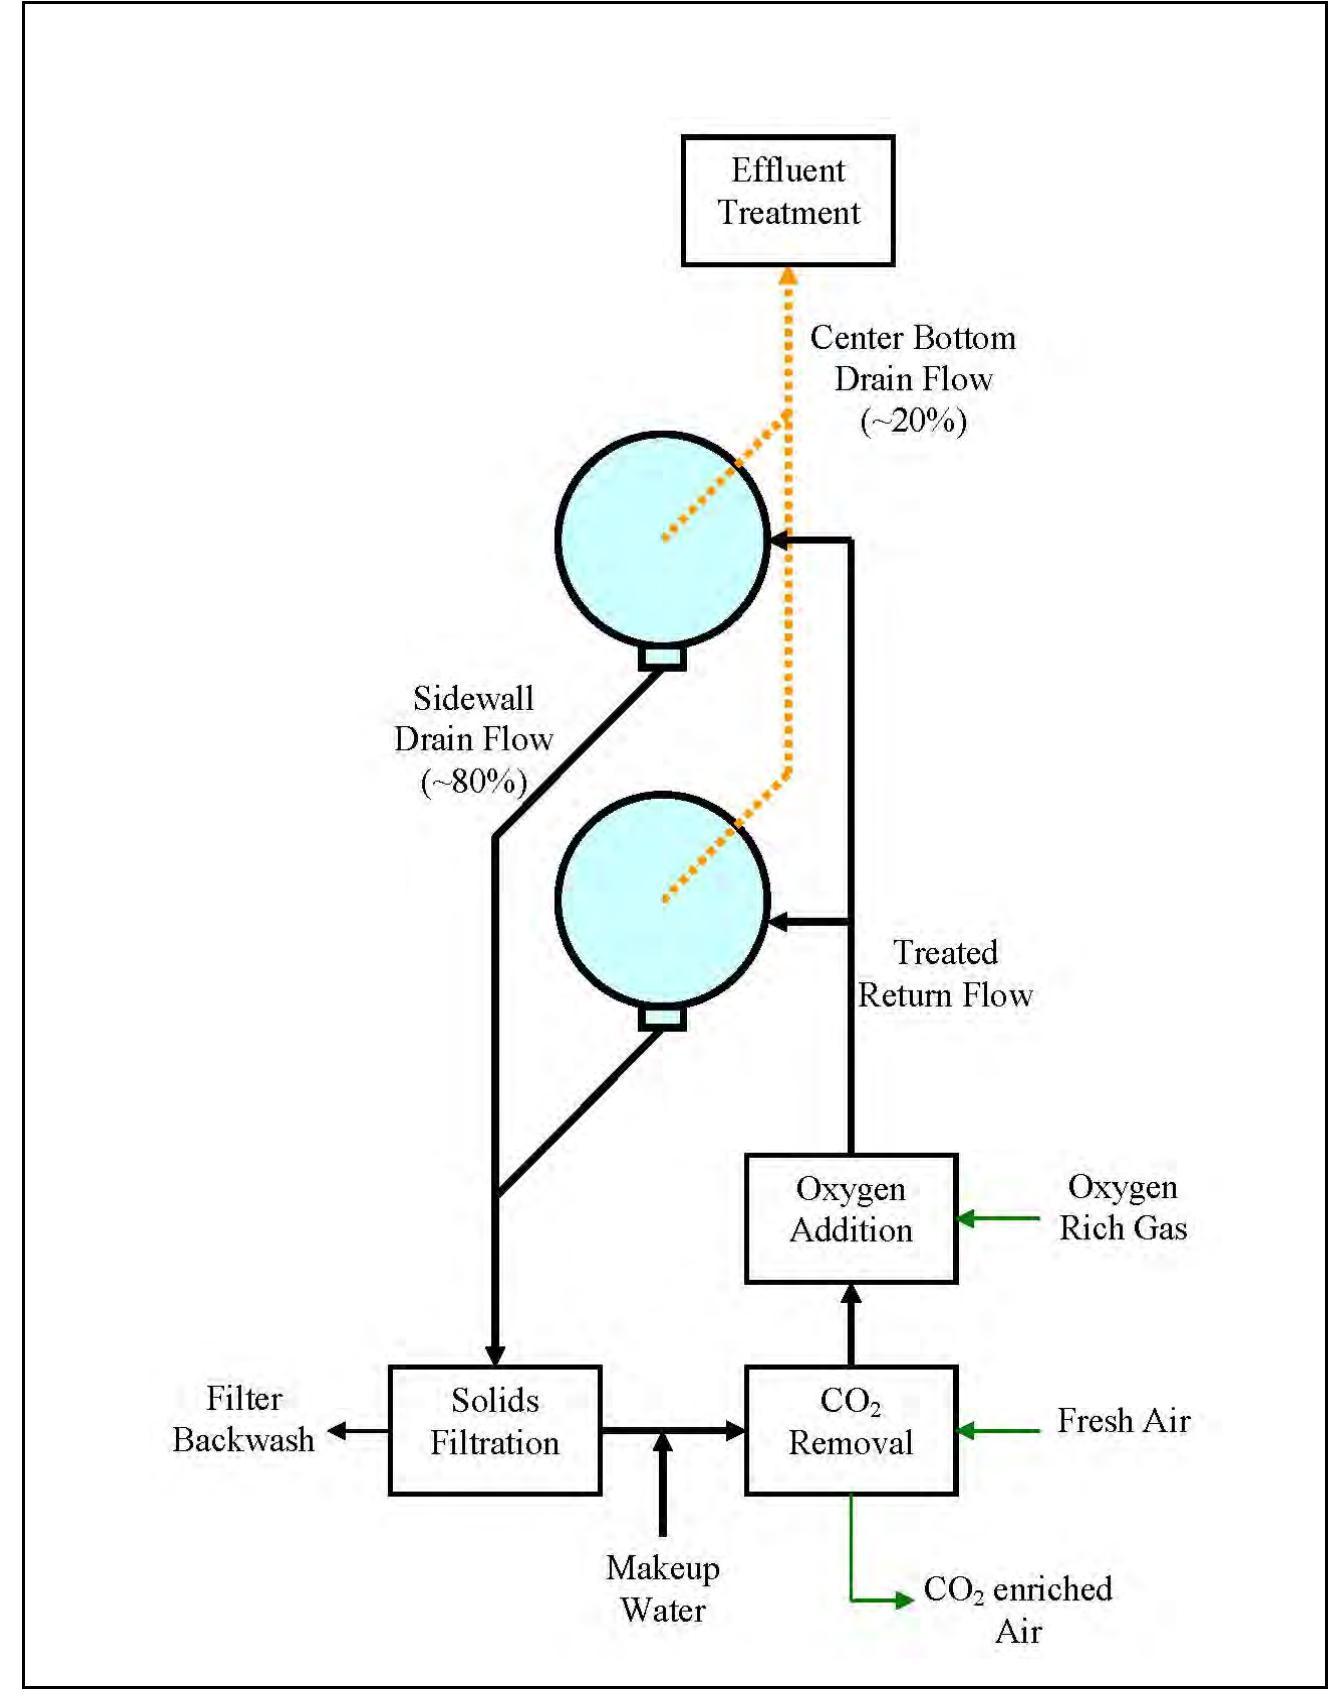
Figure 6 General Process Flow Diagram for a Partial Water Reuse System Sleepy Hollow Steelhead Rearing Facility

Solids control is critical for implementing a successful reuse system at the SHSRF. To control solids, any water being reused would be filtered in a microscreen filter with 90 micron screen media. The amount of water reuse would initially be limited to 50% (540 gpm), which improves the likelihood that solids would be controlled to maintain a low level of TSS (5 to 10 mg/L). Microscreen filters for the reuse process flow would be sized to treat the entire channel flow requirement of 1,080 gpm; this sizing allows for the full range of operations, from 50% reuse (540 gpm) to 100% reuse (1080 gpm) of the channel rearing water.

Microscreen filters would also be required to treat the river water when it has a high sediment load. It is anticipated that the reuse system would be in operation when there is a high sediment load in the river, and the river water flow requiring filtration would be 810 gpm. It is possible that the river water flow requiring filtration could range as low as 270 gpm for times when 100% of the rearing channel water is being reused, to as high as 1,350 gpm when the entire river water flow is being treated. Microscreen filters for the river water water would be sized for the range of flows from 270 gpm to 1350 gpm with a minimum of 40 micron screen media.
