Project Name: Sleepy Hollow Steelhead Rearing Facility Raw Water Intake and Water Supply System

Lead Agency: Monterey Peninsula Water Management District

INITIAL STUDY/MITIGATED NEGATIVE DECLARATION SLEEPY HOLLOW STEELHEAD REARING FACILITY RAW WATER INTAKE AND WATER SUPPLY SYSTEM UPGRADE

September 2016

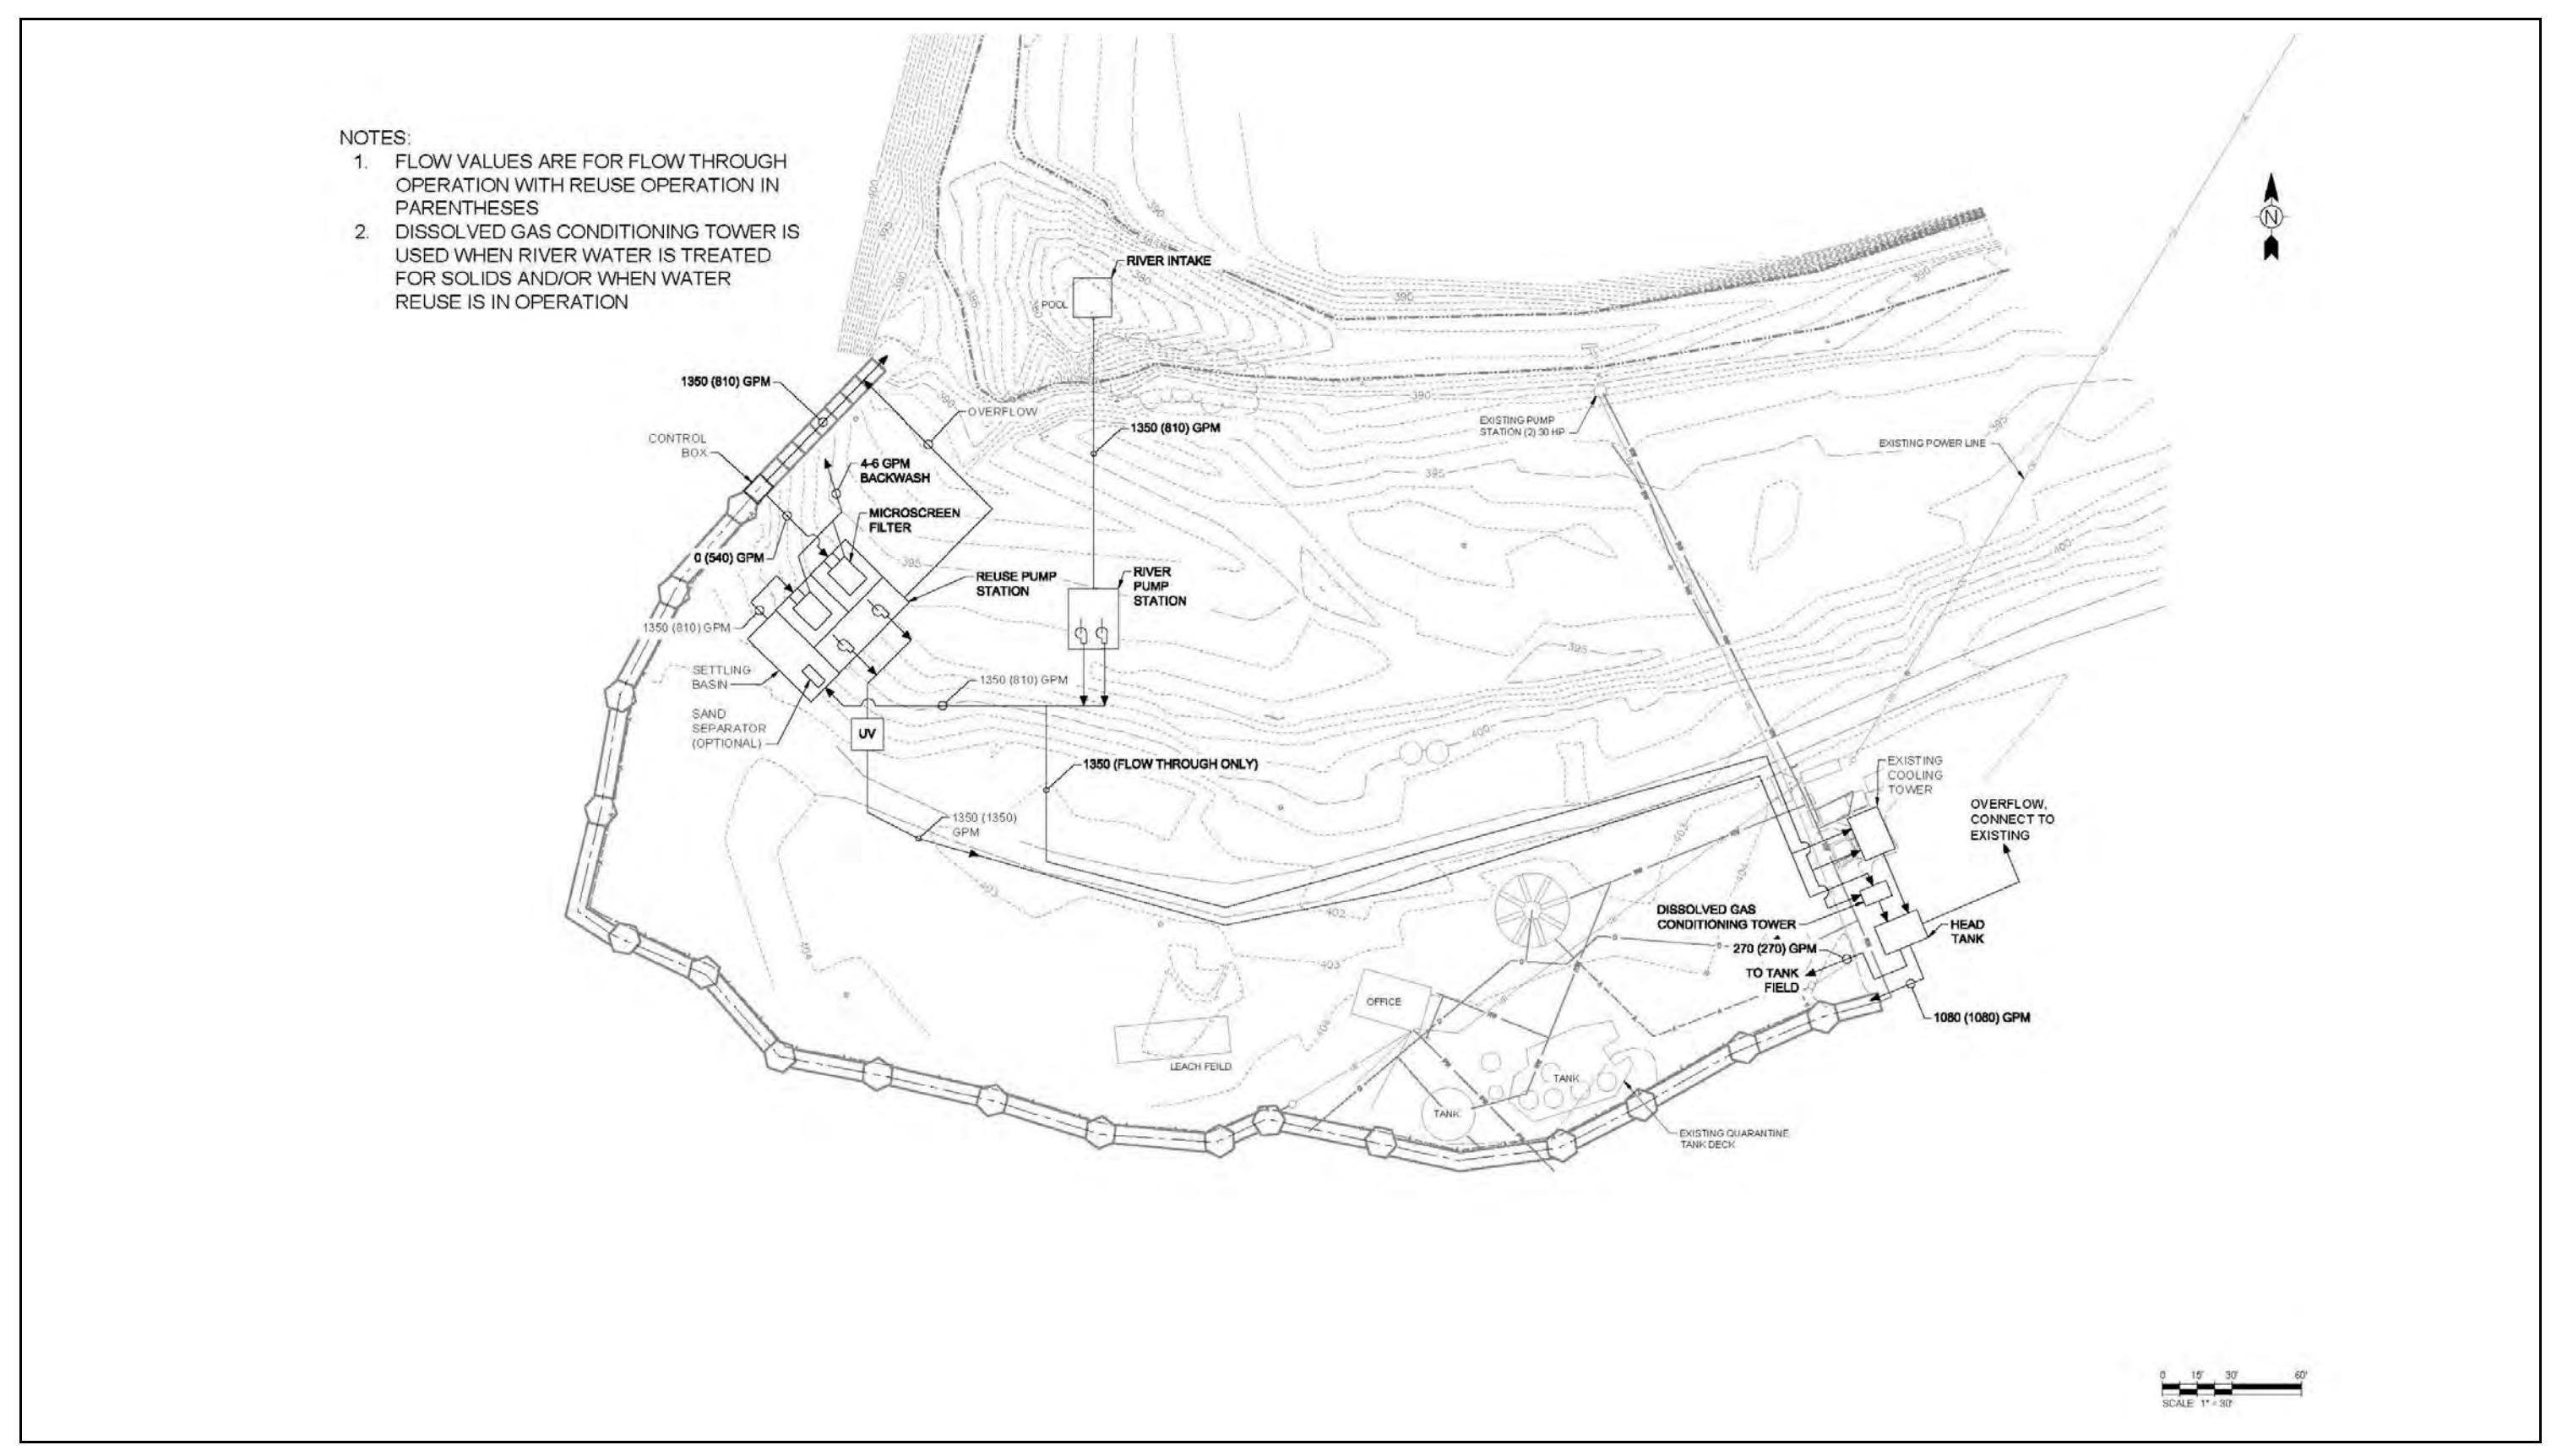
Figure 7 Process Flow Plan Sleepy Hollow Steelhead Rearing Facility

cooling tower or in the dissolved gas conditioning tower, it would flow by gravity to a new head tank to supply water to the rearing channel (1080 gpm) and tank field (270 gpm).

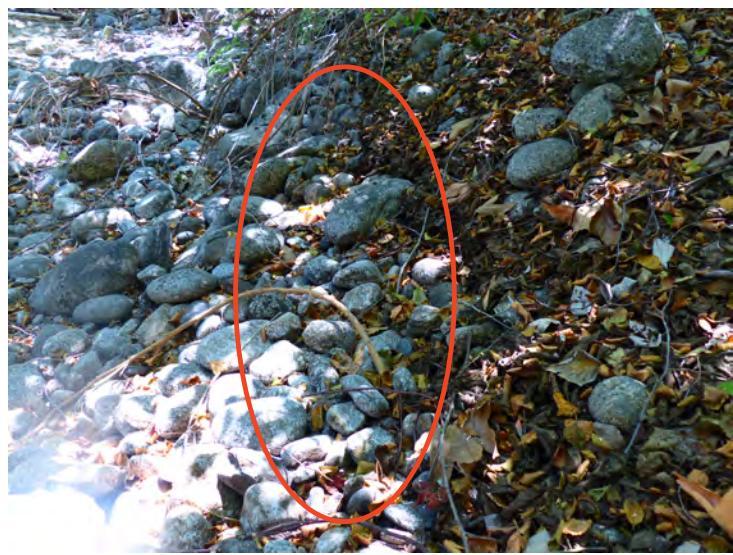
Photo 1. Example of Scour Line at Ordinary High Water

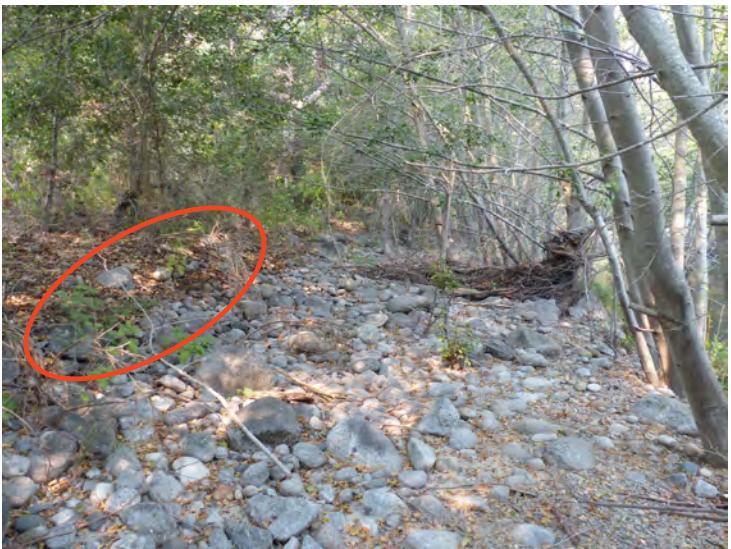
Photo 3. Example of Vegetation Transition at Ordinary High Water

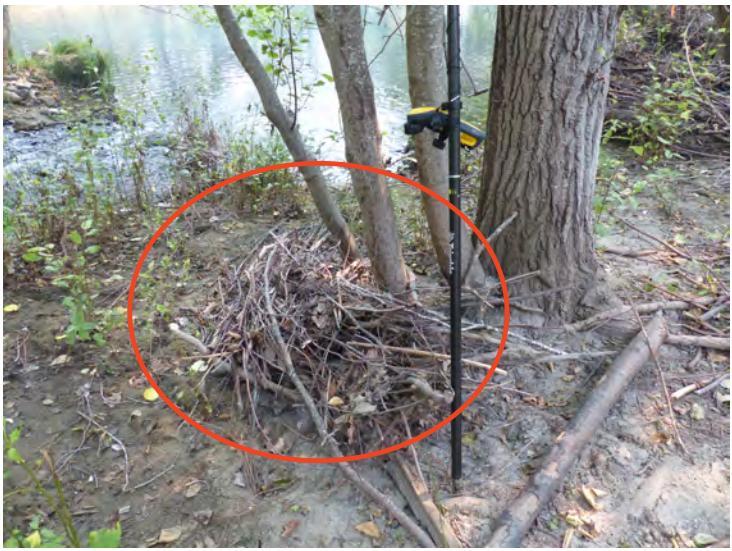
Photo 2. Example of Typical Drift Deposit
