City of Pacific Grove

Sewer System Asset Management Plan

HDR
May 2004

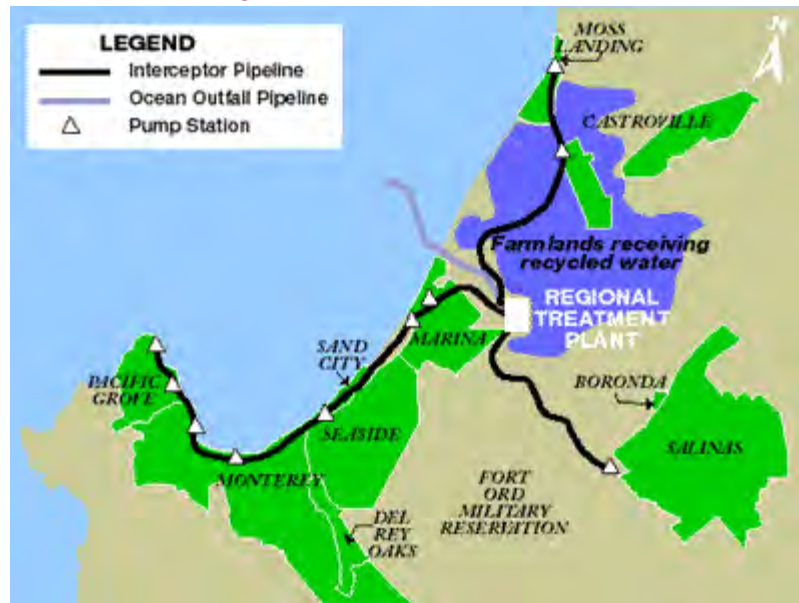
Figure 1-2: MRWPCA Facilities

The City provides sewer services for the residents. The City owns and operates the sewer collection system consisting of approximately 58 miles of pipelines (which vary in size from 4 to 18 inches in diameter), 900 manholes, and seven pump stations. An additional two pump stations that serve the City of Pacific Grove are owned by Monterey Regional Water Pollution Control Agency (MRWPCA). The collected wastewater is conveyed to the MRWPCA treatment plant by an interceptor pipeline that is located along the coast by the City's of Monterey, Seaside, and Marina. Figure 1-2 shows the MRWPCA interceptor serving the City of Pacific Grove and other MRWPCA facilities.

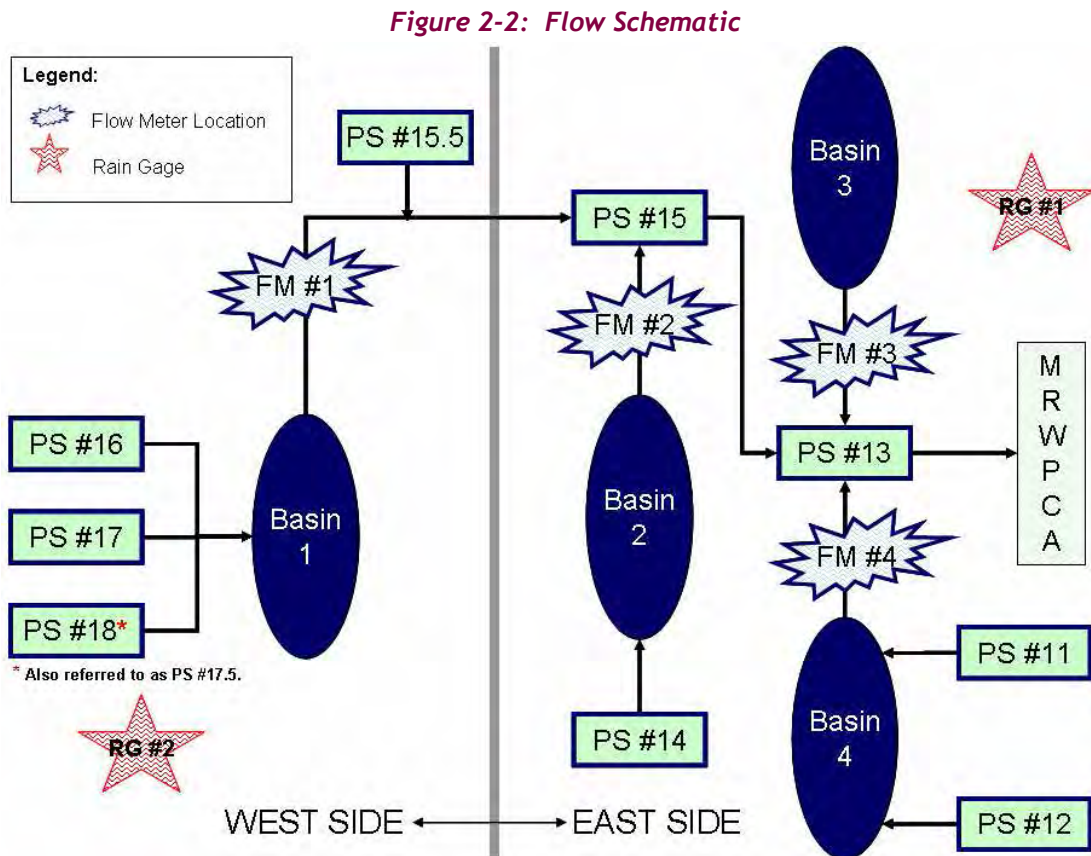
PS #18, PS #16, PS #15.5, and PS #14 flow to PS #15. The flow from PS #15 travels by force main directly to PS #13. PS #11 and PS #12 flow to PS #13. PS #13 conveys all the flows from the City to the WWTP.

Figure 2-2 presents the flow schematic and Figure 2-3 depicts the sewer basins.

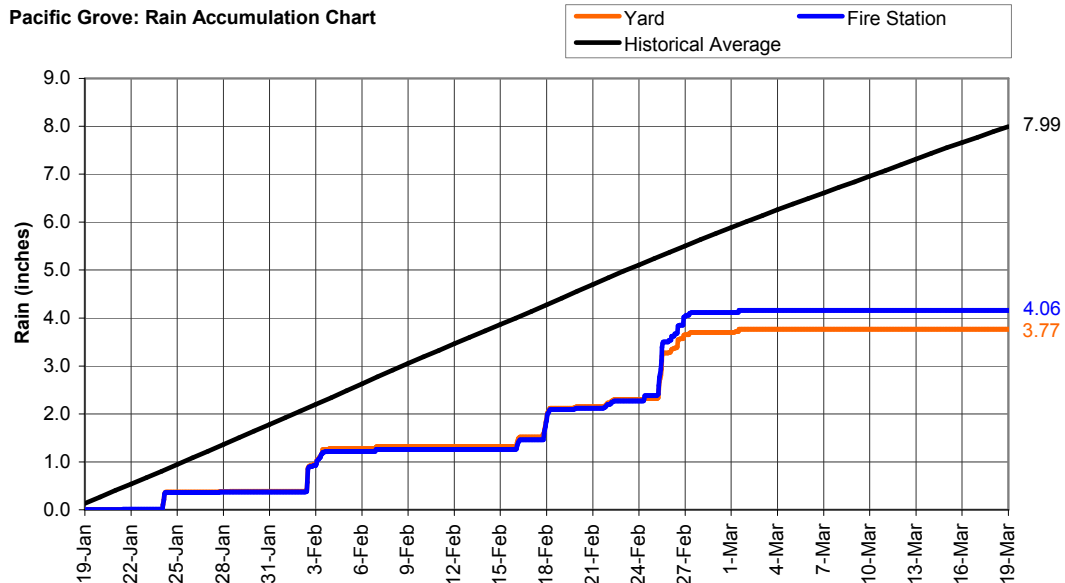
Figure 5-3: Cumulative Rainfall

The total rainfall during the flow monitoring period was 4.16 inches at the Fire Station RG and 3.77 inches at the Yard RG. Figure 5-3 shows that this is approximately half of normal levels based on the average rainfall of 7.99 inches for the period January – March (Western Regional Climate Center (WRCC) at Station 045795 in Monterey, California 1971 - 2000).

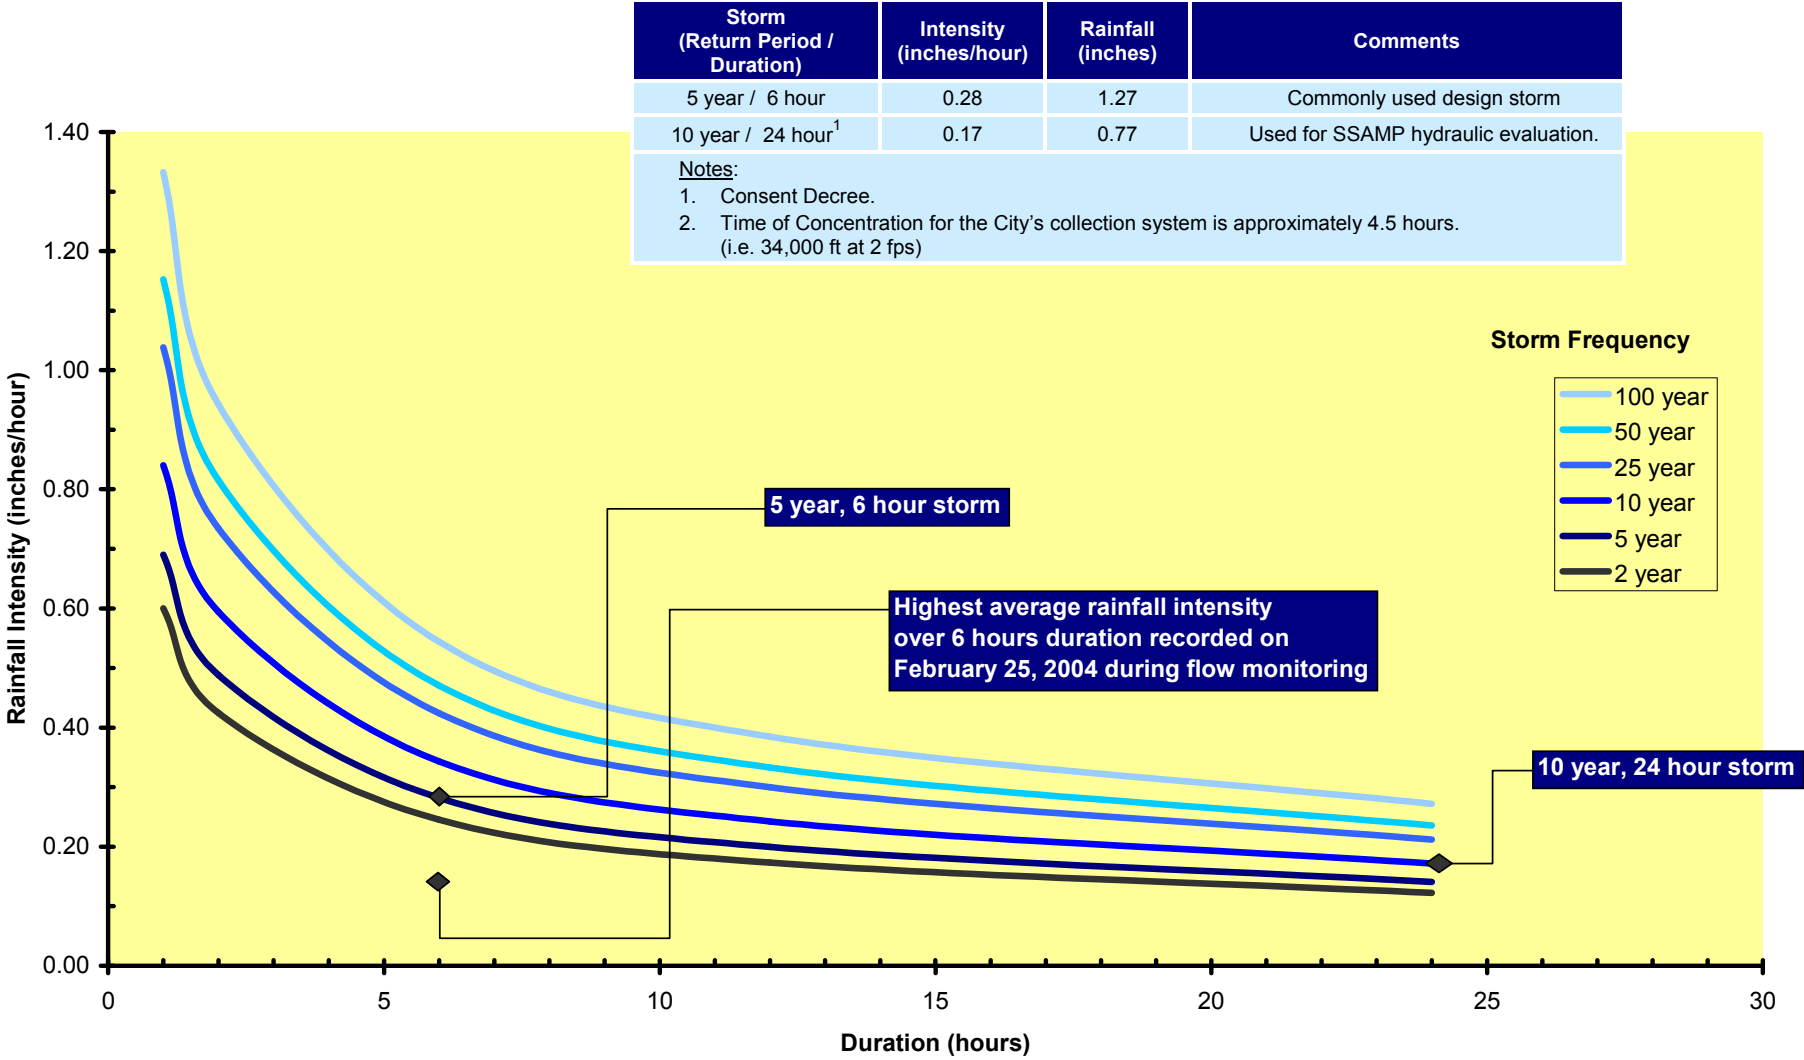
Figure 5-6: Intensity-Duration-Frequency (IDF) Curves

To aid the City in determining the Intensity-Duration-Frequency (IDF) of a storm event, Figure 5-6 was developed. To determine the frequency and duration of a storm event (i.e. 10 year 6 hours), the intensity and duration (from rain gauge data) of a particular storm event is used. The frequency is determined by where the two values intersect in the graph. For example, if a storm event had an average intensity of 0.28 inches/hour for 6 hours, it is a 5 year 6 hour storm. The source data for the IDF curves are contained in Appendix N.
