# FLOOD INSURANCE STUDY

## MONTEREY COUNTY, CALIFORNIA AND INCORPORATED AREAS

FLOOD INSURANCE STUDY NUMBER  
06053CV001A

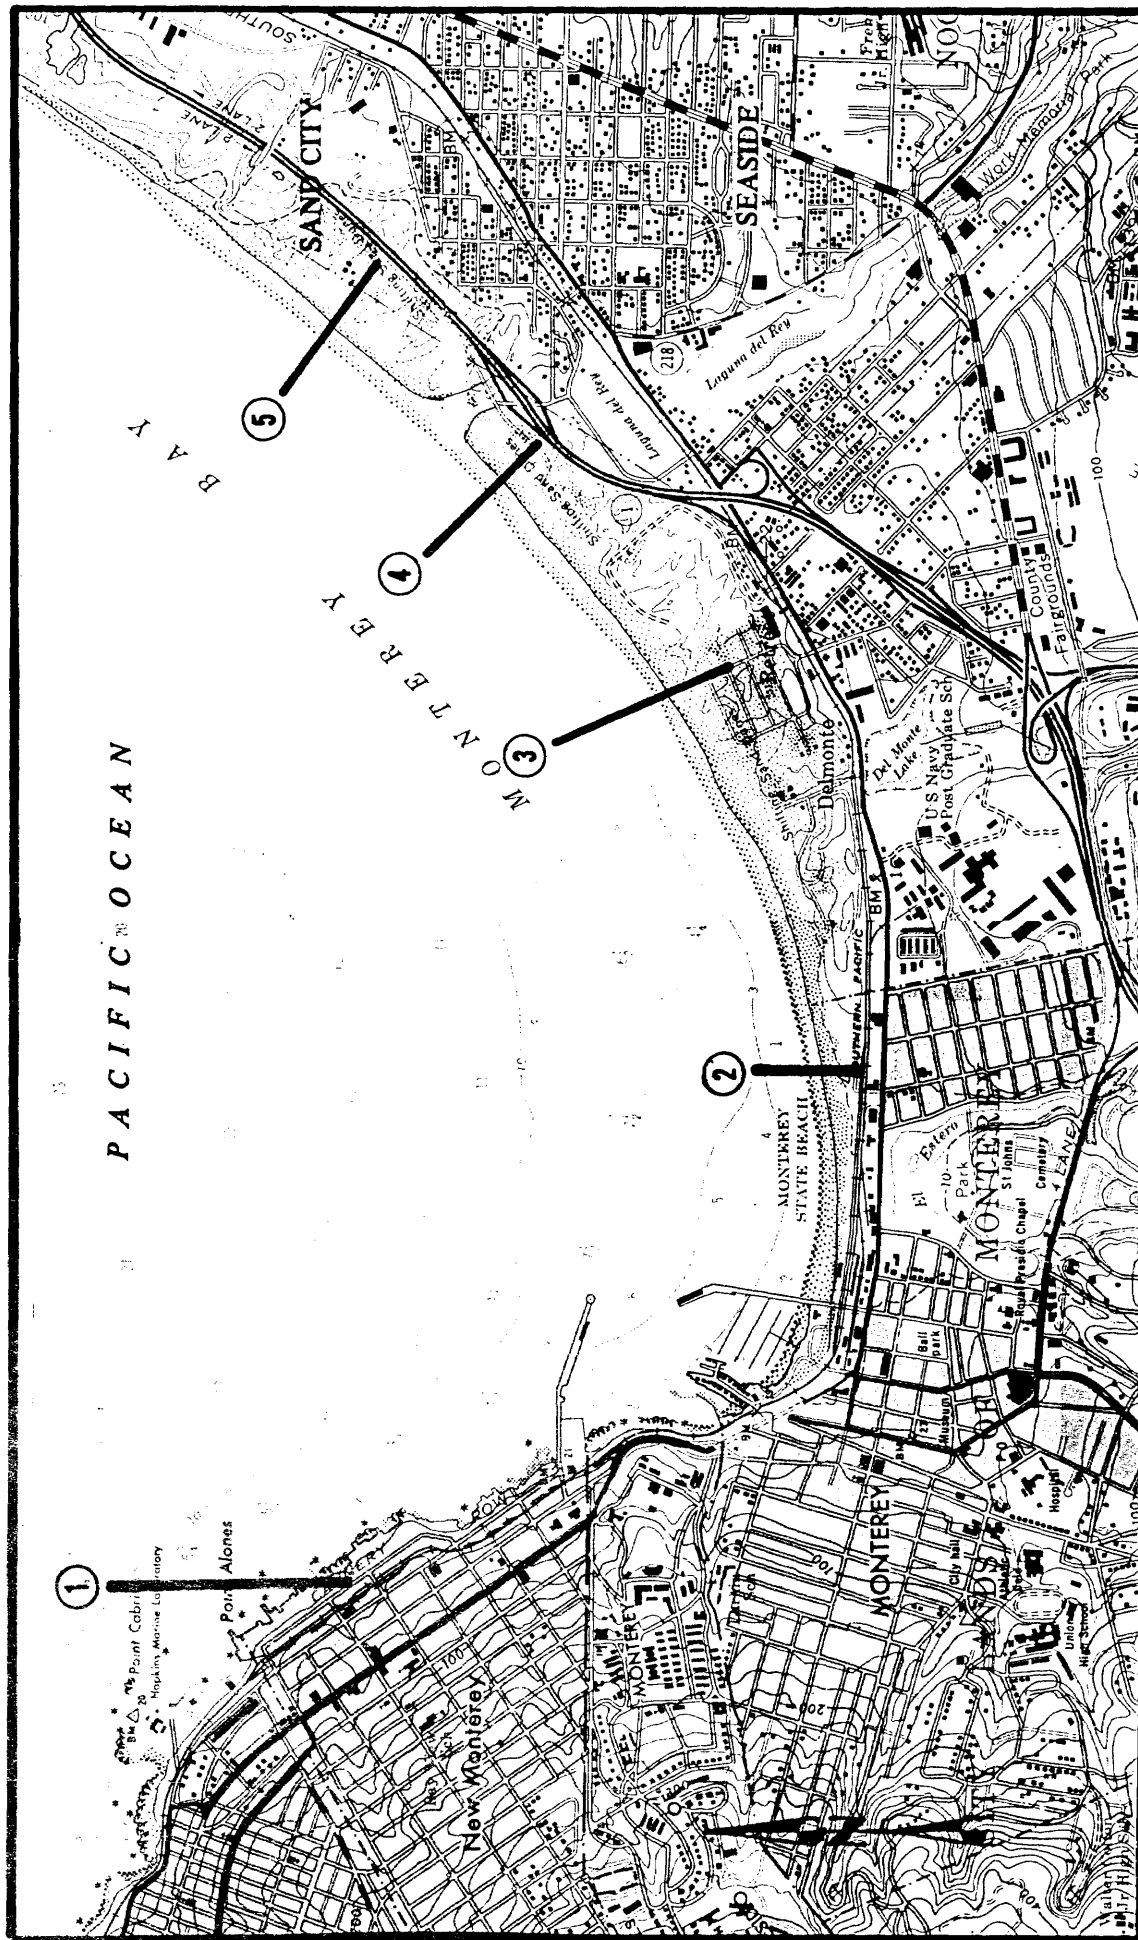
**FIGURE 5**

APPROXIMATE SCALE IN FEET  
 1000 0 1000 3000 5000 7000  
**TRANSECT LOCATIONS**

<u>Transect</u>	<u>Study Area</u>	<u>Location</u>
1		From the water's edge approximately 1,400 feet northwest from the U.S. Coast Guard Wharf Pier and southwest to Cannery Row.
2		From the water's edge, south to La Playa Street, east of Park Avenue.
3		From the coastline, southwest to the intersection of Surf Way and Tide Avenue.
4		From the water's edge southeast across the southwestern side of the Holiday Inn to Sands Dunes Drive.
